HYDROGEOLOGY, GEOCHEMISTRY, AND PUBLIC HEALTH ASPECTS
OF ENVIRONMENTAL IMPAIRMENT AT AN ABANDONED
LANDFILL NEAR AUSTIN, TEXAS

THOMAS PHILLIPS CLARK, B. A.

THESIS

May 1972

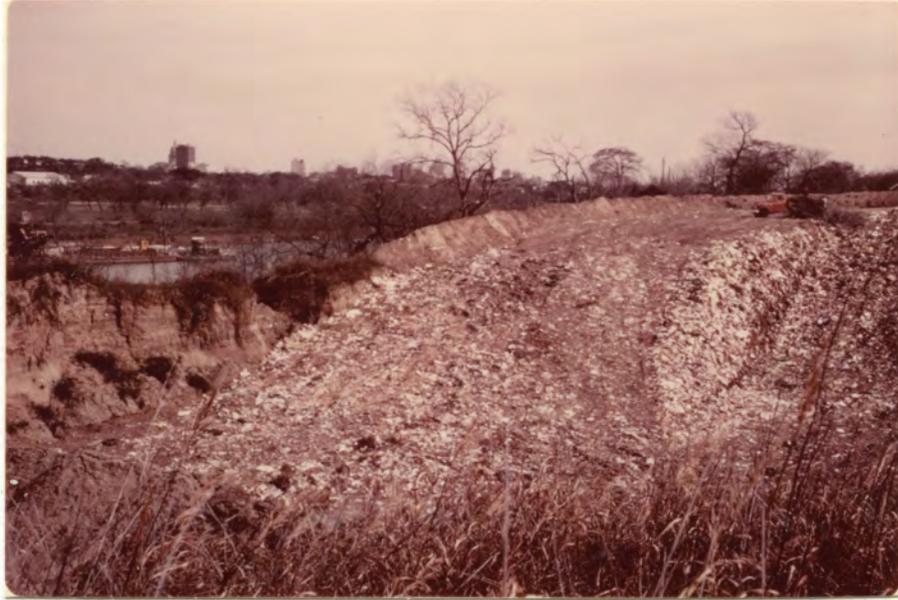
Plate 5 Butler landfill as it appeared in operation during 1966.

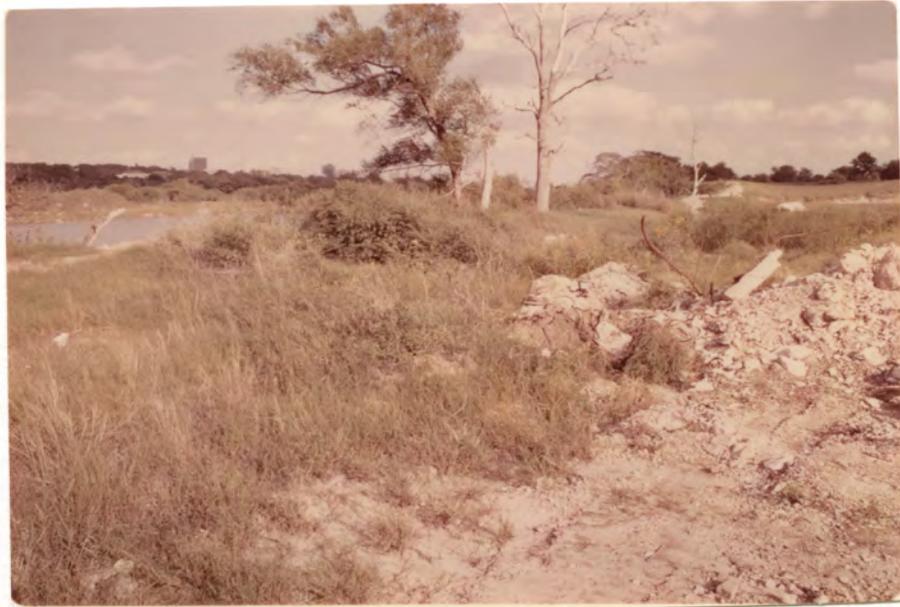
Plate 6 Butler landfill site in 1970, viewed toward east. Note Colorado River in background.

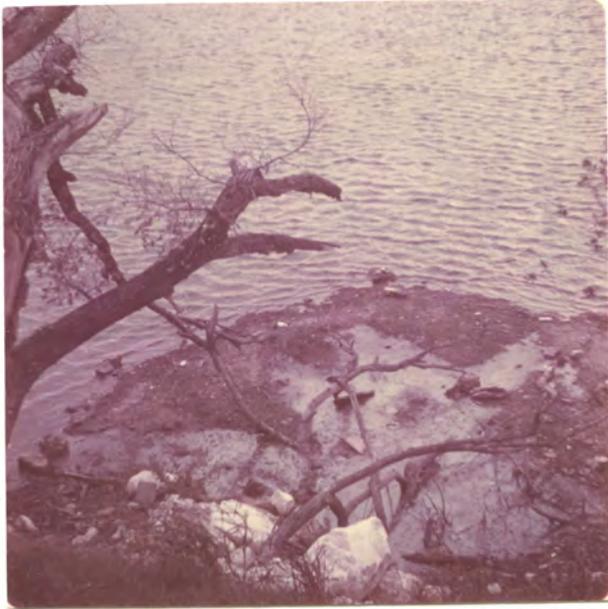
Plate 7 Leaching of pollutants into Colorado River from old Butler landfill. The waters of this part of the Colorado, called Town Lake, were judged unfit for contact sports in 1970; urban storm runoff and contributions from seeps like this add to water quality deterioration.

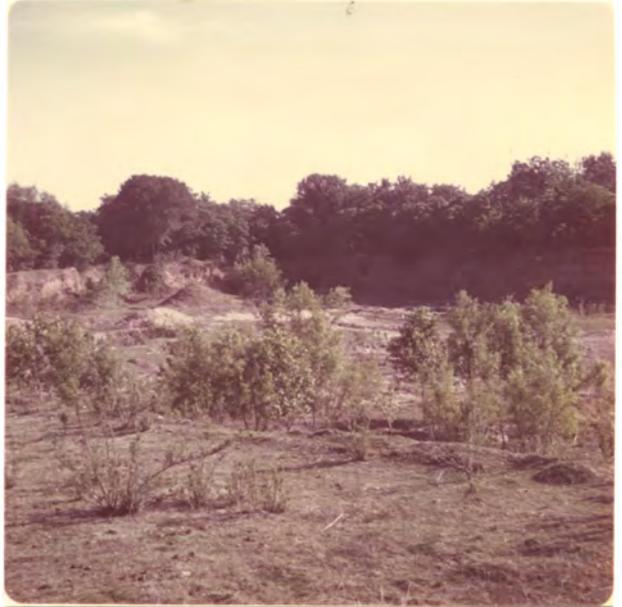
The Grove landfill (Plate 8) was abandoned within the past two years. It is also located in terrace deposits along the south bank of the Colorado River. Here, however, most of the material is sand rather than gravel. Although the movement of water through this fill may be an order of magnitude slower than through the gravel at the Butler site, the poor location of the site in an abandoned sand pit would appear to offset this apparent advantage.

Plate 8 Grove landfill viewed north toward Colorado River, showing beginning of revegetation on floor of old sand pit. River is just beyond line of trees in background.

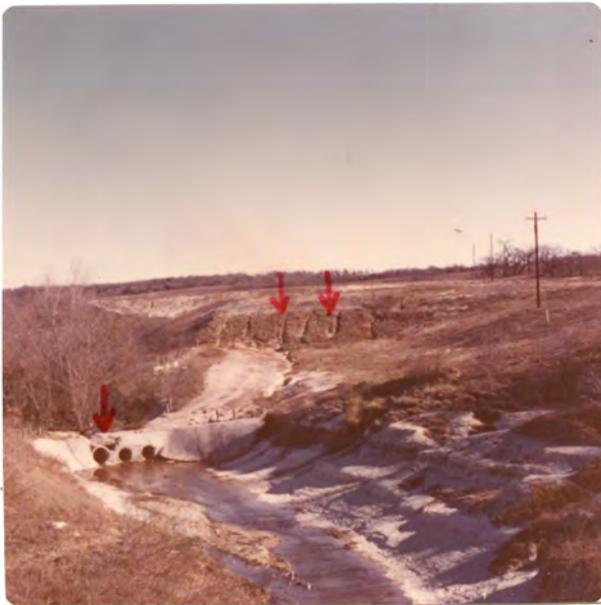
Plate 9 Deterioration of Section III. Arrows show areas of rapid erosion and destruction of concrete access bridge, viewed toward north.

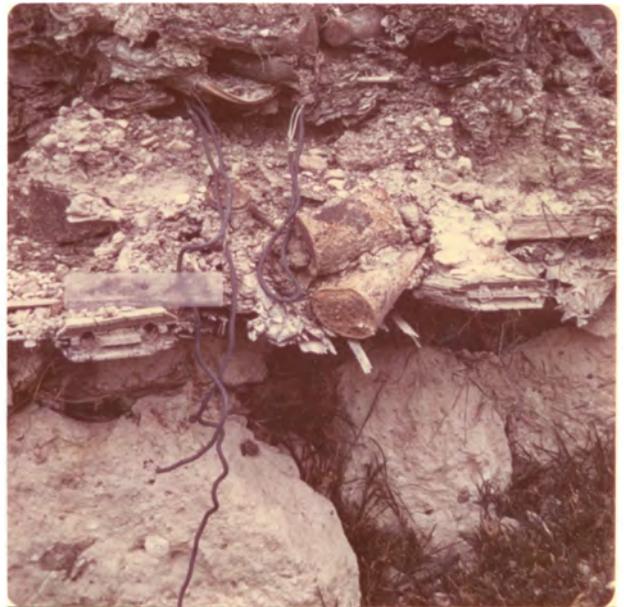
Plate 10 Contact of refuse cell with underlying Dessau limestone. Leachate emergence is concentrated at the contact along the west side of Section III.

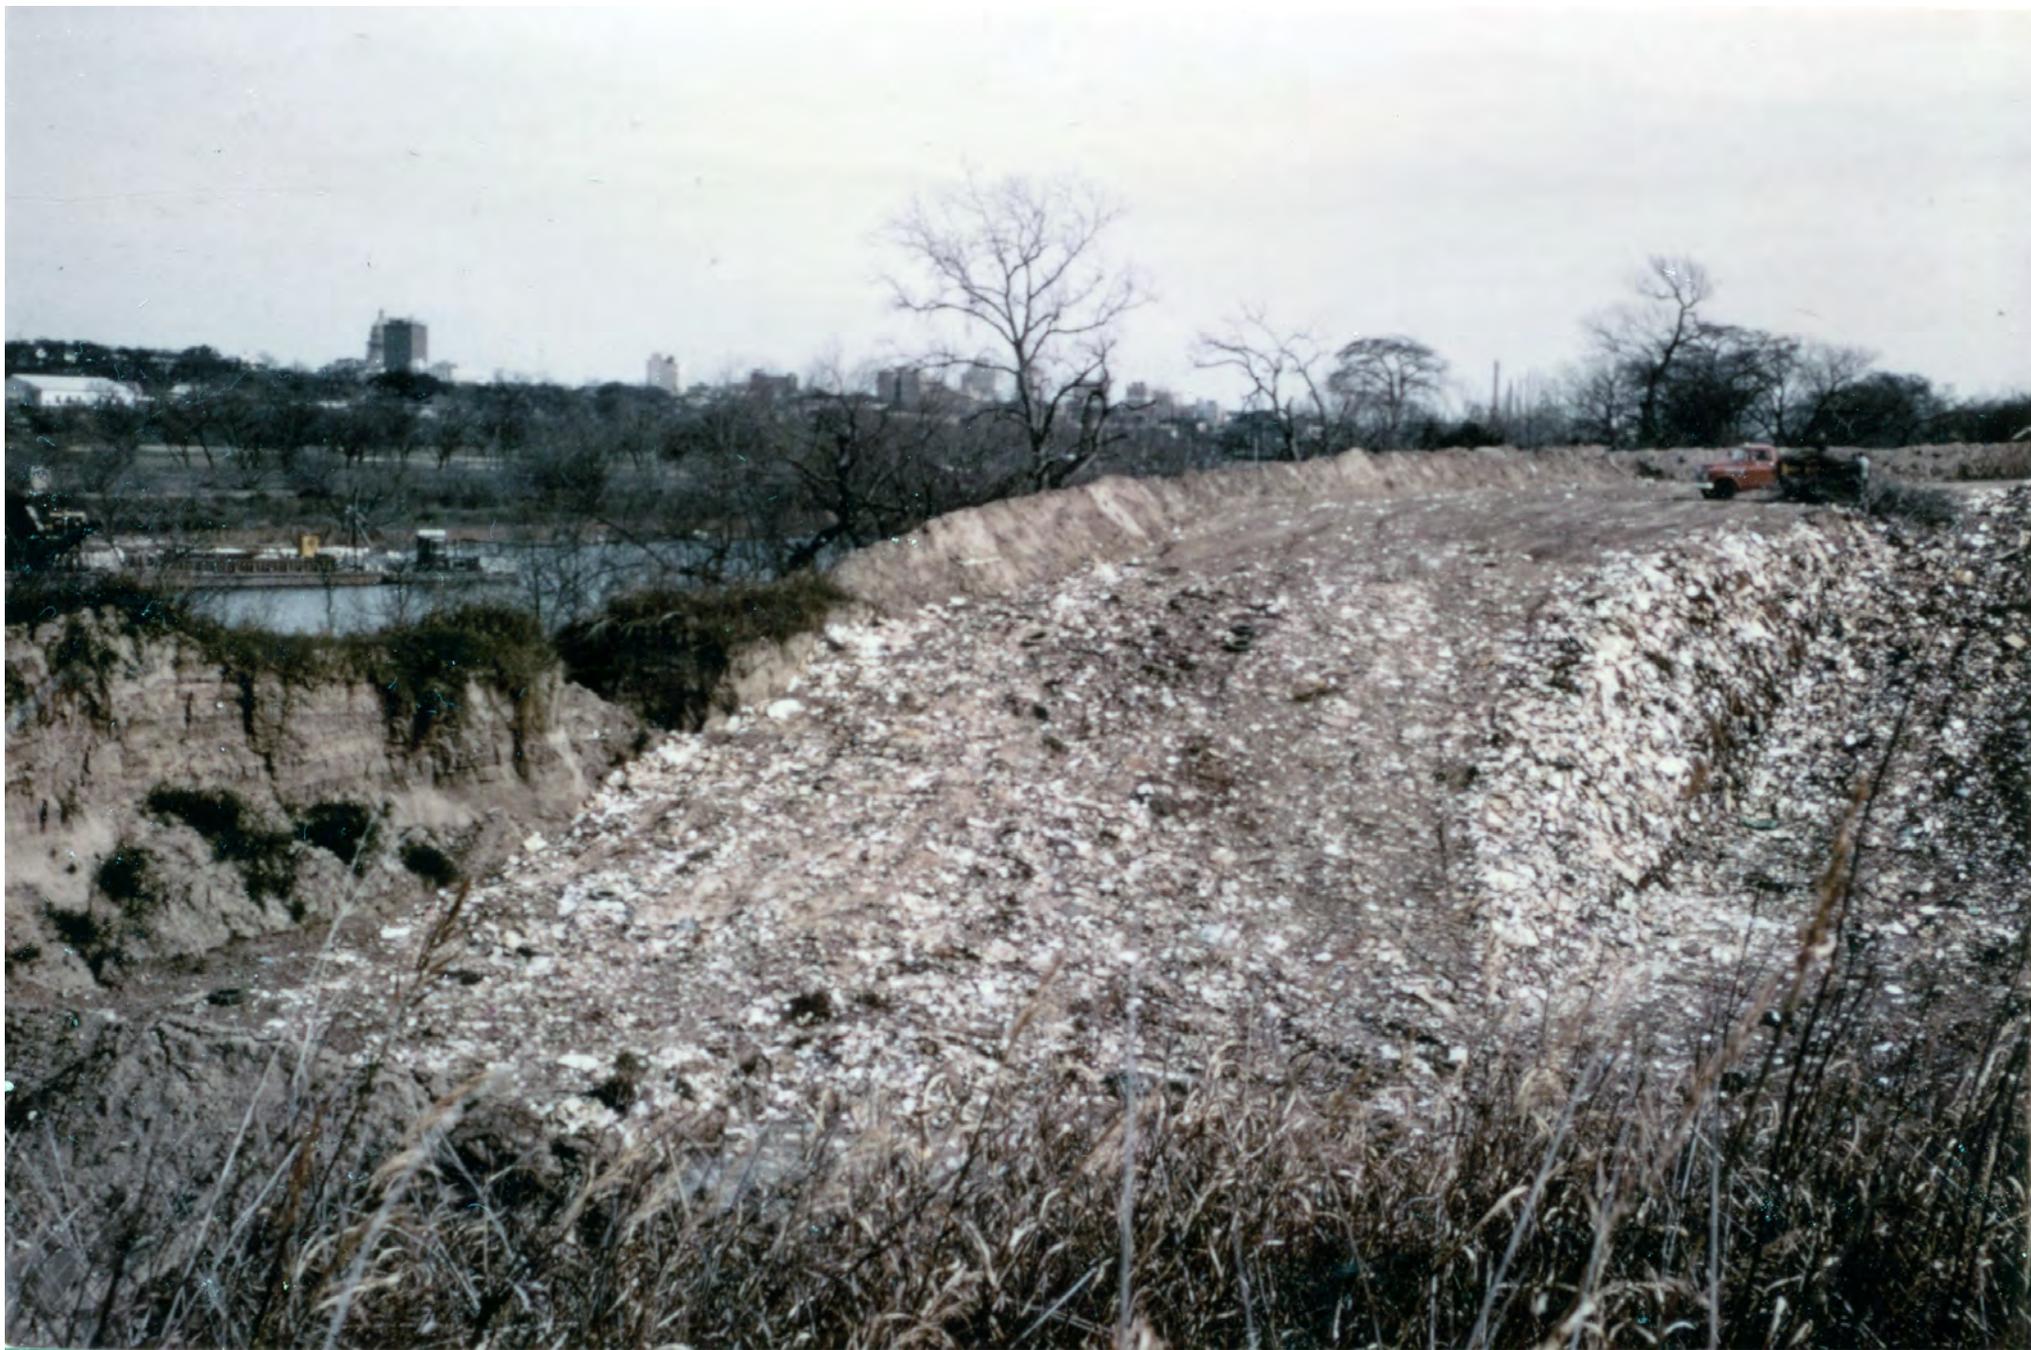
Plate 5

Butler Landfill as it appeared in operation during 1966

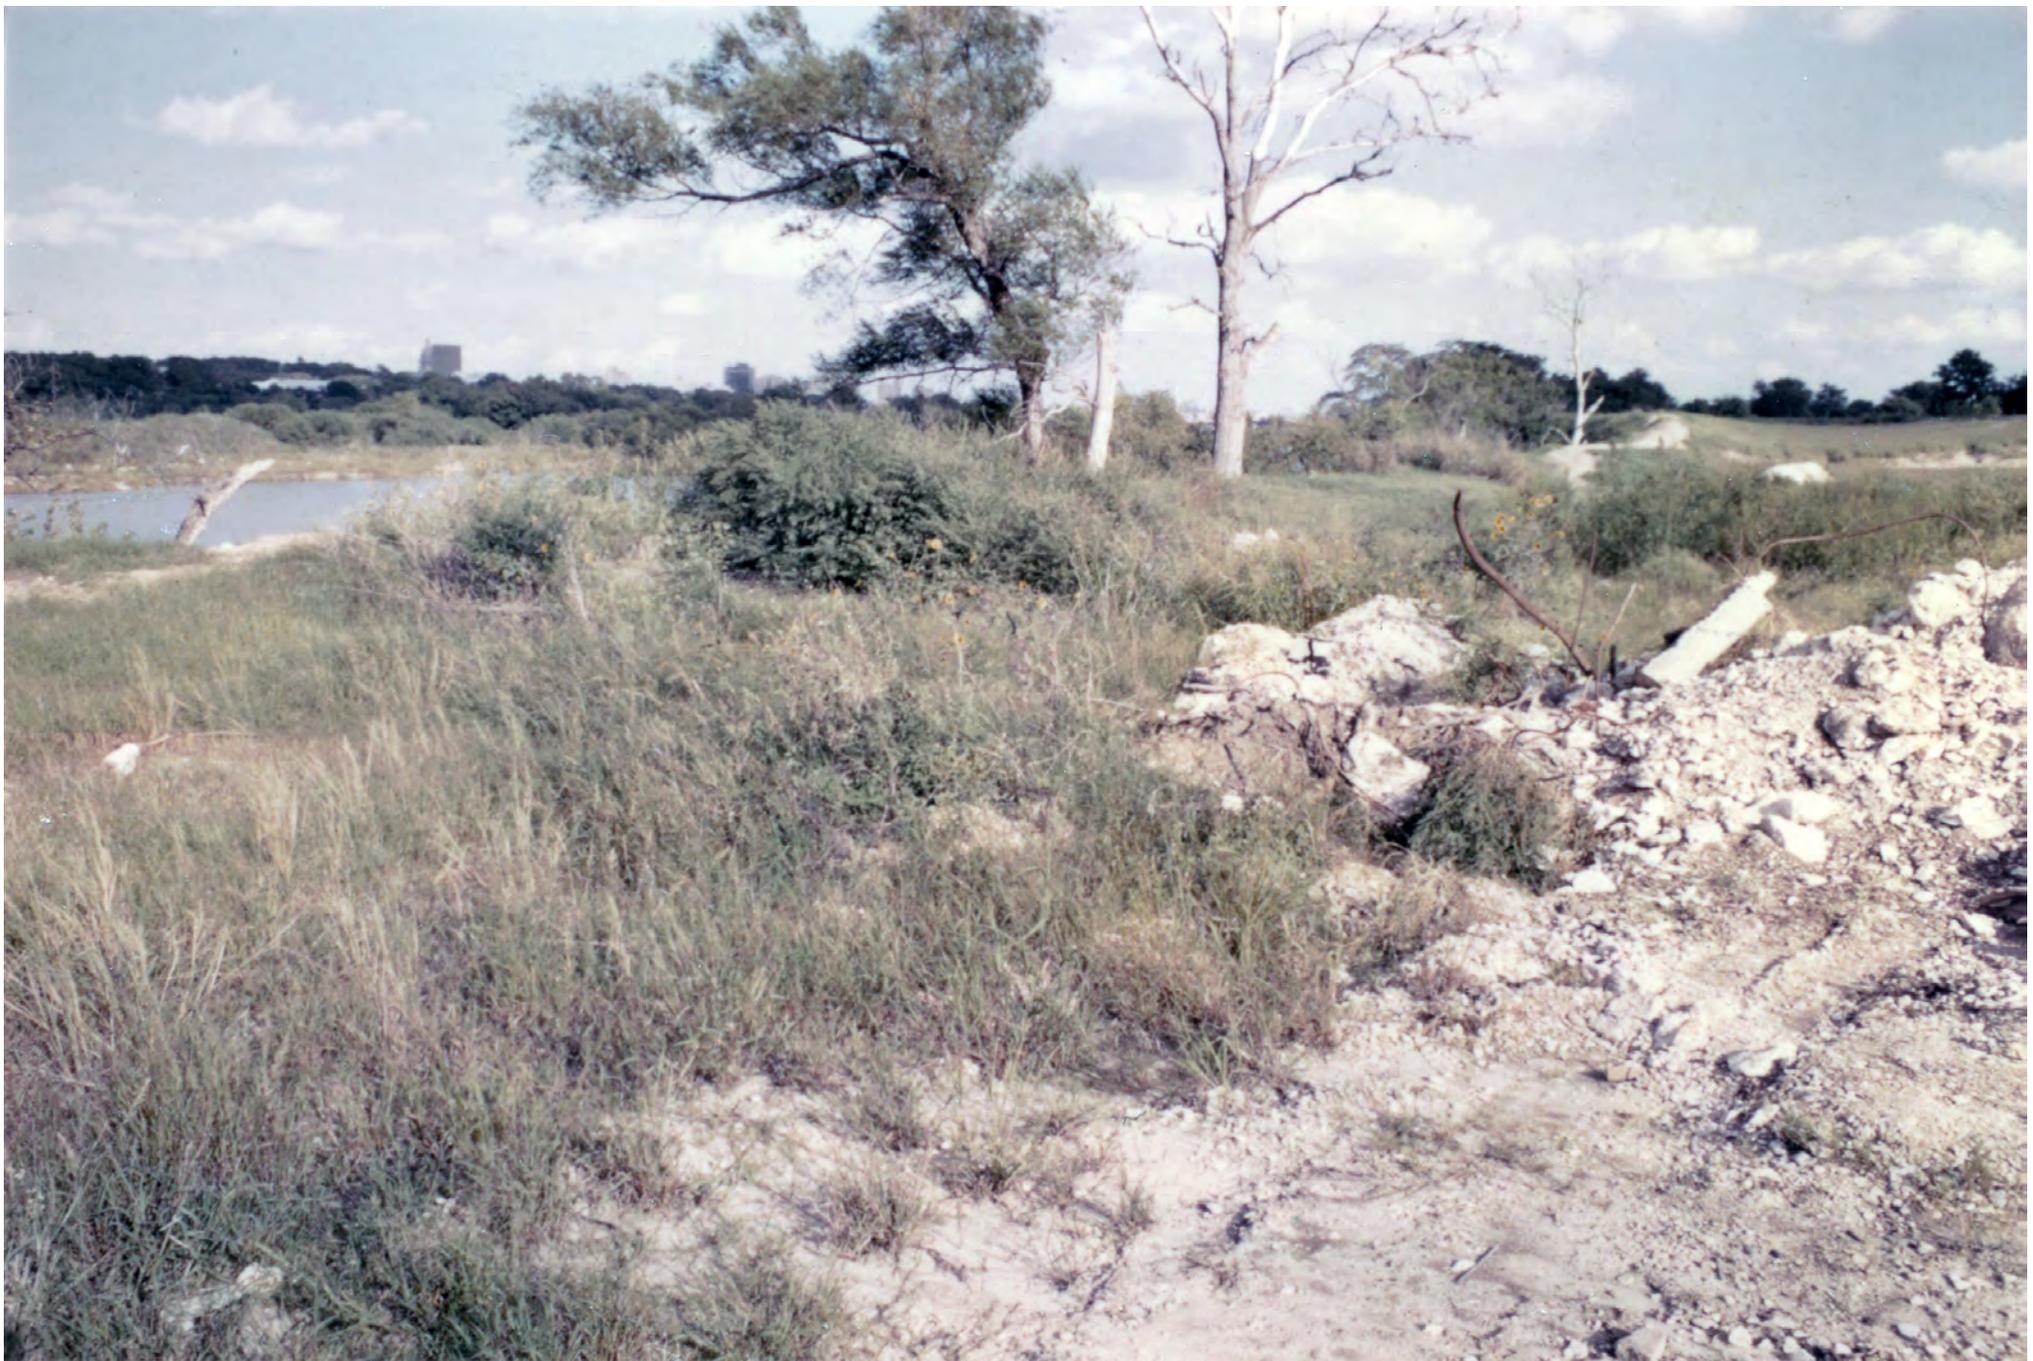
Plate 6

Butler Landfill site in 1970, as viewed toward east.
Note Colorado River in background.

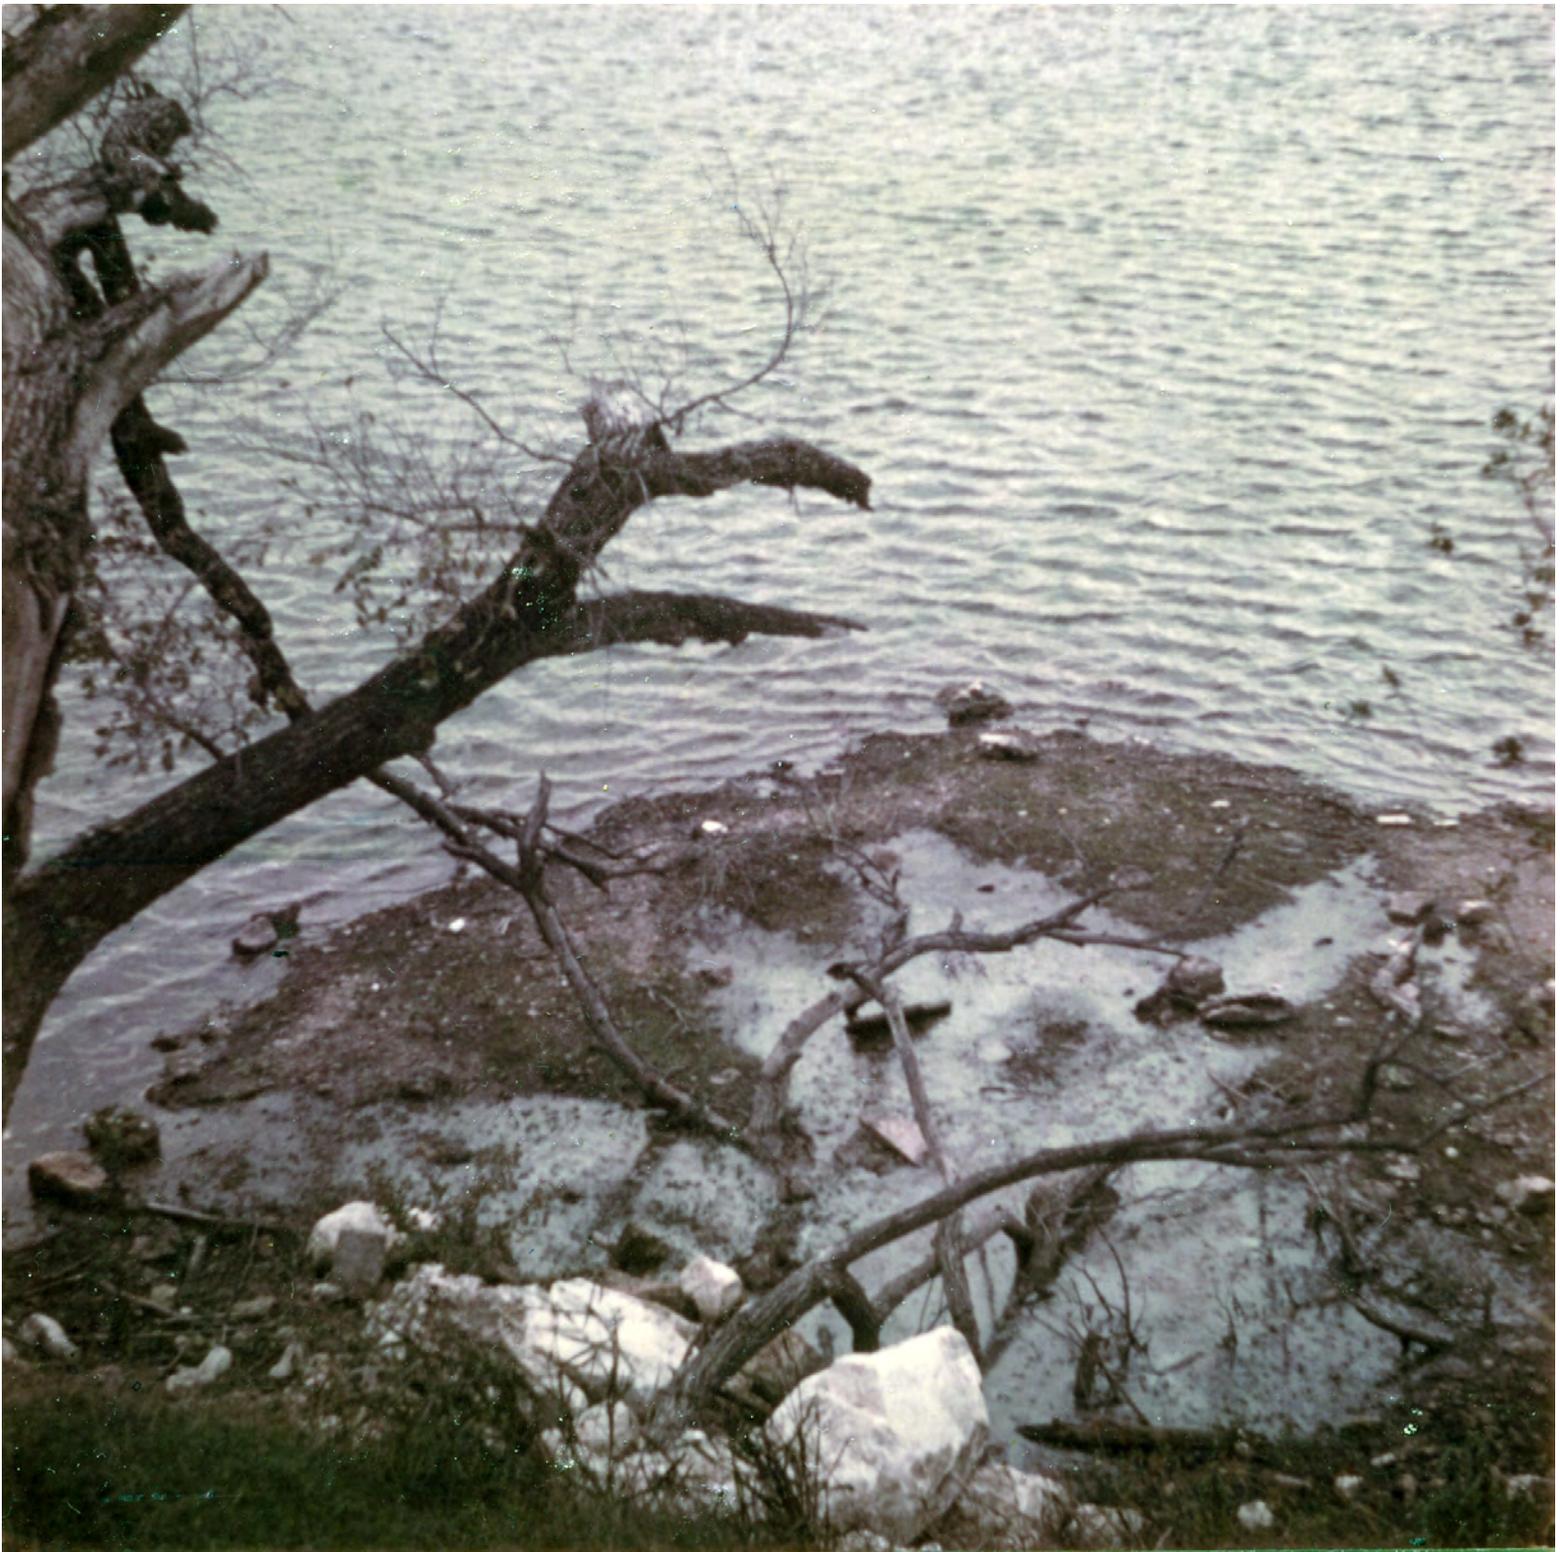
Plate 7

Leaching of pollutants into Colorado River from old Butler landfill. The waters of this part of the Colorado, called Town Lake, were judged unfit for contact sports in 1970; urban storm runoff and contributions from seeps like this add to water quality deterioration.
