# Zilker Park Bathhouse Zone Feasibility Study

City of Austin  
Parks + Recreation Department

## MWM Design Group

June 10, 2016

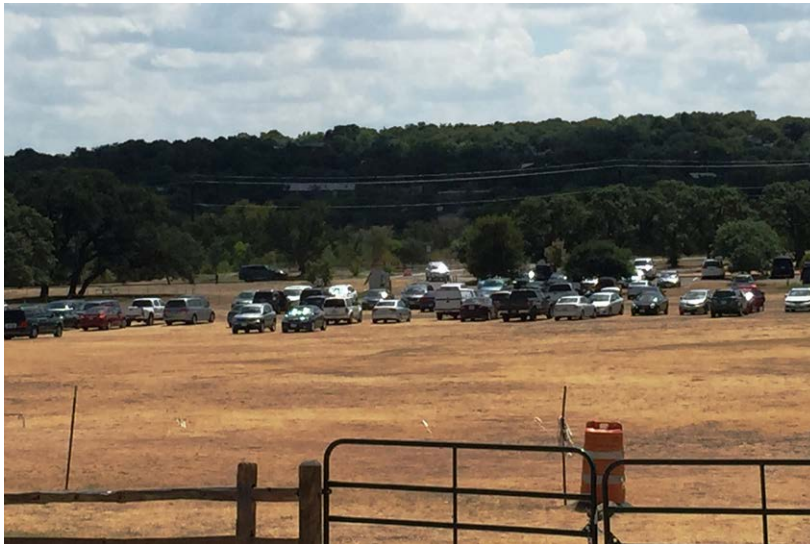
**Site Circulation:** The use of landscape areas of the park for parking and pedestrian circulation has resulted in extensive environmental degradation, most specifically within the critical root zones of trees in the park.

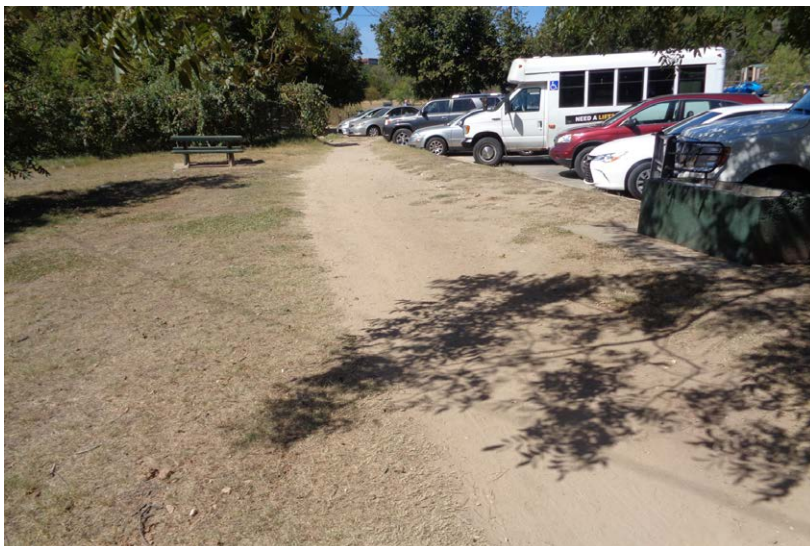
**Site Circulation:** Pathways such as this bare-earth trail to the north of the Violet Crown Trailhead do not well serve existing demand.

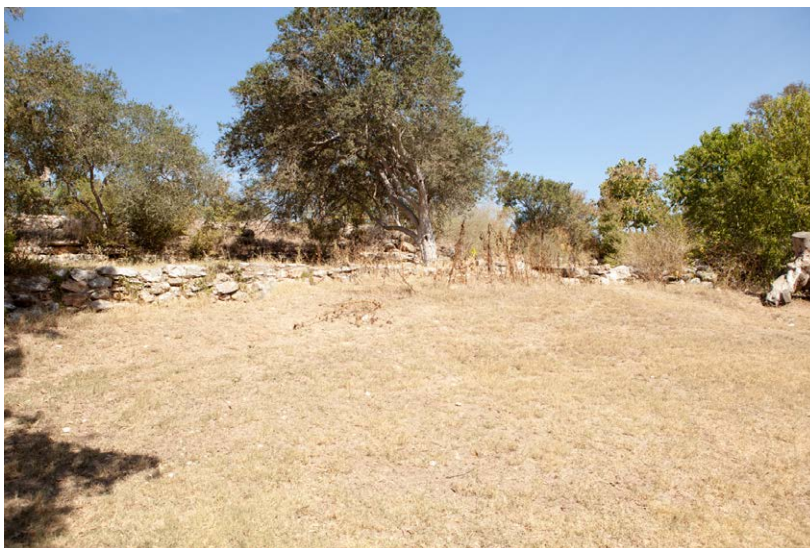
**Site Circulation:** The lack of coordination between pedestrian and vehicular amenities within the park has resulted in the development of ad-hoc trails across vegetated areas. Rationalization of trails and other pedestrian amenities will concentrate pedestrian traffic in designated corridors, mitigating damage to lawns and trees within the park and allowing for effective provision of amenities such as trash receptacles and drinking fountains.

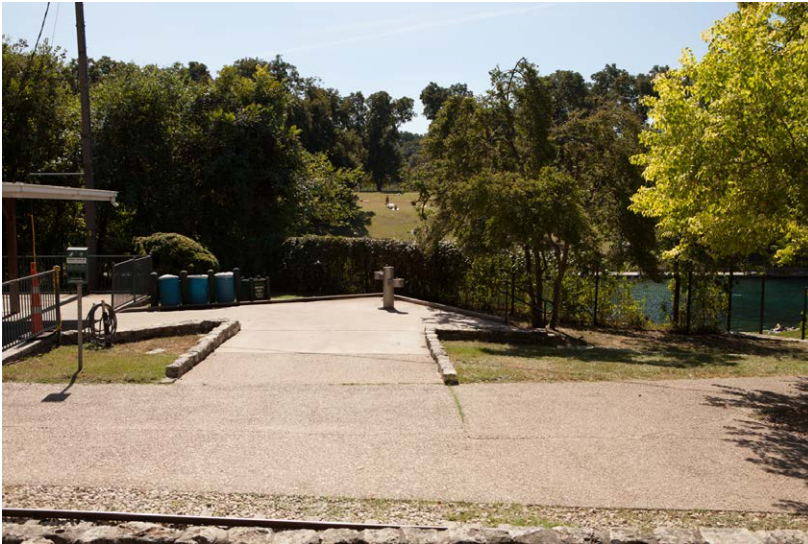
**Picnic Pavilion:** The Picnic Pavilion and its infrastructure (such as pedestrian connections, waste receptacles, and drinking fountain) are generally serviceable.

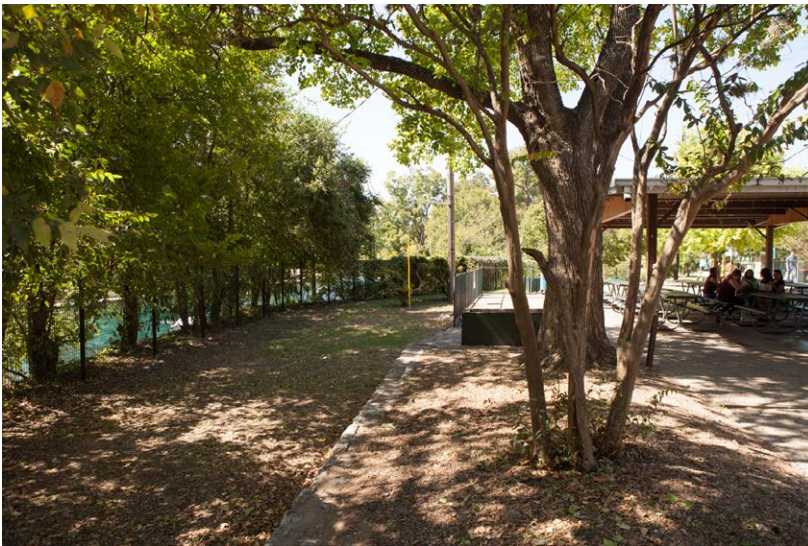
**Picnic Pavilion:** The Pavilion itself is too small for the number of tables it contains, many of which are poorly protected from sun and rain.

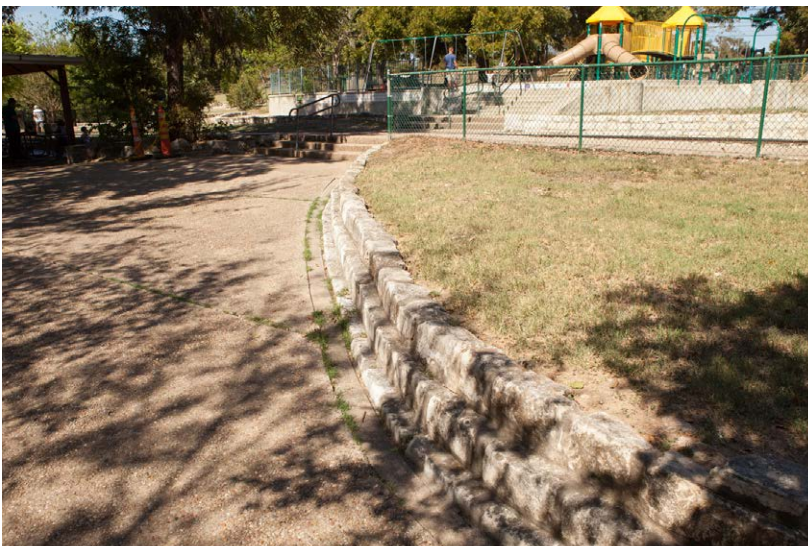
**Picnic Pavilion:** The Pavilion is well-located adjacent to the Playscape, although changes in grade, and the intervening Zilker train trackway, compromise this adjacency.

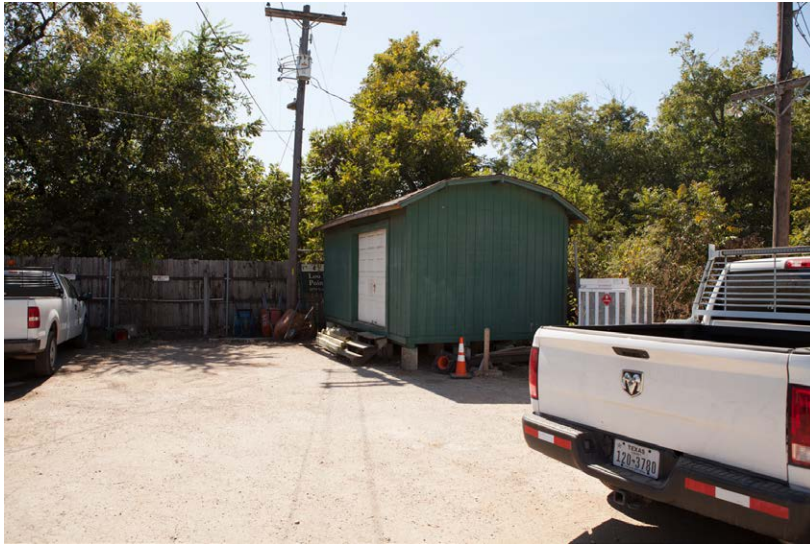
**Maintenance Yard:** Improvised storage, as in the form of this portable building, is a problem throughout the Bathhouse Zone. The quantity of equipment stored in the open-air at the Maintenance Yard indicates that even improvised storage is at a premium.

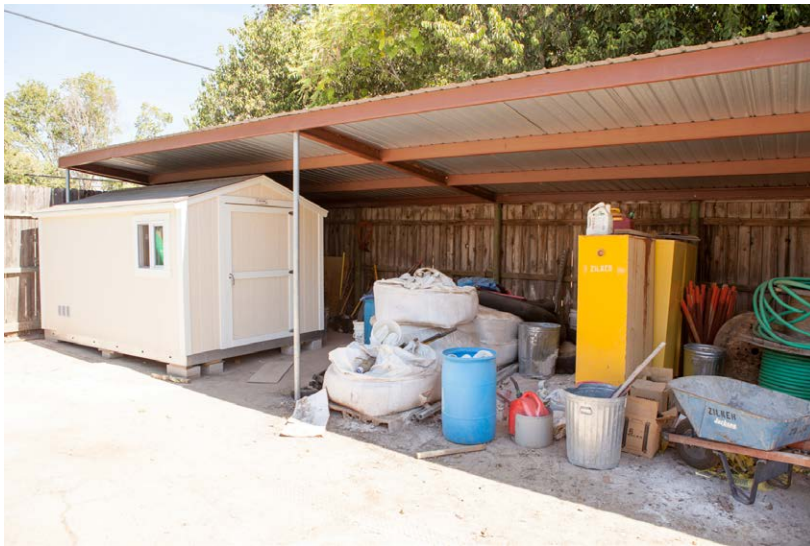
**Maintenance Yard:** Ad-hoc storage is characteristic of the current Maintenance Yard. The storage of fuels and other chemicals within the yard over the decades raises concerns over the viability of any potential re-purposing of this facility.

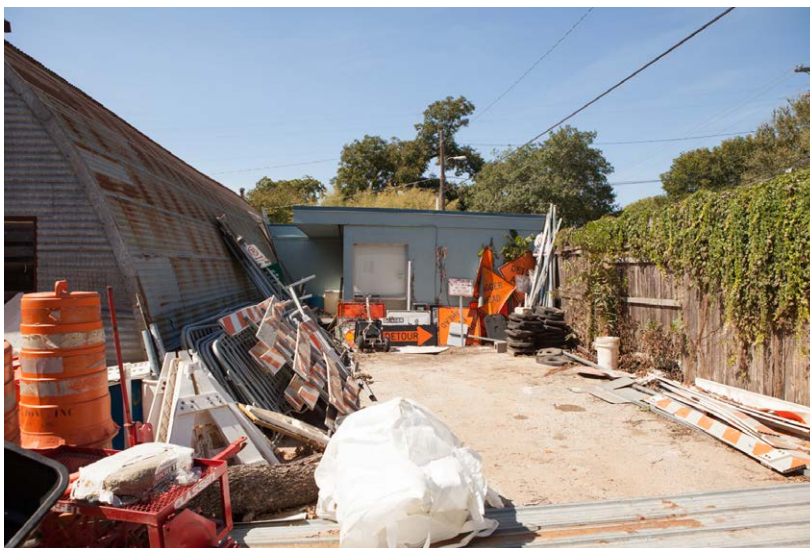
**Maintenance Yard:** The Quonset storage building, although an interesting structure, has reached a serviceability limit state. The extent of rust visible on the exterior of the building, and the number of open holes visible from the interior, indicate a building past economic rehabilitation. It would be less expensive to replace this building than it would to repair it for a different use.

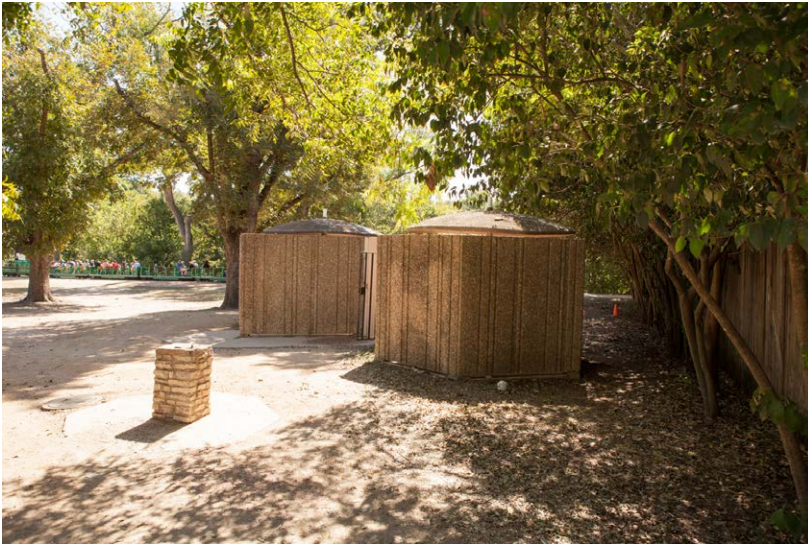
**Pecan Grove Picnic Area:** The existing restrooms at the Pecan Grove Picnic Area are in poor physical condition.

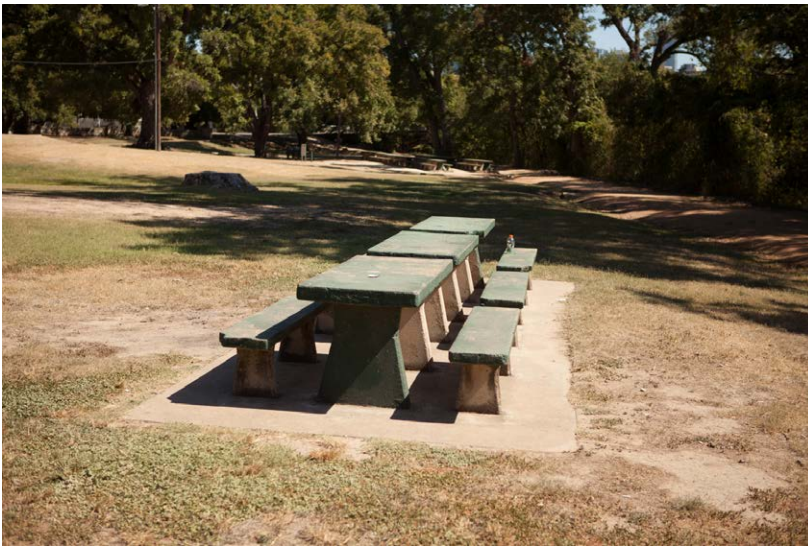
**Pecan Grove Picnic Area:** As the existing trees in the grove continue to die off, more picnic areas will be left unshaded. The Grove warrants action both to protect and preserve existing trees, and to incorporate replacement trees for future generations.

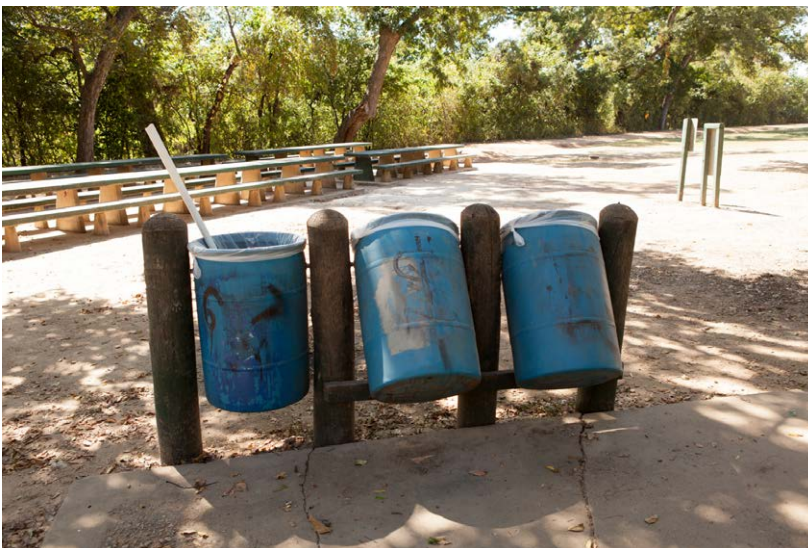
**Pecan Grove Picnic Area:** The Pecan Grove is not a particularly welcoming amenity, being poorly shaded and unprotected from the weather and incorporating significant areas of bare earth.

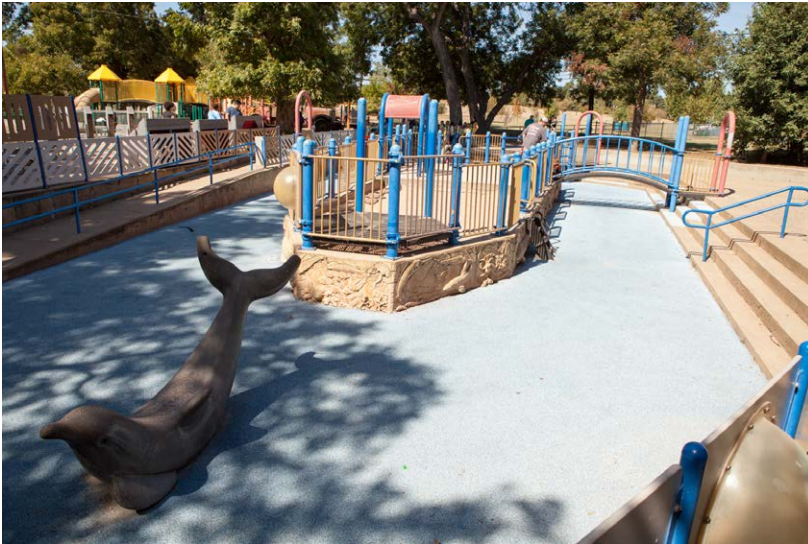
**Zilker Playscape:** Initial impressions, from the vantage point of a grade school child, is of fences and rails rather than play equipment.

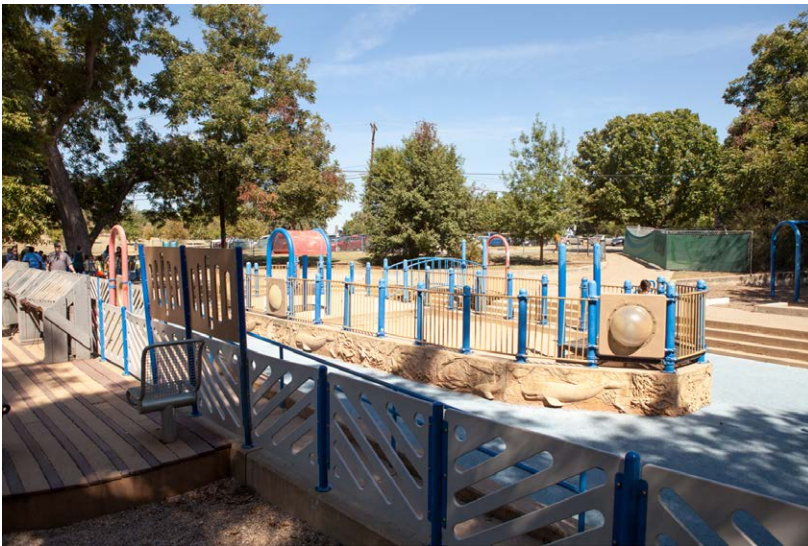
**Zilker Playscape:** The popular playscape is often overcrowded, and does not adequately address the differing needs of various age groups.

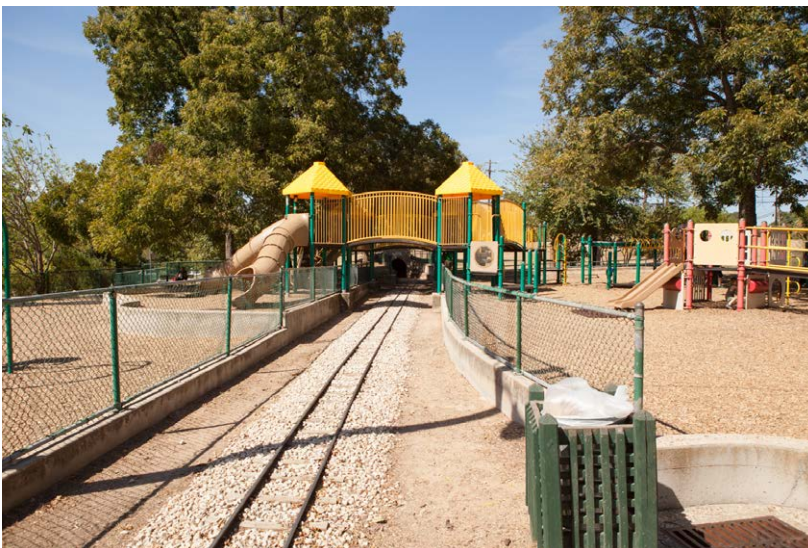
**Zilker Playscape:** The Zilker train makes a significant impact on the Playscape. Although a potential asset in differentiating areas for different age groups, the Train trackway is not well integrated into the present playscape design.

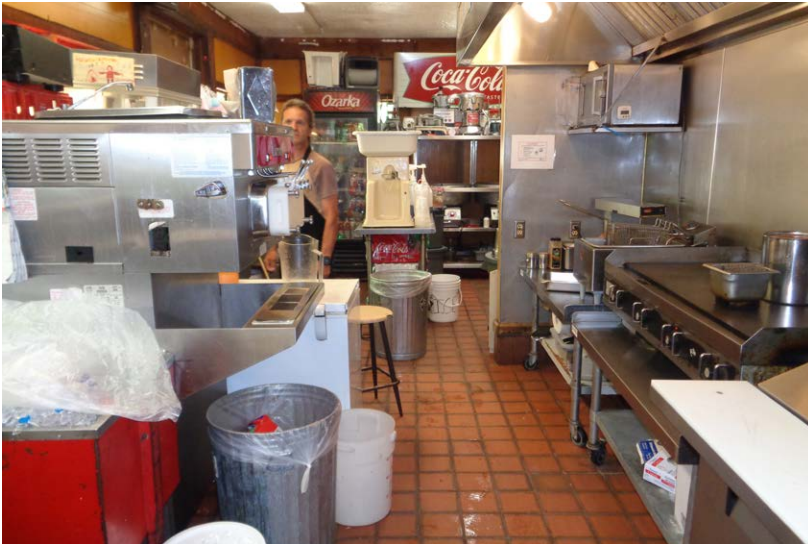
**Zilker Café:** The size of the Café is inconsistent with the number of visitors patronizing this amenity.

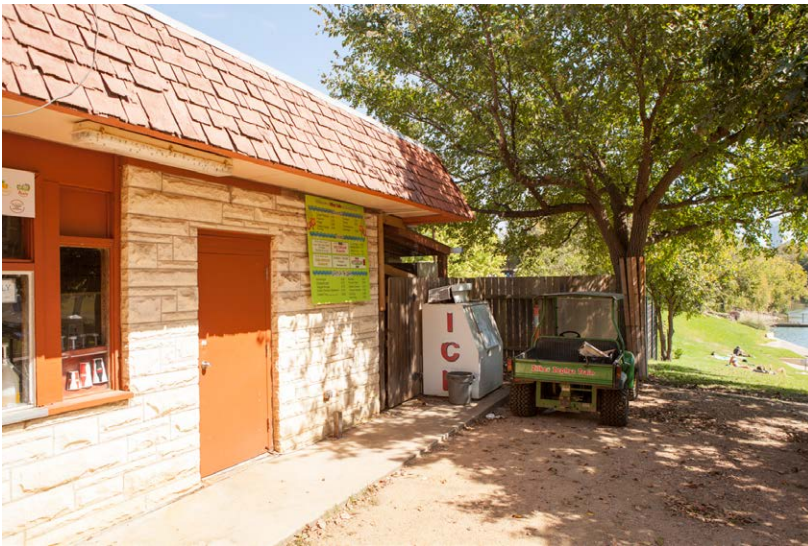
**Zilker Café:** Due to inadequate building area, the operators of the Café rely on exterior and off-site storage. The area shown here used for vehicular parking and storage is within the pool enclosure and drains into the pool.

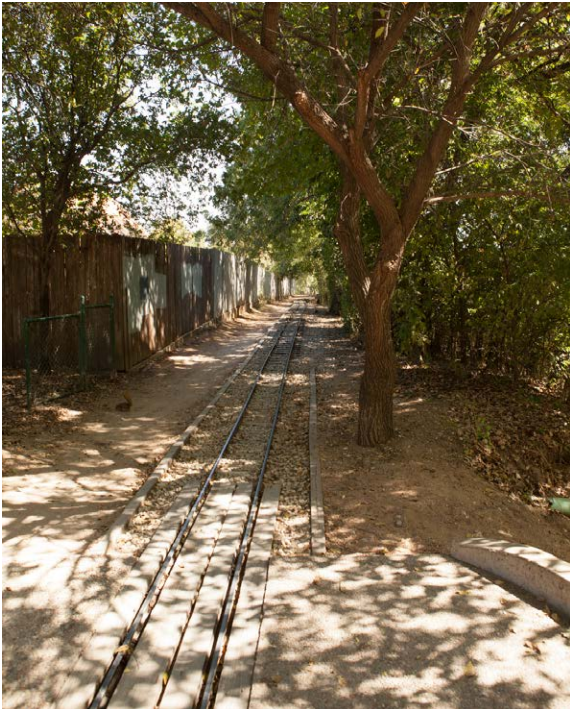
**Zilker Train:** The right-of-way allocated to the Zilker train leaves an excessively narrow pathway between the track and the enclosure of the maintenance yard.

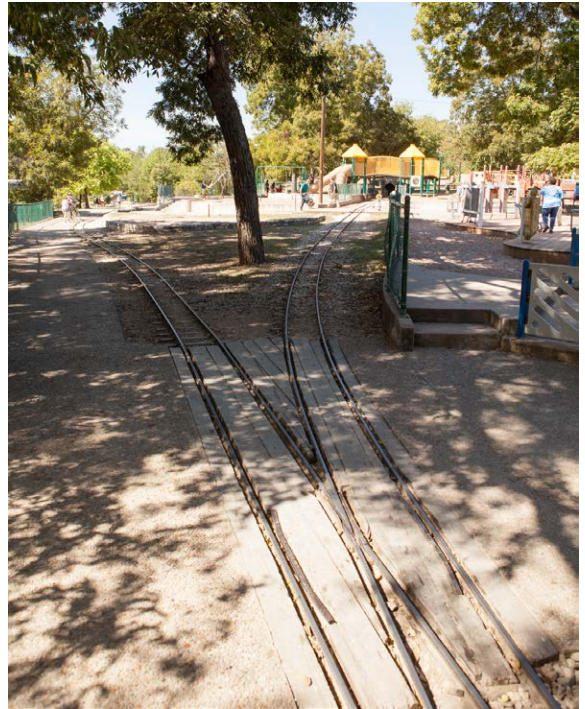
**Zilker Train:** The Zilker train has been in service since the early 1960s. The track, which is visibly irregular and variable in gauge, appears to be approaching the end of its serviceable lifespan.

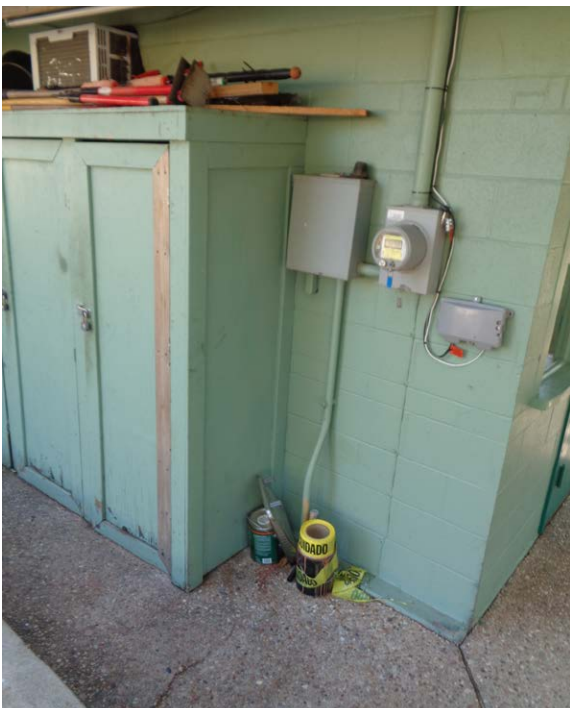
**Zilker Train:** Deficient storage, as here at the train depot, is a common throughout the Bathhouse Zone.

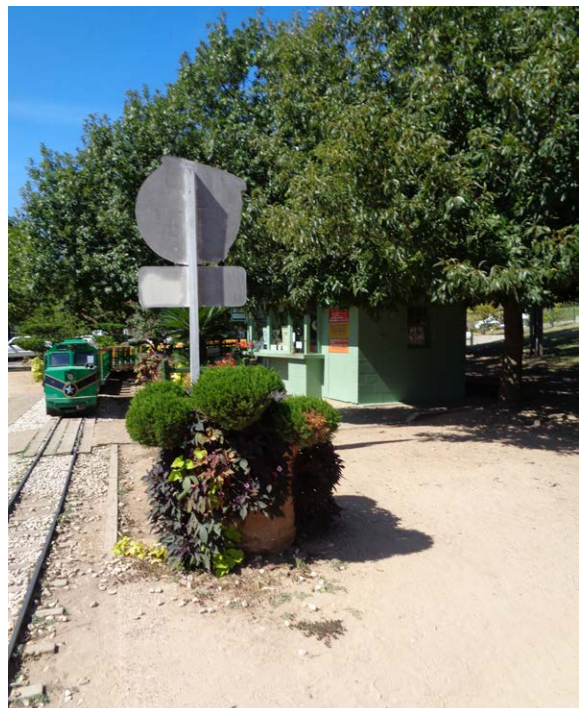
**Zilker Train:** The Zilker train is uncomfortably positioned in the most densely-developed, and intensely visited area of the park.

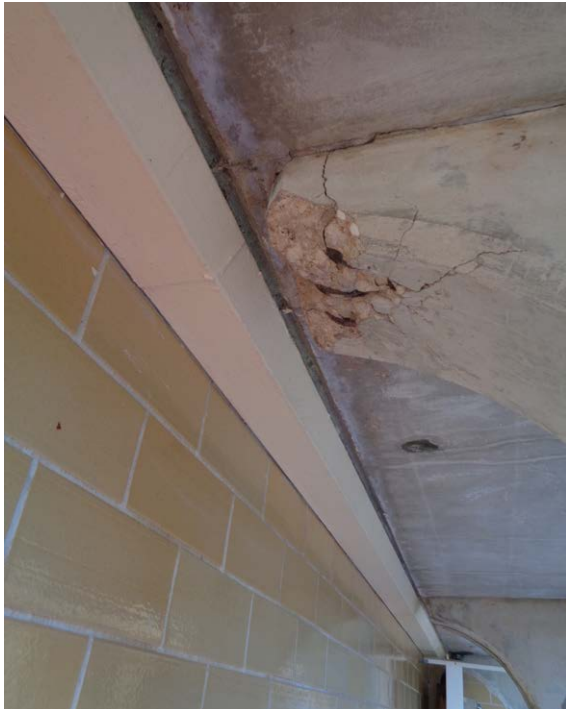
**Bathhouse Men's Changing Area:** The concrete canopy structures in the mens' and womens' changing areas are in poor condition, with a significant percentage exhibiting spalling concrete and exposed reinforcing.

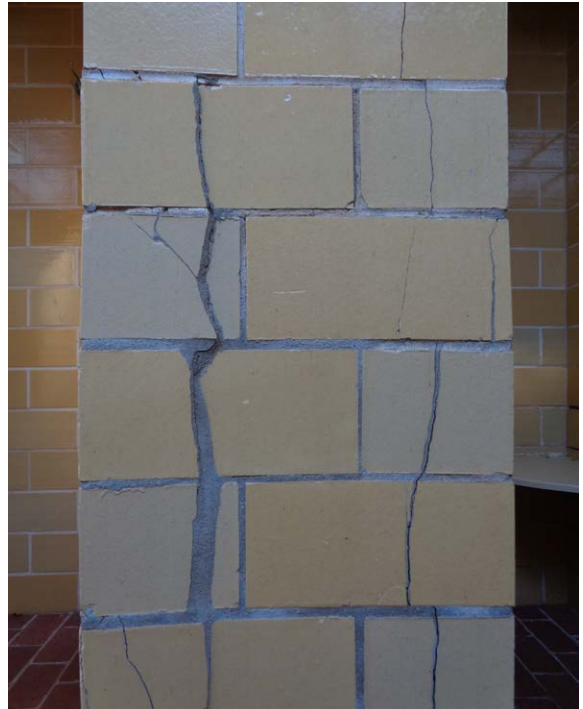
**Bathhouse Men's Changing Area:** A typical example of structural deterioration of the glazed structural tile partitions in the mens' and womens' changing areas. This appears to be the consequence of a flaw in the original building design, which did not include dedicated foundations for these partitions.

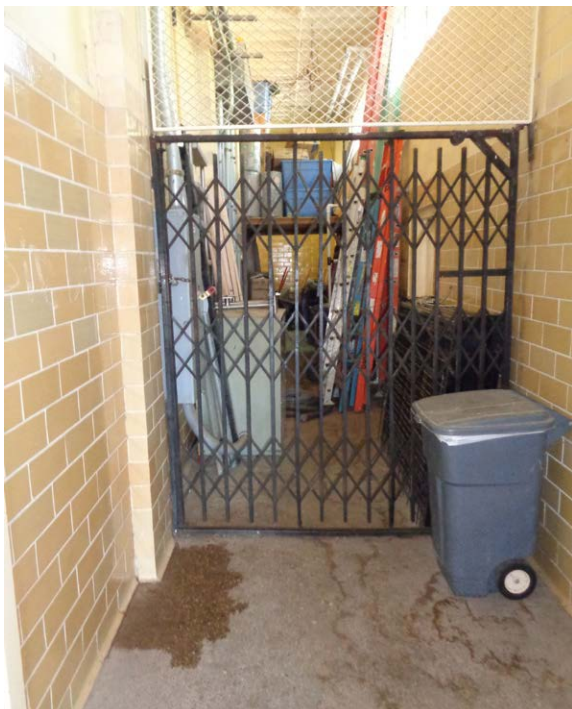
**Bathhouse Men's Changing Area – Entry Corridor:** This corridor is used both for storage (including the incorporation of an improvised mezzanine) and for the location of portions of the electrical service for the Bathhouse.

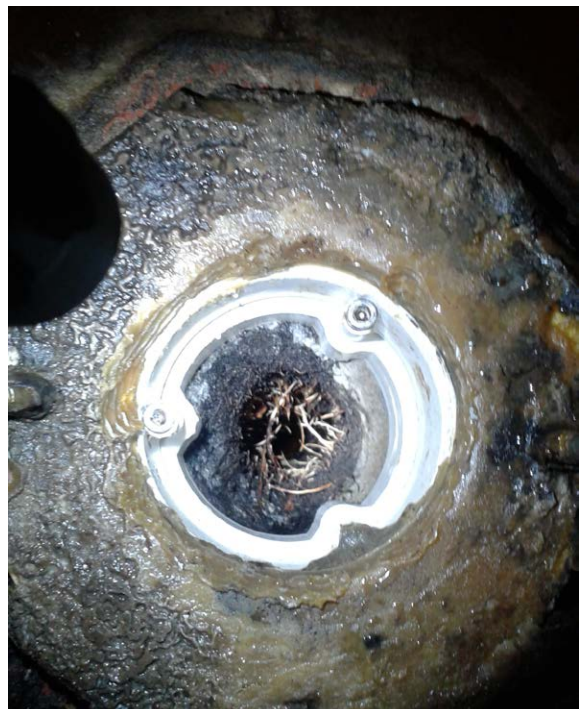
**Bathhouse Men's Changing Area:** An example of the failure of a sanitary sewer line in the Mens' Changing Area restrooms. Much of the existing plumbing within the Bathhouse is seventy years old and in poor physical condition.

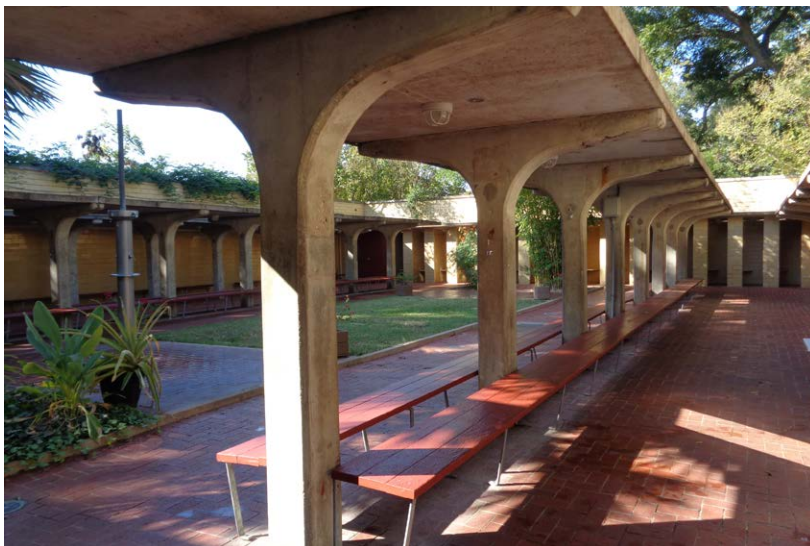
**Bathhouse Mens' Changing Area:** The mens' changing area specifically preserves much of the original design intent, although the louvered steel doors that originally closed the individual dressing cubicles are no longer existent.

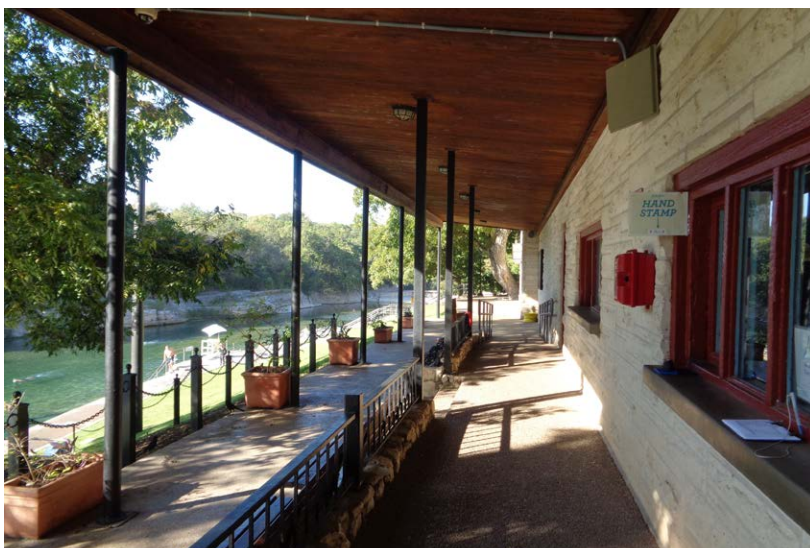
**Bathhouse Spectators' Gallery:** The Spectators' Gallery serves as the principal means of access to and from the north side of the pool. The Gallery was not intended for this purpose.

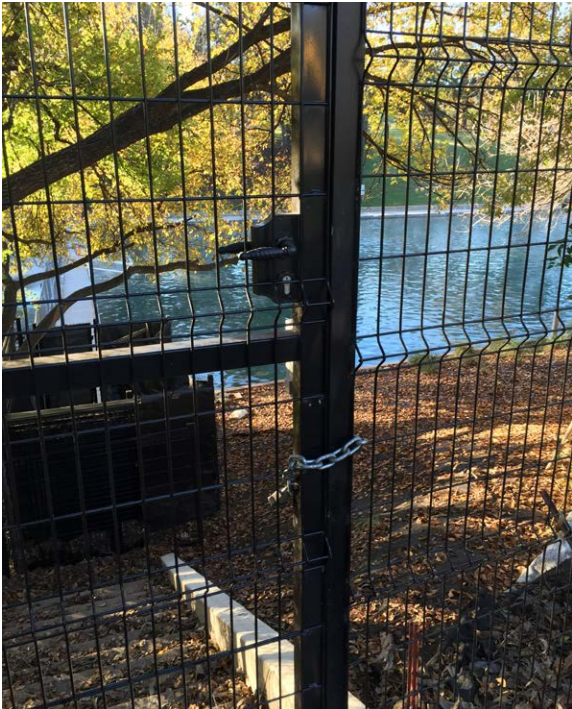
**Pool Enclosure:** Emergency egress from the pool enclosure is a matter of significant concern. Exits from the enclosure do not comply with current code requirements, a deficiency compounded by features such as locked gates.

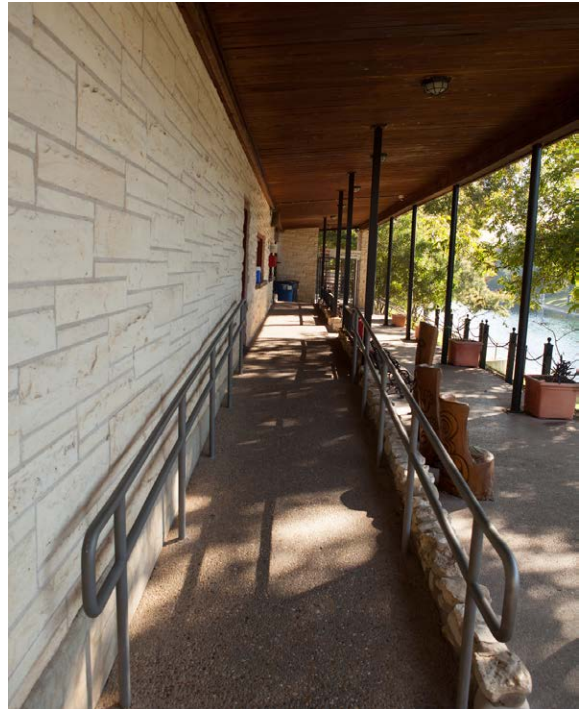
**Pool Enclosure:** Emergency egress from the pool enclosure is through the Spectators' Gallery. This is a very narrow pathway given the potential number of people within the pool enclosure.

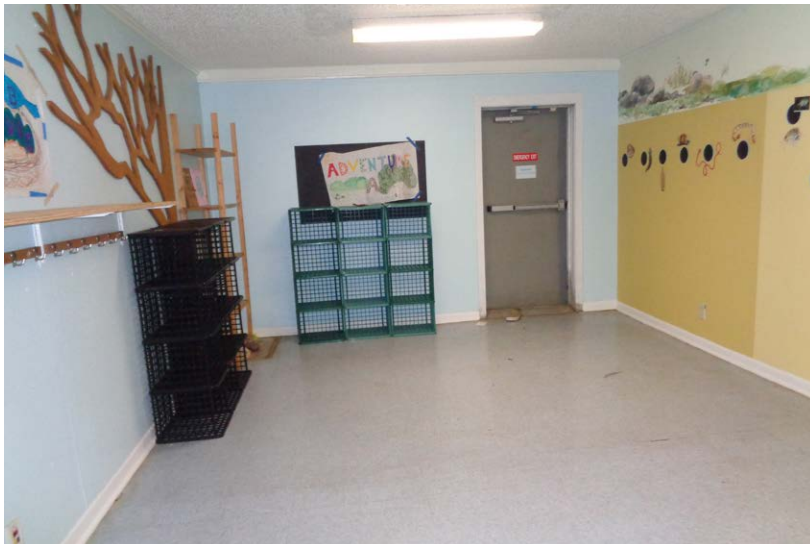
**Sheffield Center Classrooms:** The existing classrooms are too small. The emergency exit discharging into the pool enclosure is inconsistent with both the current Building Code and the Texas Administrative Code.

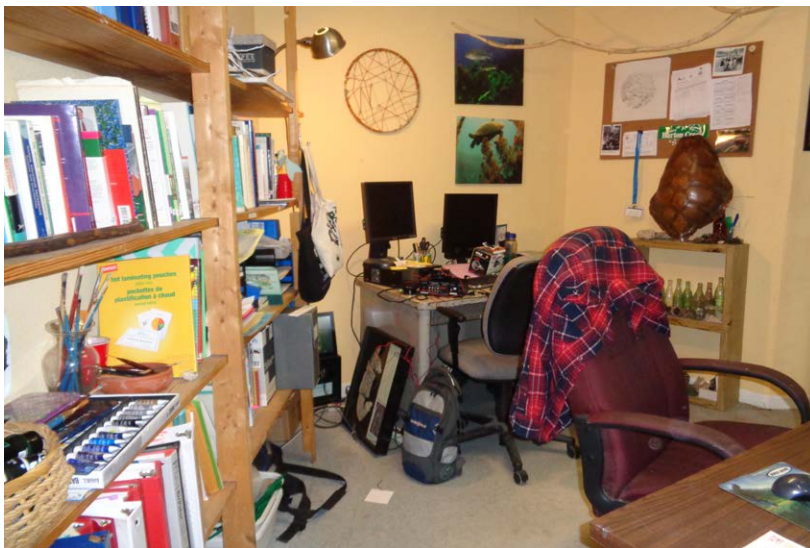
**Sheffield Center Offices:** The limited support space available to Sheffield Center staff constrains the efficient operation of facility programs.
