BARTON SPRINGS ROAD OVER BARTON CREEK

Bridge Inspection and Condition Assessment Report

Bridge 14-227-0-B002-26-001
Austin, Texas
January 2017

2016 Bridge Inspection Report
Barton Springs Road over Barton Creek
Bridge 14-227-0-B002-26-001

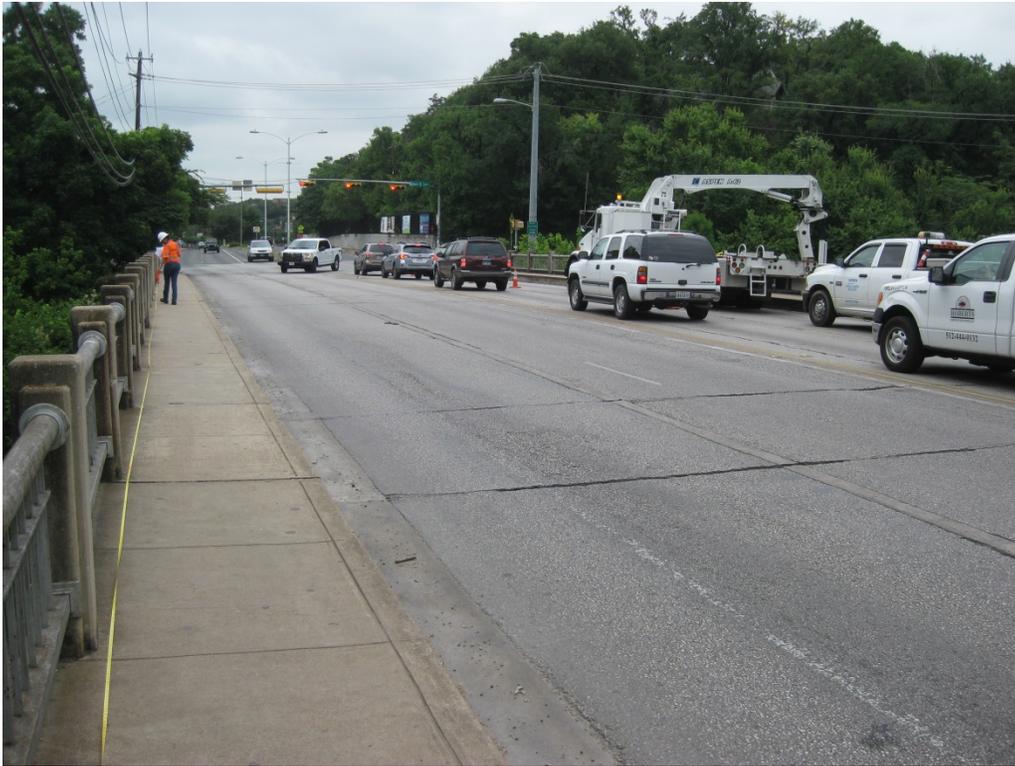
The deck is in satisfactory condition (see **Photo 9**).

Photo 9: Typical topside deck condition

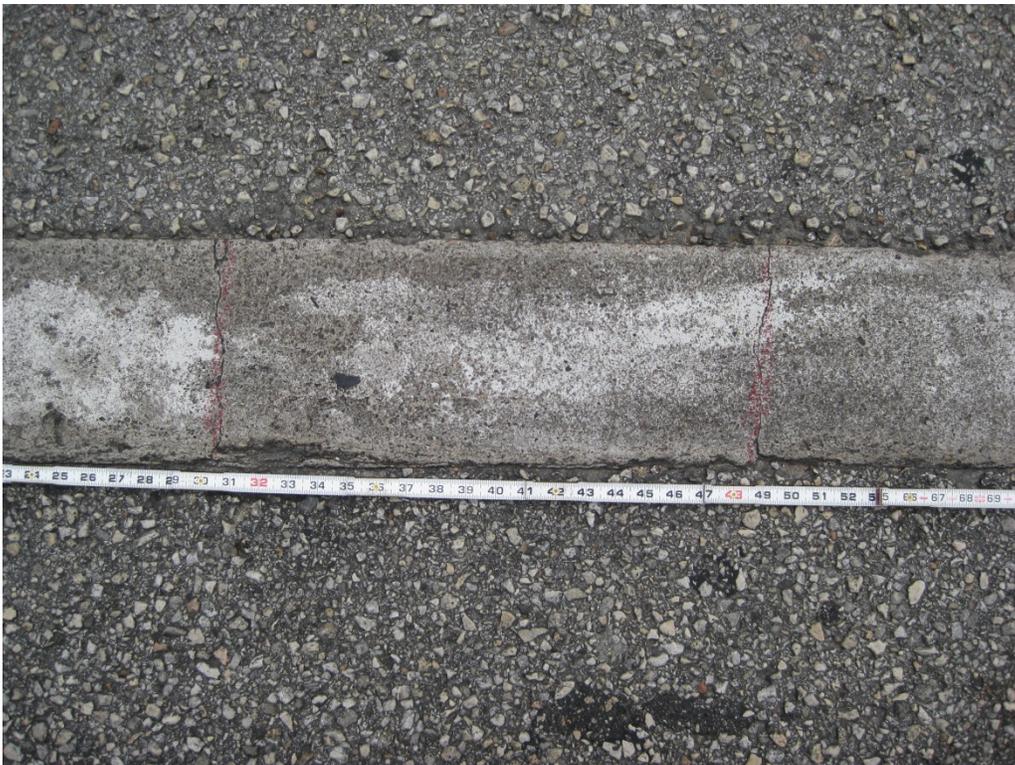
1. The concrete traffic stripe bump-outs, which run the length of the deck and match the grade of the asphalt wearing surface, typically exhibit cracks up to 1/16 inch wide, generally spaced at 18-inch intervals throughout the length of the bridge (see **Photo 10**).

Photo 10: Typical cracking in concrete traffic stripe markers

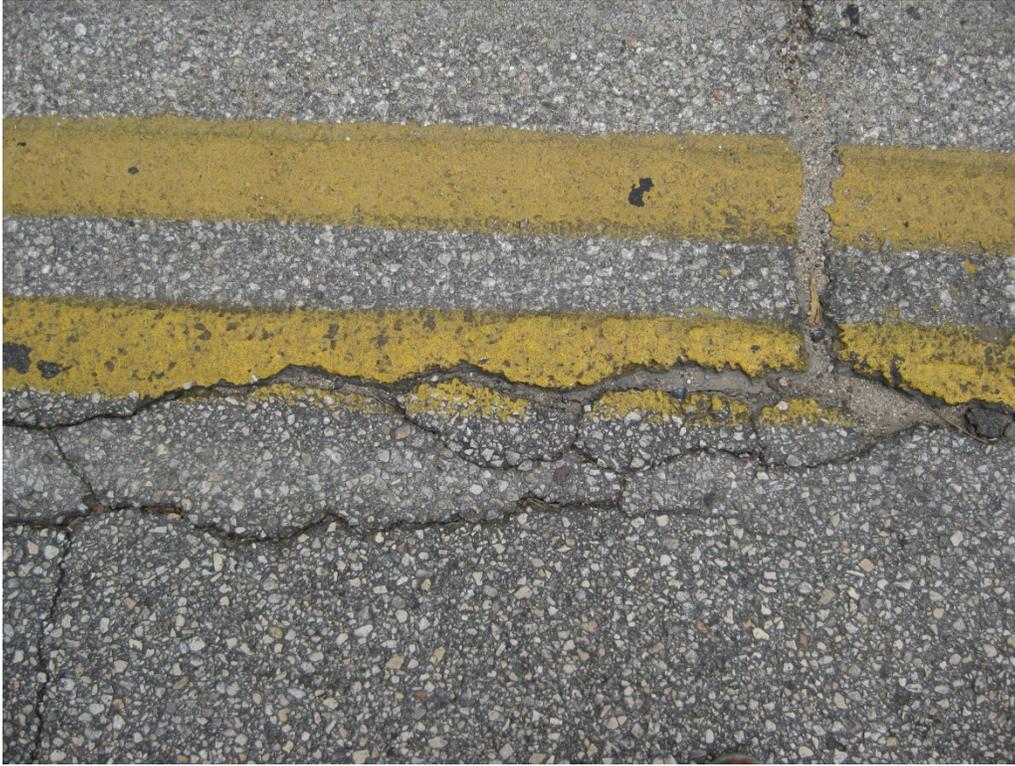
2. There is a full-length longitudinal joint separating the North and South Structures. There are also two full-width transverse deck expansion joints centered about the crown in each span. In the North Structure, the transverse expansion joints are spaced 11'-3" apart, whereas in the South Structure, the transverse expansion joints are spaced 19'-10" apart. The expansion joints are typically paved over with asphalt. However, the asphalt wearing surface exhibits reflective cracking, up to 1½ inches wide, and edge spalling for the full length and width at all the deck expansion joint locations (see **Photos 11 and 12**).

Photo 11: Reflective cracking in centerline of bridge along longitudinal deck joint

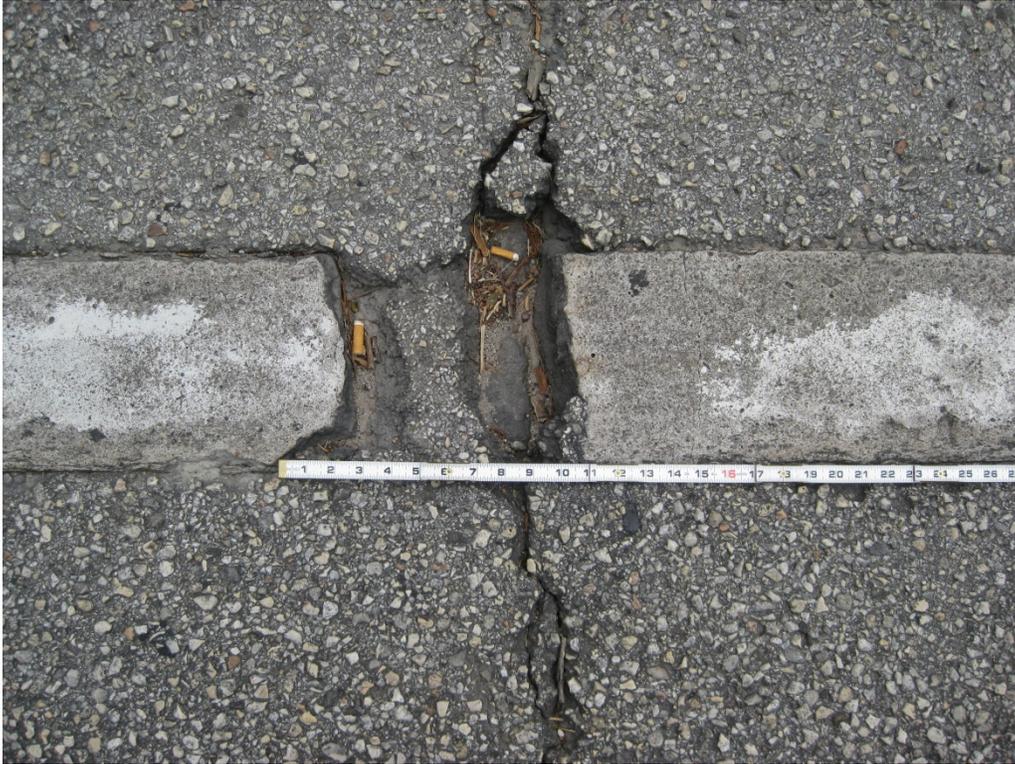
3. In the South Structure, the concrete traffic stripe bump-out is spalled 11 inches long by its full width at the first transverse joint from the West Abutment that has resulted in a pot hole (see **Photo 13**).

Photo 13: Spall in concrete traffic stripe marker in South Structure deck

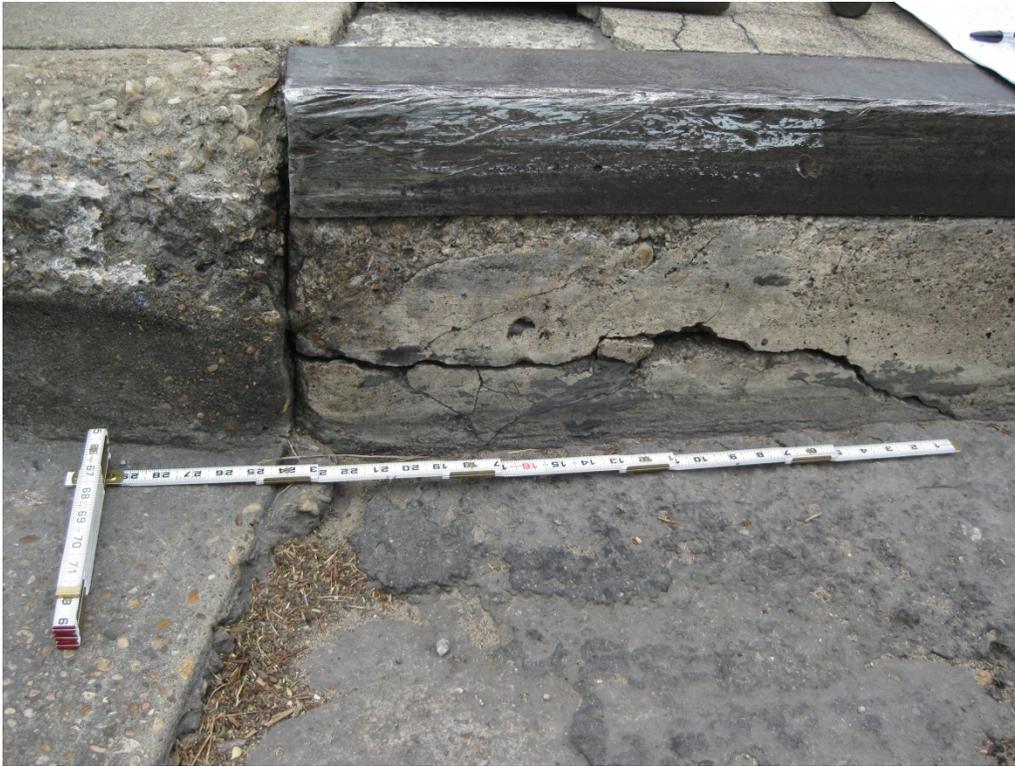
5. In the South Structure, there is a 25 inch long by 5 inch high imminent spall on the vertical face of the southeast concrete curb at the East Abutment (see **Photo 15**).

Photo 15: Imminent spall in southeast curb at the East Abutment

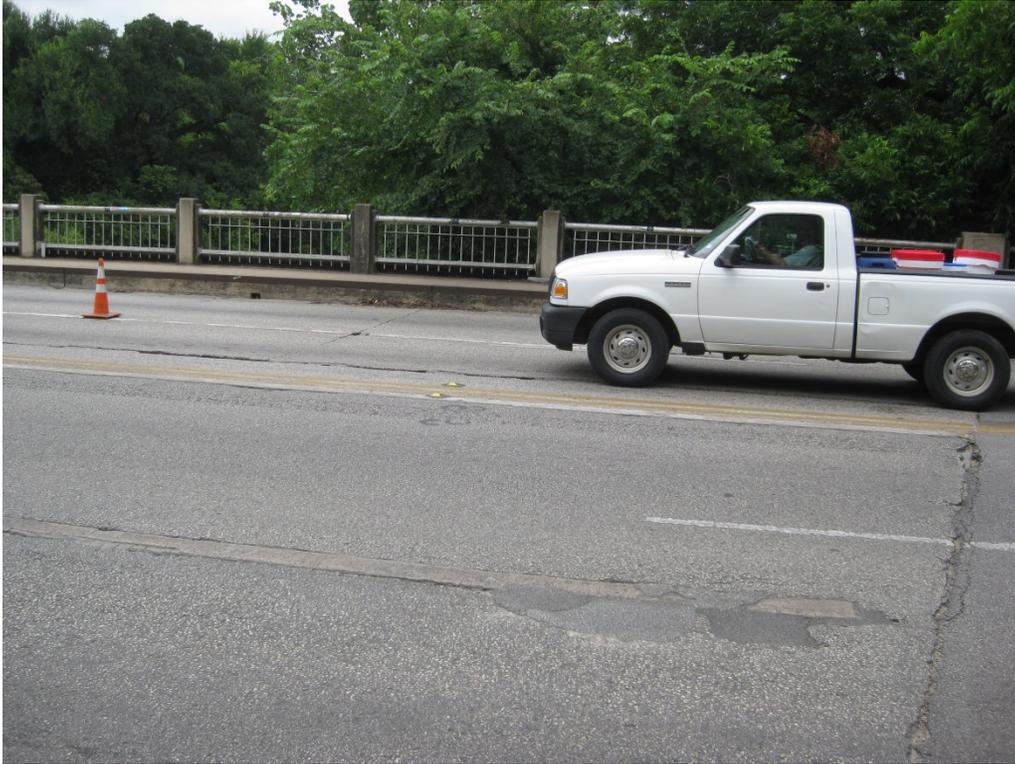
8. In the North Structure, the concrete traffic stripe bump-out near the West Abutment joint has spalled away for a 30-inch length and the area has been patched with asphalt (see **Photo 19**).

Photo 19: Patch in the North Structure wearing surface near West Abutment

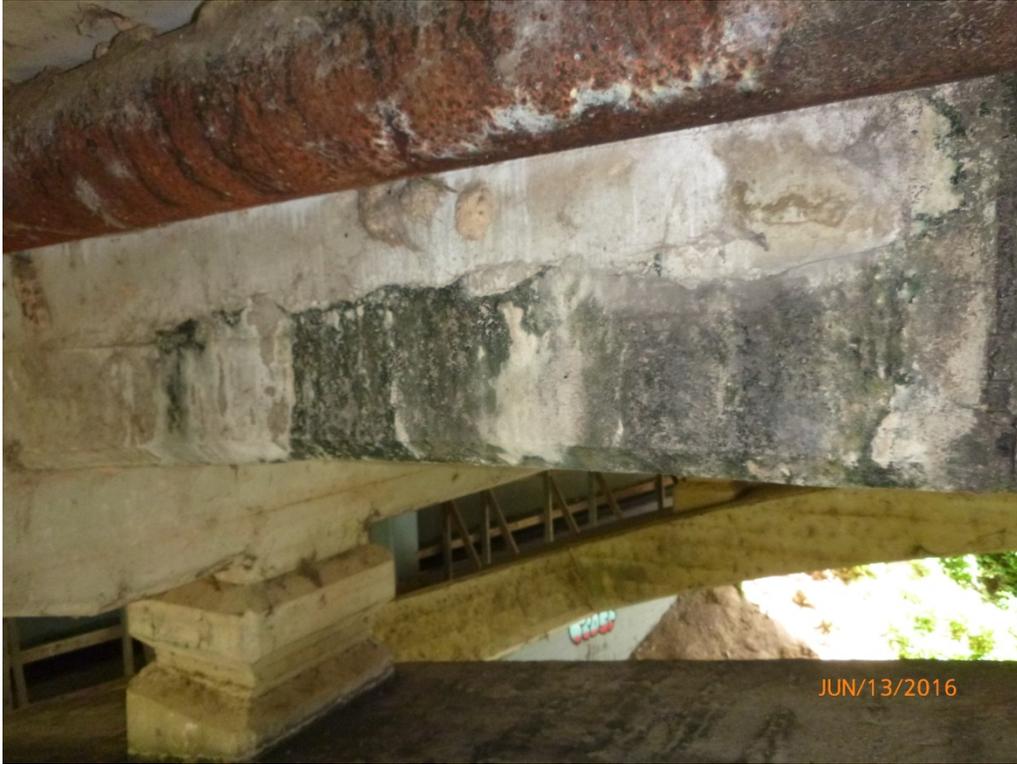
Photo 22: Crack in Span 1 south slab edge between Floorbeams 2 and 3 with greenish-black mold observed emanating from crack

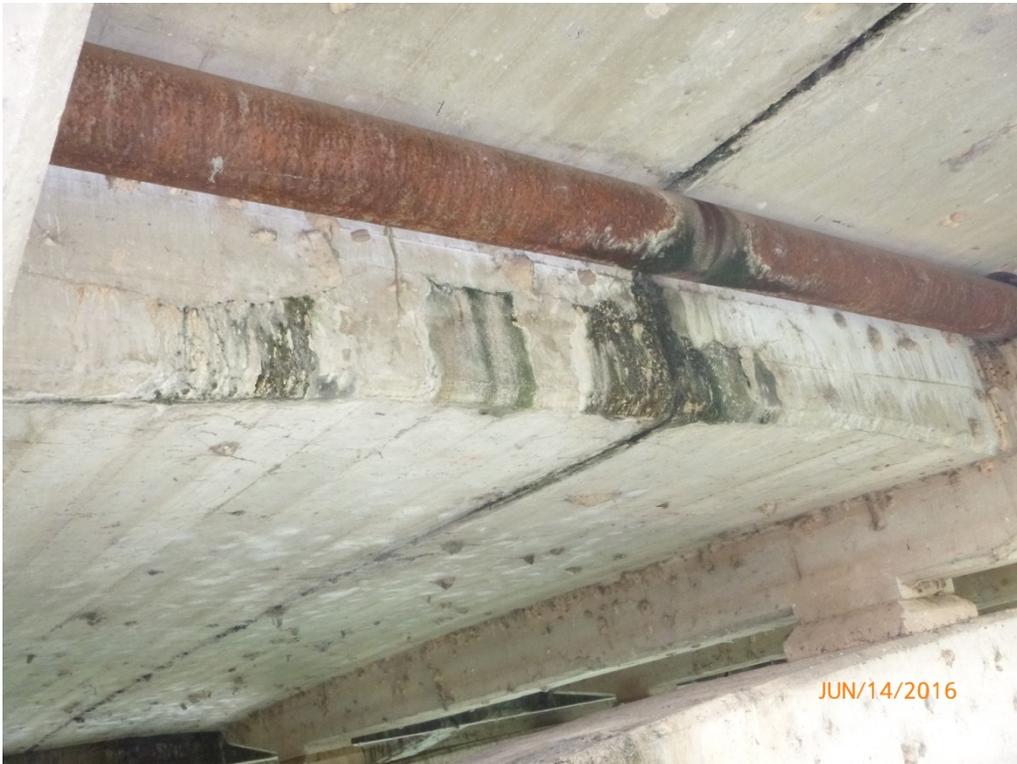
Photo 23: Crack in Span 2 south slab edge between Floorbeams 9 and 10

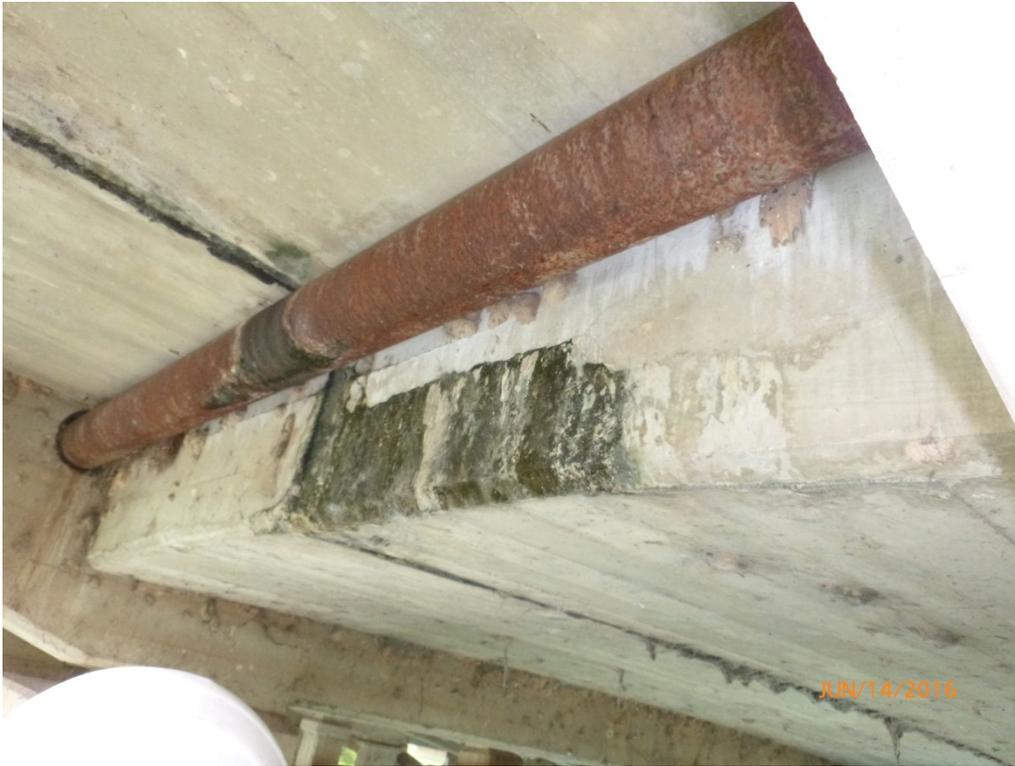
Photo 24: Crack in Span 2 south slab edge between Floorbeams 11 and 12

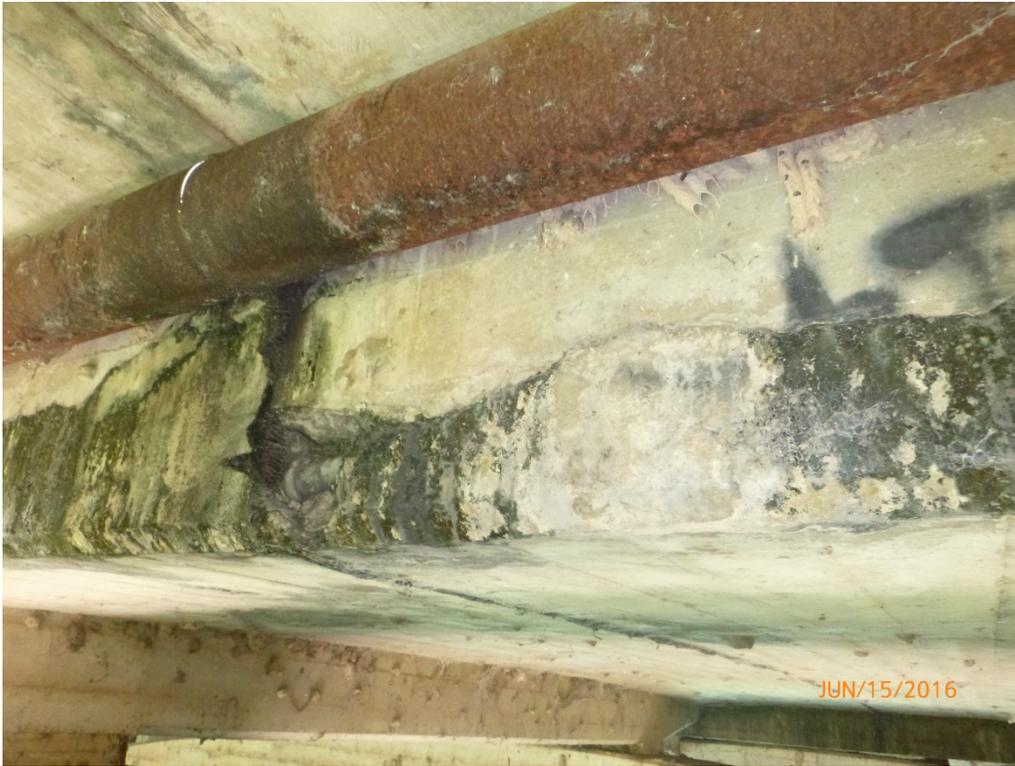
Photo 26: Crack and spall in Span 3 south slab edge between Floorbeams 18 and 19

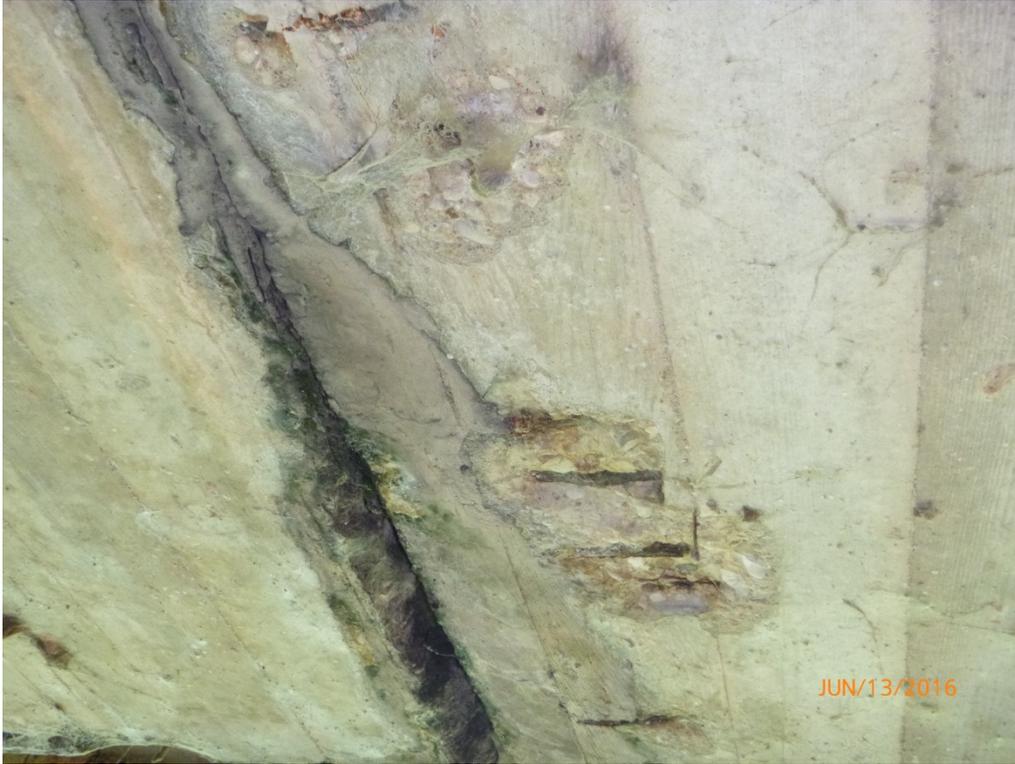
Photo 28: Spall in Span 1 underside of the deck above Arch Rib 4 near the expansion joint midway between Floorbeams 4 and 5

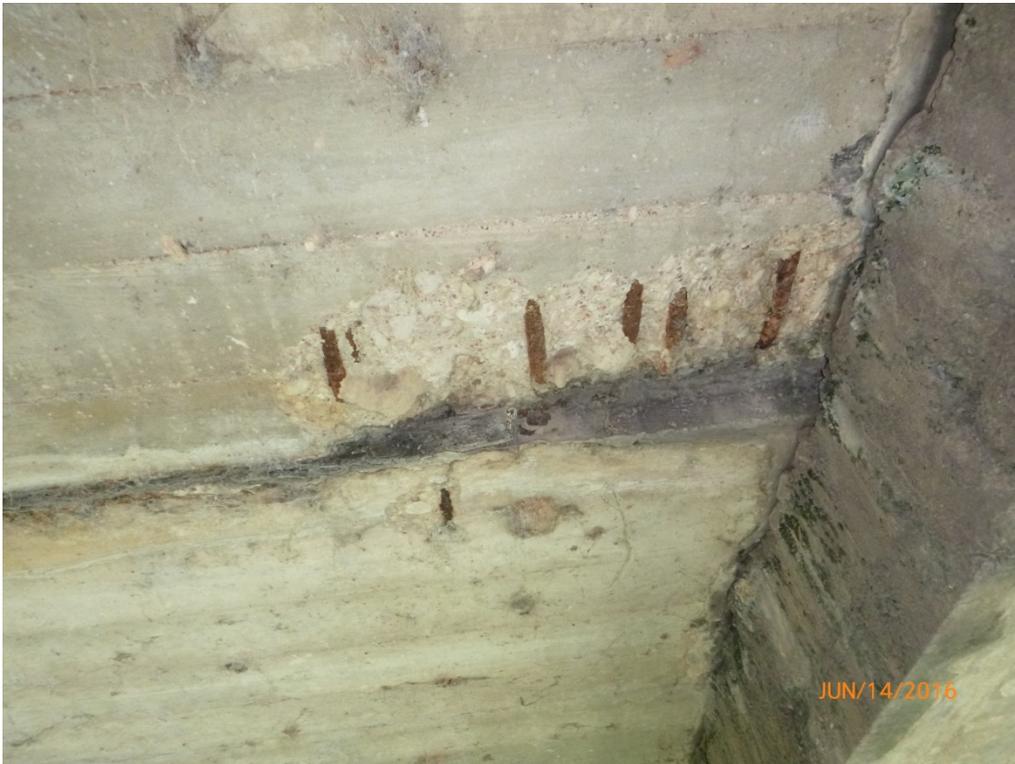
Photo 29: Spall in underside of Span 2 adjacent to expansion joint at longitudinal beam midway between Floorbeams 11 and 12

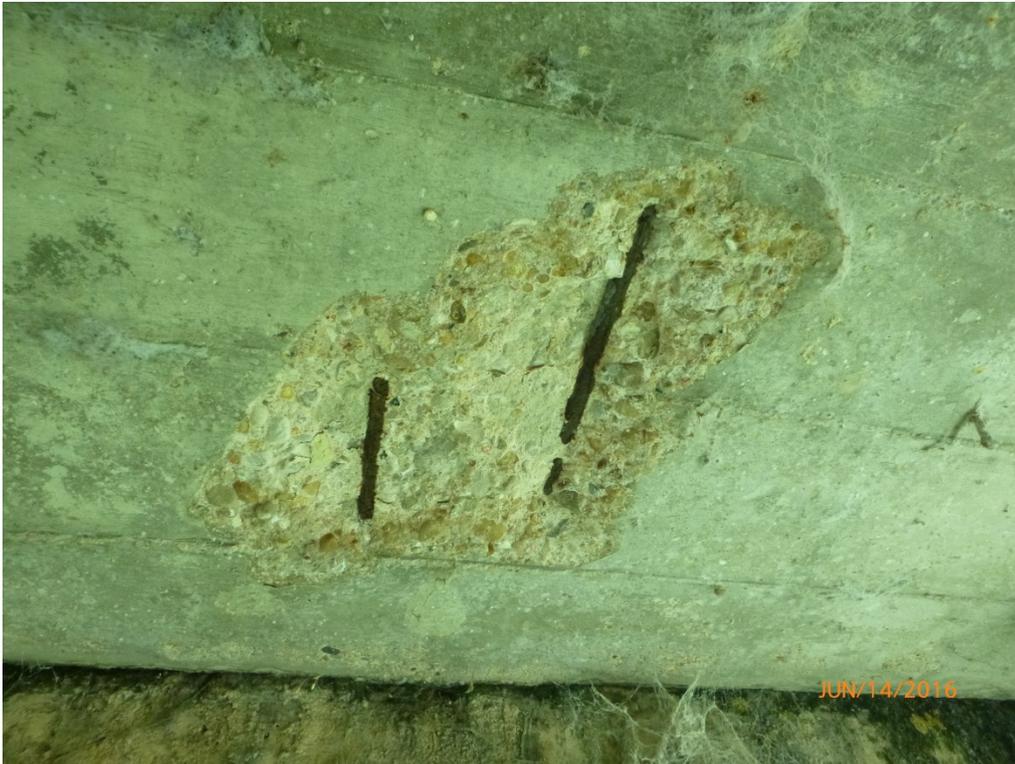
Photo 30: Spall in underside of Span 2 North Structure deck east of Floorbeam 11 midway between Arch Ribs 1 and 2

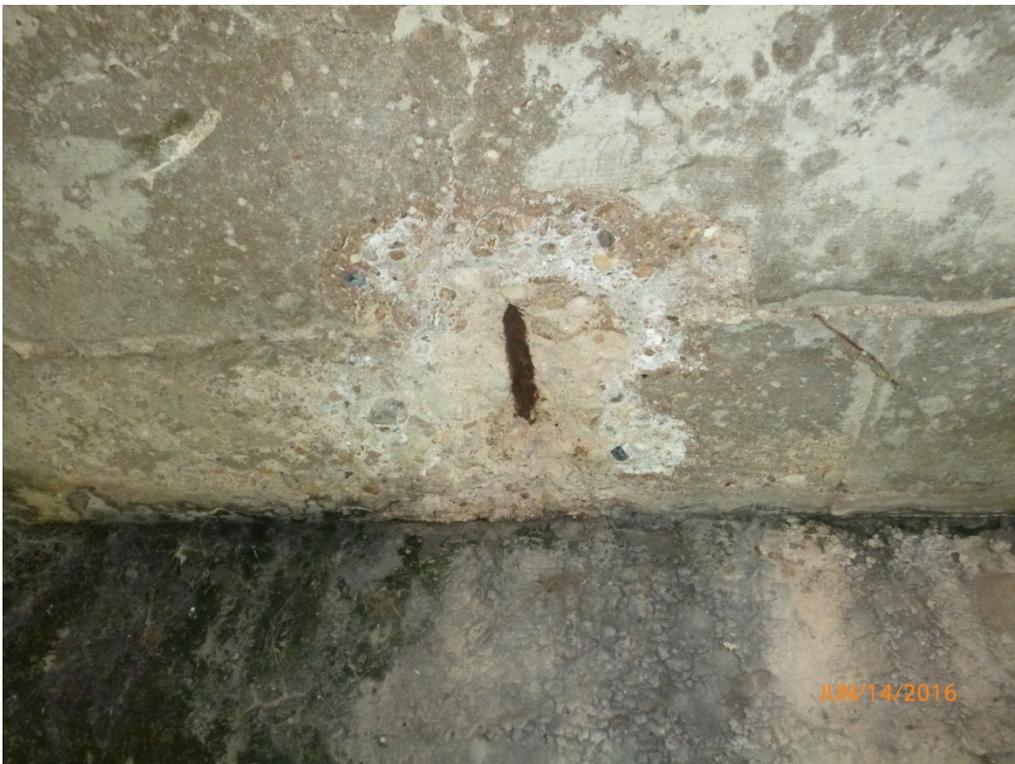
Photo 31: Spall in underside of Span 2 North Structure deck east of Floorbeam 11 directly over Arch Rib 2

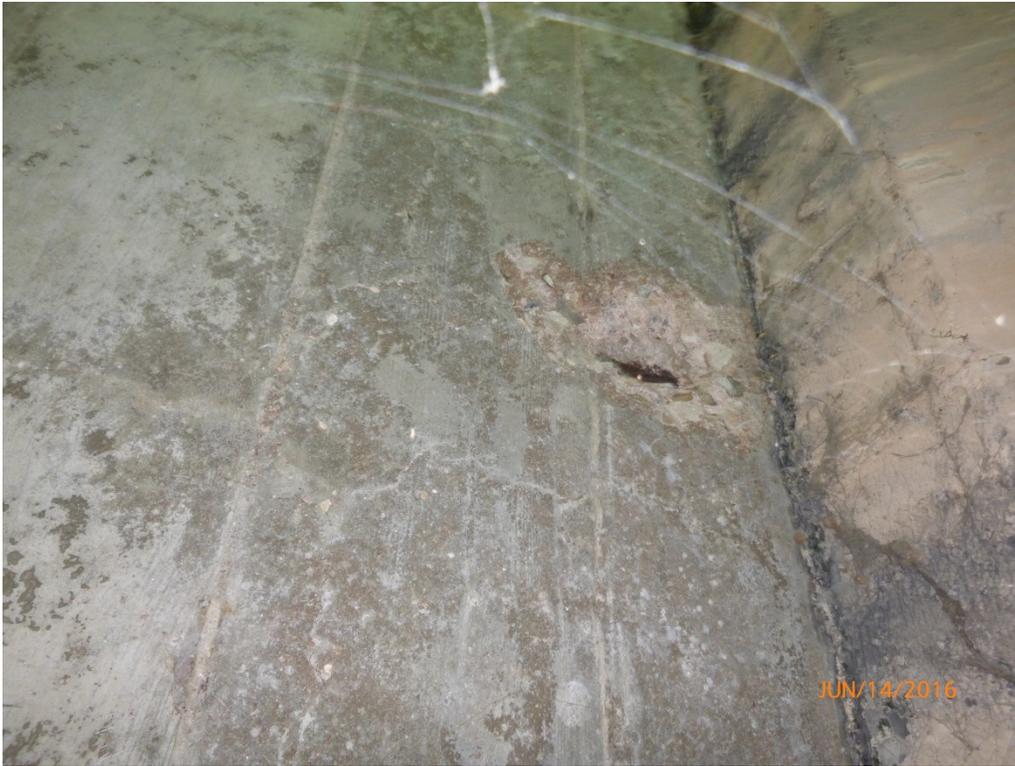
Photo 32: Spall in underside of Span 2 North Structure deck east of Floorbeam 11 directly over Arch Rib 1

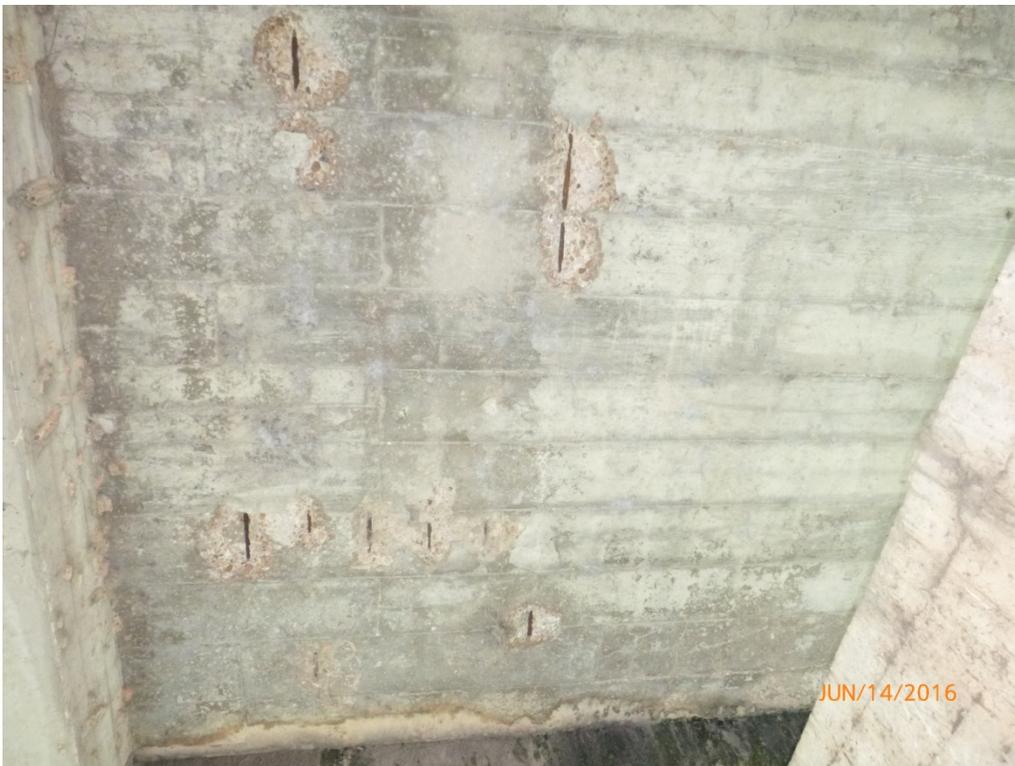
Photo 33: Spalls in underside of Span 2 North Structure deck between the longitudinal beam and Arch Rib 2 between Floorbeam 11 and 12

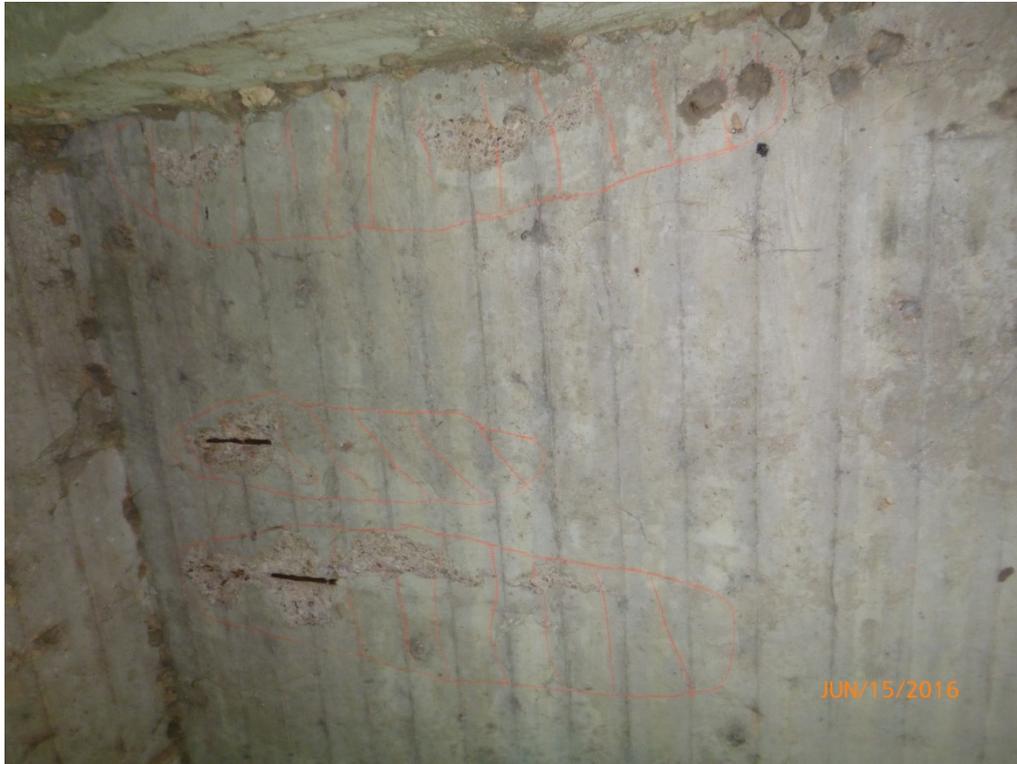
Photo 34: Spalls and delaminations in underside of Span 3 North Structure deck between the longitudinal beam and Arch Rib 2 between Floorbeam 14 and 15

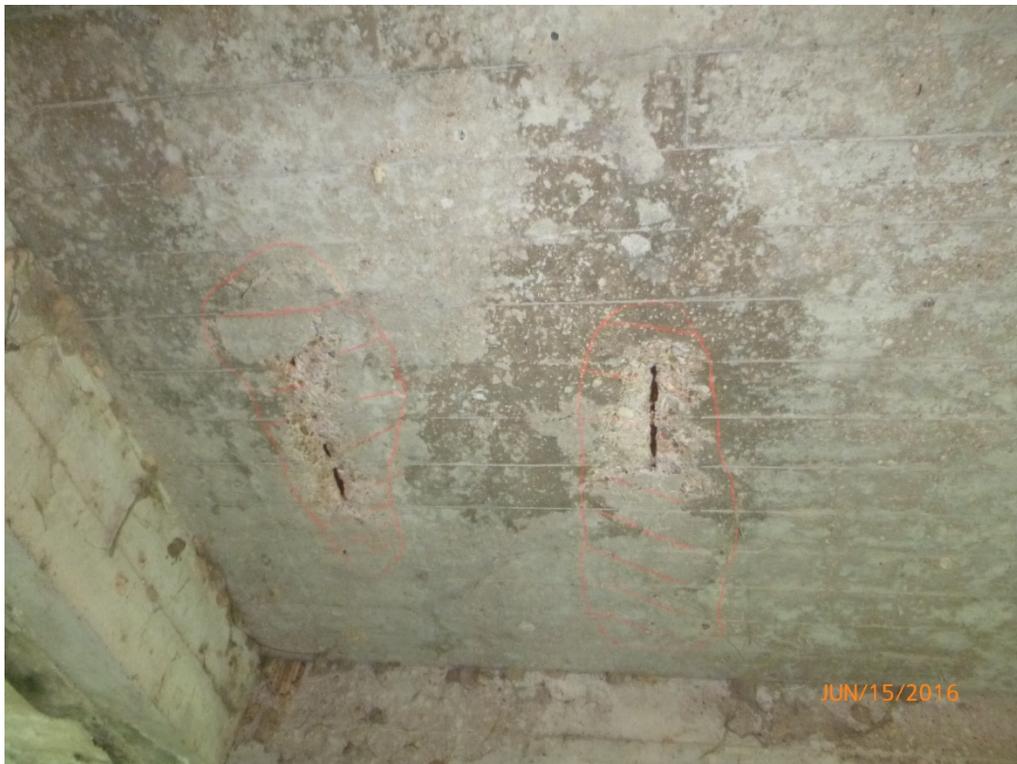
Photo 35: Spalls and delaminations in underside of Span 3 North Structure deck between the longitudinal beam and Arch Rib 2 between Floorbeam 15 and 16

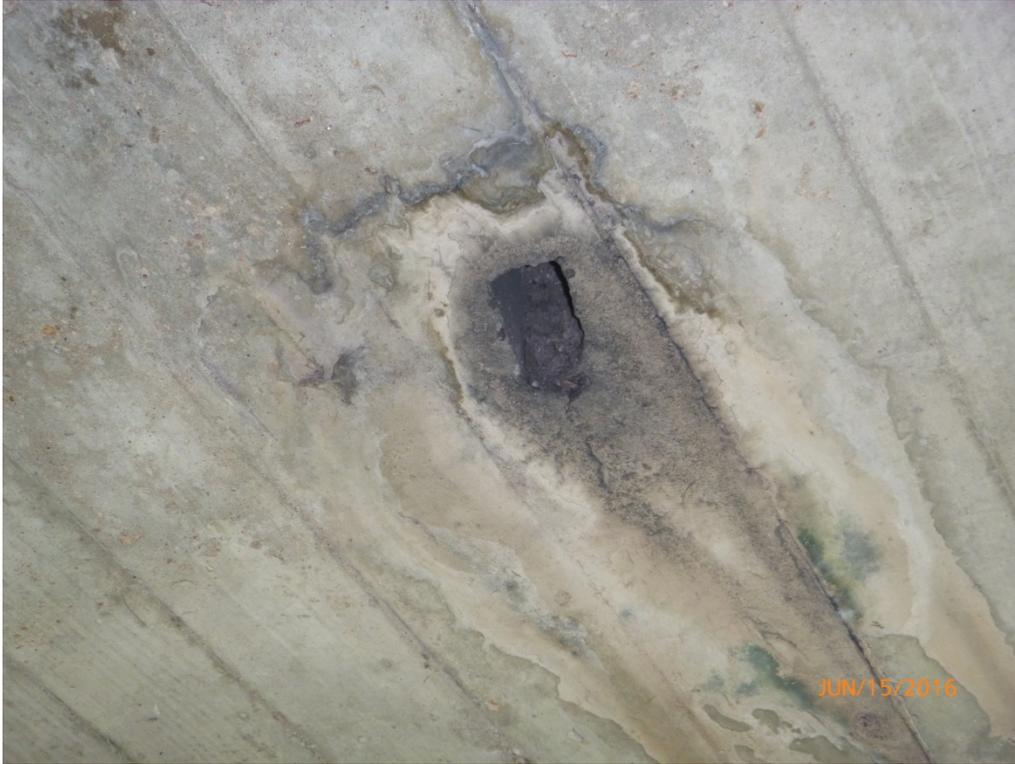
Photo 36: Rectangular hole in Span 3 of the North Structure deck underside above Arch Rib 1 between Floorbeams 15 and 16

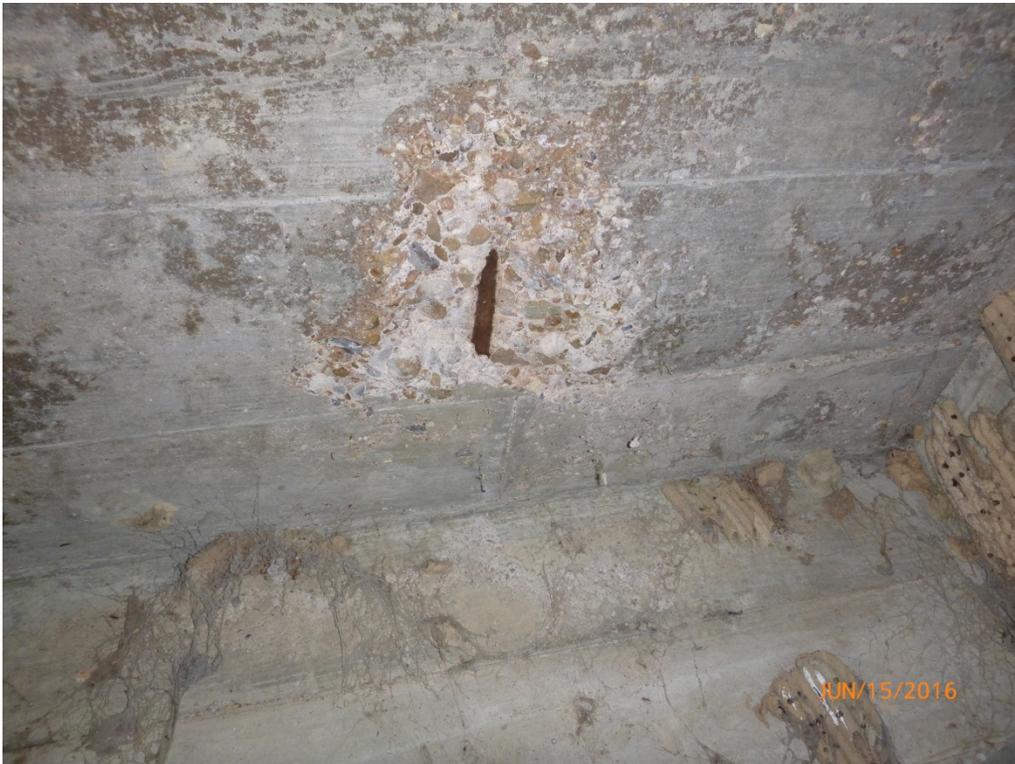
Photo 37: Spall in Span 3 of the North Structure deck underside 2' north of the longitudinal beam and 1 ft. west of Floorbeam 19

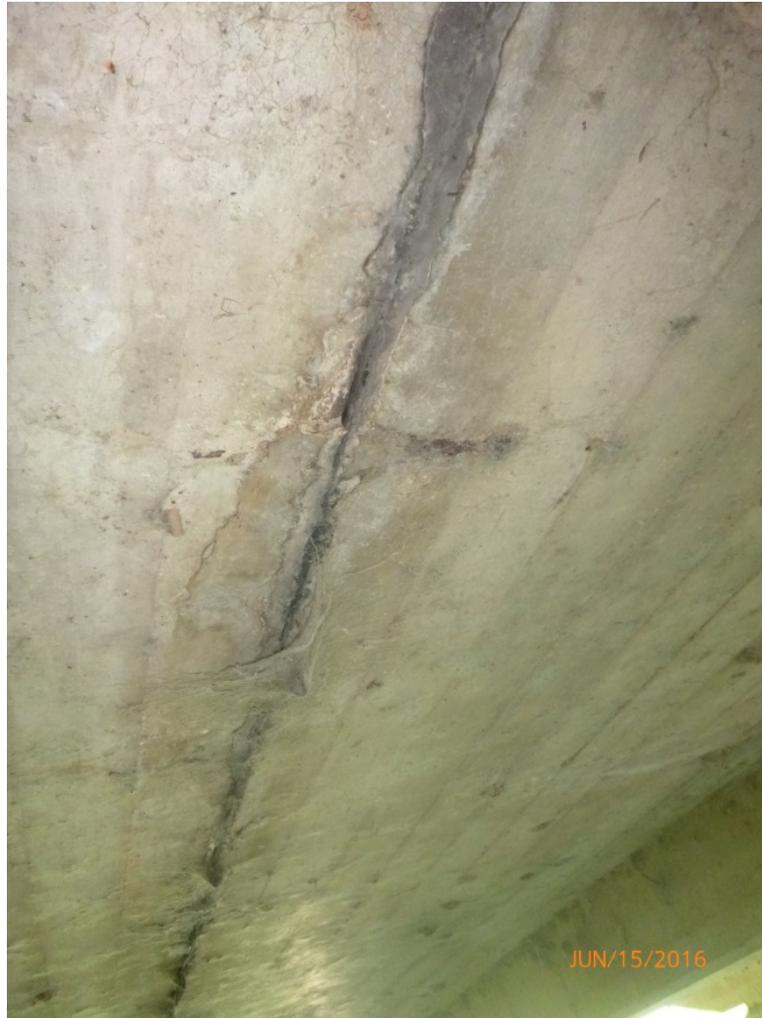
Photo 40: Edge spalls along expansion joint in Span 3 of the South Structure midway between Floorbeams 16 and 17

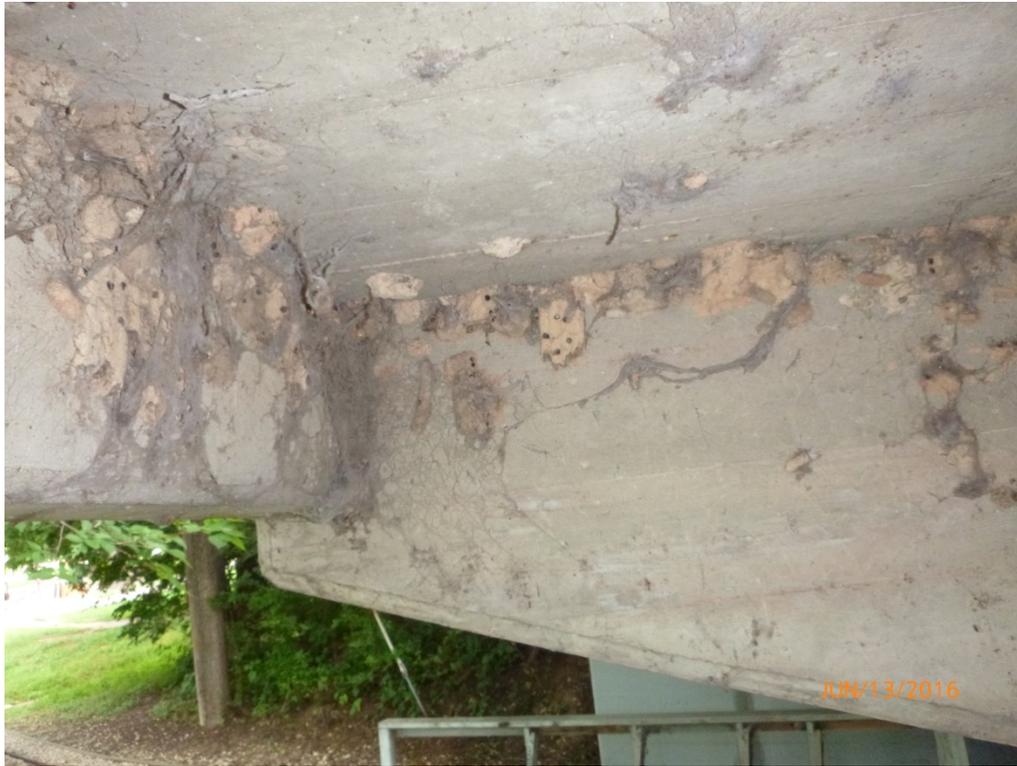
Photo 41: Mud dauber nests cover the superstructure

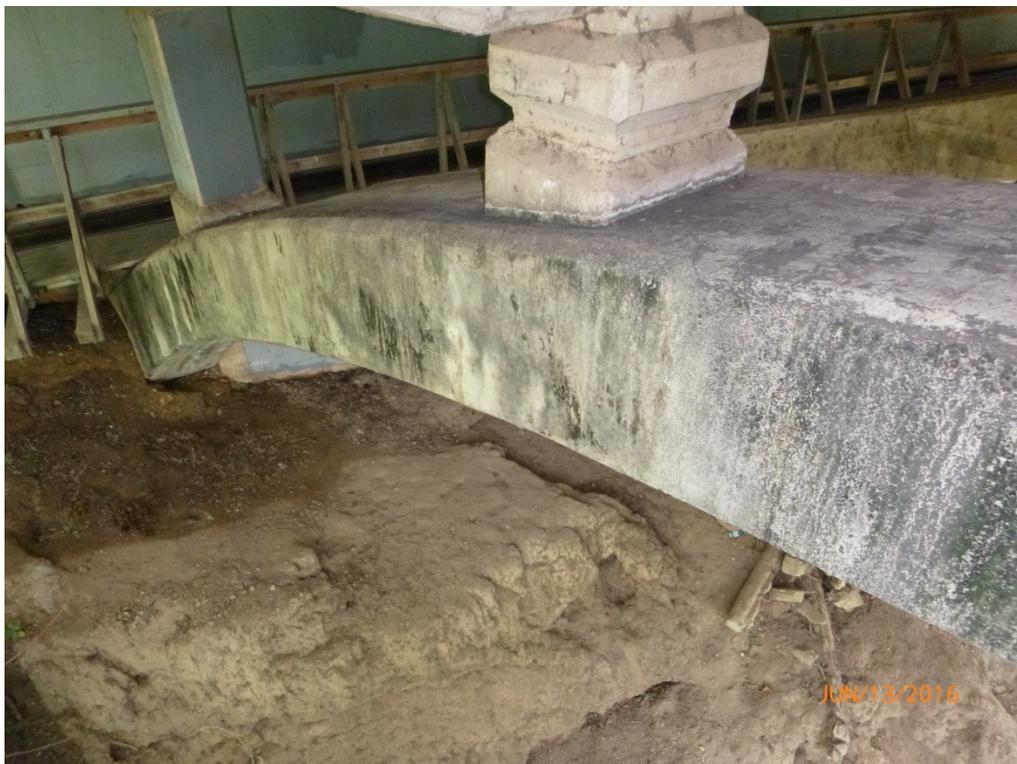
Photo 42: Typical Arch Rib 4 heavily stained with mold and dirt

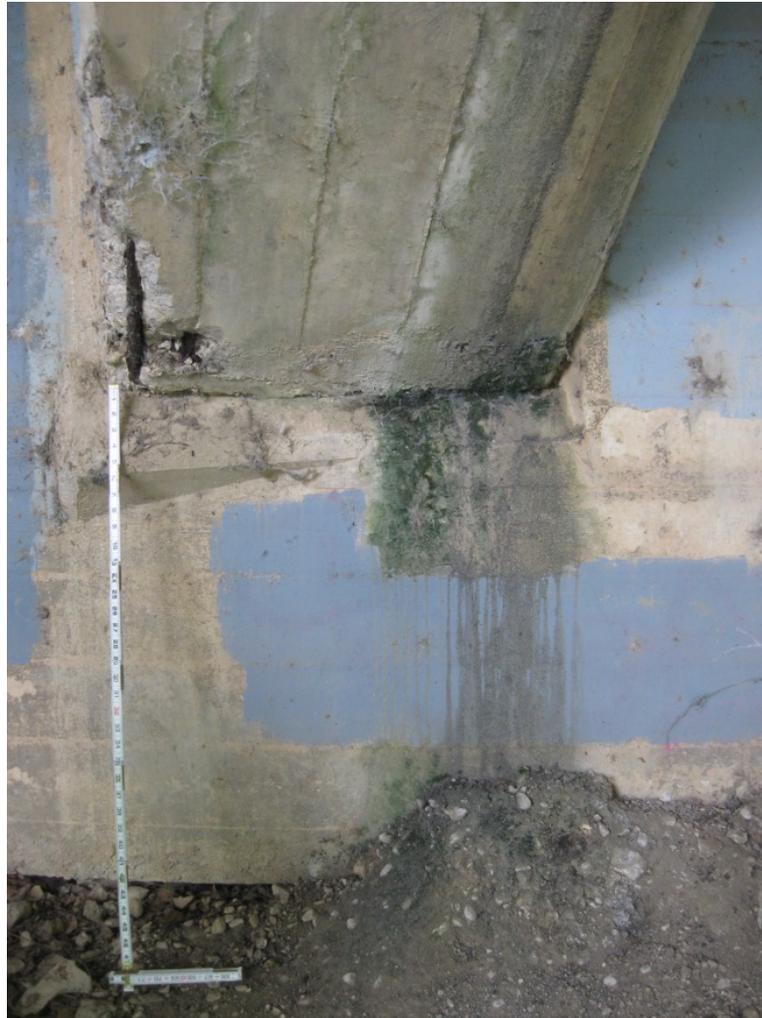
Photo 43: Spall in south edge of Arch Rib 3 adjacent to the West Abutment Springing Line

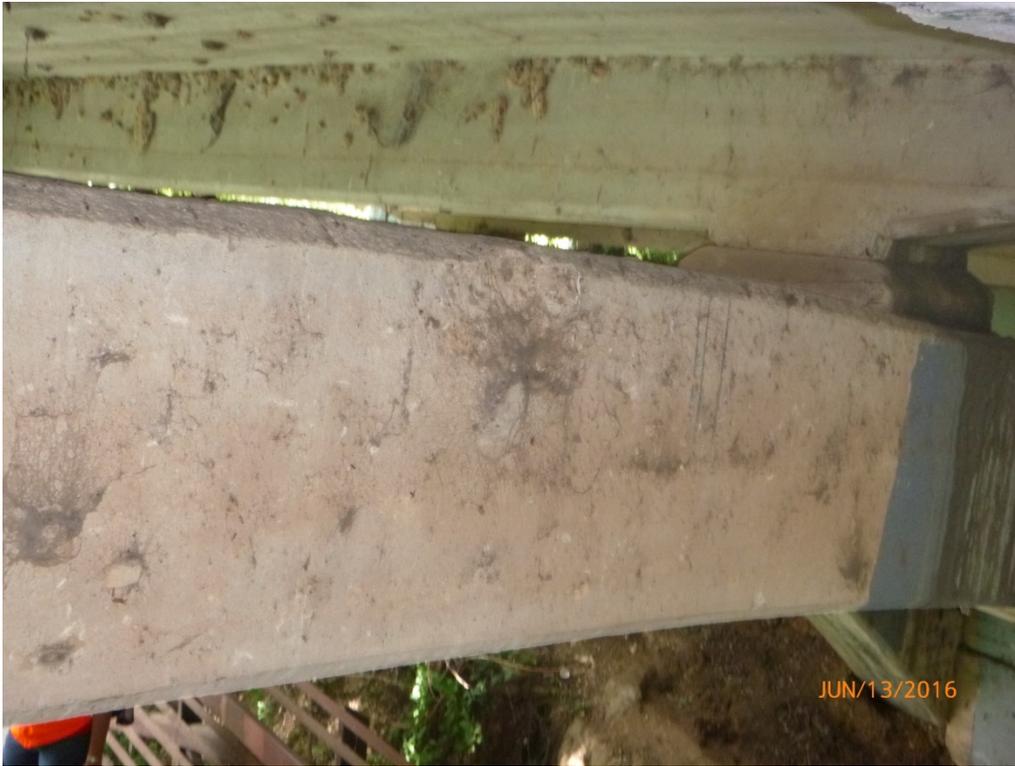
Photo 44: Spall in north face of Arch Rib 3 in Span 1 between Floorbeams 3 and 4

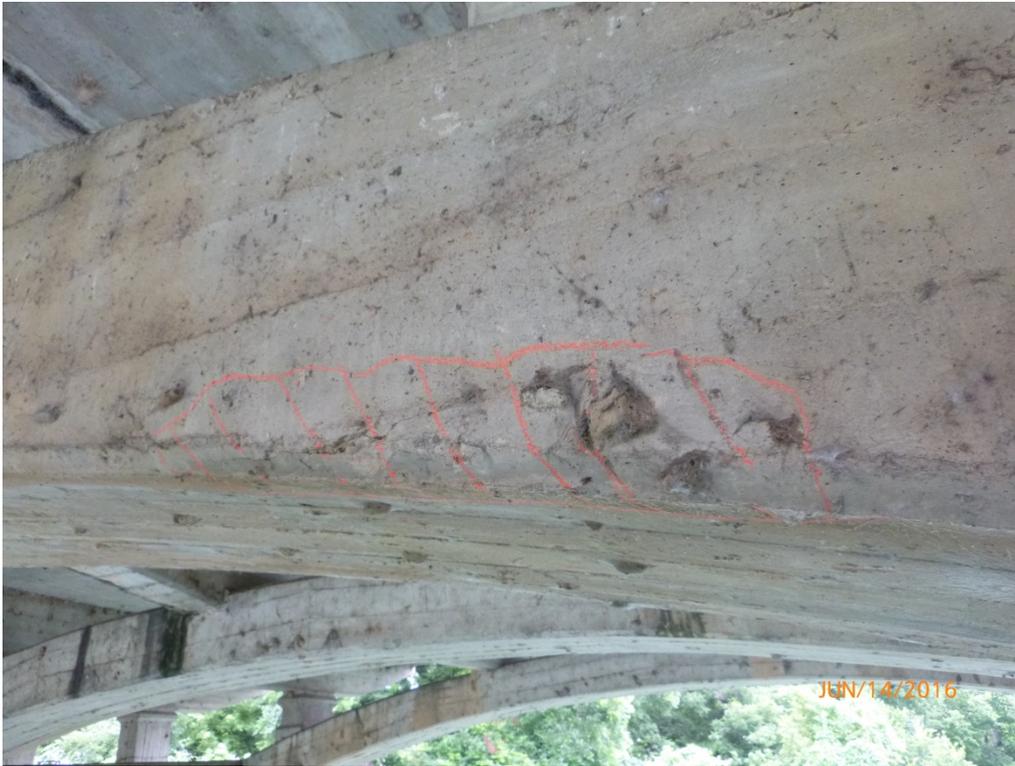
Photo 46: Imminent spall on lower south corner of Arch Rib 3 in Span 2 below Floorbeam 12

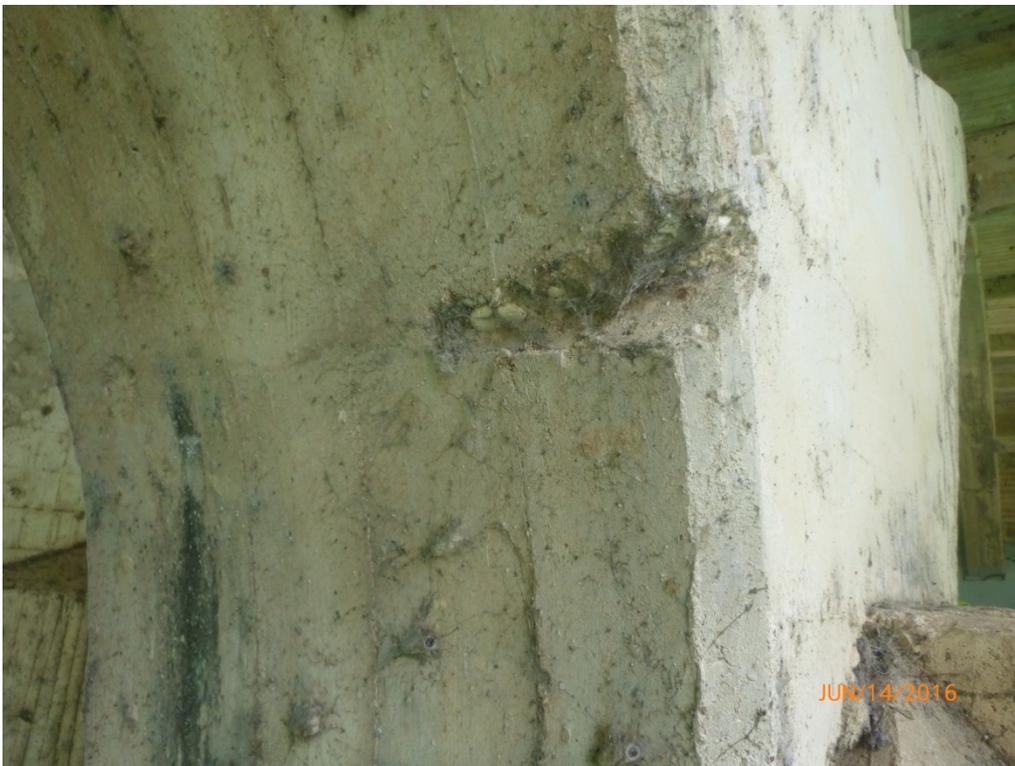
Photo 47: Deterioration on south edge of the underside of Arch Rib 3 along cold joint at Span 2 Pier 2 Springing Line

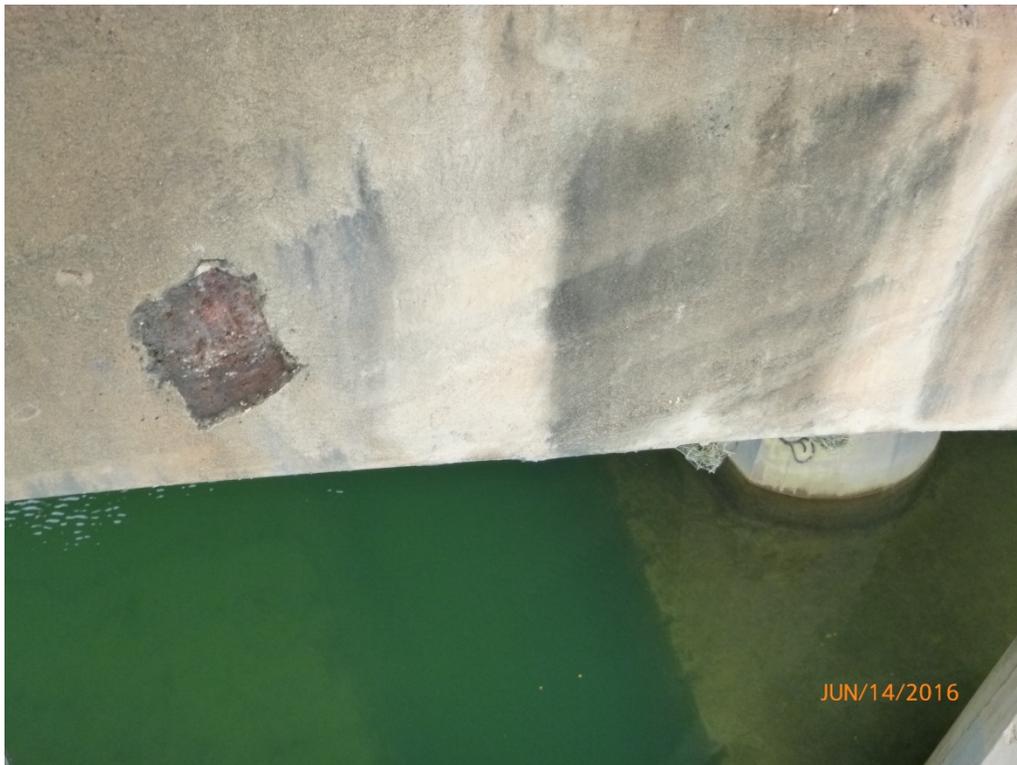
Photo 48: Shallow surface defect in south face of Arch Rib 4 2' west of Floorbeam 12 in Span 2
