BARTON SPRINGS ROAD OVER BARTON CREEK

Bridge Inspection and Condition Assessment Report

Bridge 14-227-0-B002-26-001
Austin, Texas
January 2017

2016 Bridge Inspection Report
Barton Springs Road over Barton Creek
Bridge 14-227-0-B002-26-001

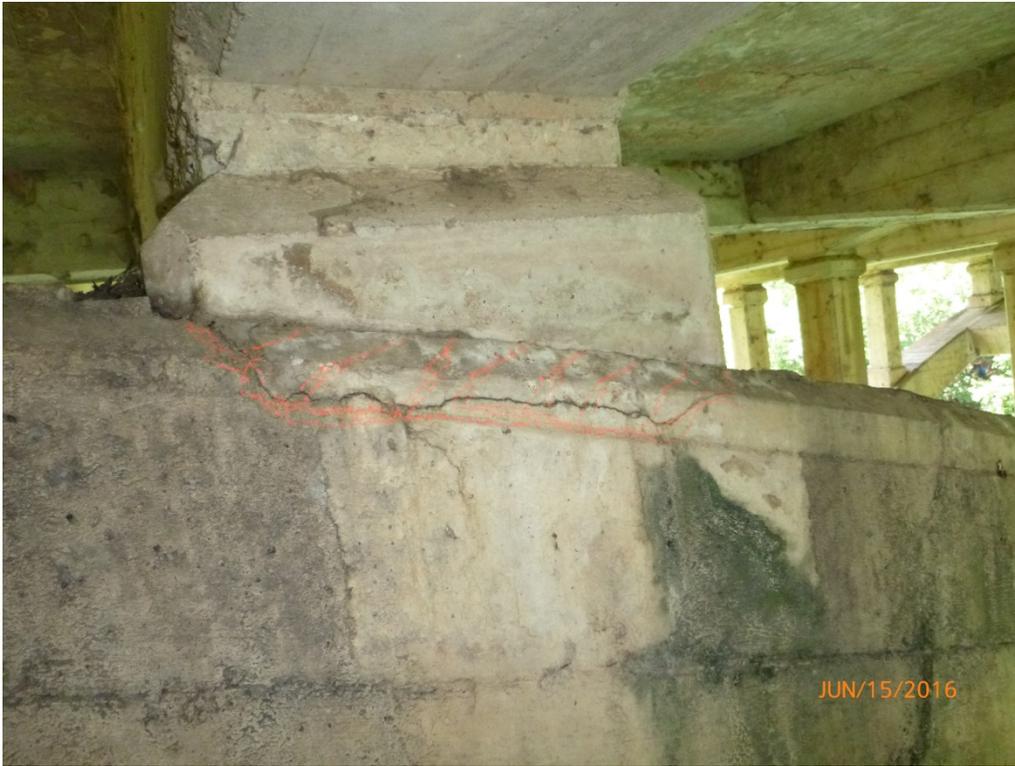
Photo 49: Longitudinal crack and delamination of the north side of Arch Rib 2 below Floorbeam 16 in Span 3

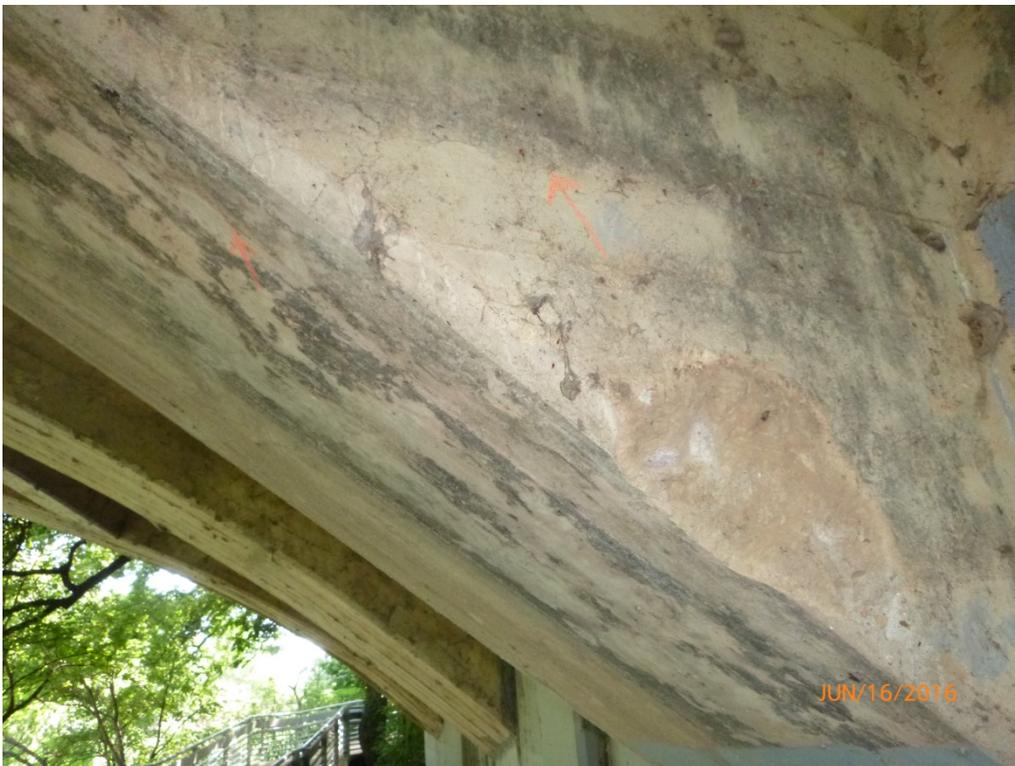
Photo 50: Spall and cracking in lower south corner of Arch Rib 3 at the East Abutment Springing Line

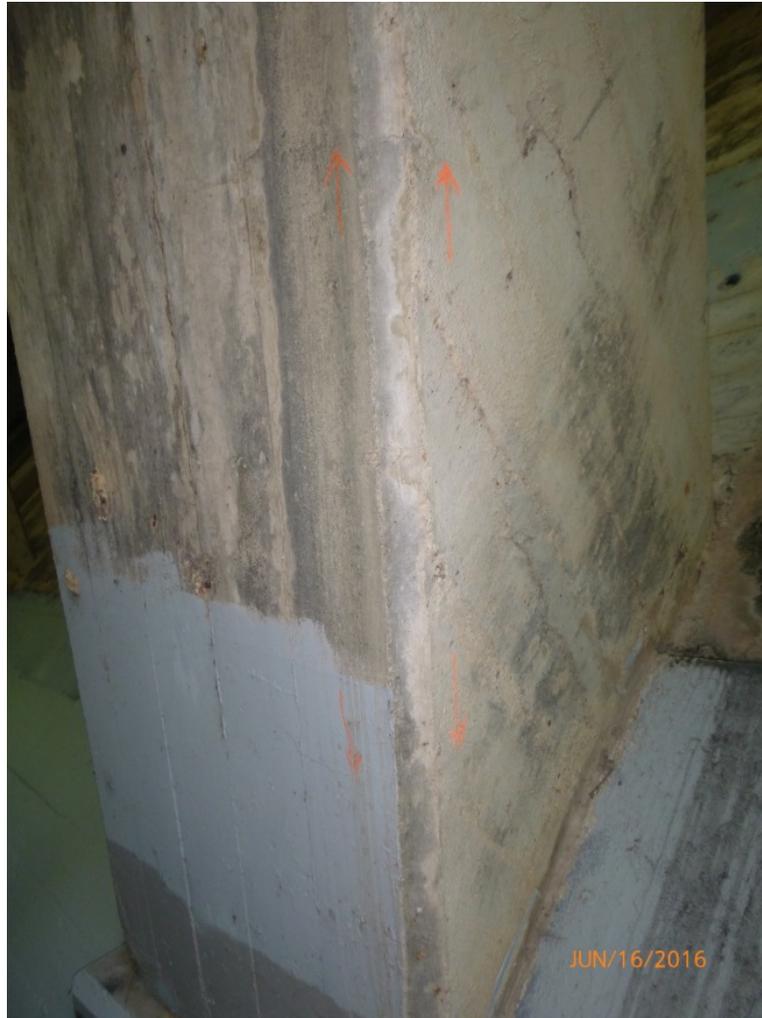
Photo 51: Hairline cracking in the lower south edge of Arch Rib 4 at the East Abutment Springing Line

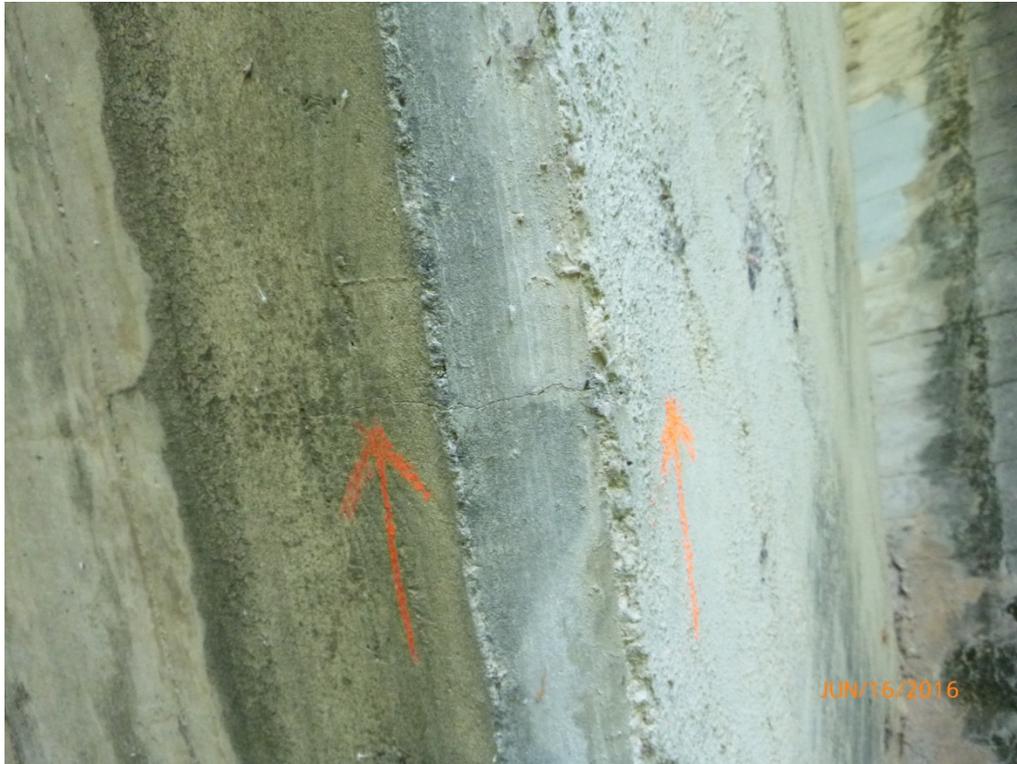
Photo 52: Close-up of hairline cracking in the lower south edge of Arch Rib 4 at the East Abutment Springing Line

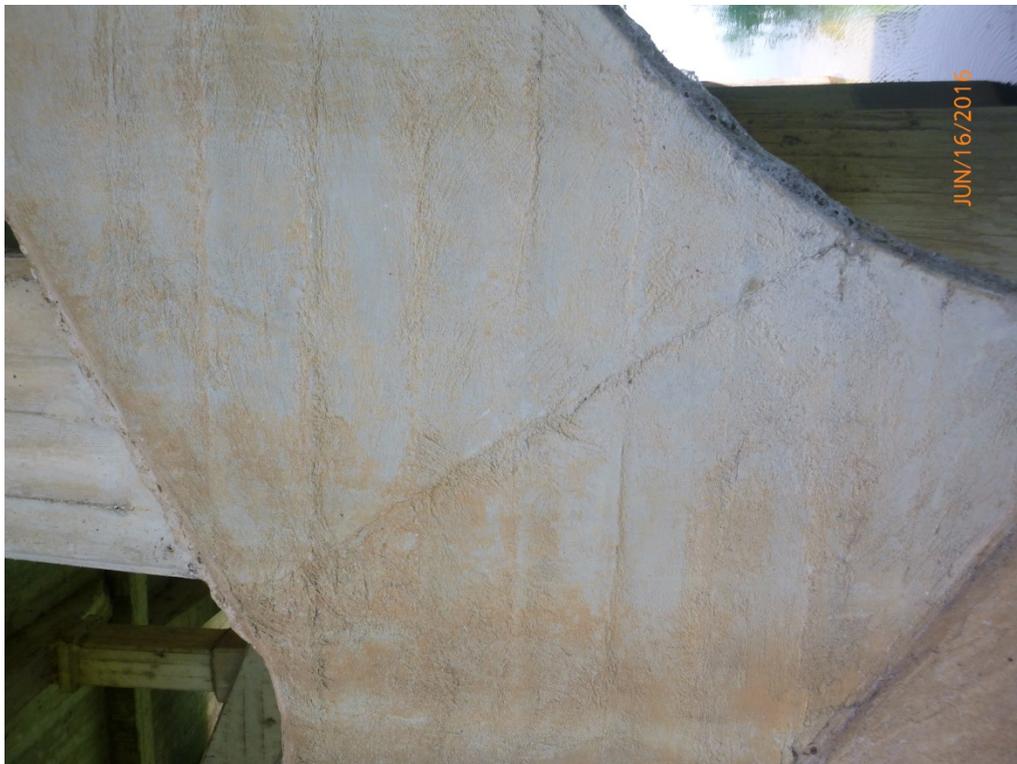
Photo 53: Typical hairline crack at the cold joint between the arch rib and pier

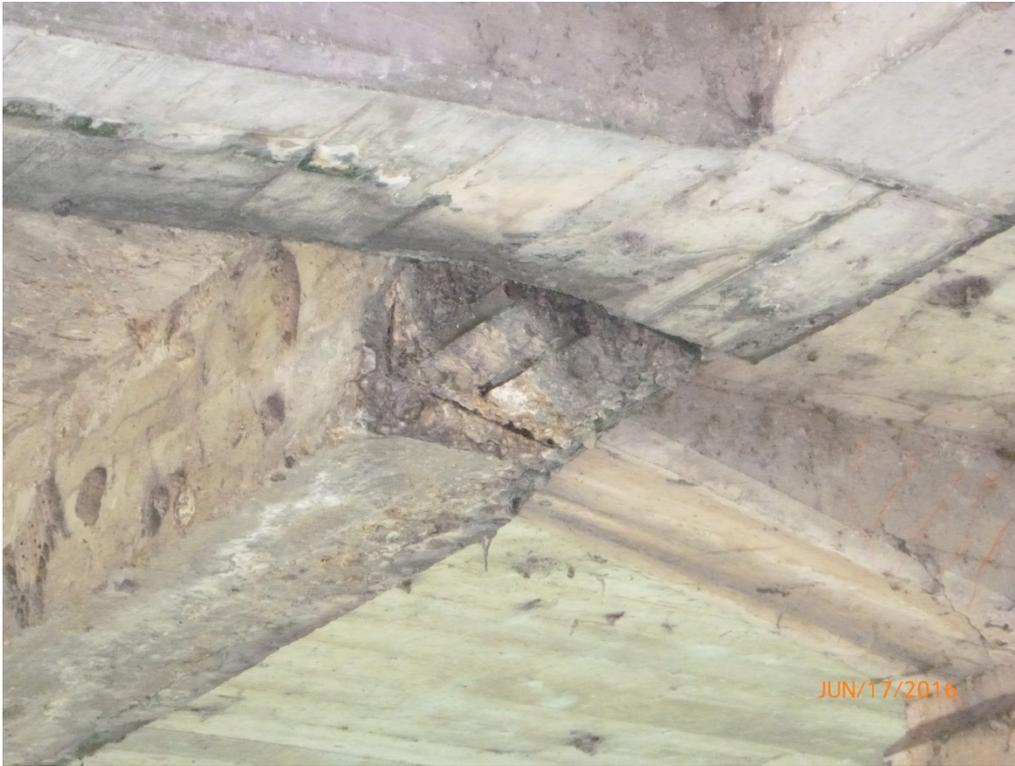
Photo 54: Full width spall in underside of longitudinal beam in Span 1 adjacent to expansion joint at North Structure Floorbeam 4

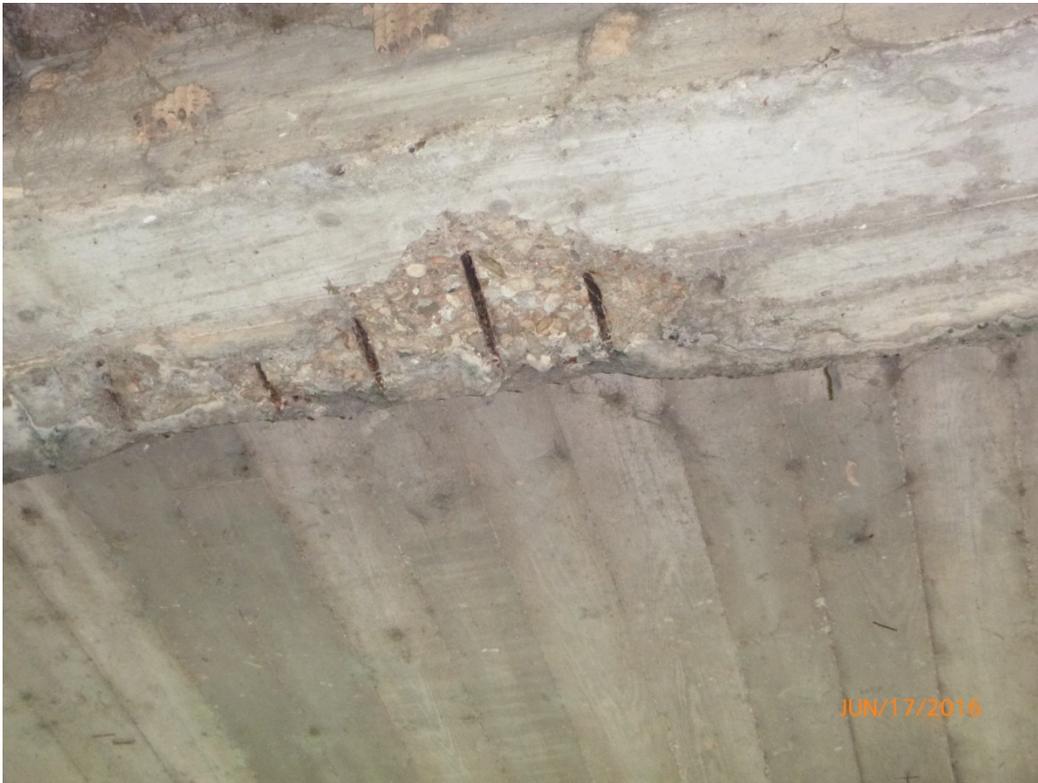
Photo 55: Spalls in underside of longitudinal beam in Span 1 between Floorbeams 2 and 3

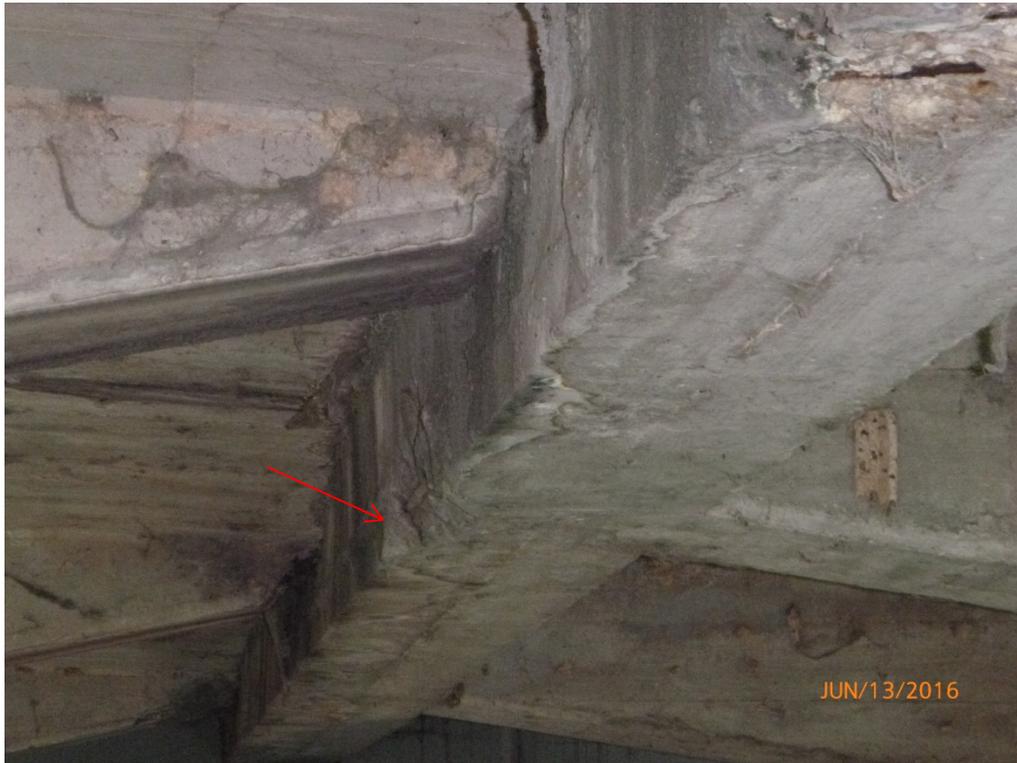
Photo 56: Spall with exposed rebar in lower south edge of longitudinal beam
in Span 1 at Floorbeam 2

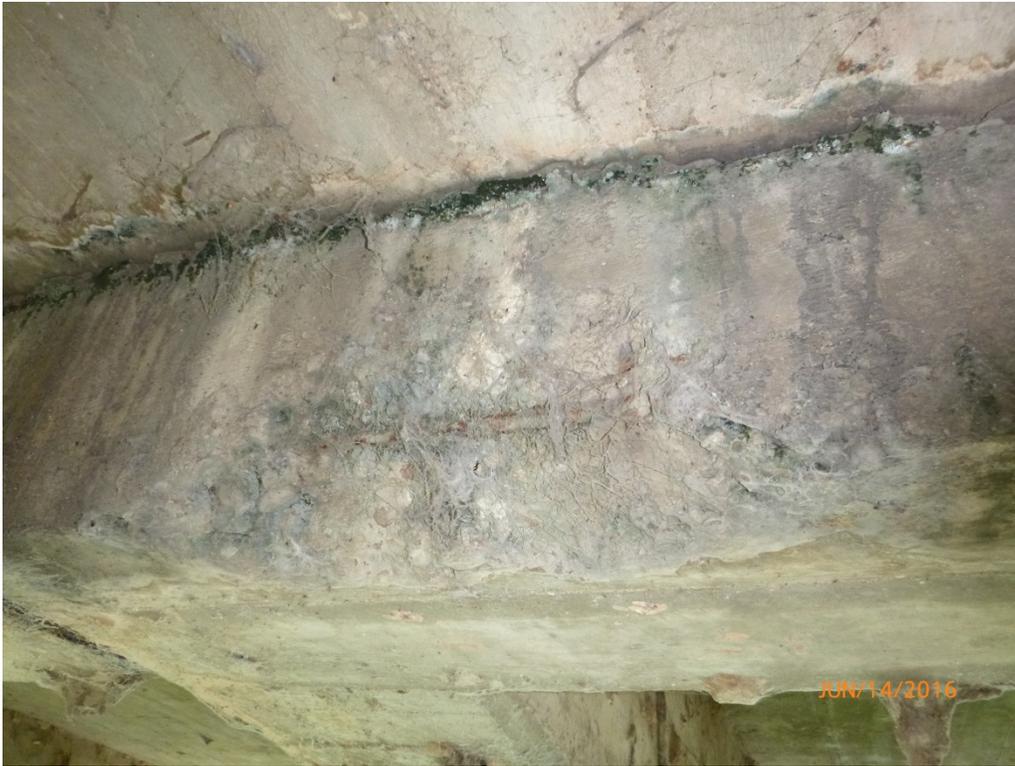
Photo 57: Spall with exposed rebar in underside of longitudinal beam in Span 2 immediately west of Floorbeam 11 of the South Structure

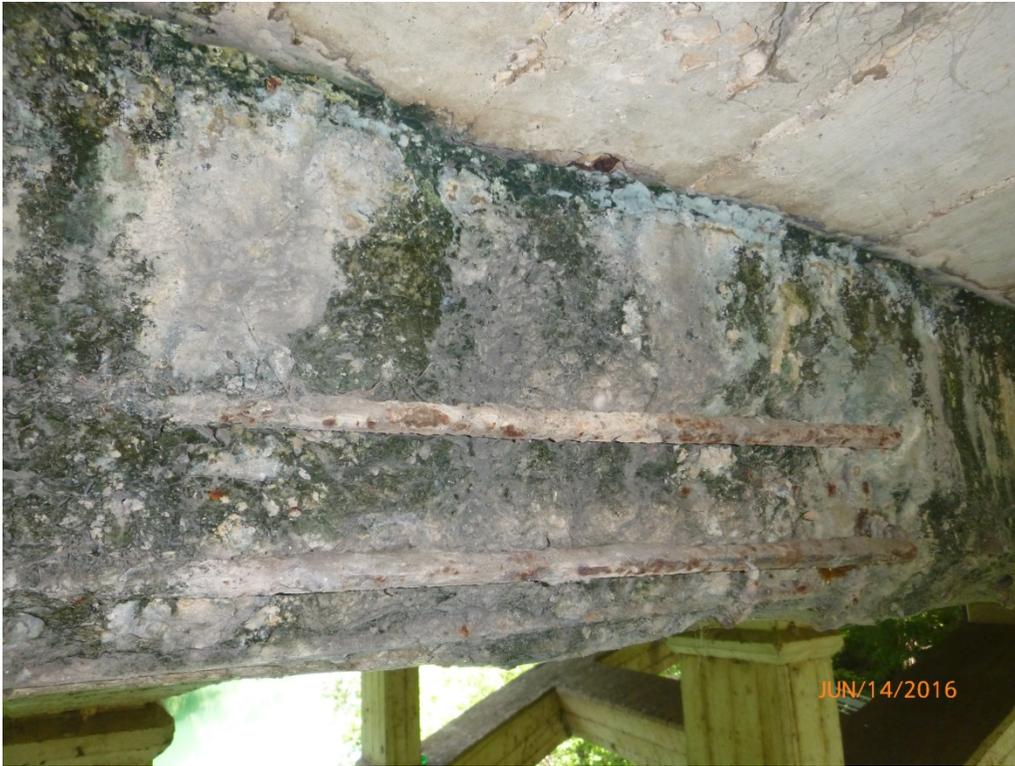
Photo 61: Deterioration in lower south face and corner of longitudinal beam with exposed rebar in Span 2 between Floorbeams 13 and 14

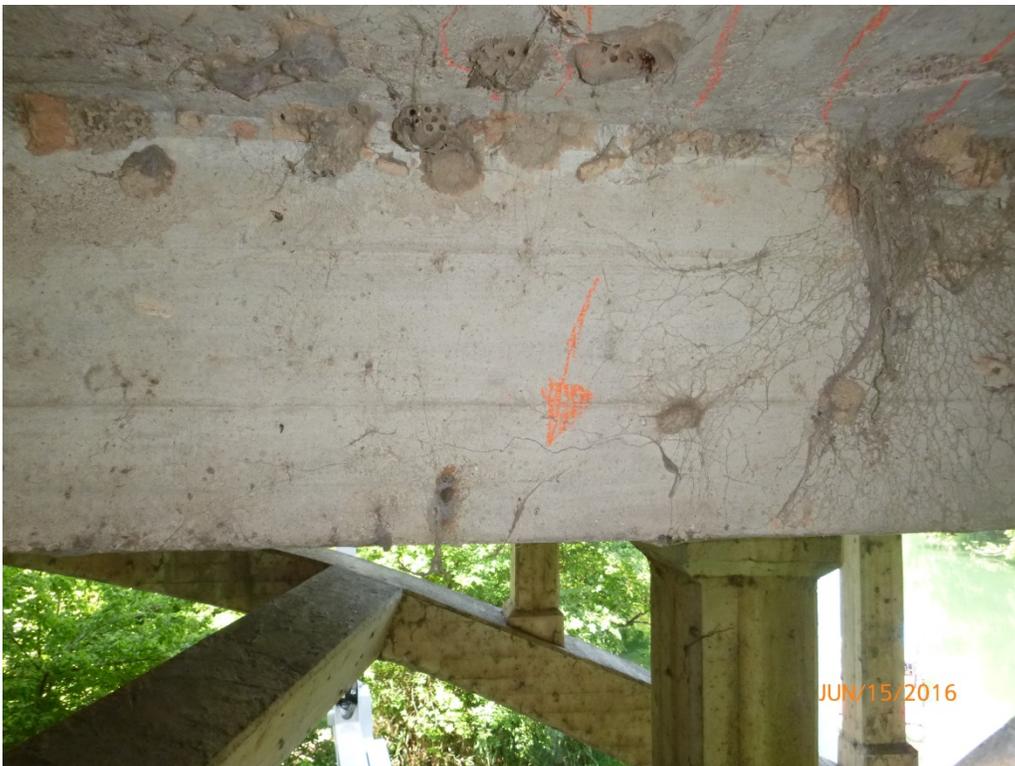
Photo 62: Cracks in north face of longitudinal beam between North Structure Between Floorbeams 14 and 15

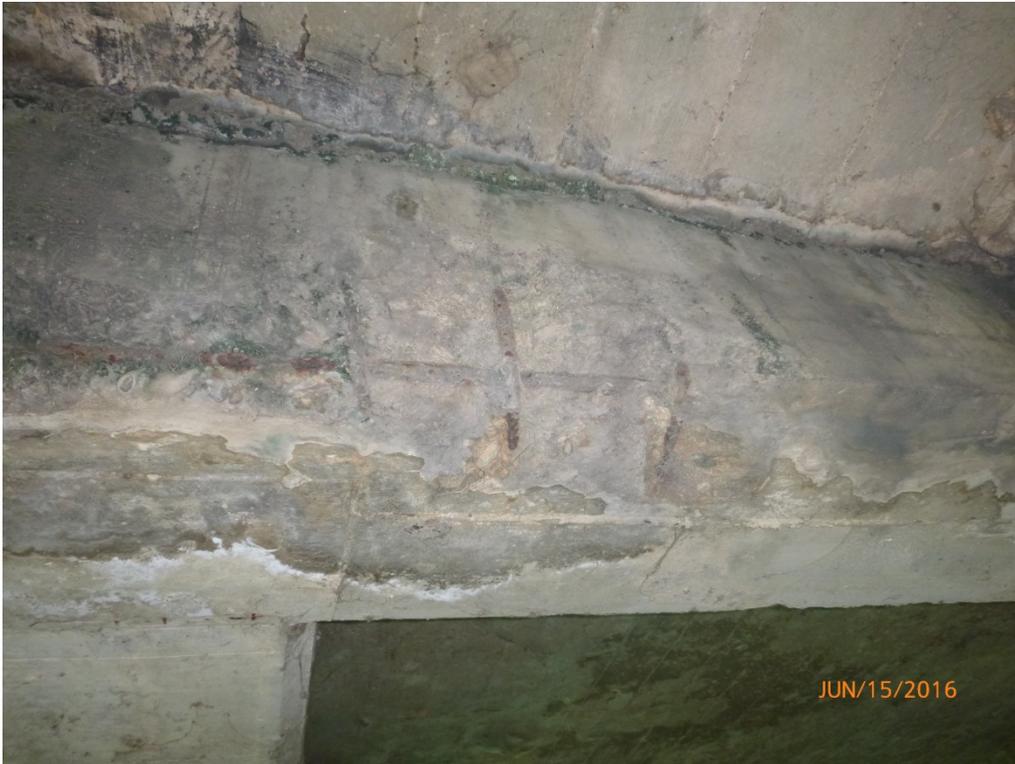
Photo 63: Deterioration in lower south face and corner of longitudinal beam with exposed rebar in Span 3 at North Structure Floorbeam 15

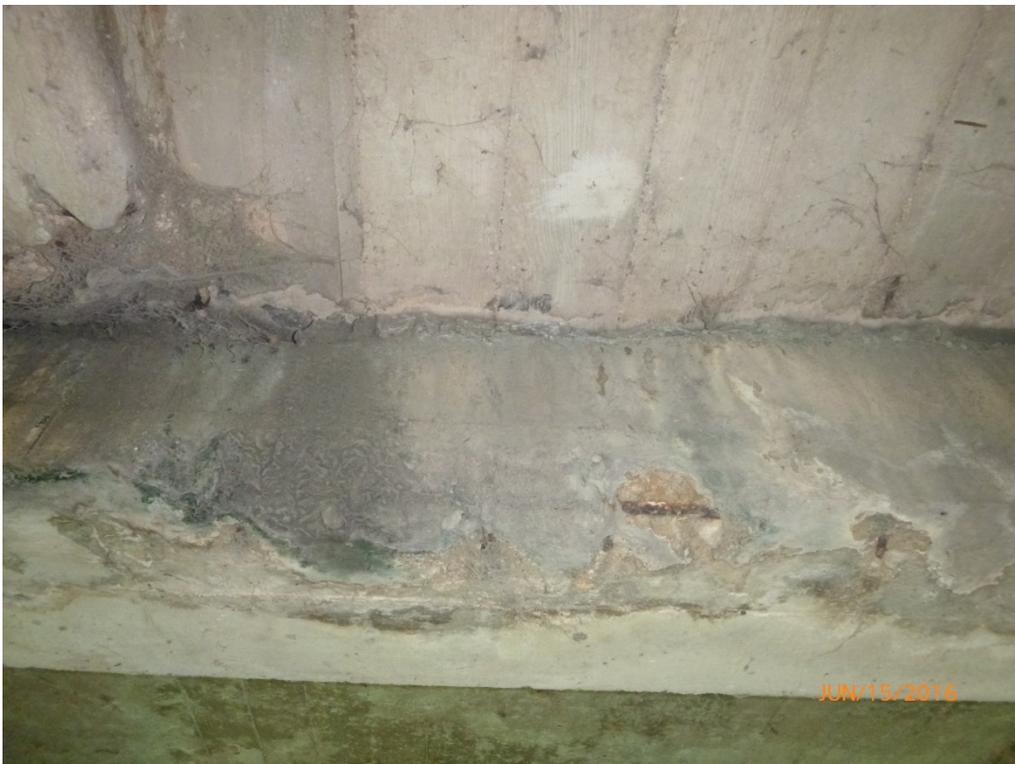
Photo 64: Deterioration in lower south face and corner of longitudinal beam with exposed rebar in Span 3 between North Structure Floorbeams 15 and 16

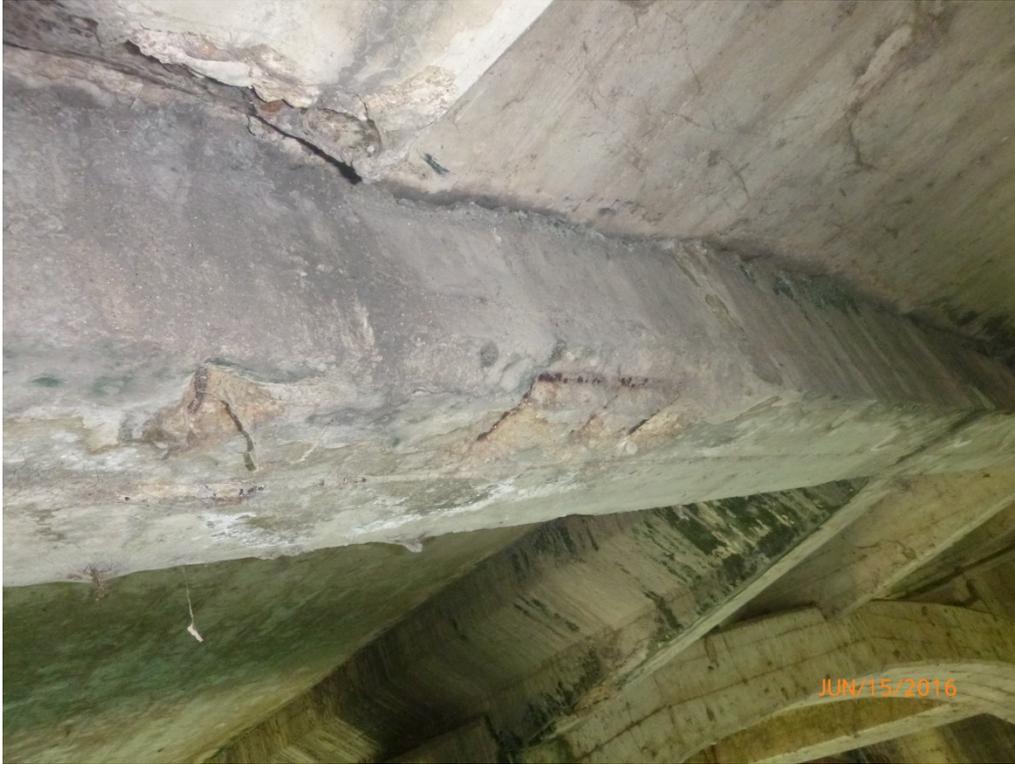
Photo 65: Deterioration on lower south face and corner of longitudinal beam with exposed rebar in Span 3 between North Structure Floorbeams 16 and 17

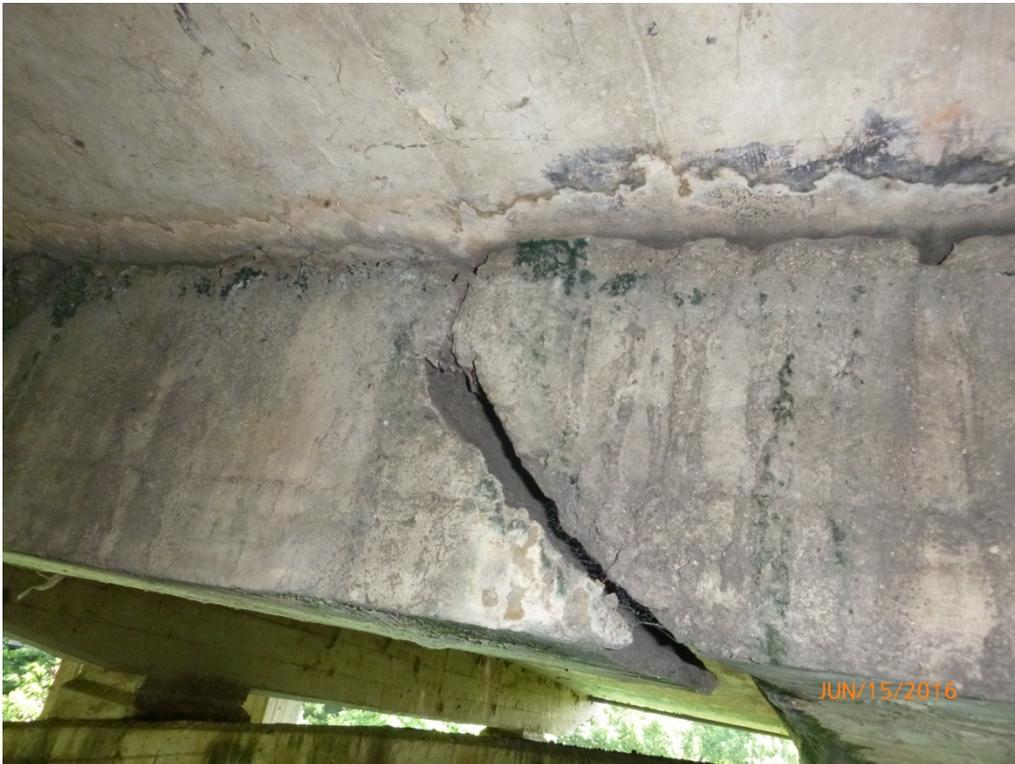
Photo 66: Deterioration of longitudinal edge girder at the expansion joint located at North Structure Floorbeam 17

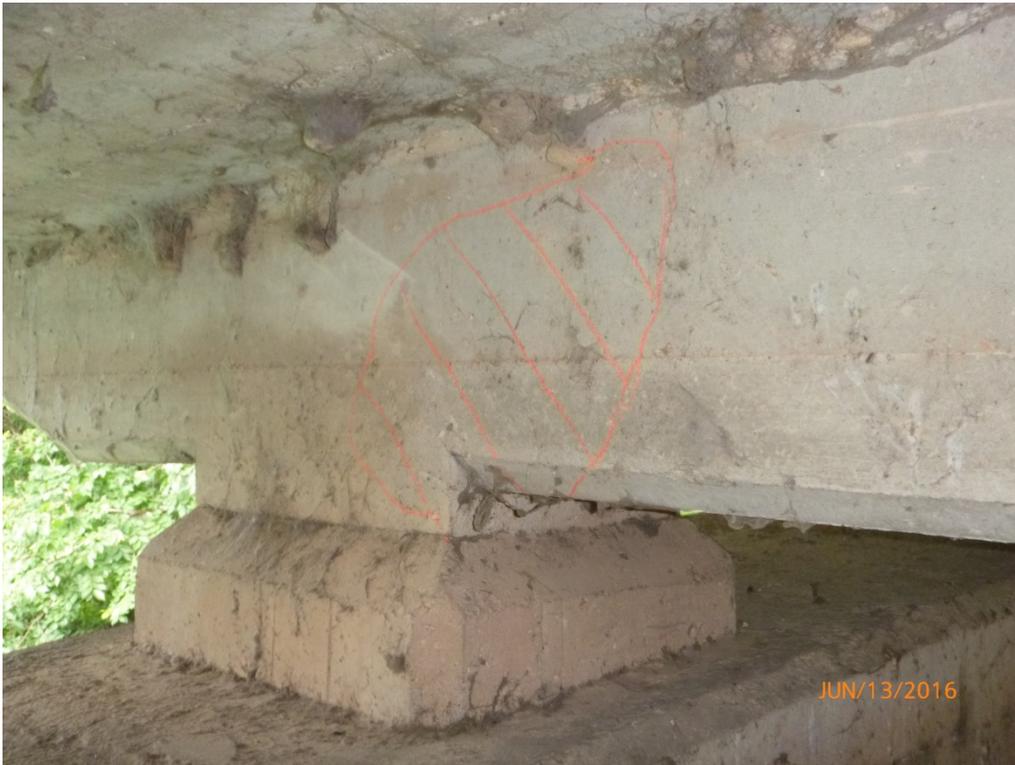
Photo 67: Delamination in east face of Floorbeam 4 at Arch Rib 4

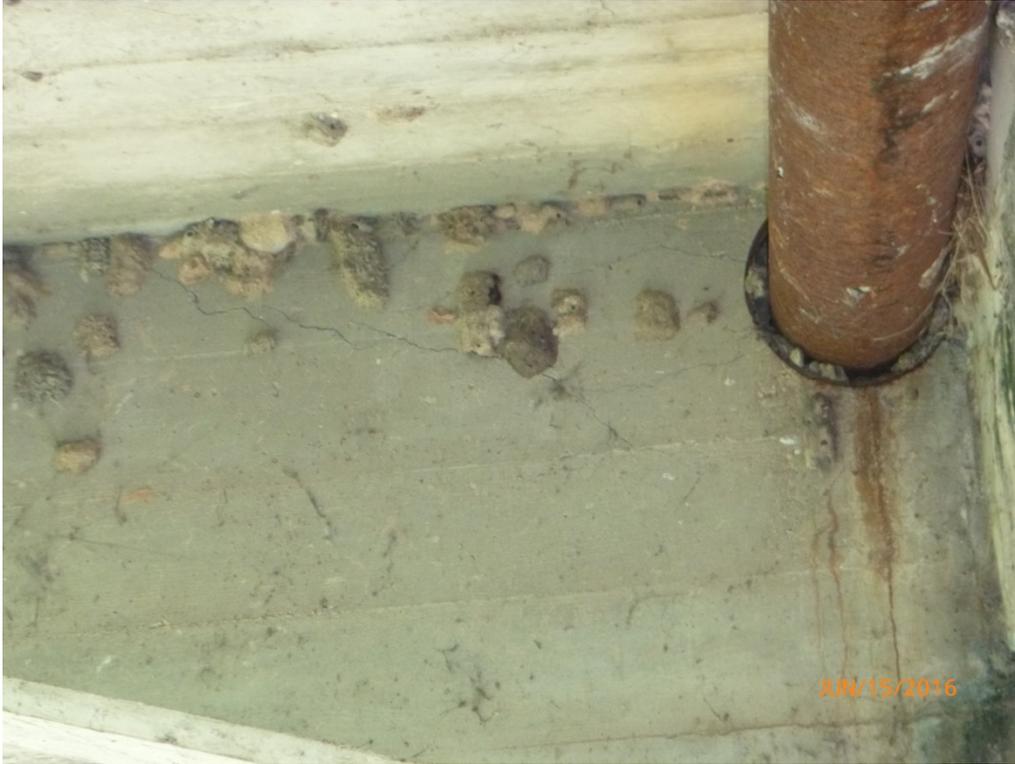
Photo 80: Cracks (up to 1/32") in south cantilever east face of South Structure Floorbeam 19

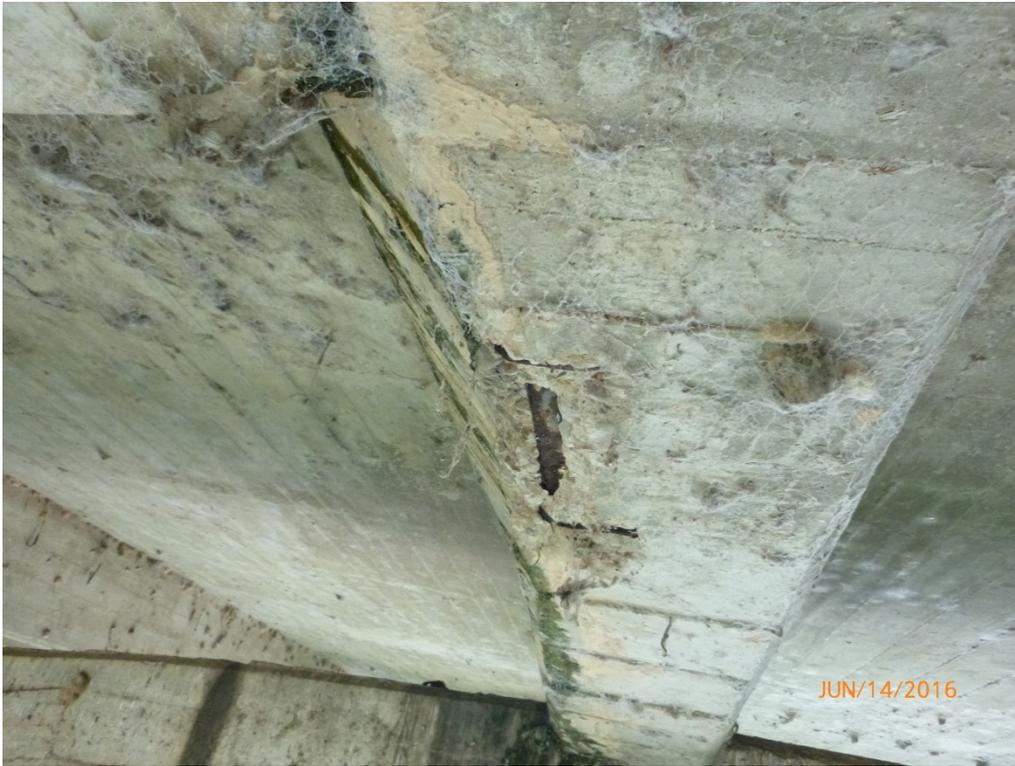
Photo 87: Spalling with exposed rebar in west face of south cantilever of North Structure Floorbeam 10

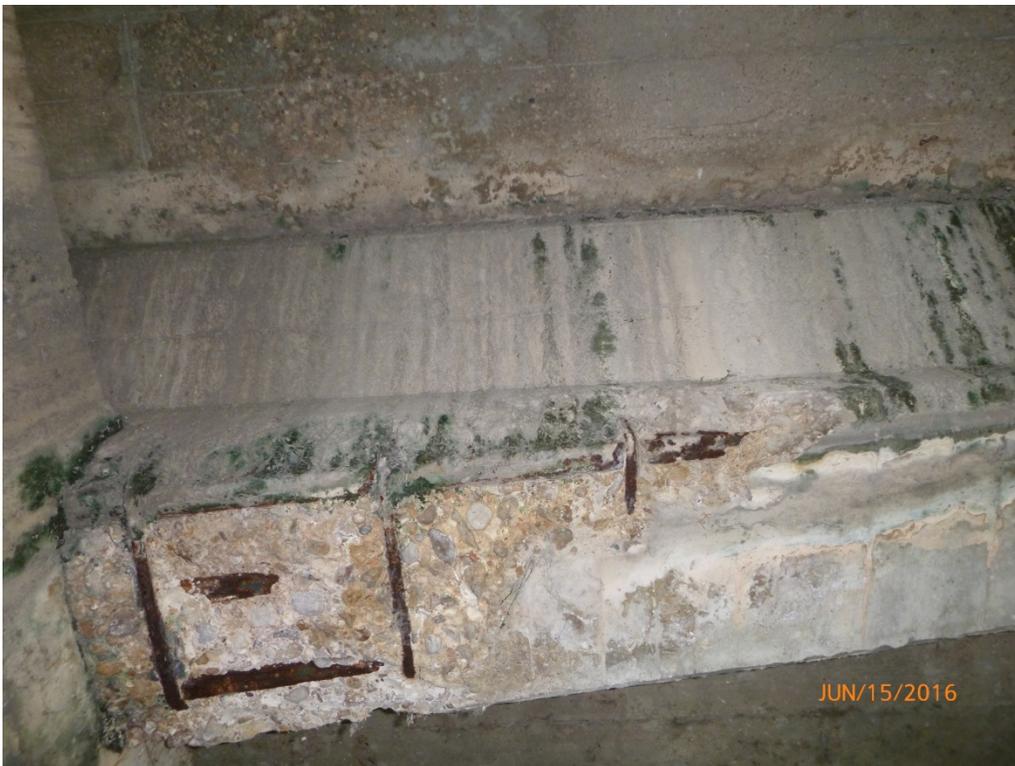
Photo 88: Spall with exposed rebar of underside of south cantilever of North Structure Floorbeam 17

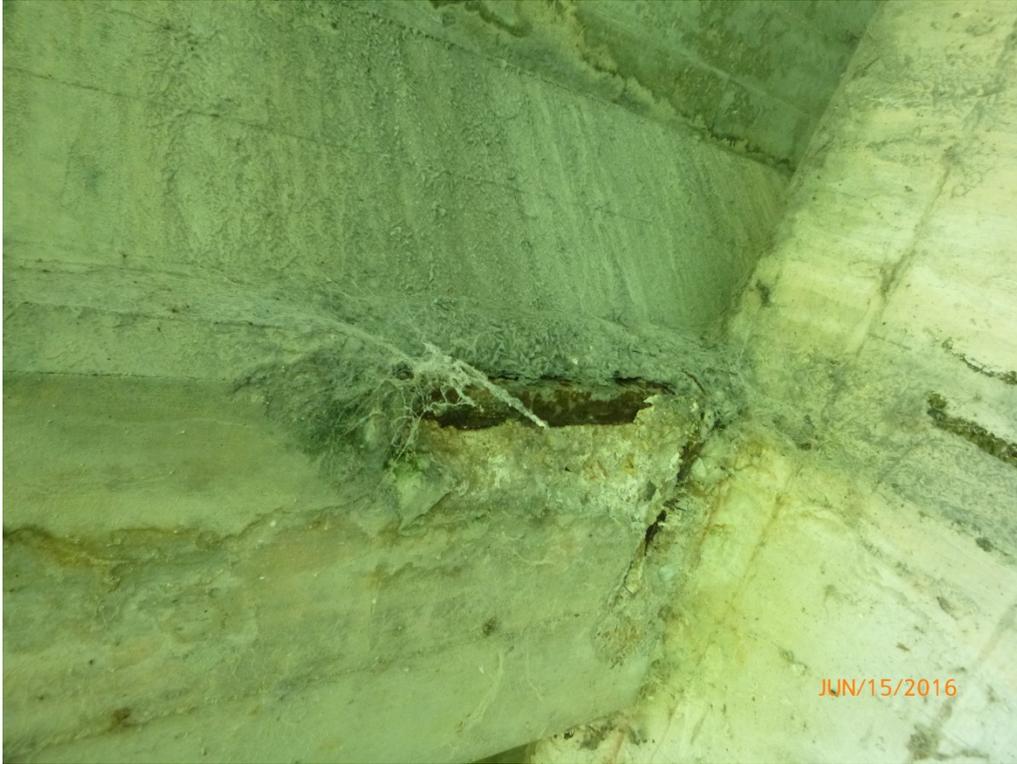
Photo 89: Spall with exposed rebar in underside of north cantilever of North Structure Floorbeam 17

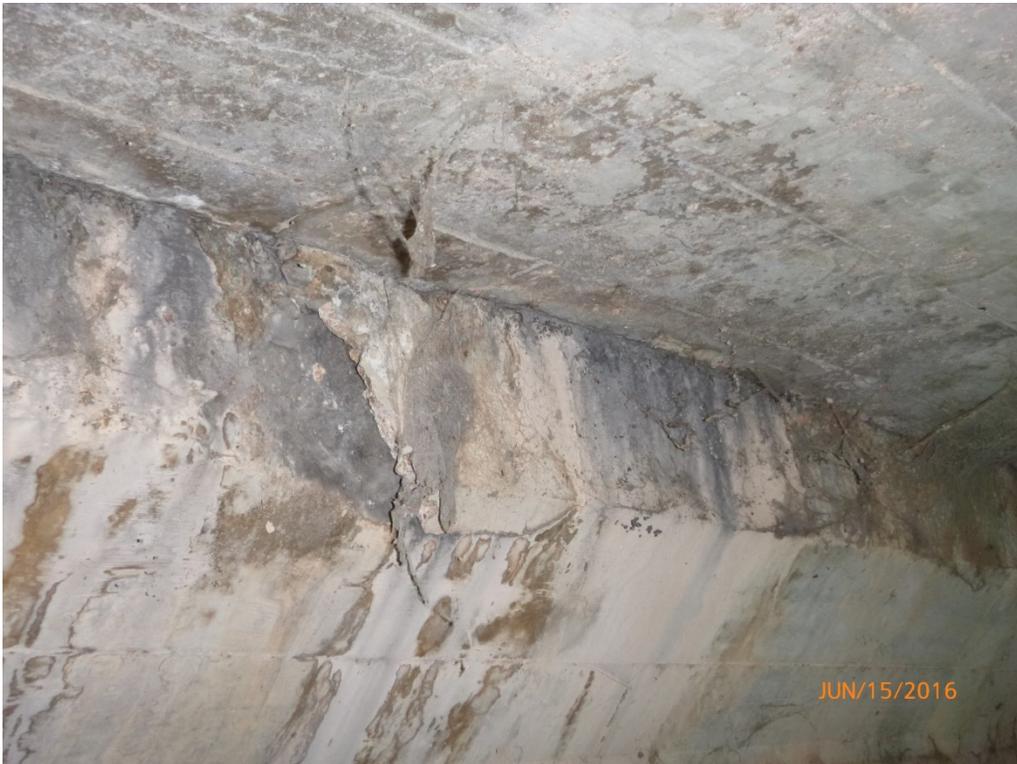
Photo 90: Spall in top edge of the east face of Floorbeam 18 over Arch Rib 2

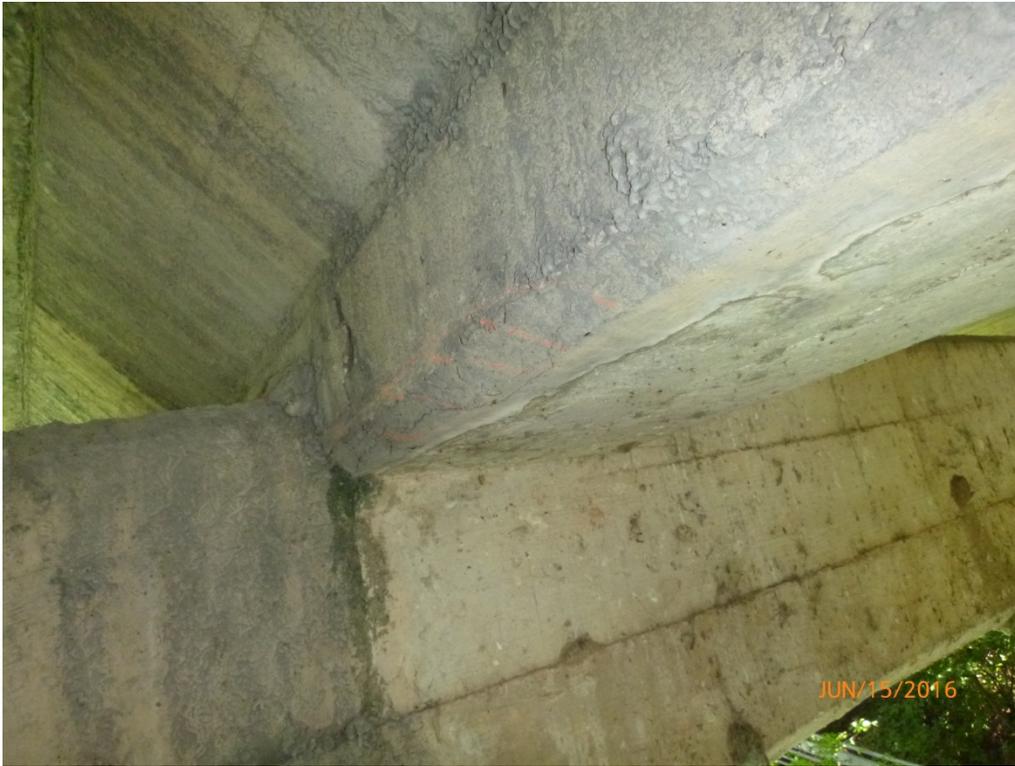
Photo 91: Cracking and delamination of lower west edge of Floorbeam 17 on the south side of Arch Rib 1

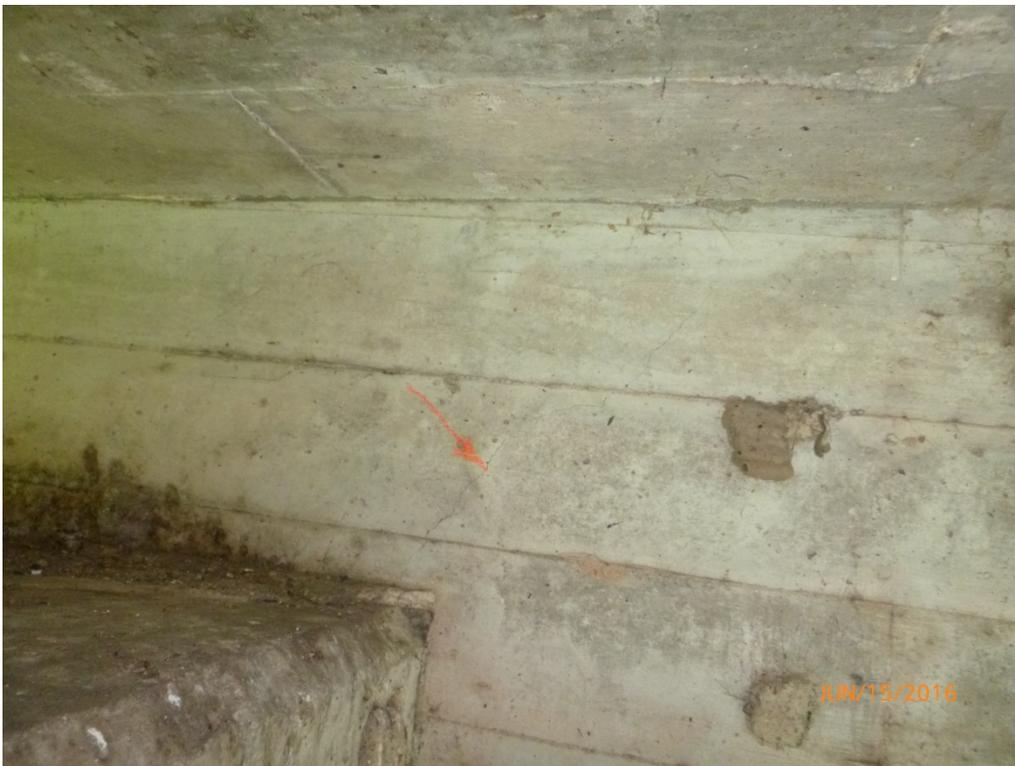
Photo 92: Hairline diagonal crack visible on both east and west faces of Floorbeam 18 at Arch Rib 1

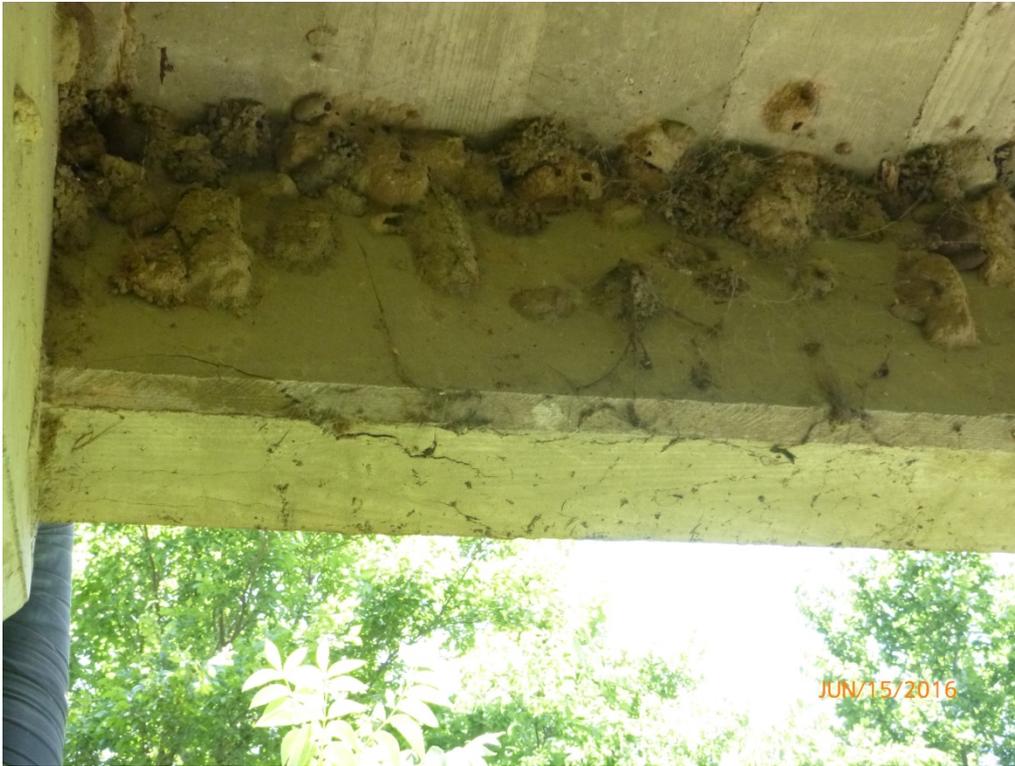
Photo 99: Crack in south sidewalk fascia beam at west side of South Structure Floorbeam 20

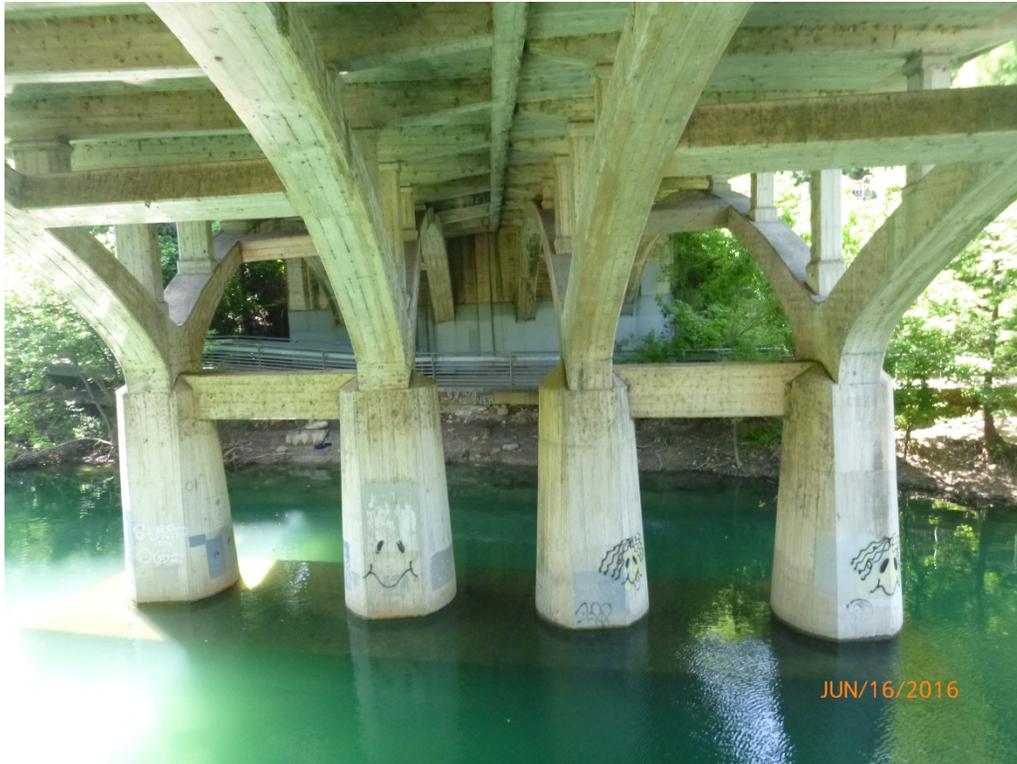
Photo 101: Typical condition of Pier 2 – west face shown

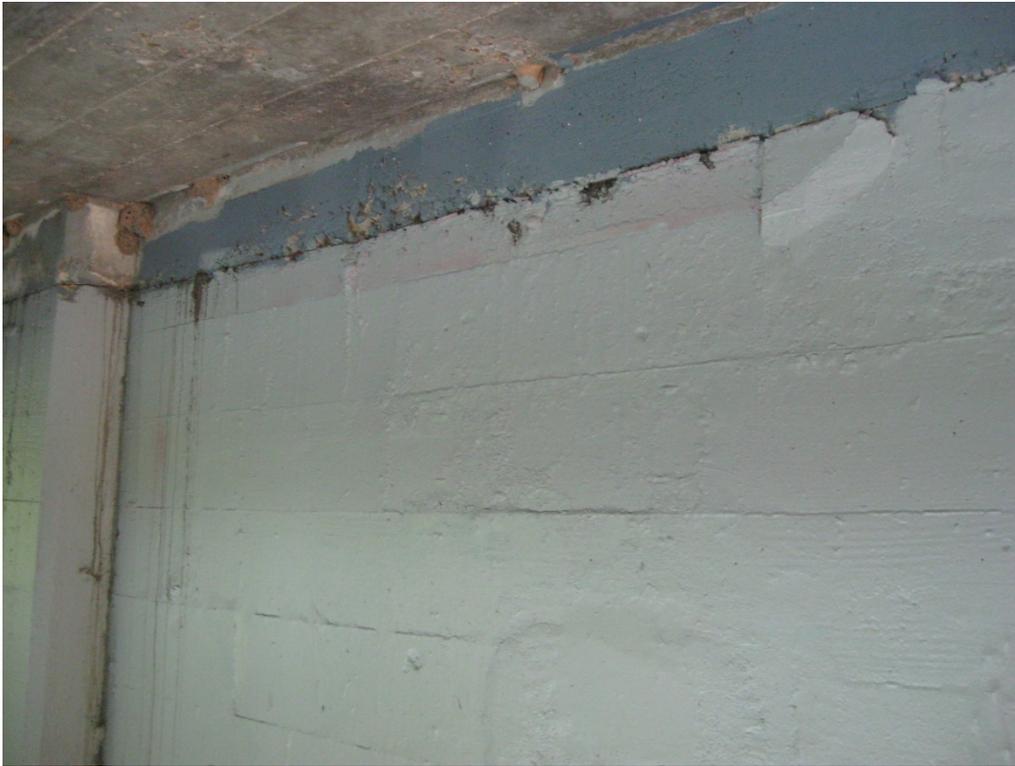
Photo 103: Spall in top of West Abutment Backwall 4' north of the North/South Structure joint

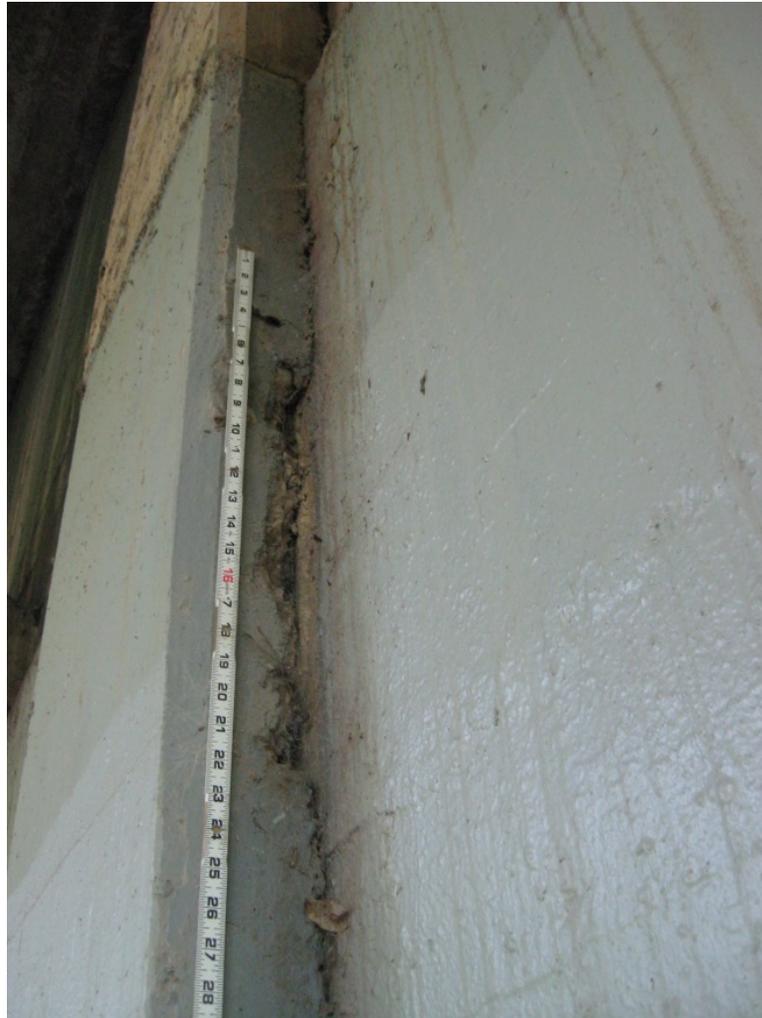
Photo 107: Spalls and delaminations in the North/South Structure joint cover at the East Abutment – bottom 15' shown

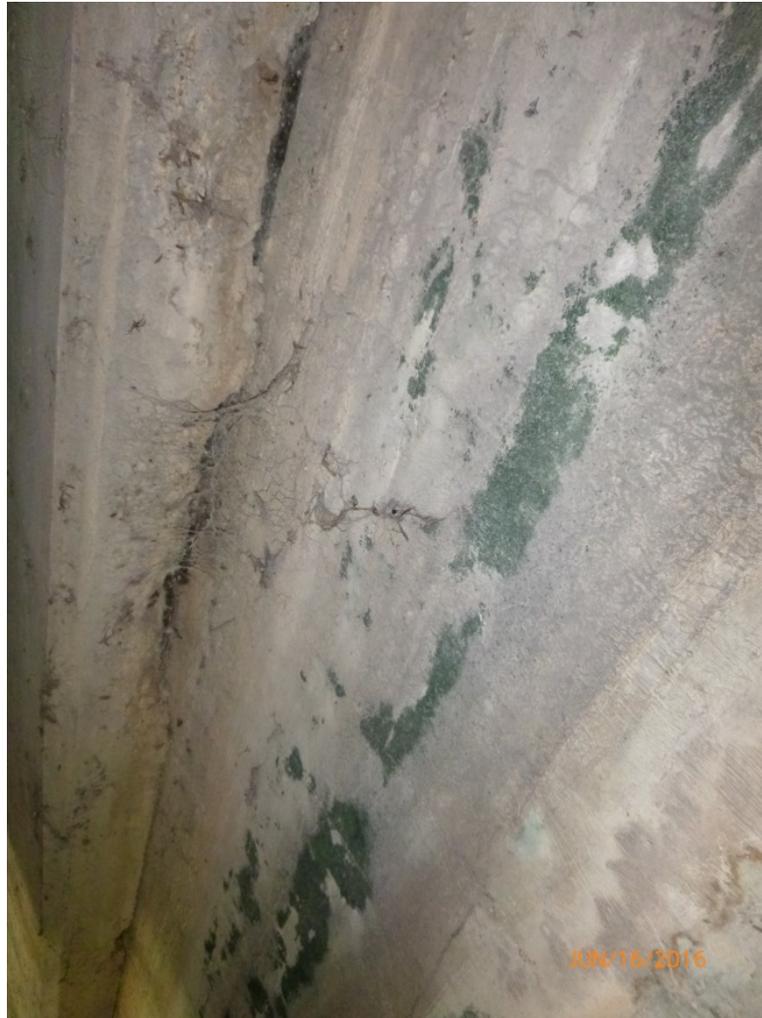
Photo 108: Spalls and delaminations in the North/South Structure joint cover at the East Abutment – top 15' shown
