BARTON SPRINGS ROAD OVER BARTON CREEK

Bridge Inspection and Condition Assessment Report

Bridge 14-227-0-B002-26-001
Austin, Texas
January 2017

2016 Bridge Inspection Report
Barton Springs Road over Barton Creek
Bridge 14-227-0-B002-26-001

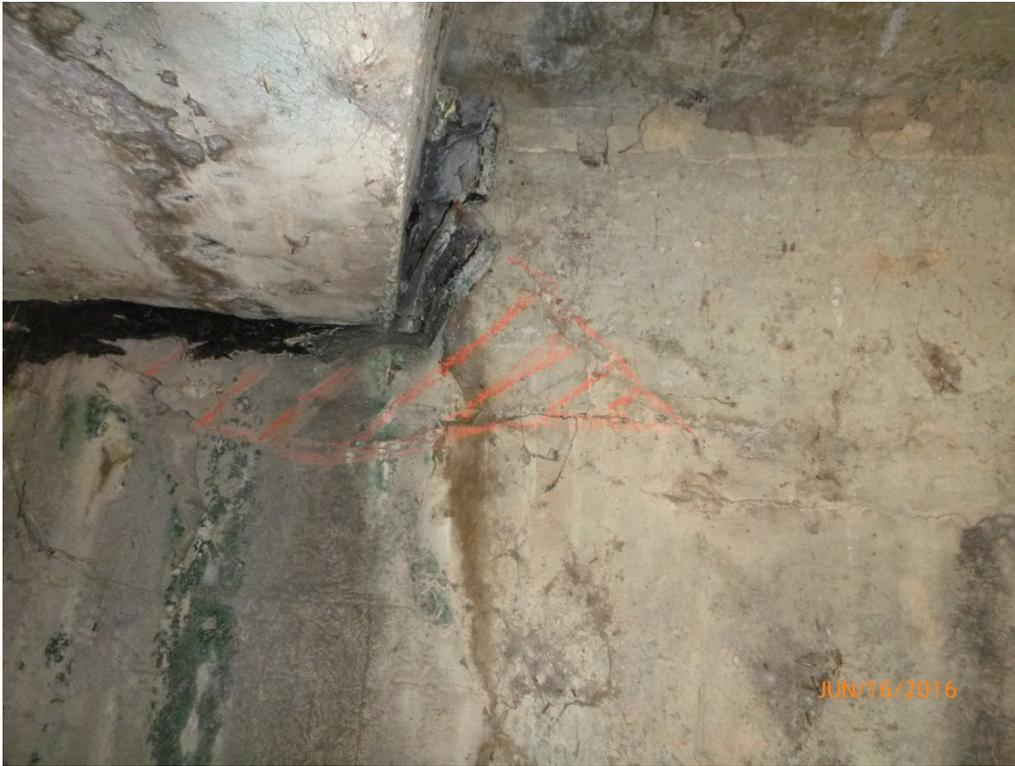
Photo 109: Delamination below the longitudinal edge girder at the East Abutment

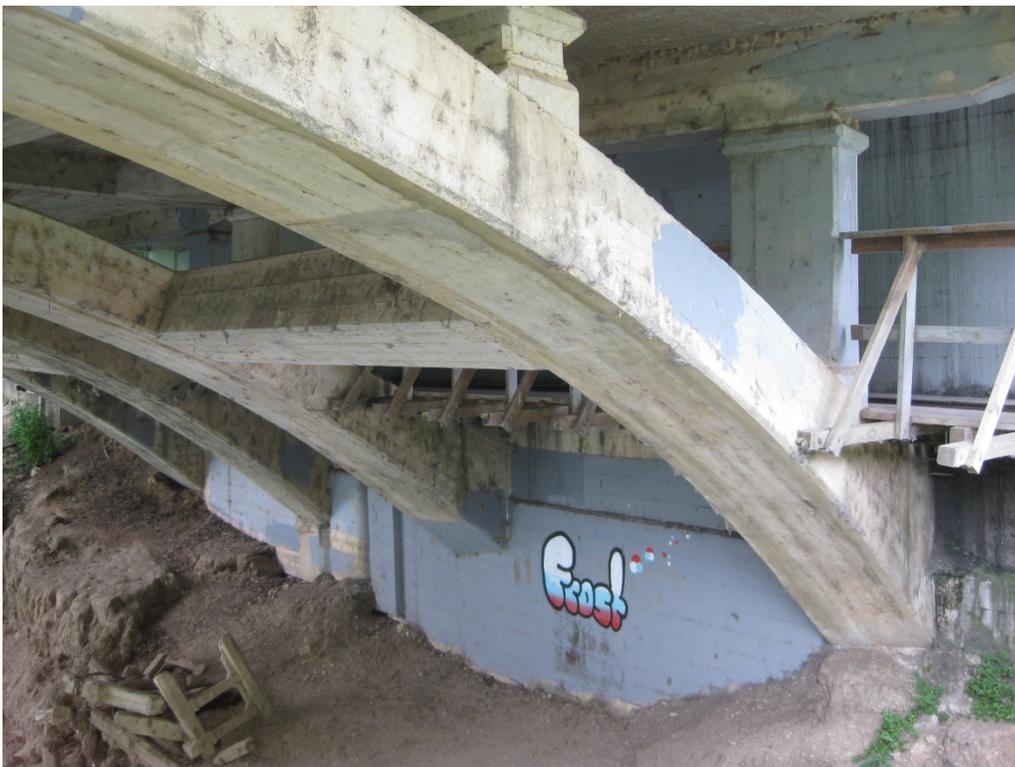
Photo 112: Typical condition of West Abutment slope with erosion and bare slopes

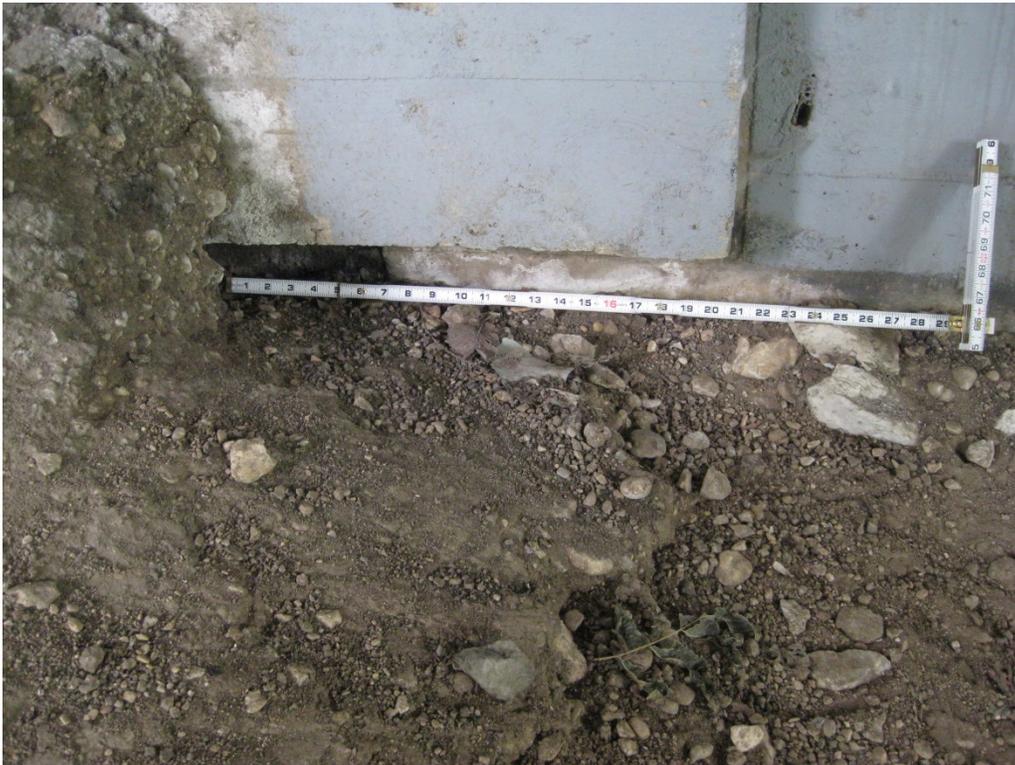
Photo 113: Undermining of West Abutment below the North/South Structure joint cover

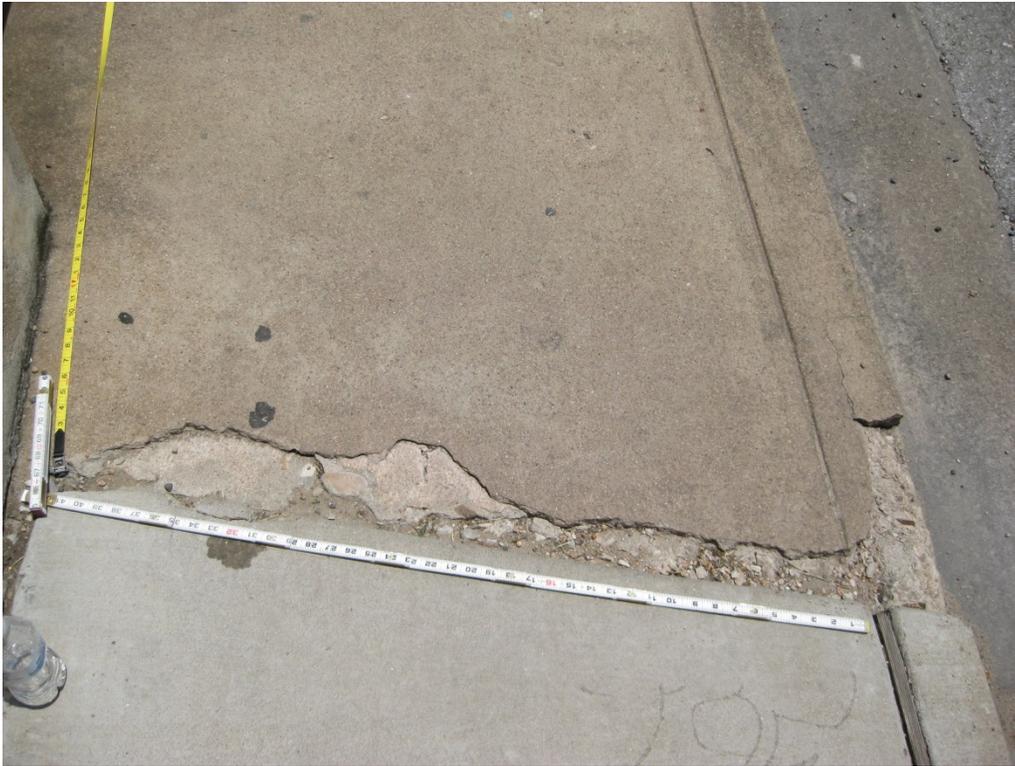
Photo 117: Sidewalk edge spall of the north sidewalk at the West Abutment joint

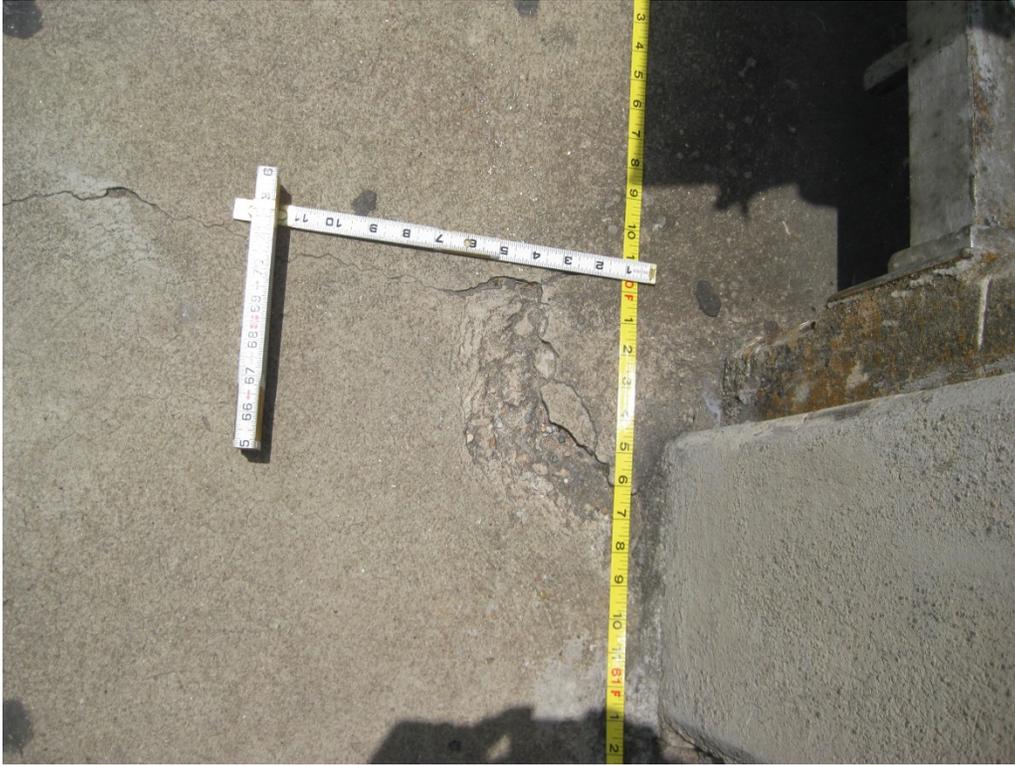
Photo 119: Spall in North Sidewalk 153'-8" east of the West Abutment

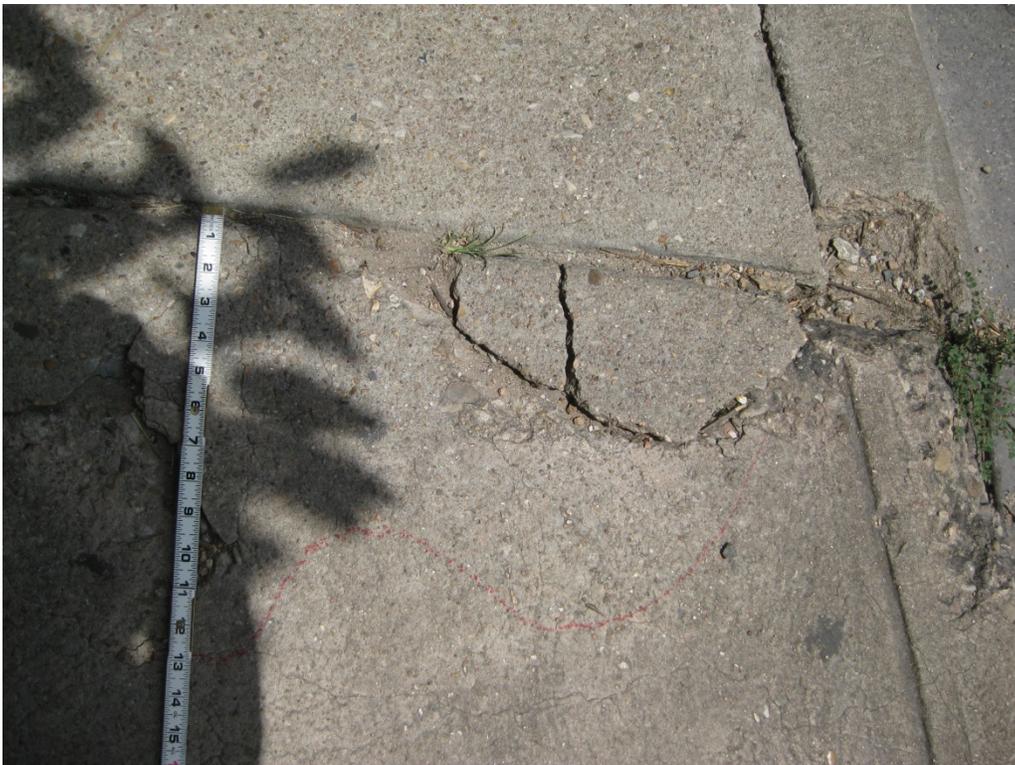
Photo 120: Spall in North Sidewalk at the East Abutment joint

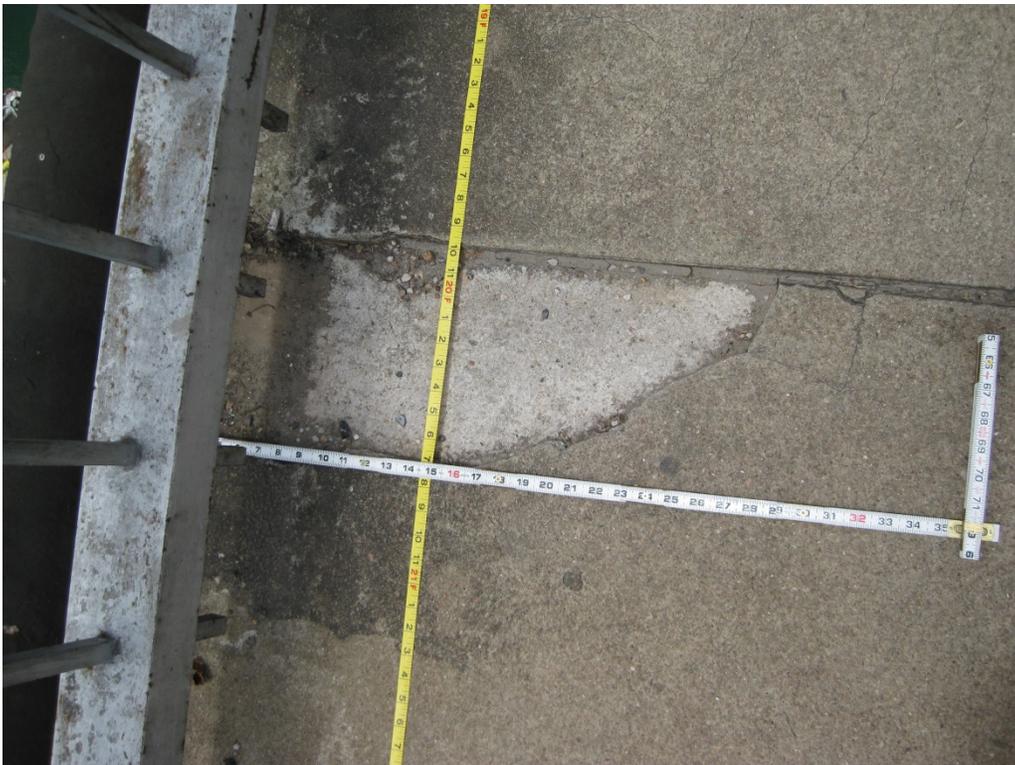
Photo 124: Spall in South Sidewalk overlay 117' east of West Abutment

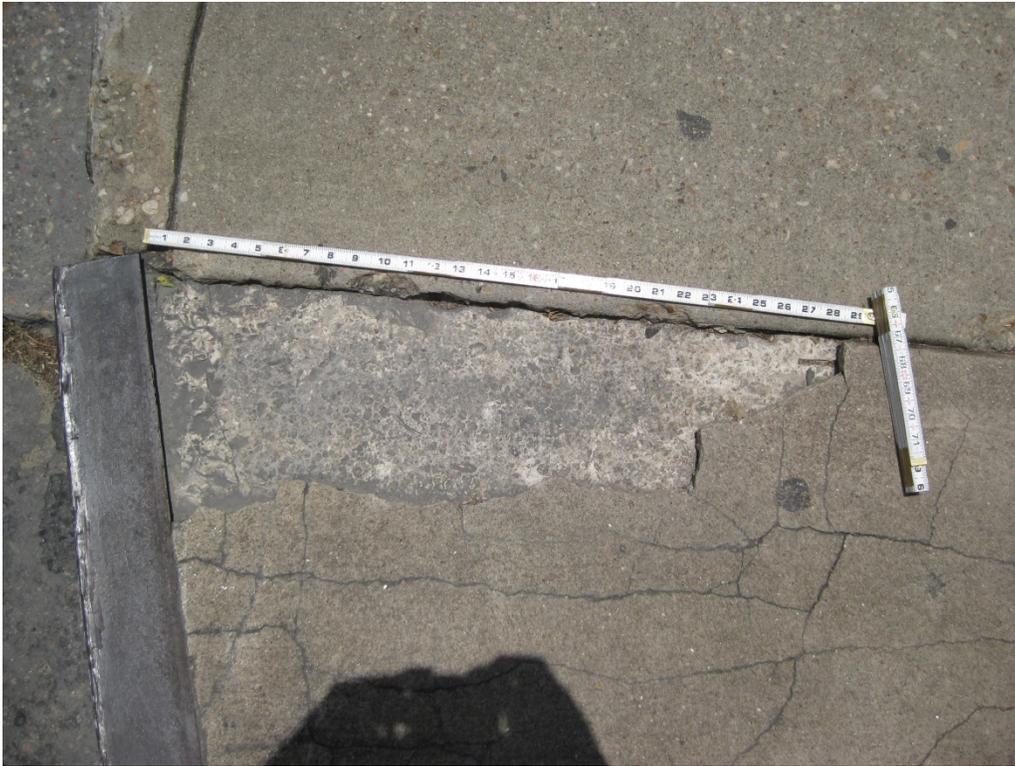
Photo 125: Spall in South Sidewalk overlay at the face of the East Abutment

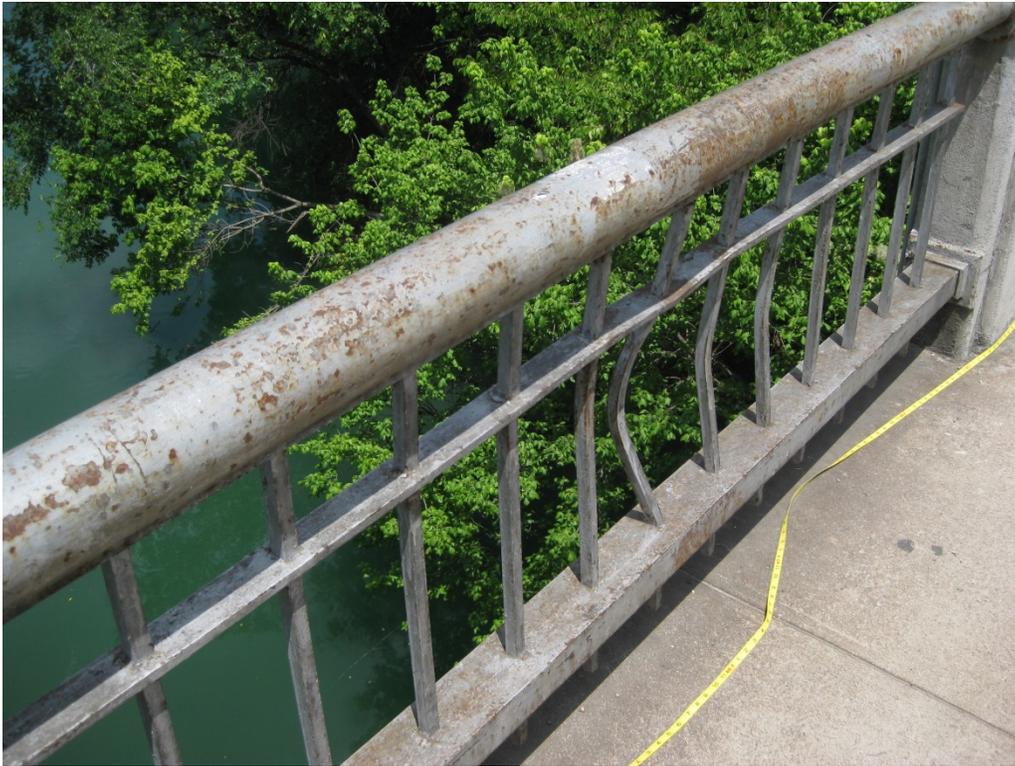
Photo 127: Impact damage to the North Railing 139'-8" east from the West Abutment

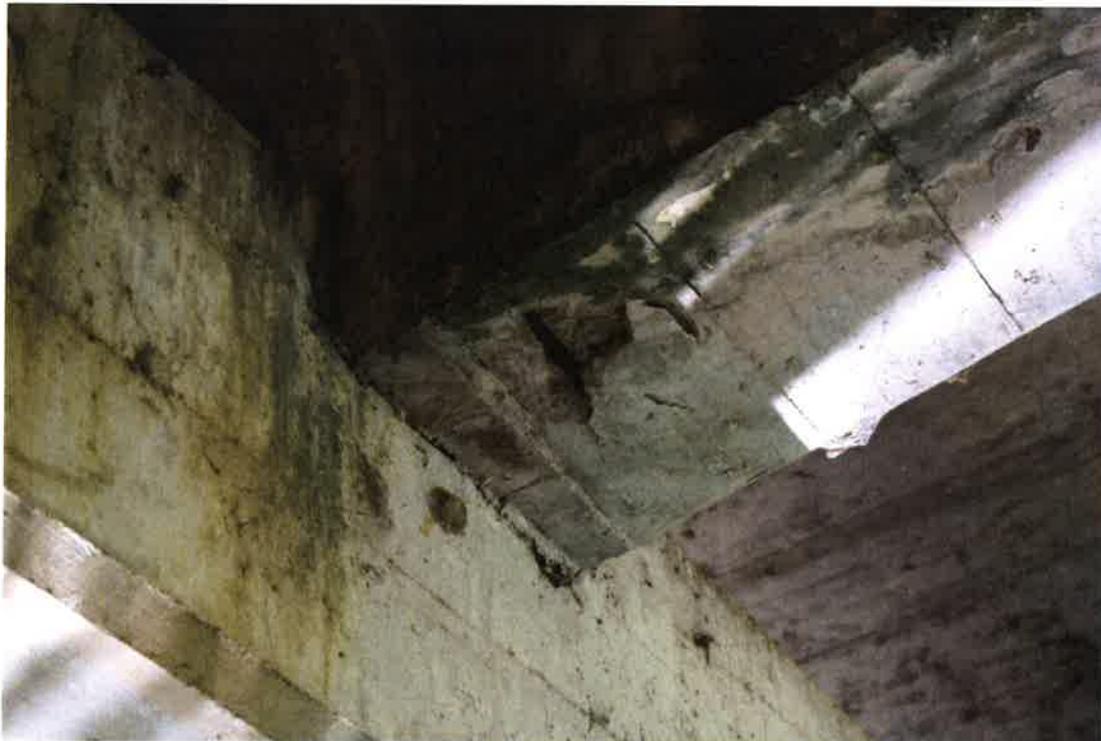
Figure 4 – Concrete spall and exposed corroded reinforcement

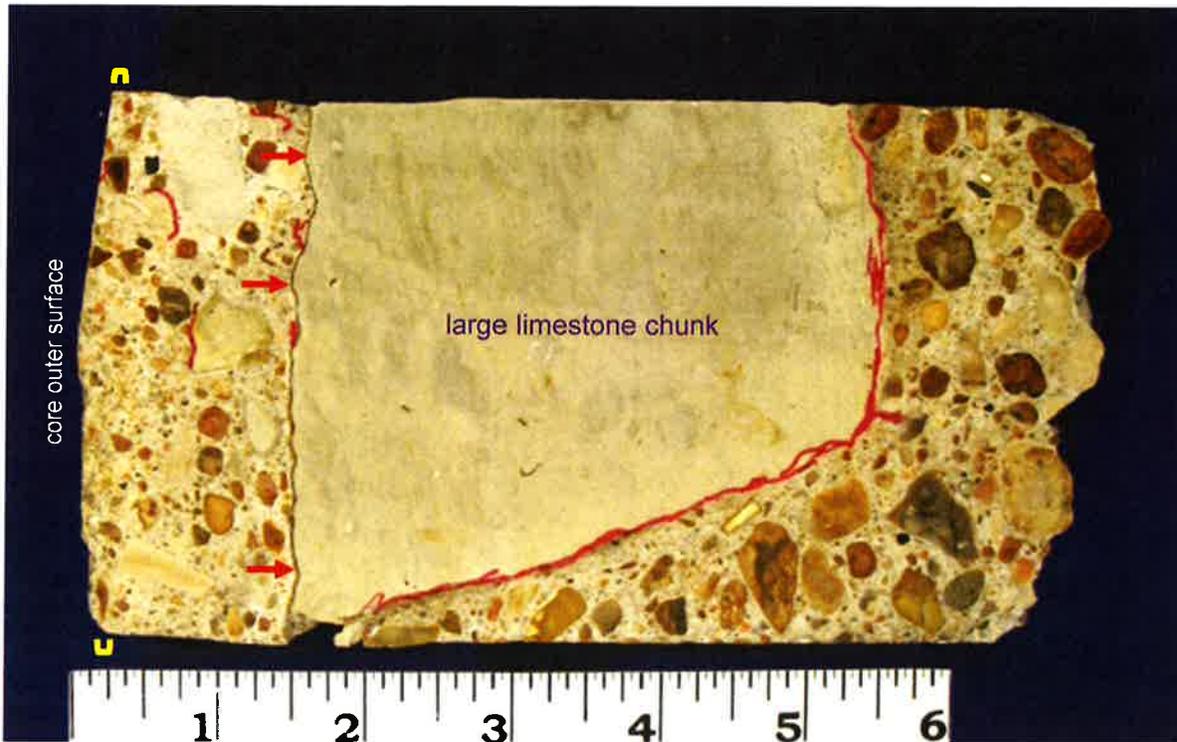
Photo C11-2 Lapped, cross-sectional (longitudinal) concrete surface of Core C11.

Paste carbonation is to a depth of 0.1 to 0.4 in. (yellow brackets) from the outer core surface.

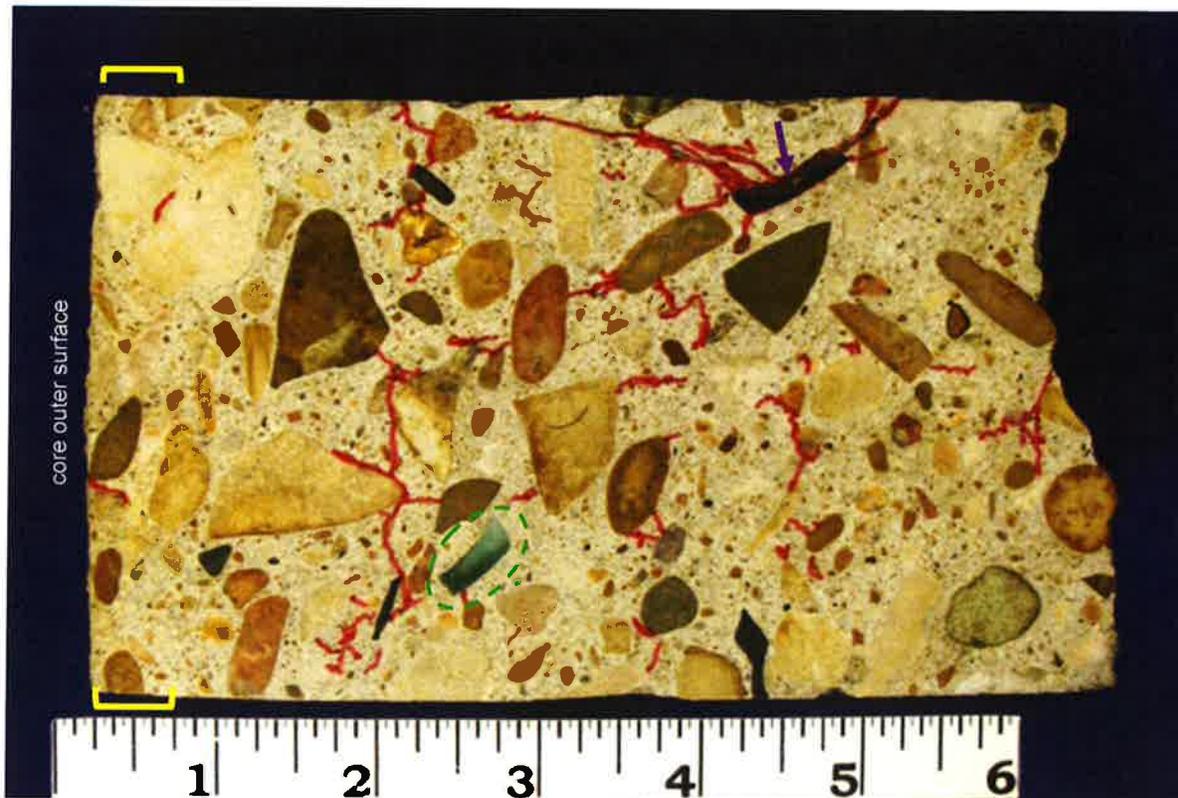
Photo C12-2 Lapped, cross-sectional (longitudinal) concrete surface of Core C12.

Paste carbonation is to a depth of 0.5 to 0.6 in. (yellow brackets) from the outer core surface.
