08 May 2019

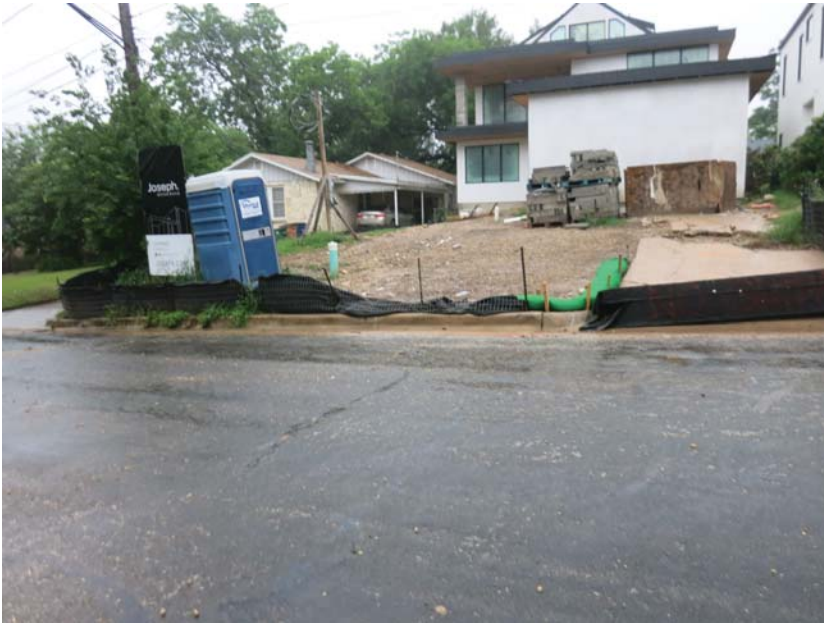
**2019 Ashby** - crushed silt fence

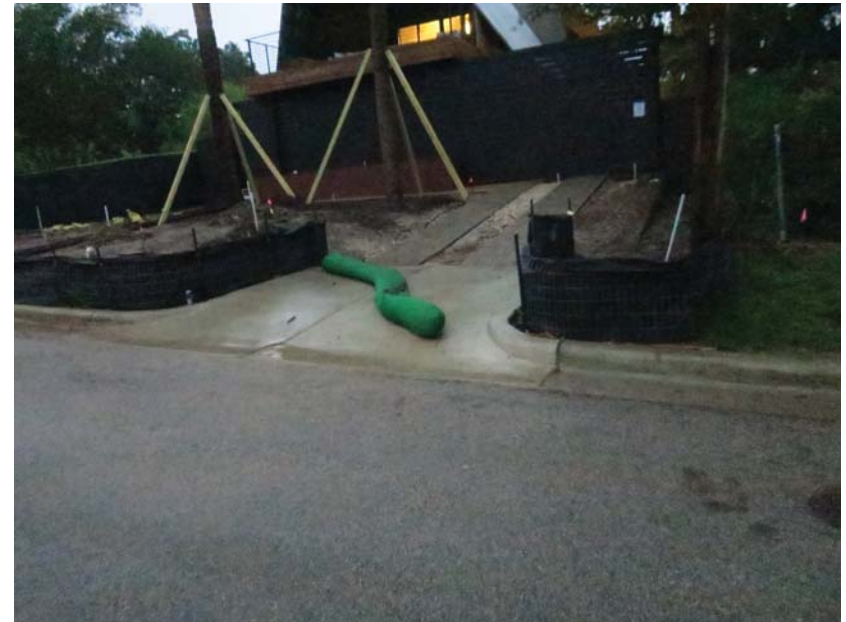
**8640 Garner** - mulch sock not secured; as a result, runoff and sediment is just directed down the driveway and into the gutter

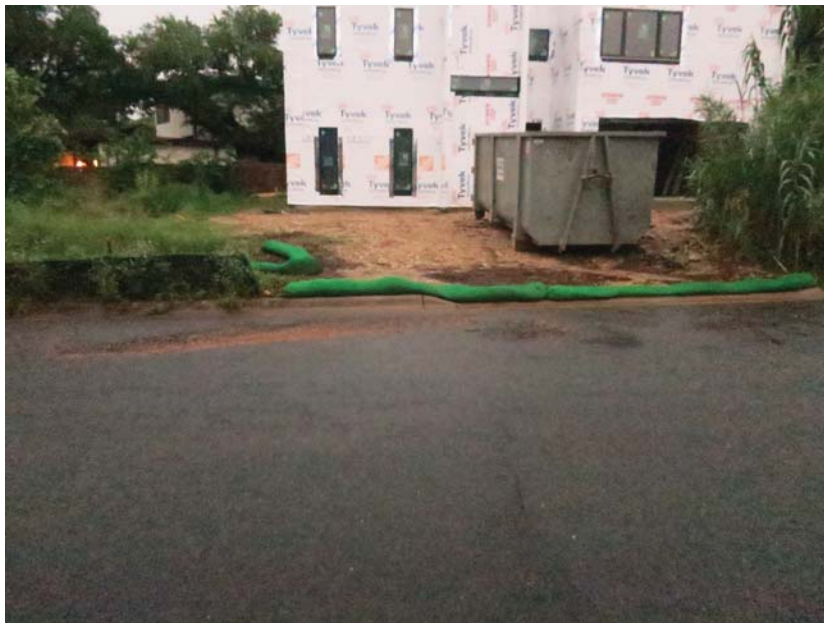
**1401 Rabb** - gaps between silt fence and mulch sock; mulch socks are not effective in prevent sediment from leaving site; the runoff overtops the controls as evidenced by sediment in street

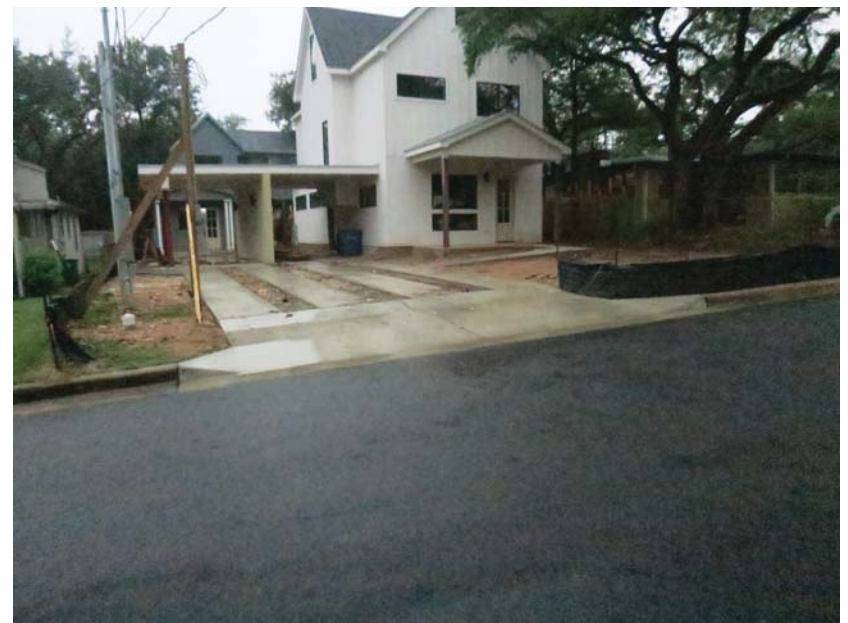
**2207 Rundell** - controls do not exist to prevent runoff and sediment from leaving site on left side and from ribbon strips

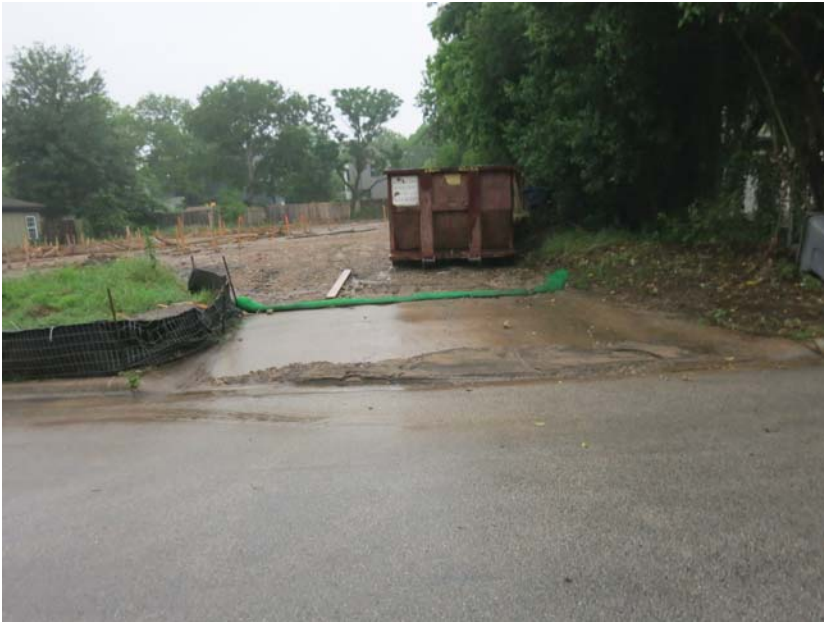
**1706 Goodrich** - flattened mulch sock; sediment leaving site, some much of which still remains in the gutter

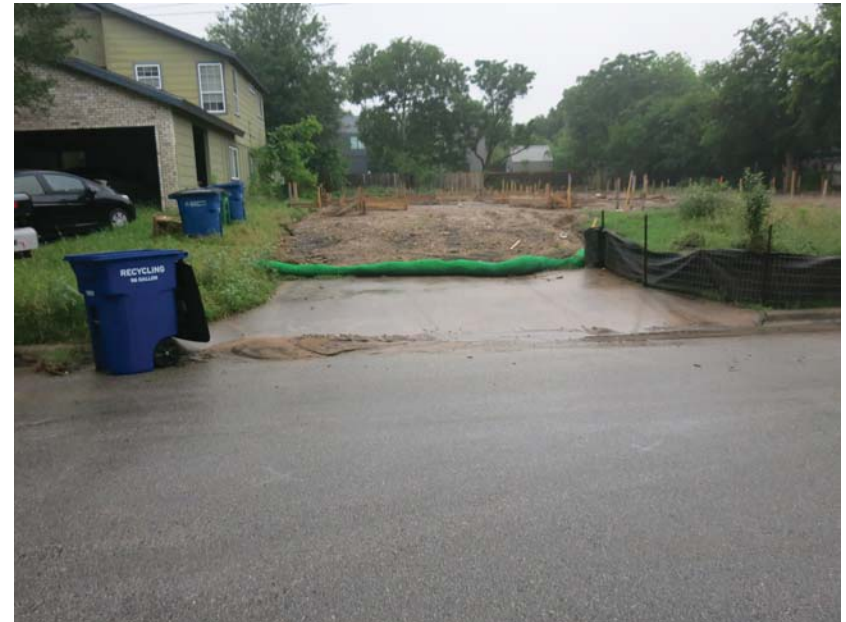
**1708 Goodrich** - mulch sock not preventing sediment from leaving the site; sediment visible in gutter

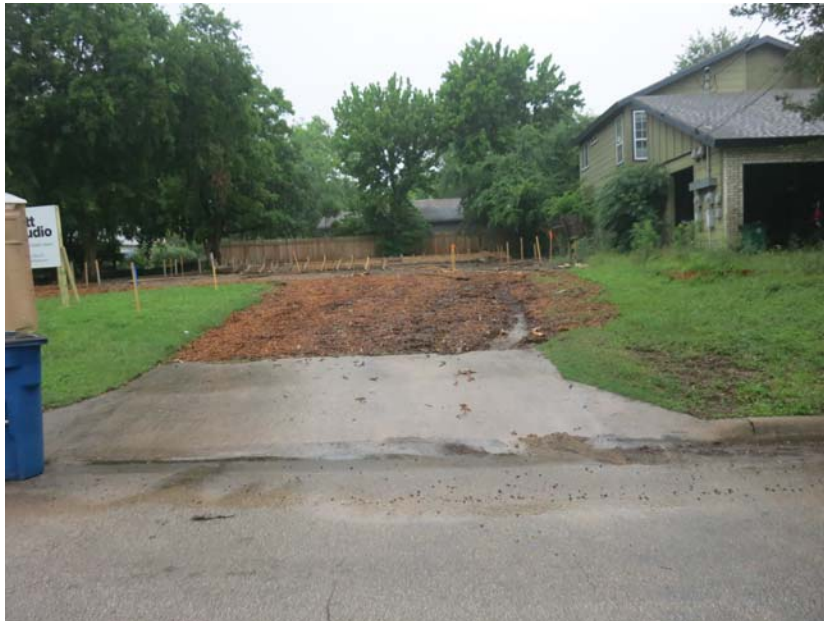
**1712 Goodrich** - placing mulch on bare ground with this much slope is ineffective; it simply washes off with the sediment; more controls are needed

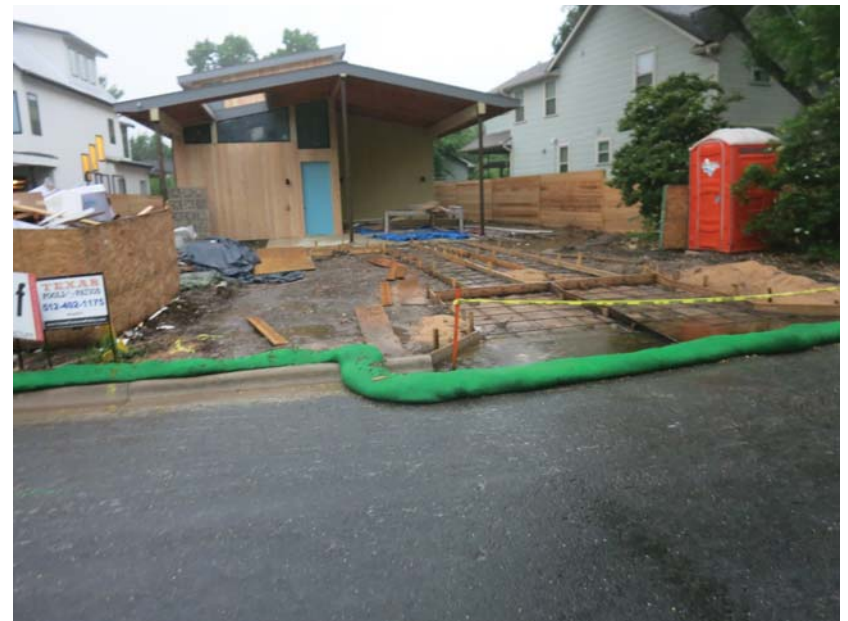
**1811 Collier** - flattened mulch socks on left side do not prevent sediment from leaving site; much socks in street not secured; heavy rain will wash them down the street

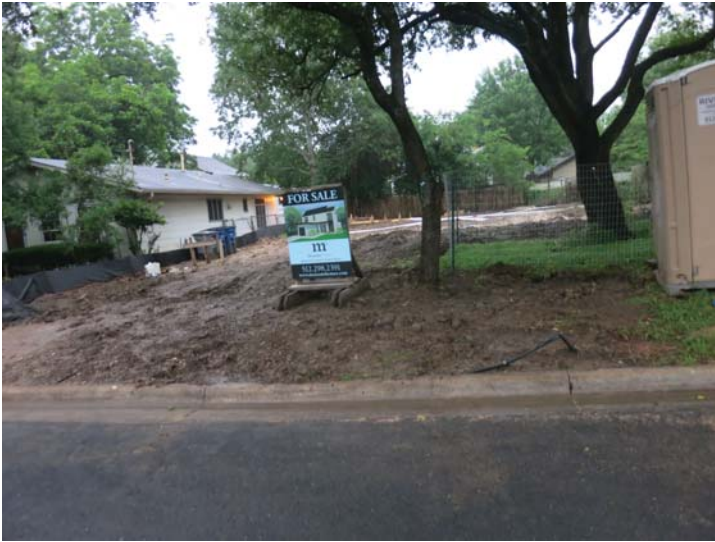
2103 Peach Tree

no controls along street

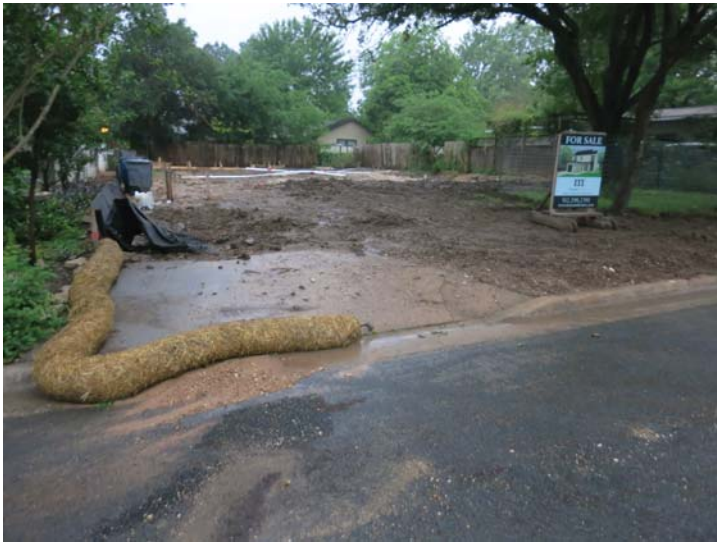
straw waddles are not acceptable controls and this one is mostly ineffective

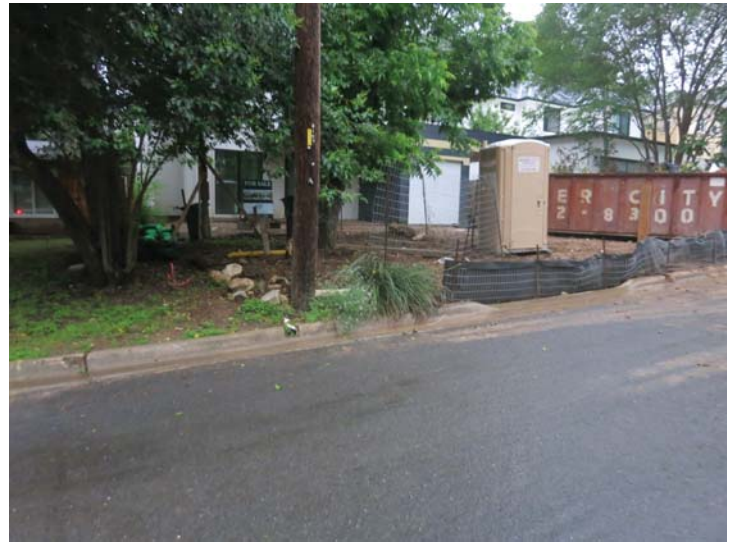
2109 Peach Tree

silt fence does not have j-hook on left end allowing runoff to escape after it flows along the silt fence

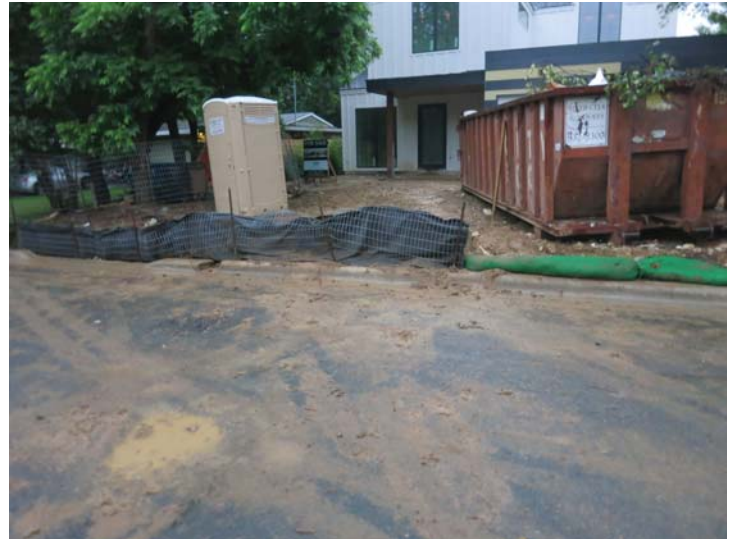
bottom of silt fence not towed-in; sediment escaping site

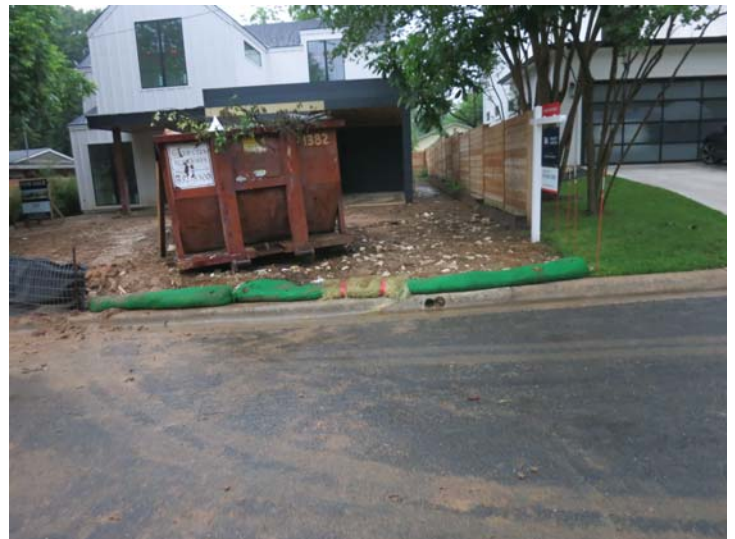
straw waddle unacceptable; hopefully just filling the gap until it is replaced
