30 May 2019 (all three sites in the Barton Springs Zone)

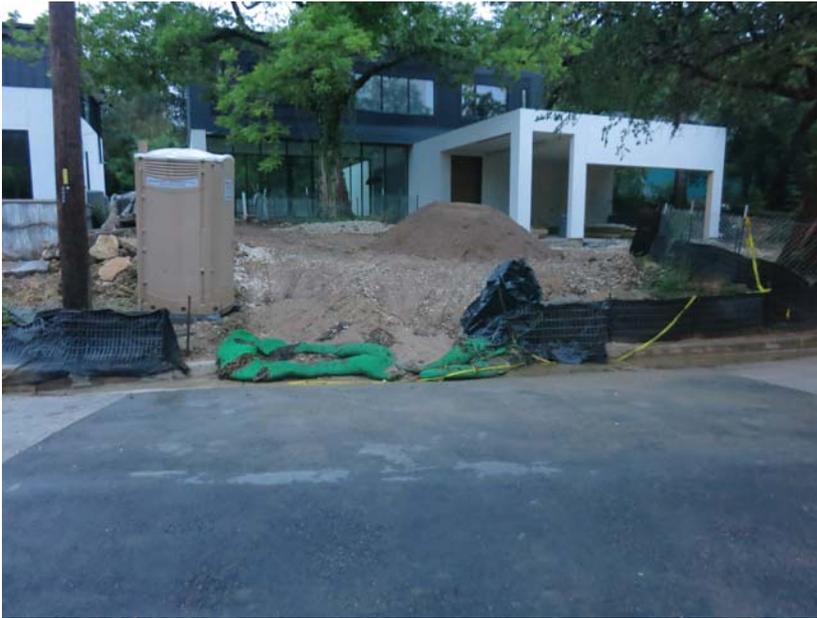
2005 Melridge - sediment flowing over unsecured mulch socks, much of it from uncovered pile of sand

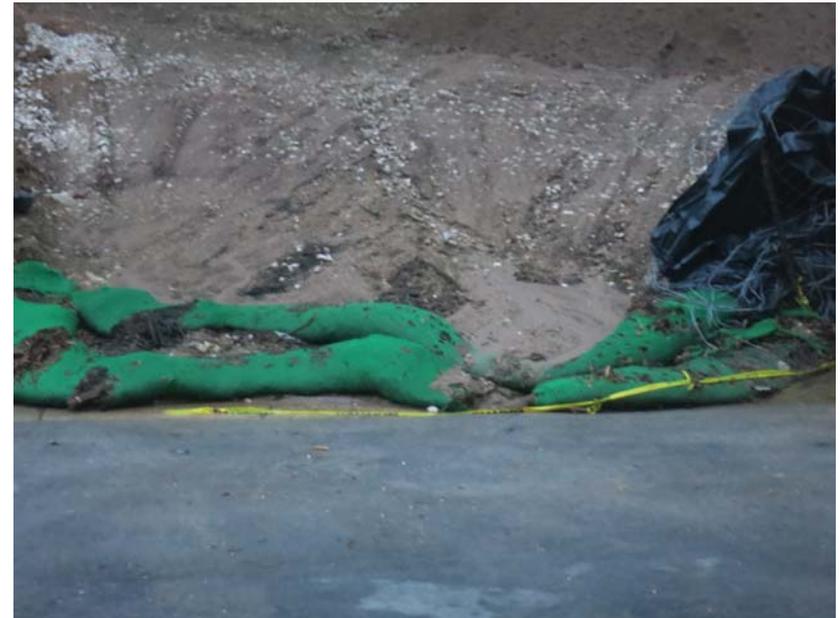
2005 Melridge - closeup; mulch socks will not impede sediment on slopes this steep

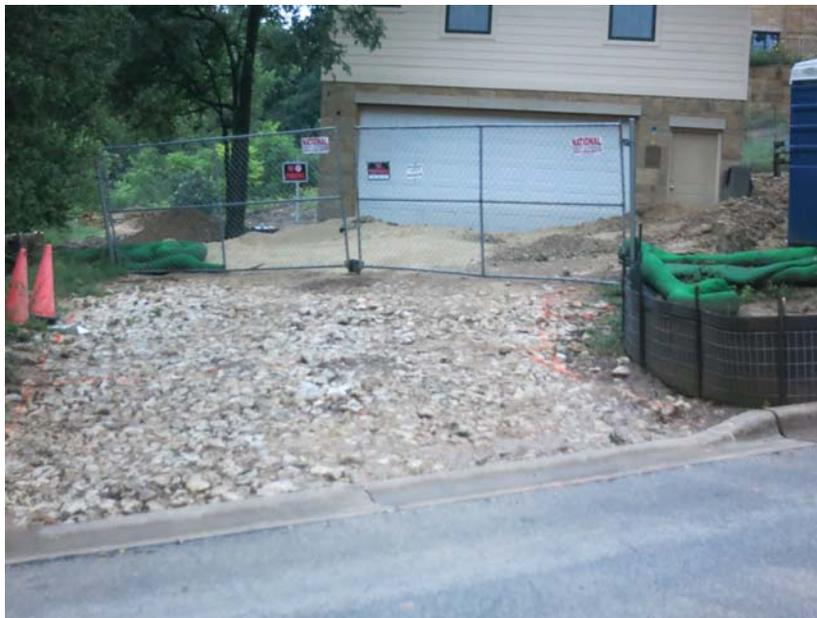
1113 Azie Morton - no controls across driveway with piles of dirt and aggregate above; rock entrance is not a control to prevent sediment upstream from simply flowing across it

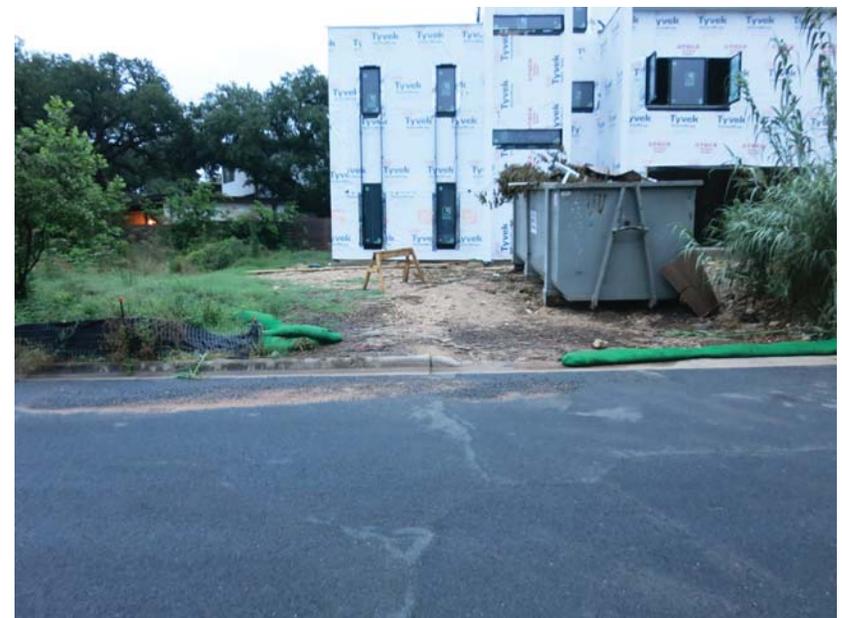
1401 Rabb - missing controls allow sediment to leave site into street

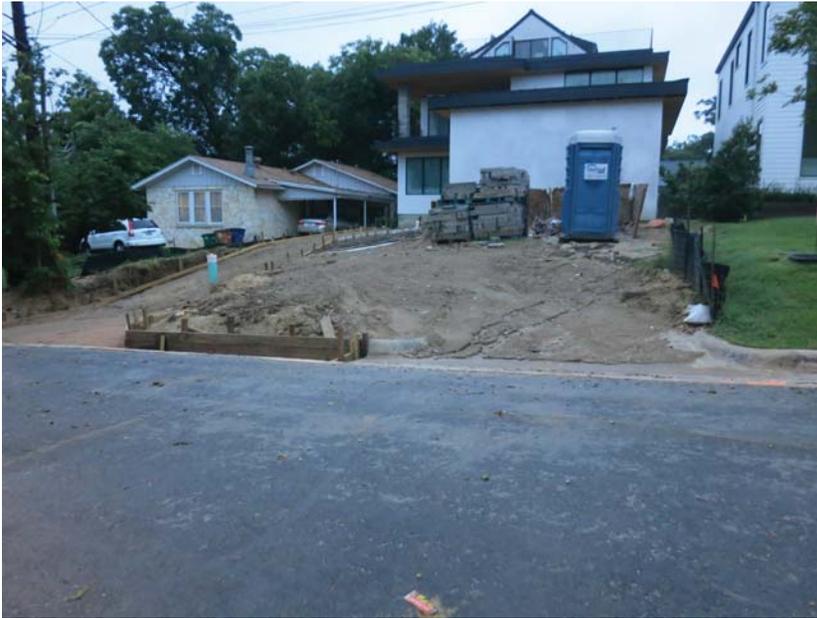
2019 Ashby - no controls; sediment flowing off of the site and into gutter and street

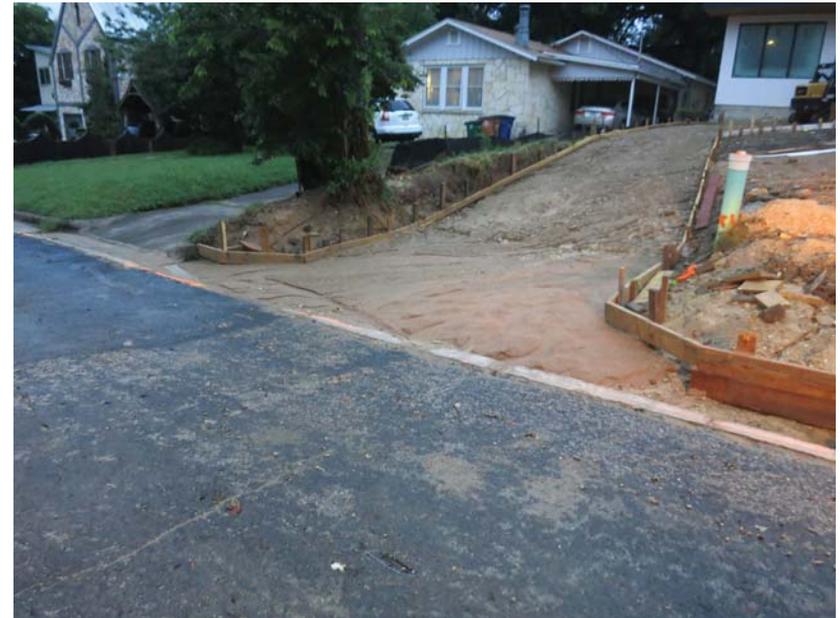
2019 Ashby - no controls; sand from driveway has washed down into gutter and street; this is totally irresponsible

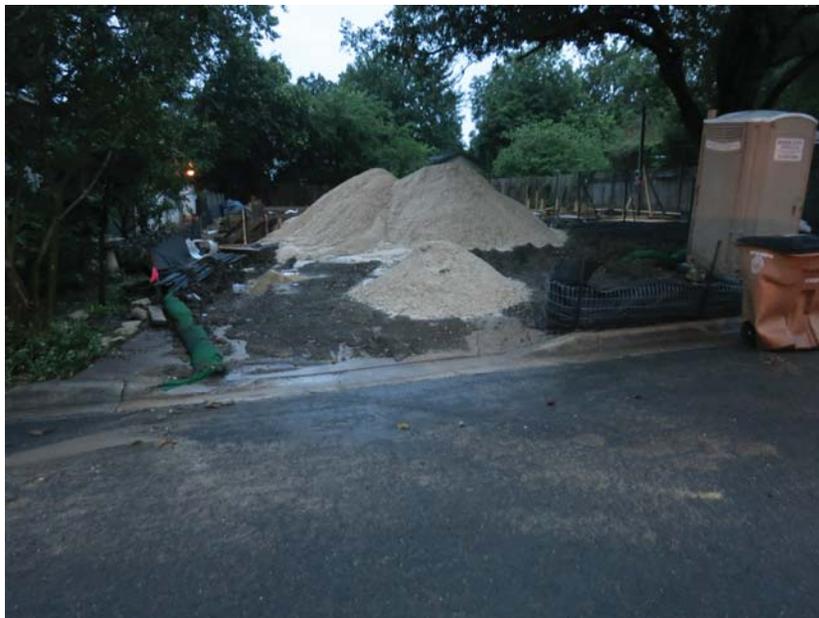
2103 Peach Tree - no controls with dirt and large piles of aggregate that erode and flow into street

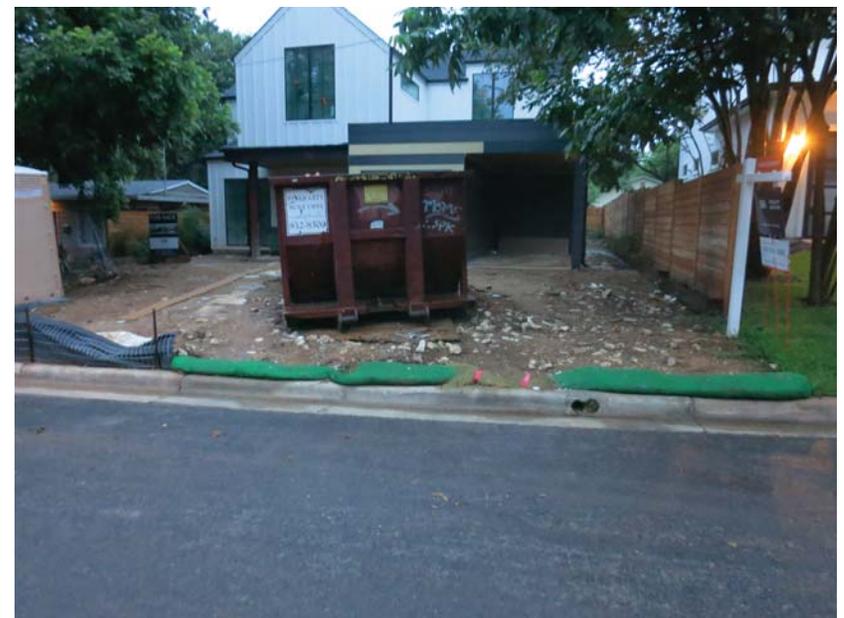
2109 Peach Tree - flattened mulch sock allows overtopping; straw waddle in middle is not an accepted erosion control

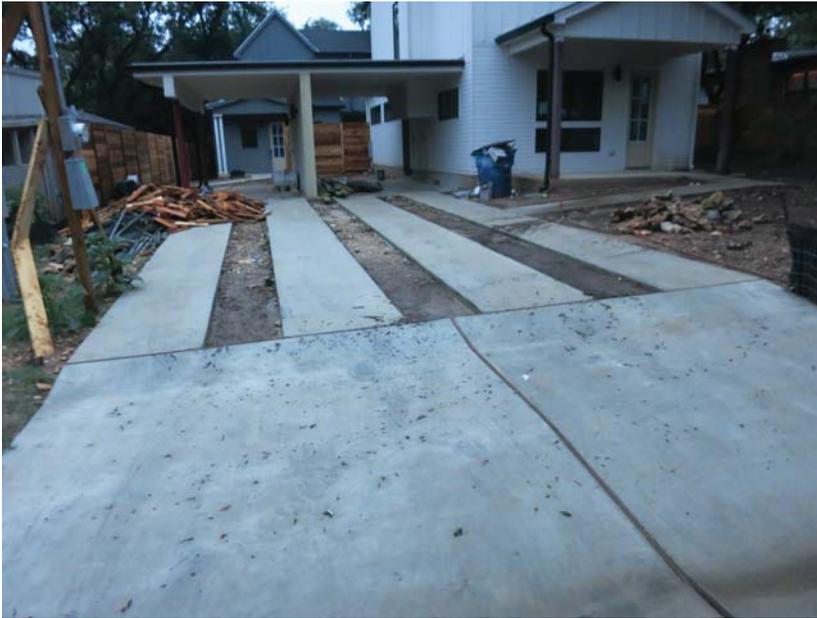
2207 Rundell - no controls; sediment flowing off of the site and into gutter and street

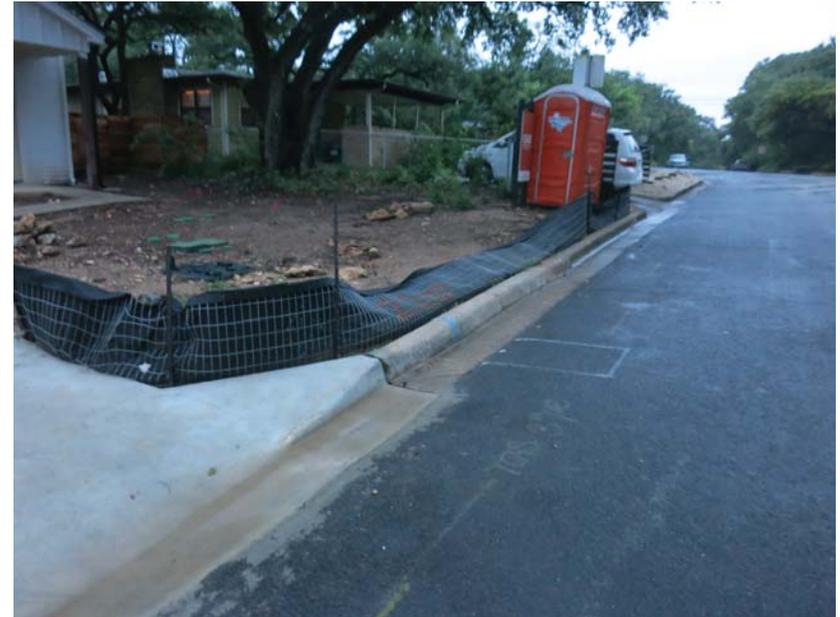
2207 Rundell - no controls; sand from driveway has washed down into gutter and street; this is totally irresponsible

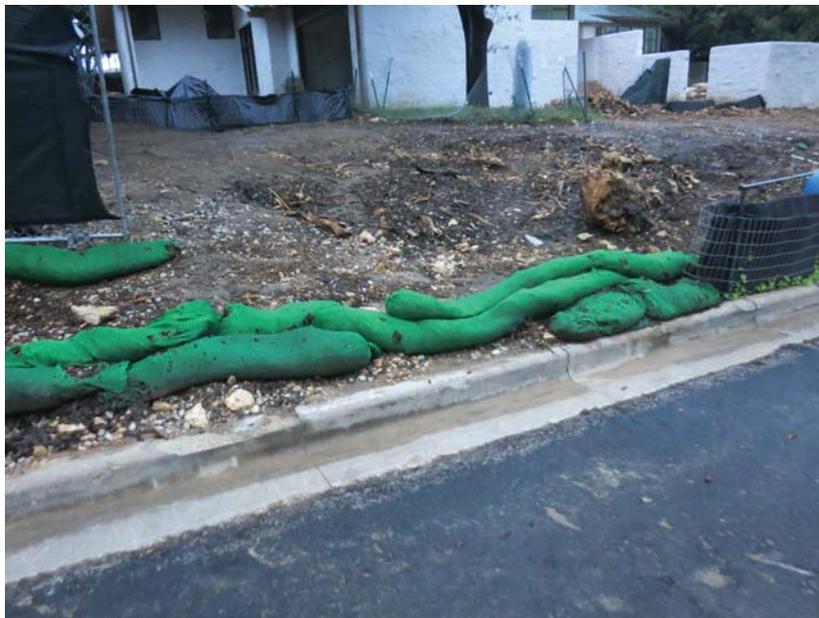
1912 Paramount - mulch socks do not provide adequate control on this much slope; they are easily overtopped

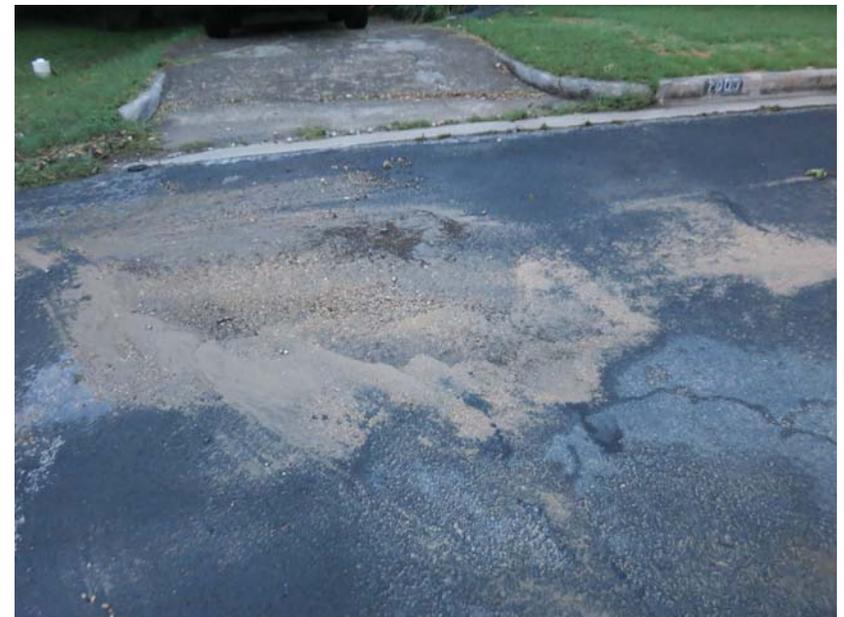
1912 Paramount - as a result, sediment ends up downstream in the street

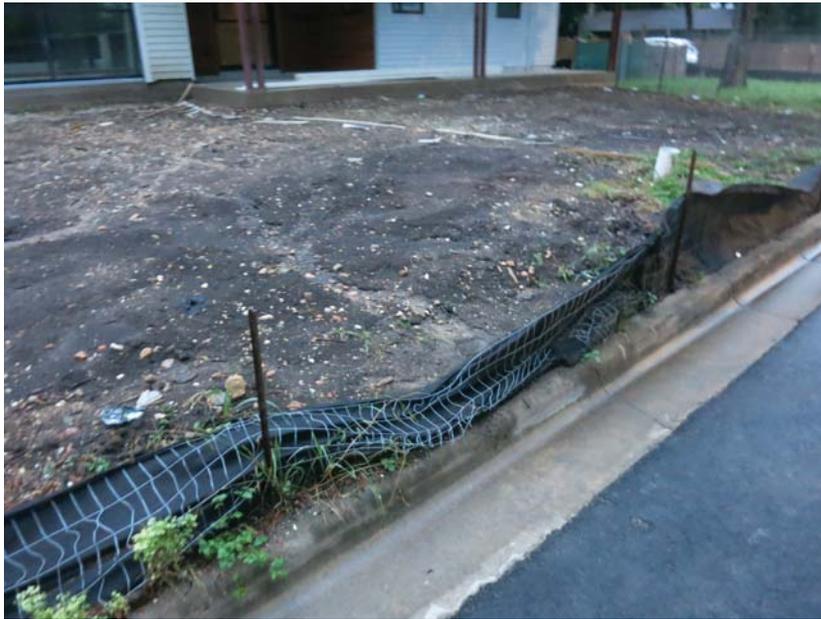
crushed silt fence

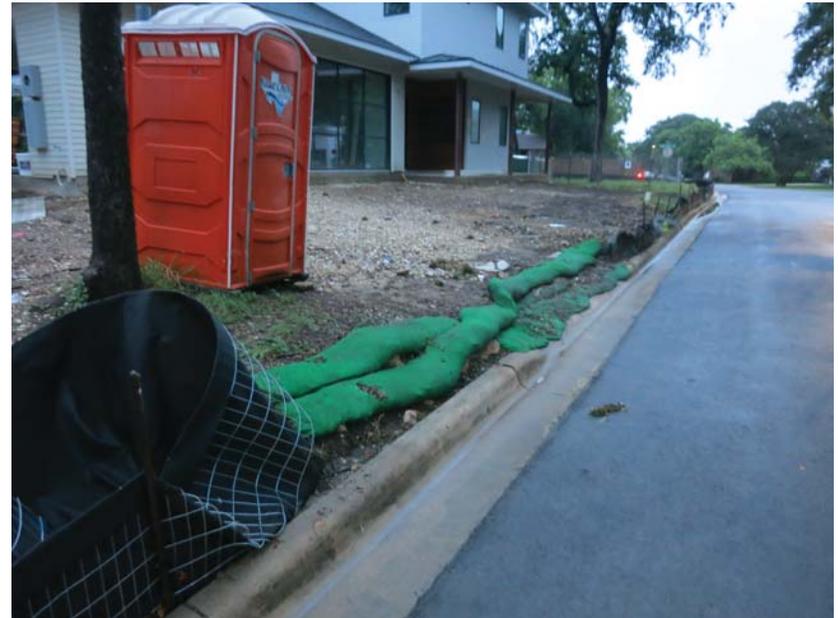
unsecured and flattened mulch socks will not prevent sediment from leaving site

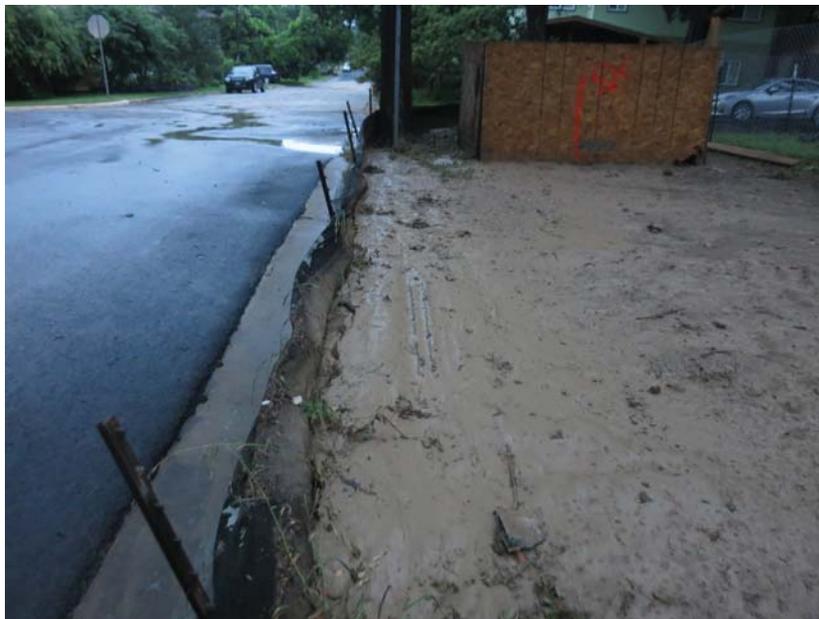
sediment has built up over halfway to top of silt fence; on back side of silt fence where the sediment line is to the top of the fence is the evidence that runoff overtopped the silt fence

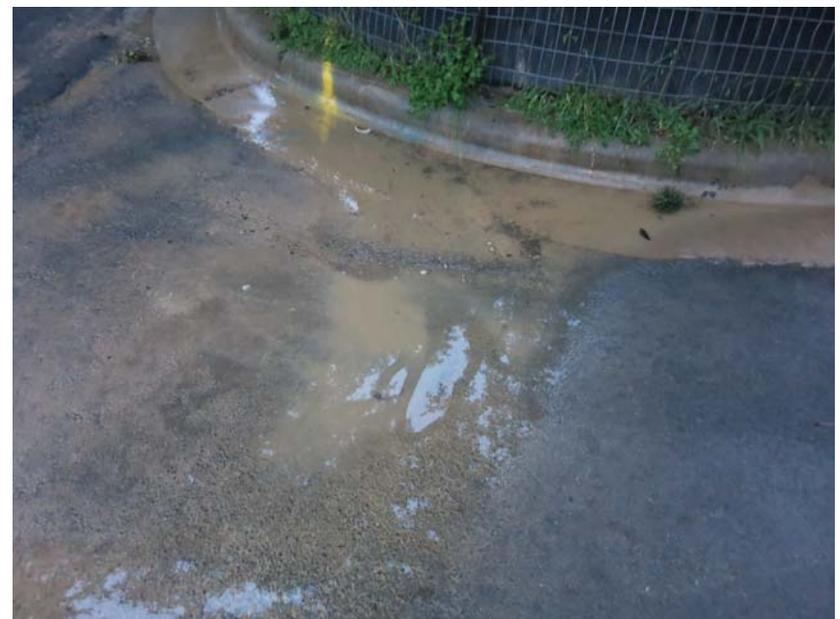
sediment in the street as a result of inadequate controls

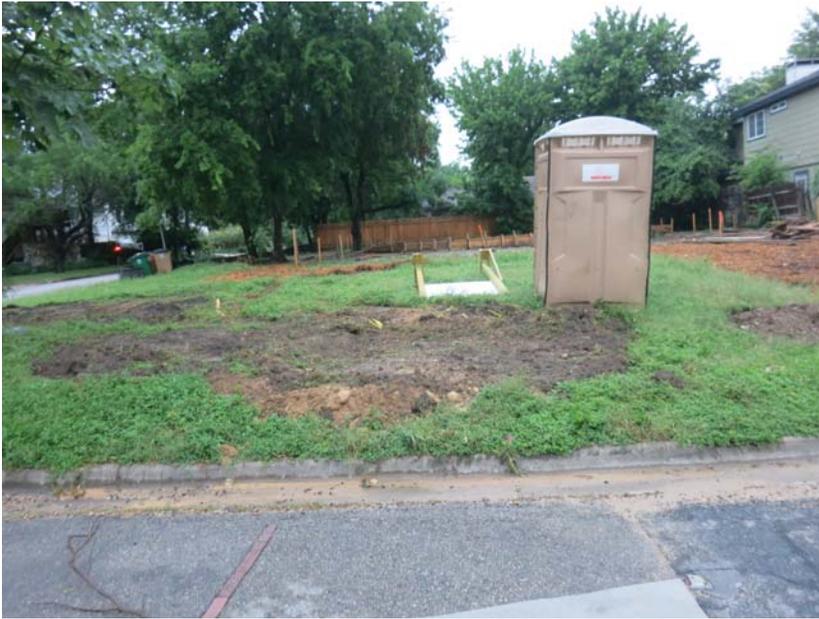
1712 Goodrich - no controls; sediment visible in street

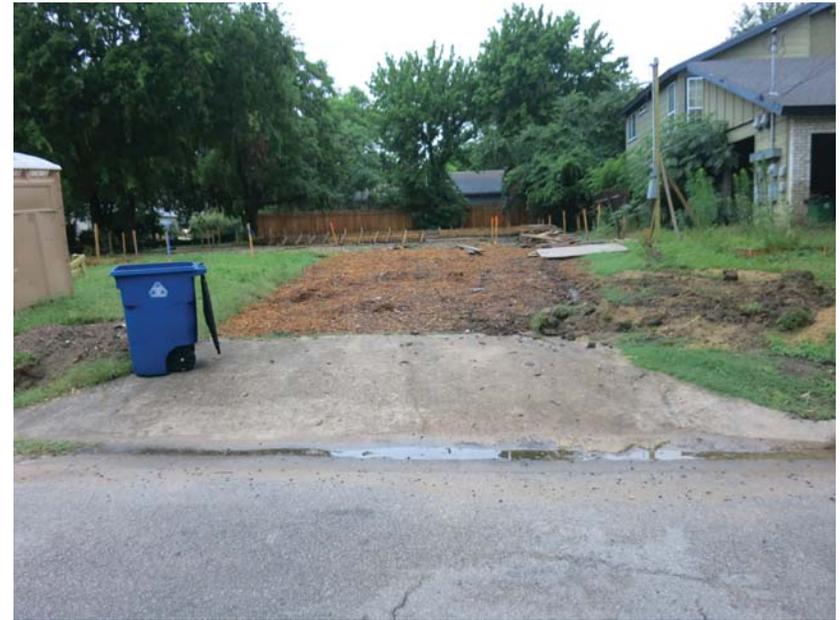
1712 Goodrich - no controls; some mulch covers some of the dirt but on this slope it isn't effective as it simply washes off with dirt

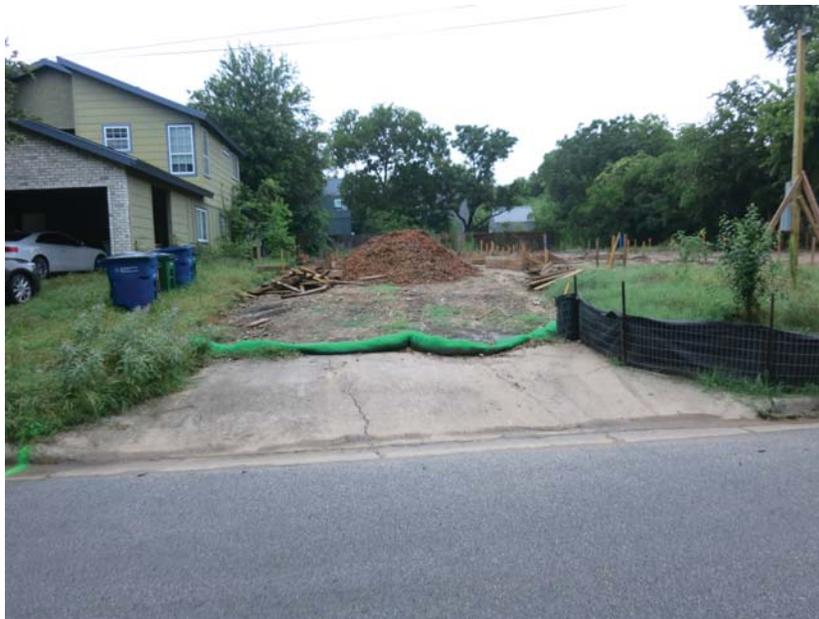
1708 Goodrich - mulch socks are not adequate; sediment has filled in behind and overtopped

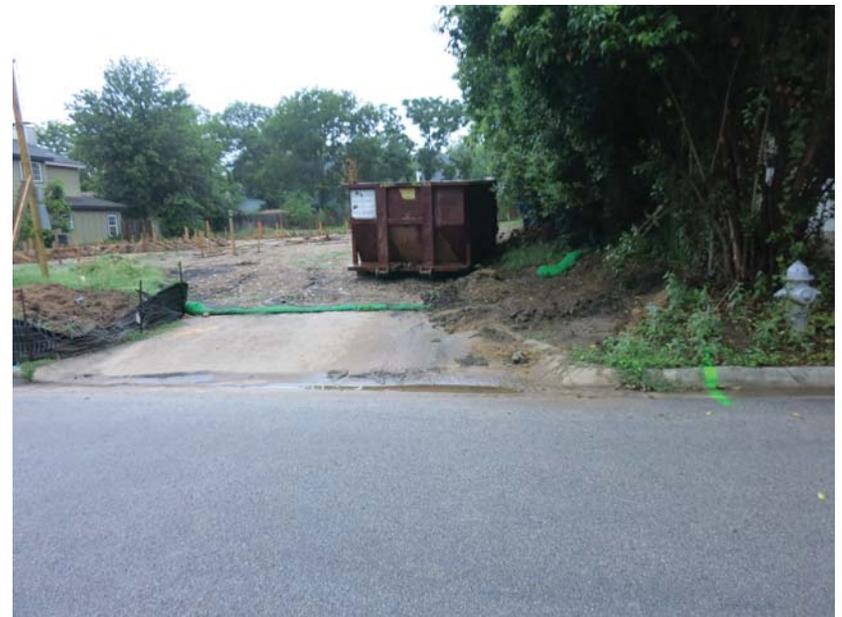
1706 Goodrich - flattened mulch sock allows overtopping; no controls for dirt piled to the right of the entrance; crushed silt fence on left side

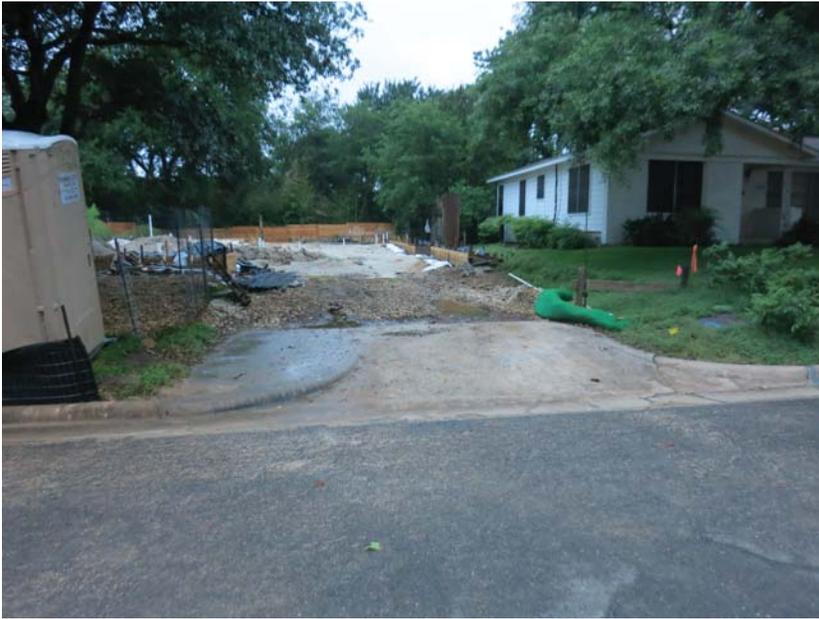
1208 Folts - no controls across drive to prevent sediment from leaving site

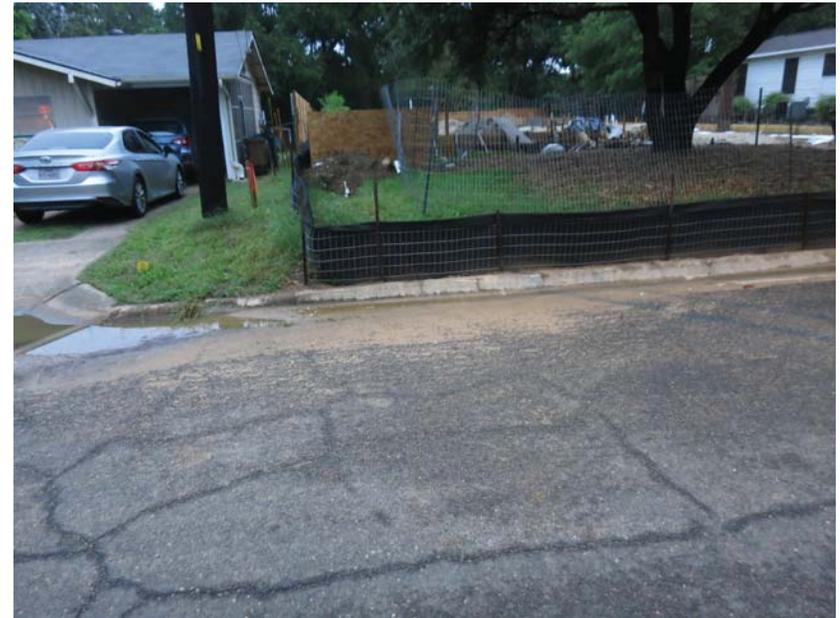
1208 Folts - sediment from site has been deposited in gutter and street

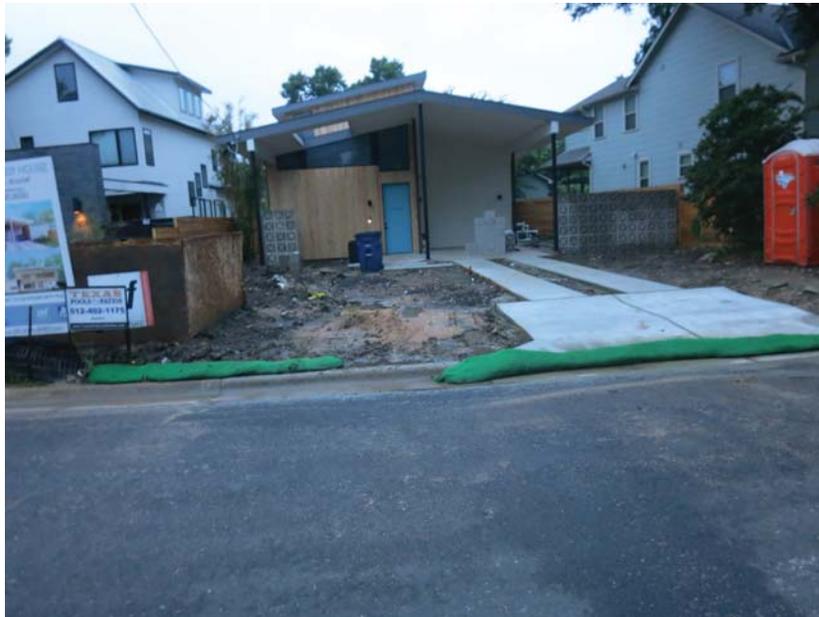
1901 Collier - gap in mulch socks allows sediment to leave site

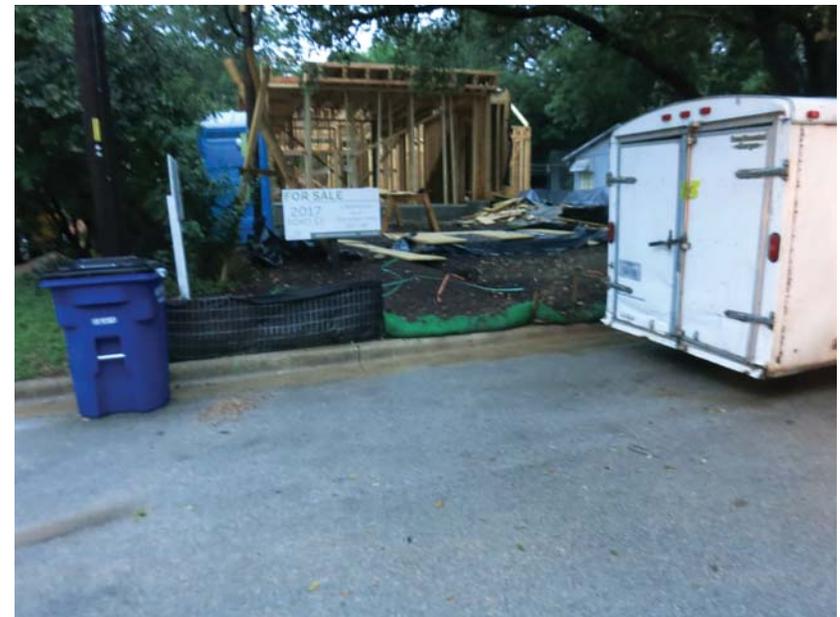
2017 Ford - material overtopping mulch sock
