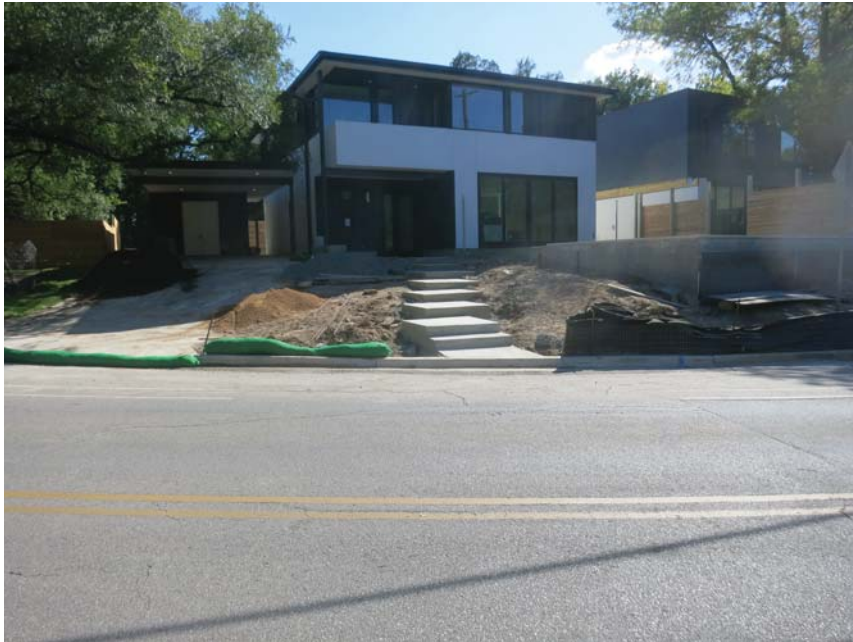
**2003 Melridge (BSZ)** - The controls do not extend along the entire frontage. Multiple repeat offender a few feet from Little Zilker Creek.

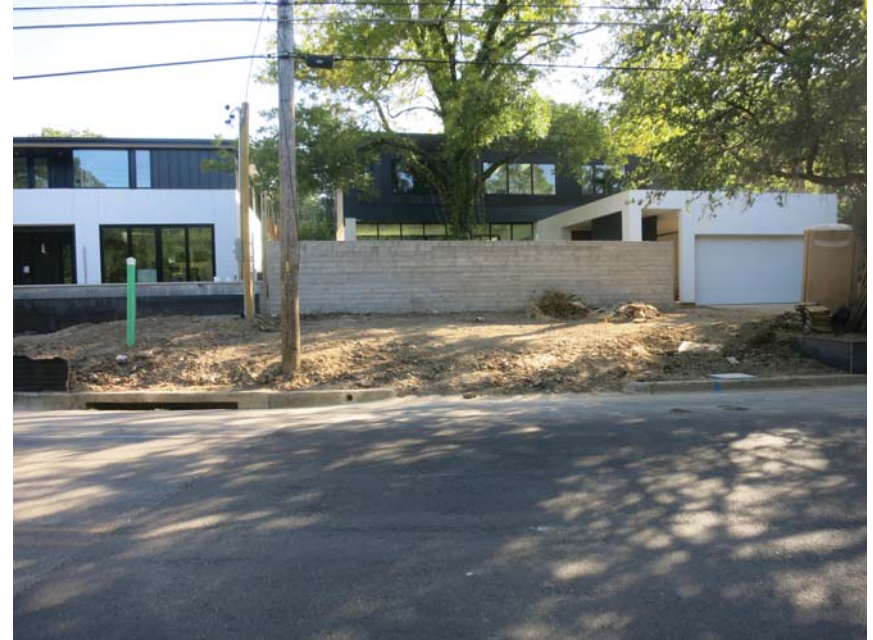
**2005 Melridge (BSZ)** - No controls. Multiple repeat offender. Storm sewer discharges directly to Little Zilker Creek.

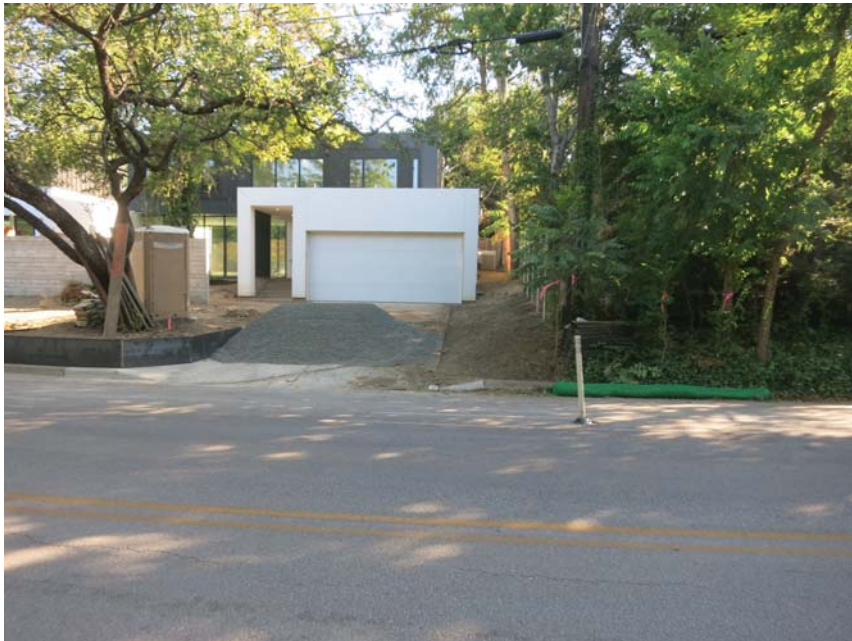
**2005 Melridge (BSZ)** - No controls to stop stream of water that will flow on steep slope down side of house, eroding sediment as it goes.

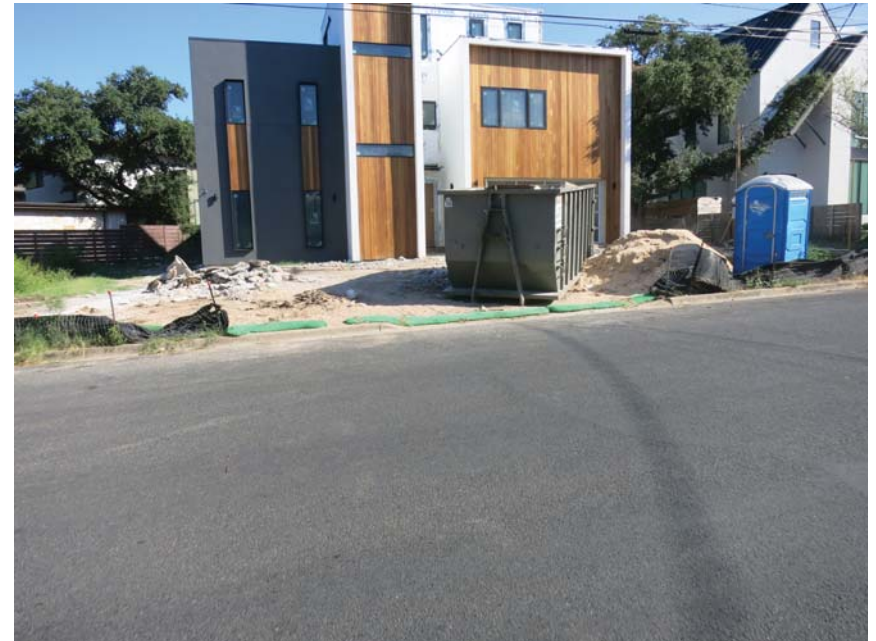
**1401 Rabb (BSZ)** - Mulch sock flattened and with gaps. No controls over or around dirt piles to prevent erosion.

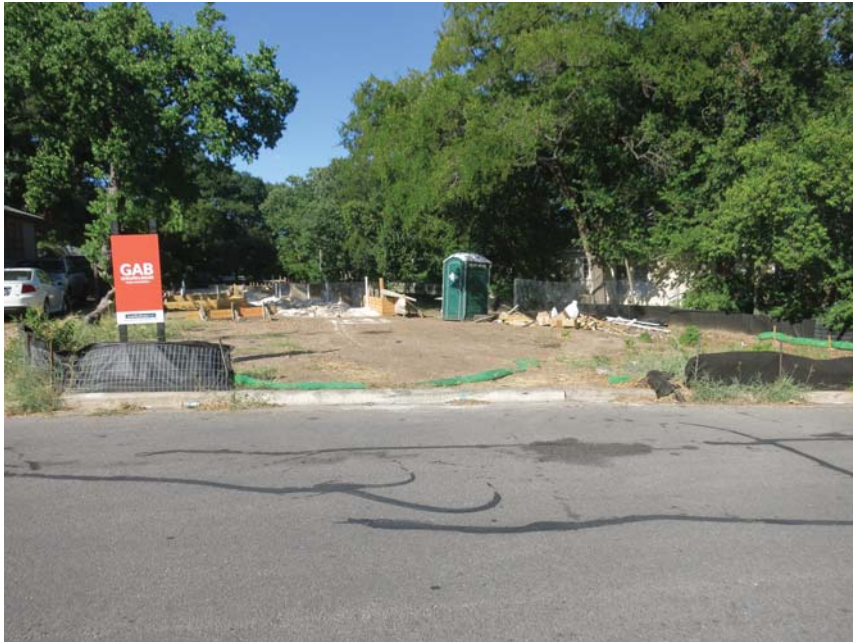
**2104 La Casa** - Flattened mulch socks (barely visible) will not prevent sediment from leaving the site.

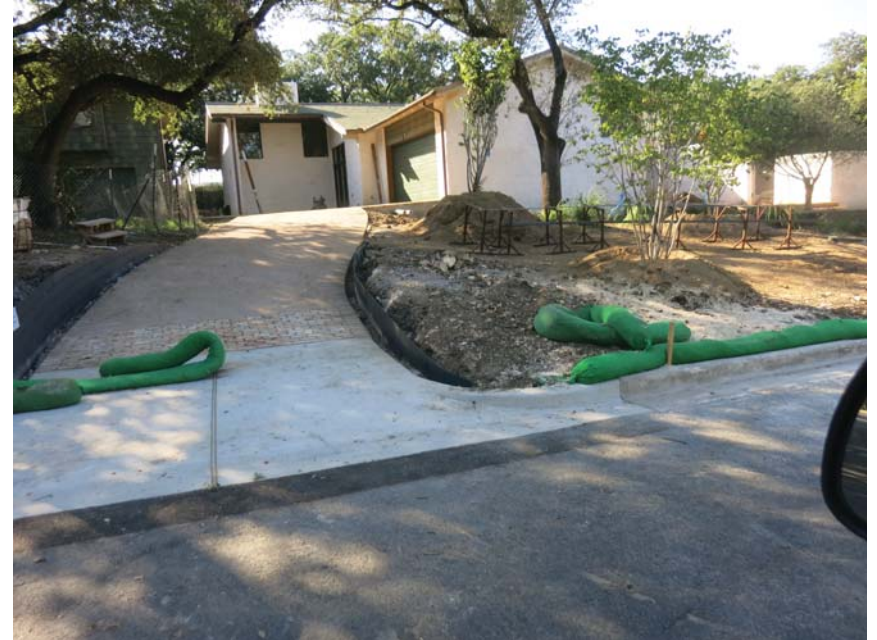
**1912 Paramount (BSZ)** - Steep slope without controls extending all the way across frontage will allow sediment to leave site.

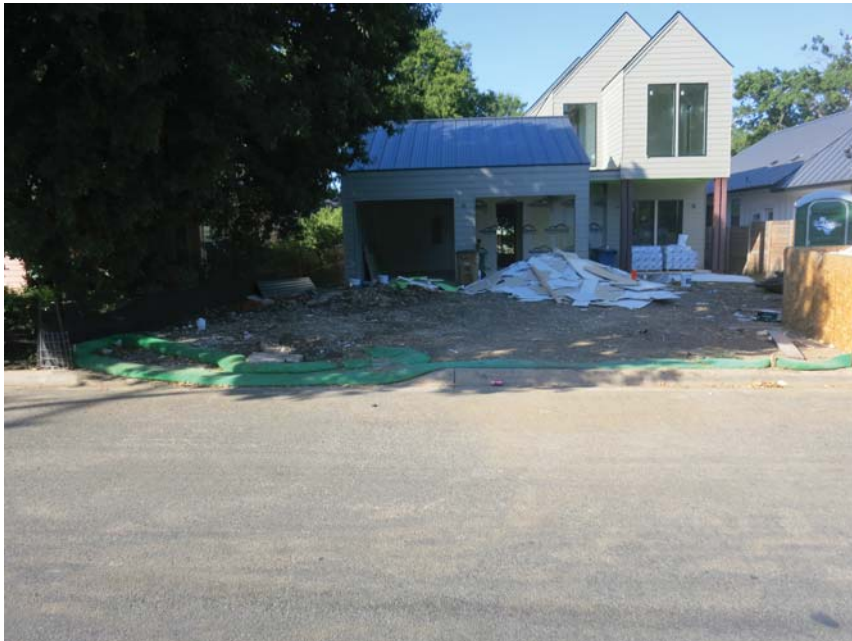
**2012 Rundell (BSZ)** - Flattened mulch sock will not prevent sediment from escaping.

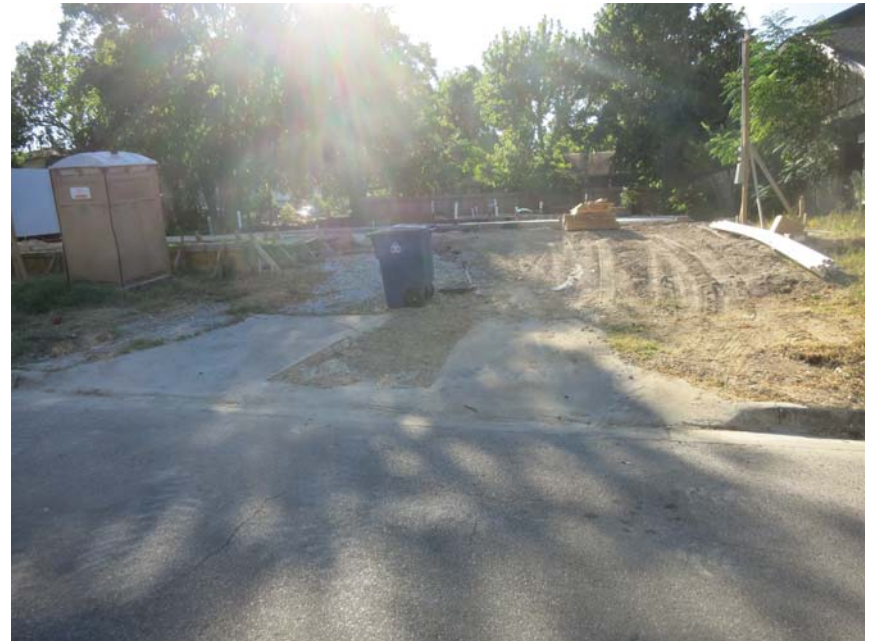
**1712 Goodrich** - No controls.

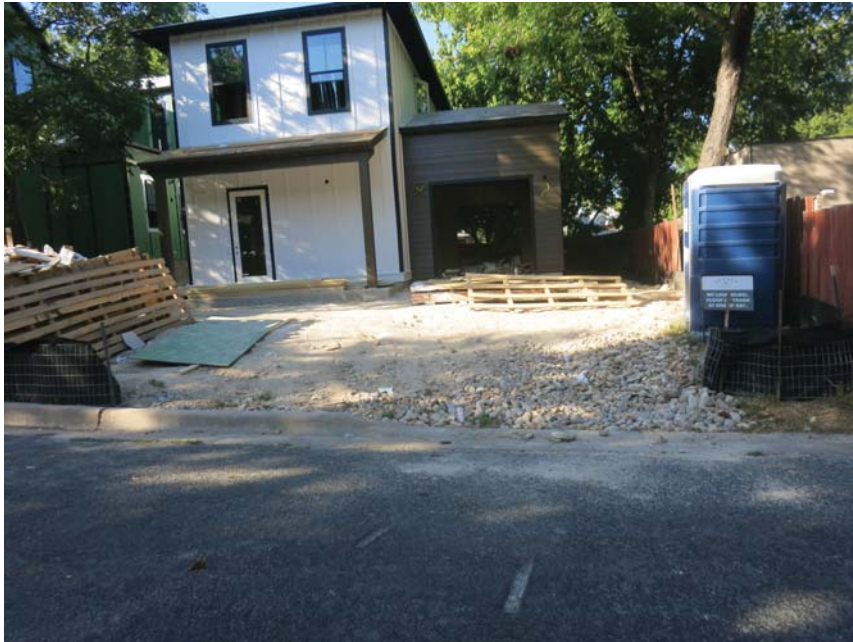
**1718 Valeria** - No controls across entrance. The silt fence on the left has no j-hook and will simply direct runoff to the street.

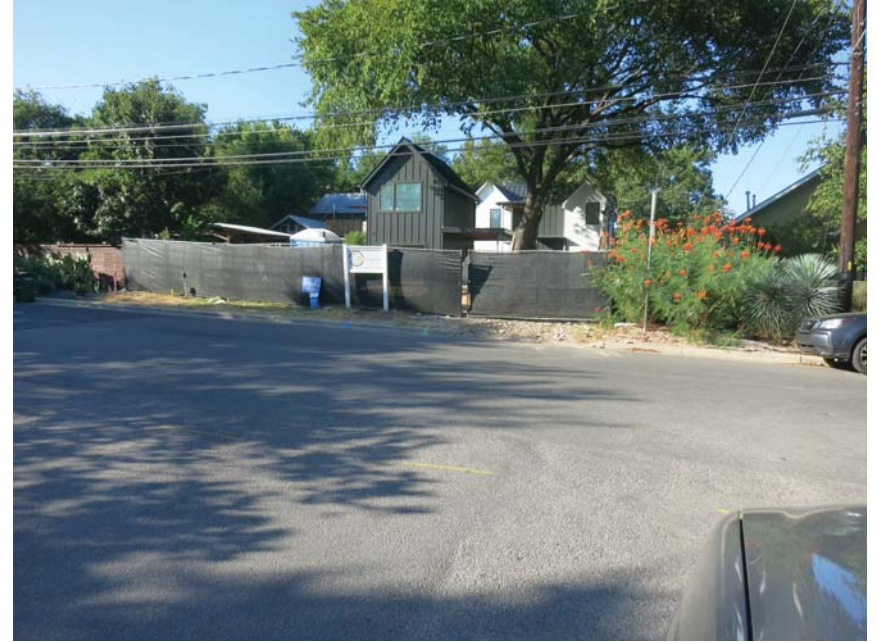
**1610 Hether** - Lack of erosion controls is hidden by the privacy fence.

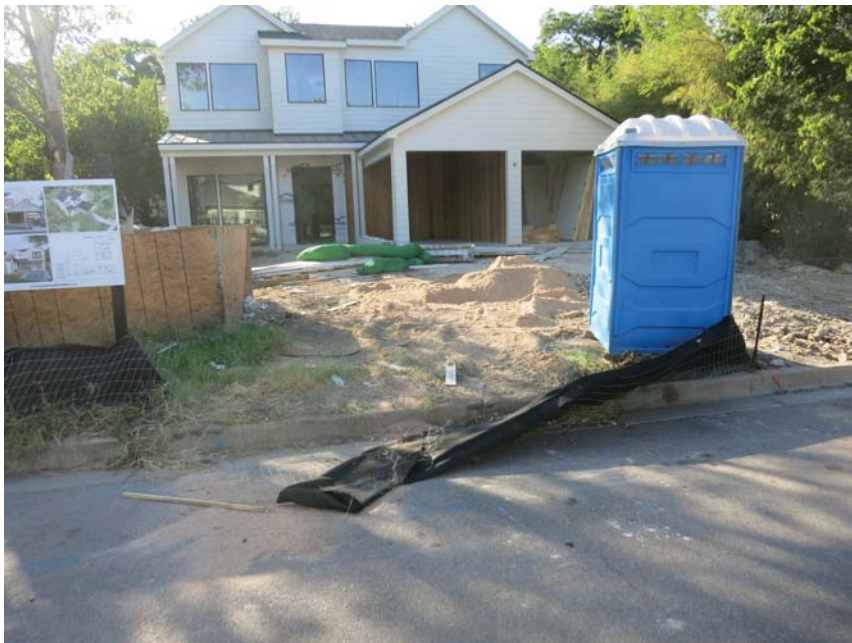
**2004 Oxford** - This needs no explanation. A picture is worth a 1000 words.

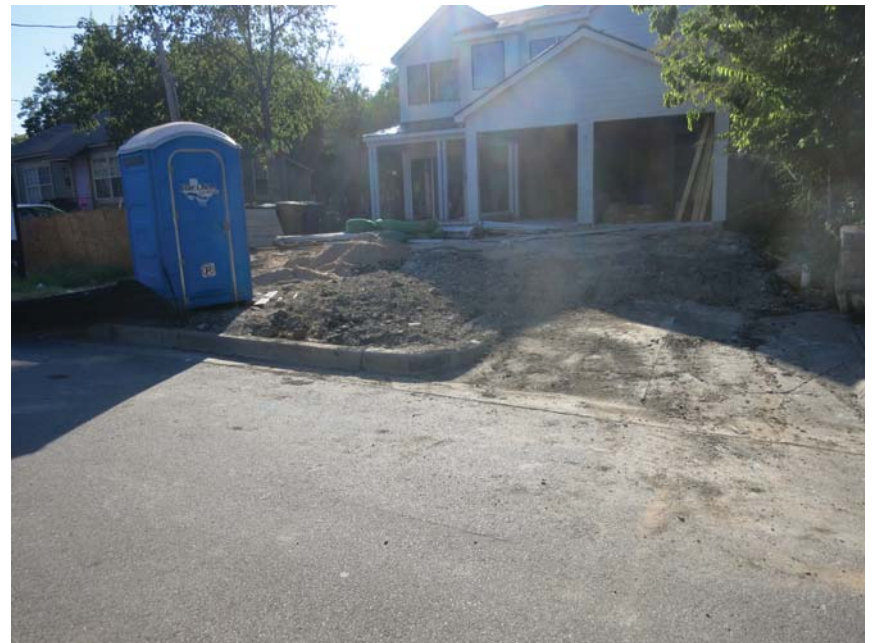
**2004 Oxford** - No controls.

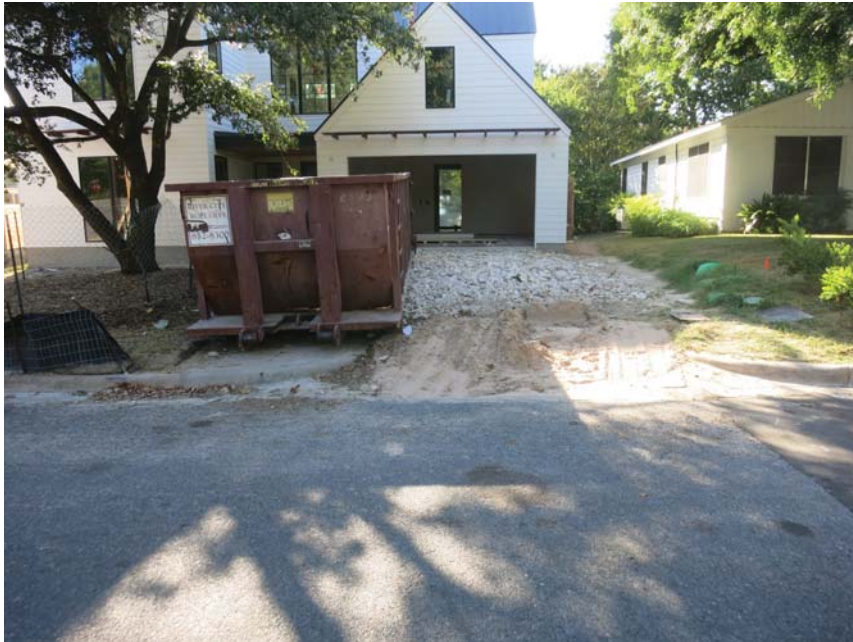
**1208 Folts (BSZ)** - Sand/dirt is piled at the end of the driveway and partially in the gutter where it will easily escape the site.

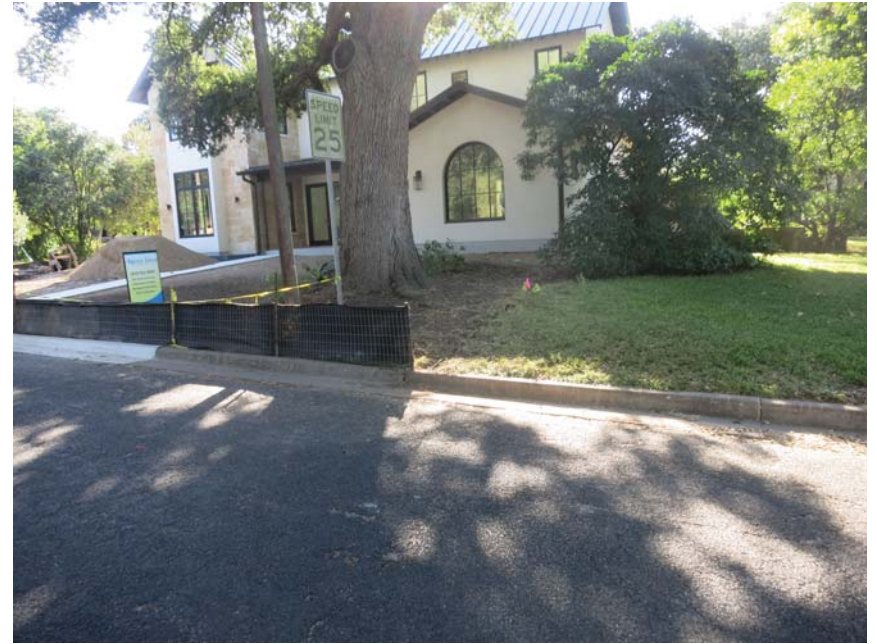
**1804 Treadwell** - Along Garner. The runoff with sediment will just flow along the silt fence and exit at the downstream end. All they would have needed to do is put in a j-hook to prevent the flow from exiting at the end. Without it, the silt fence might as well not be there.

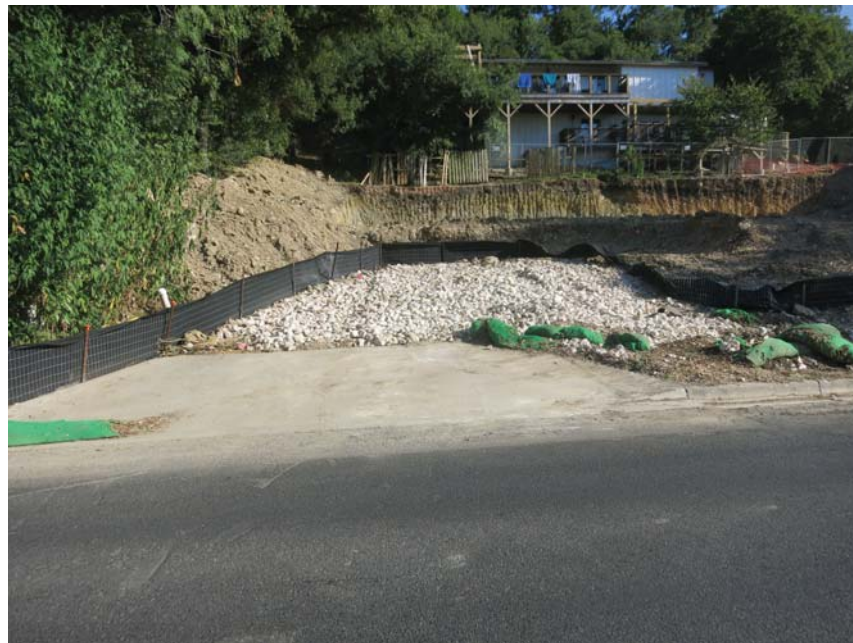
**809 Azie Morton** - Crushed silt fence with gaps under it. This site has high slope and unbraced excavation. It has the potential to be an environmental disaster if it rains. Flows to Barton Creek below BSP.
