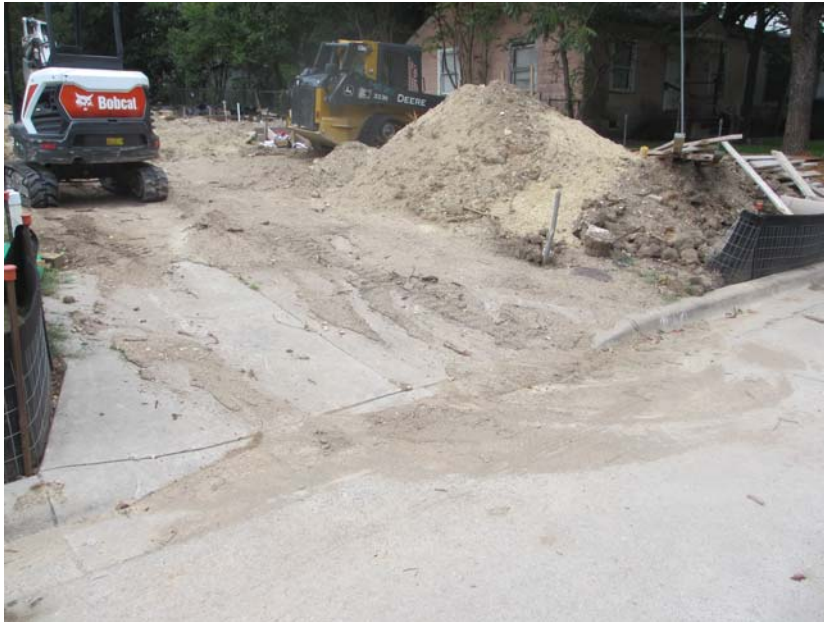
1404 Oxford - no erosion controls across entrance; considerable sediment in the street

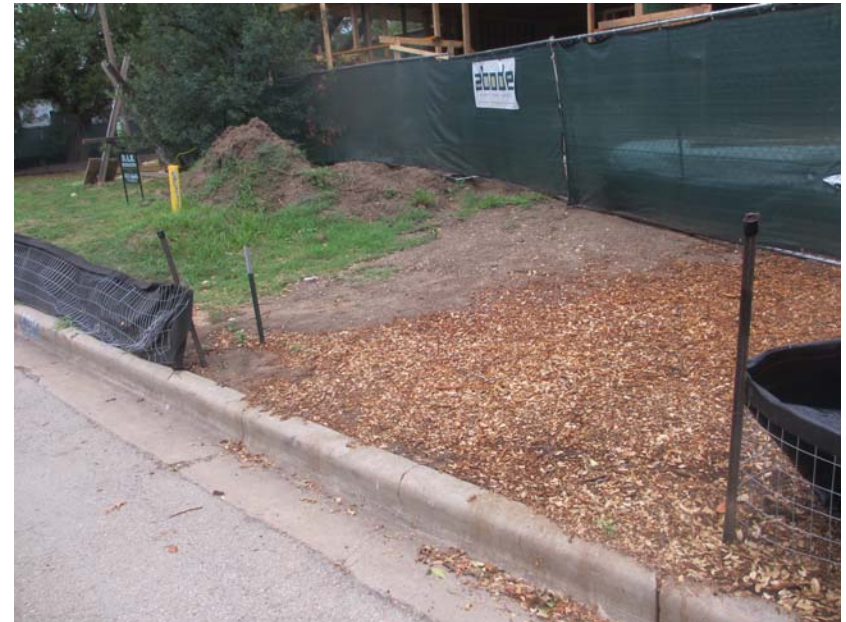
1206 Garner - gap in silt fence; while mulch may prevent soil under it from eroding, it is not contain runoff from upgradient

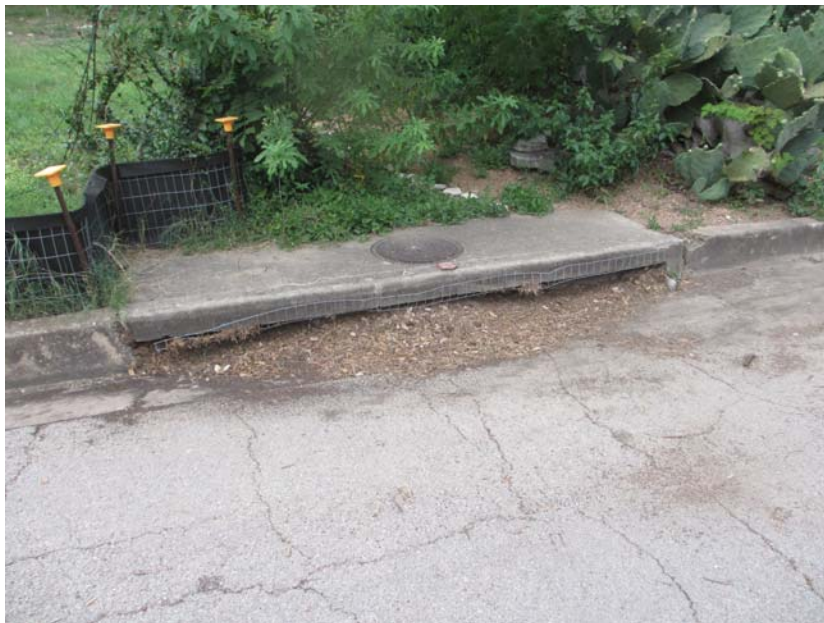
1813 Treadwell - sediment control screen on storm drain inlet is clogged and needs cleaned

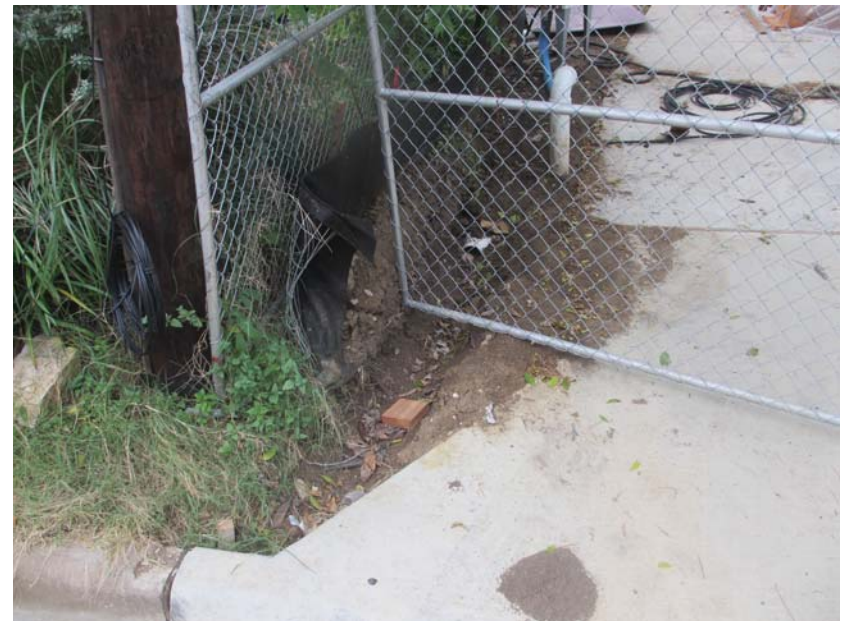
1819 Treadwell - no controls at the lowest corner on the lot allows sediment to escape; erosion channel readily visible

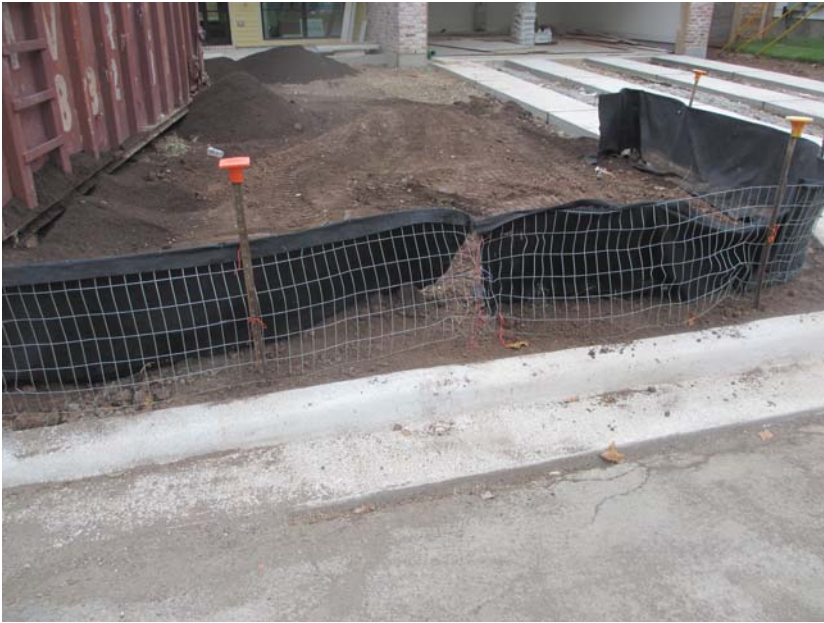
1300 Folts - silt fence not maintained; gap readily visible

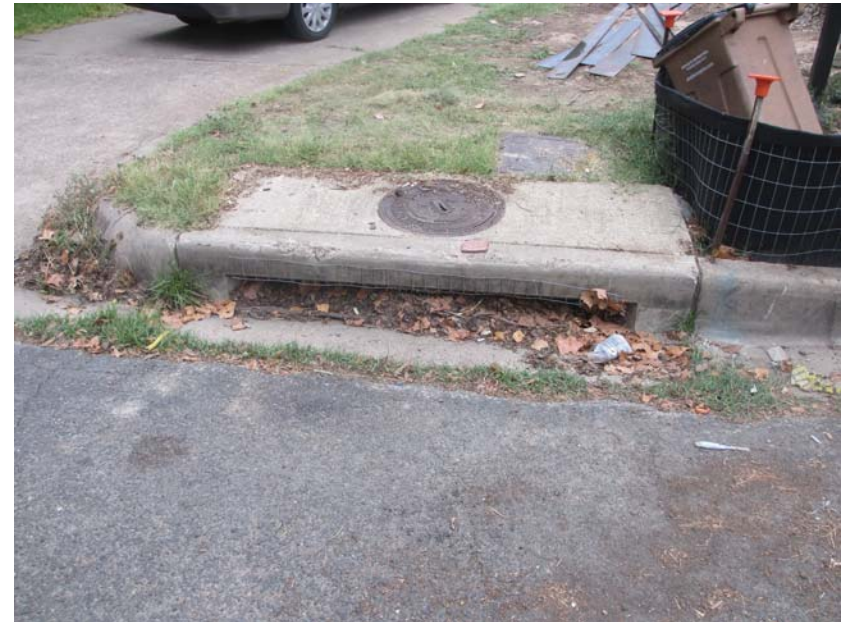
1300 Folts - sediment control screen on storm drain inlet is clogged and needs cleaned

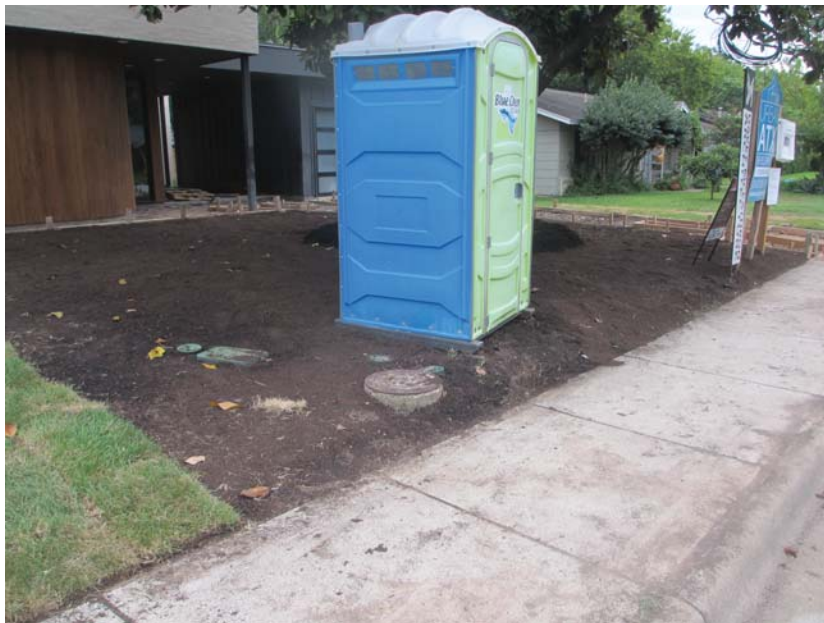
1811 Ashby - no controls; LDC § 25-8-181 requires controls to remain in place until permanent revegetation has been established

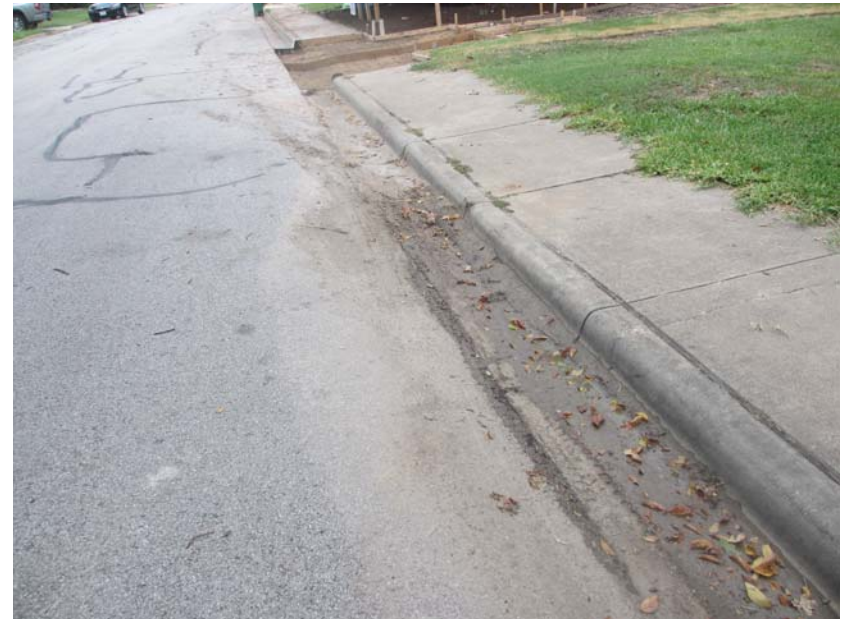
1811 Ashby - sediment deposited in gutter just downstream of construction site
