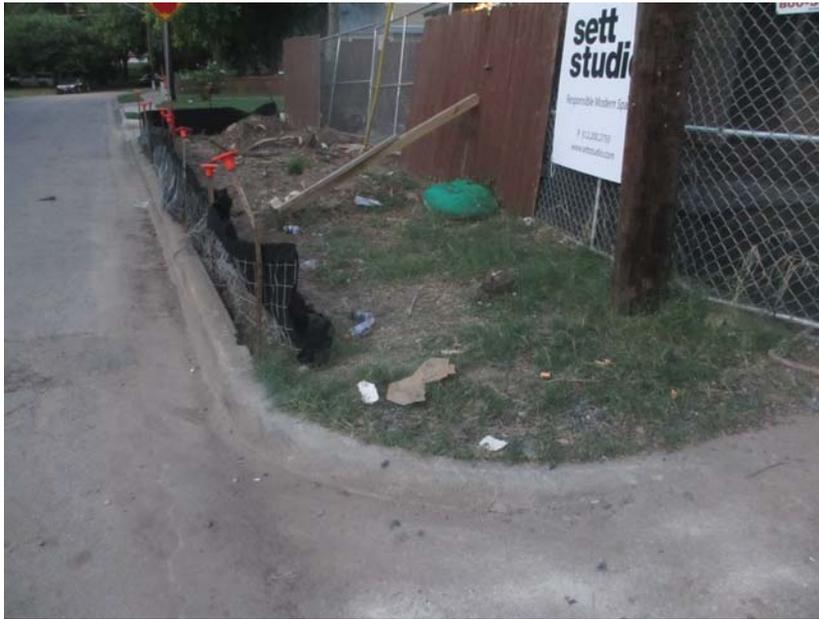
**1706-1716 Nash** - along Goodrich; no J-hook; runoff will just flow out at the end of the J-hook

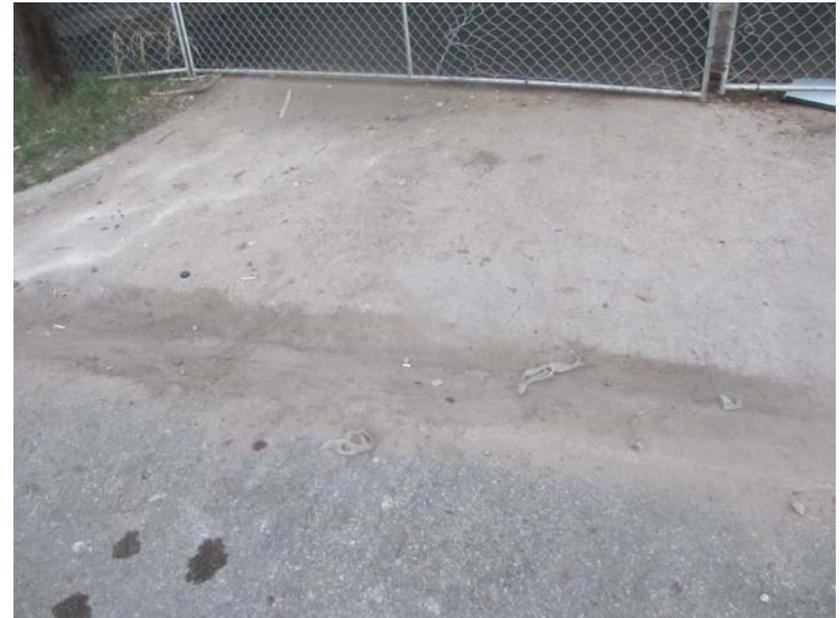
**1706-1716 Nash** - along Goodrich; sediment in drive and gutter

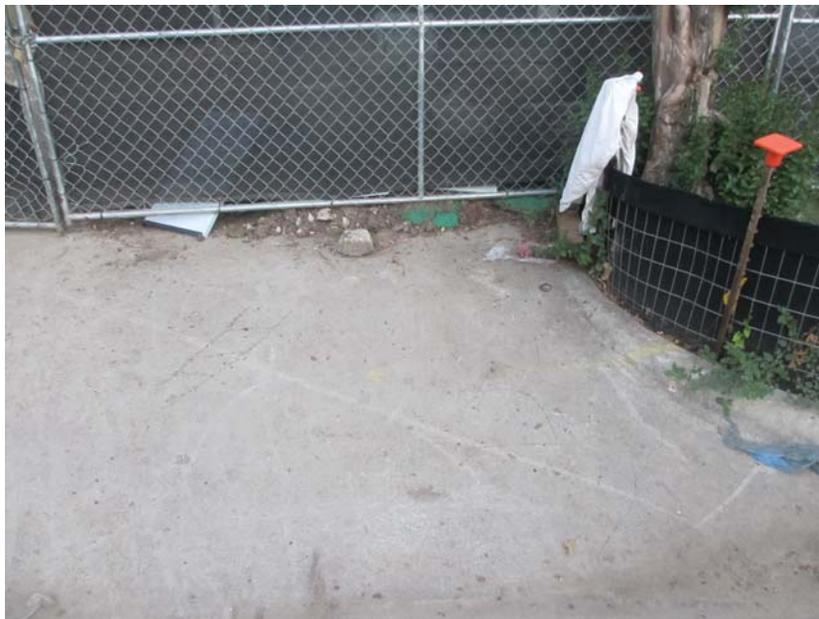
**1706-1716 Nash** - along Goodrich; dirt piled on top of mulch socks under fence

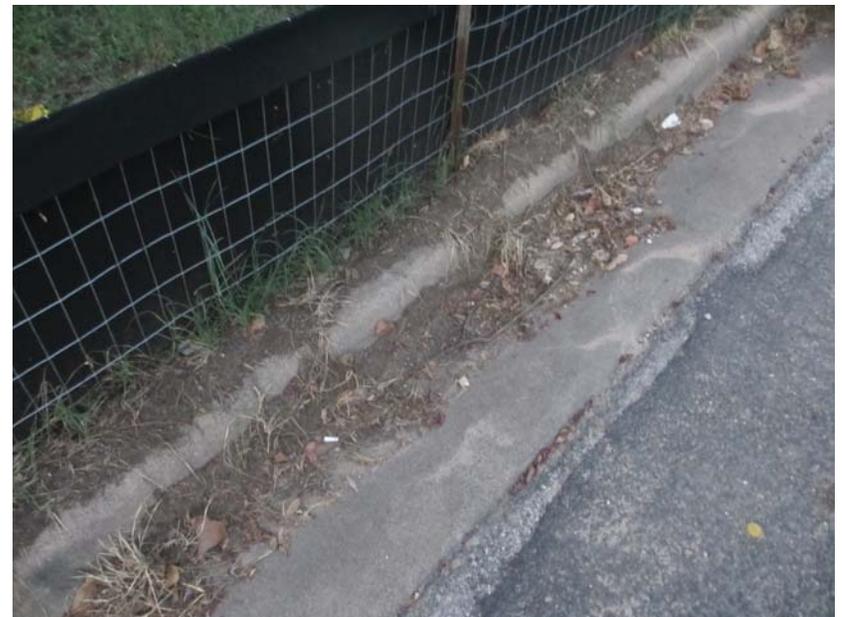
**1706-1716 Nash** - along Goodrich; dirt and sediment on top of curb and in the gutter

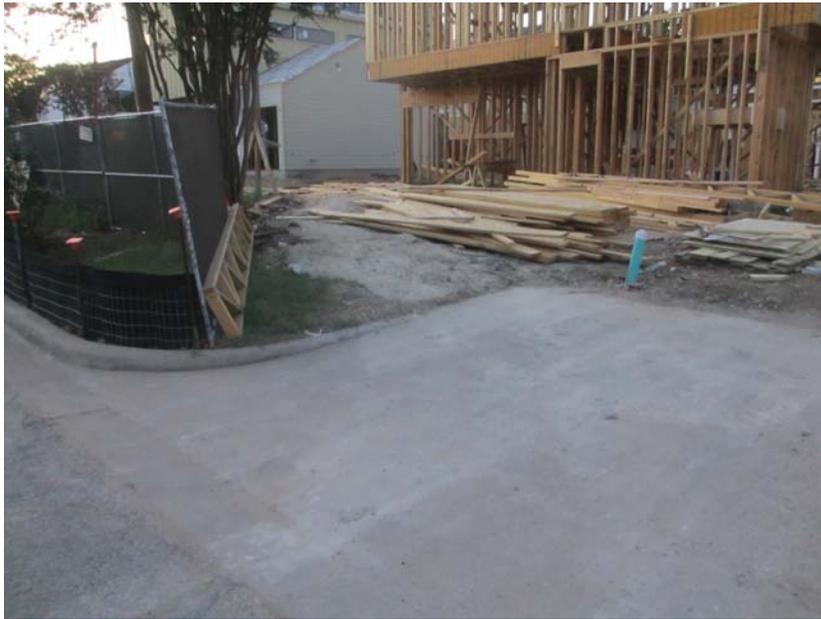
**1706-1716 Nash** - along Nash; no controls around drive; silt fence needs to extend along left side of drive or sediment will escape

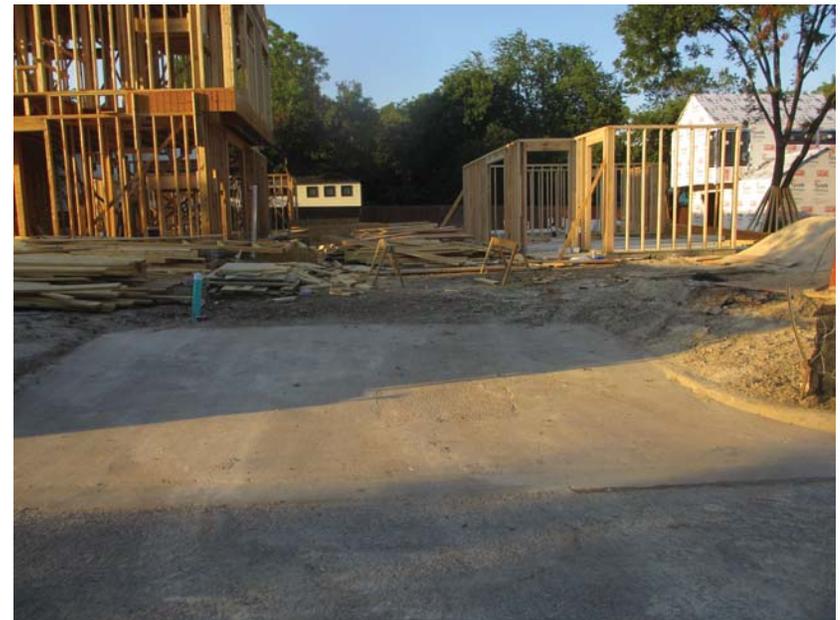
**1706-1716 Nash** -along Nash; no controls across entrance

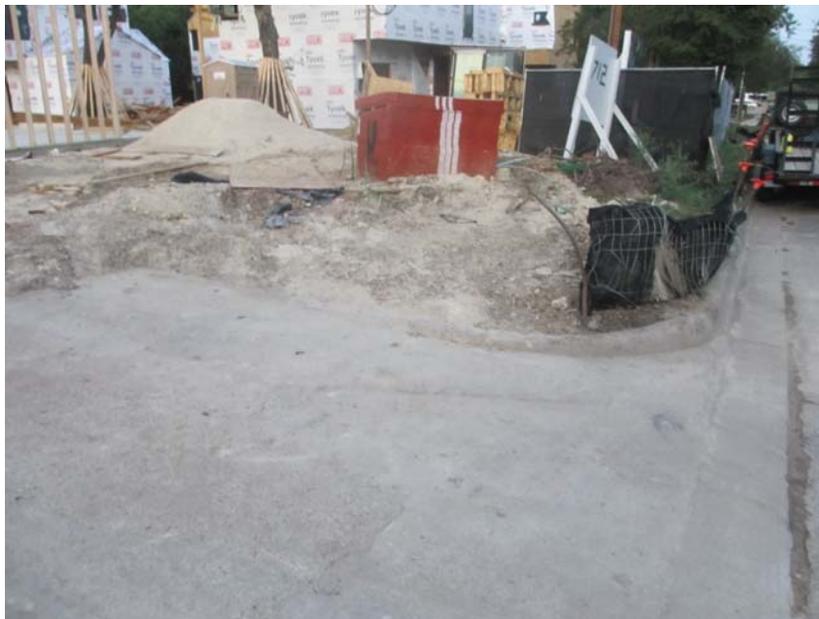
**1706-1716 Nash** - along Nash; no controls around drive; silt fence needs to extend along right side of drive or sediment will escape

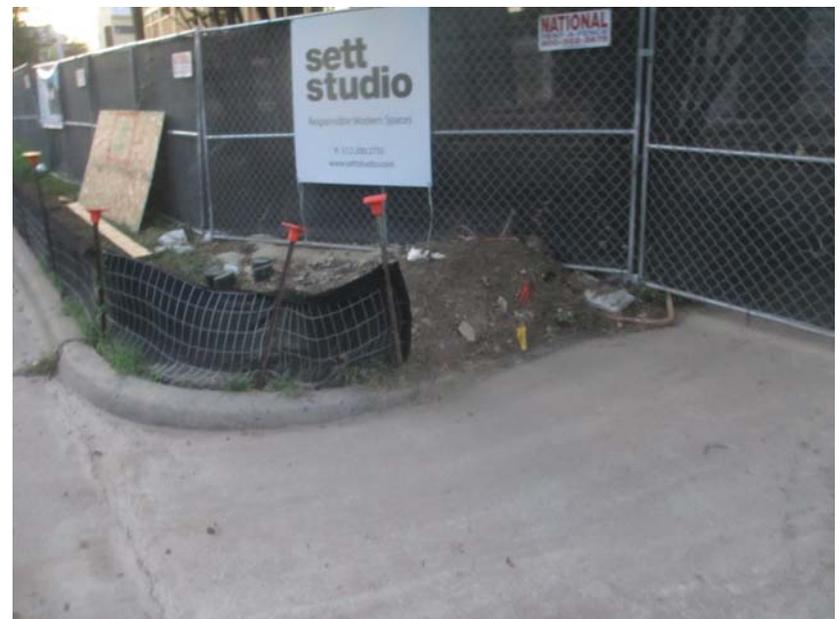
**1706-1716 Nash** - along Nash; dirt pile exposed; silt fence needs to extend up past dirt pile or sediment will escape

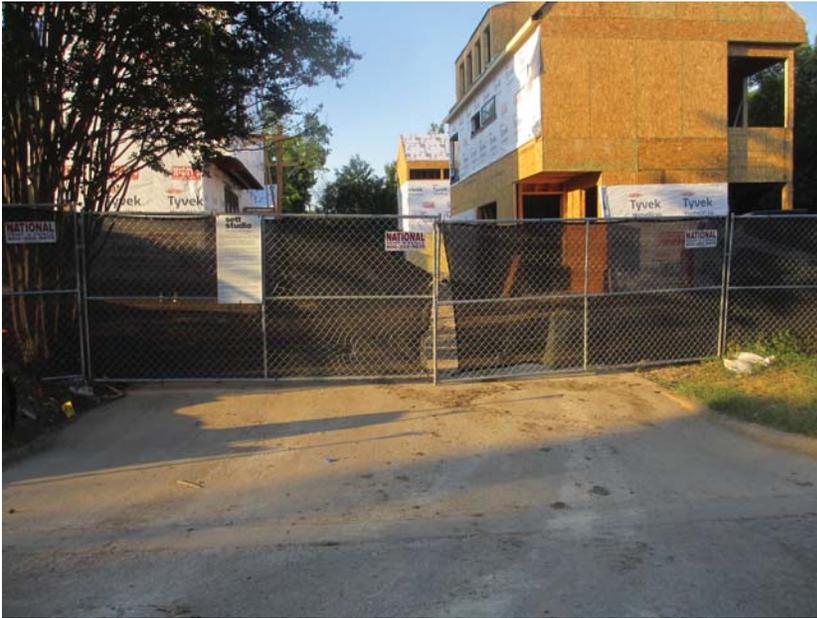
**1706-1716 Nash** - along Nash; no controls across entrance behind privacy fence

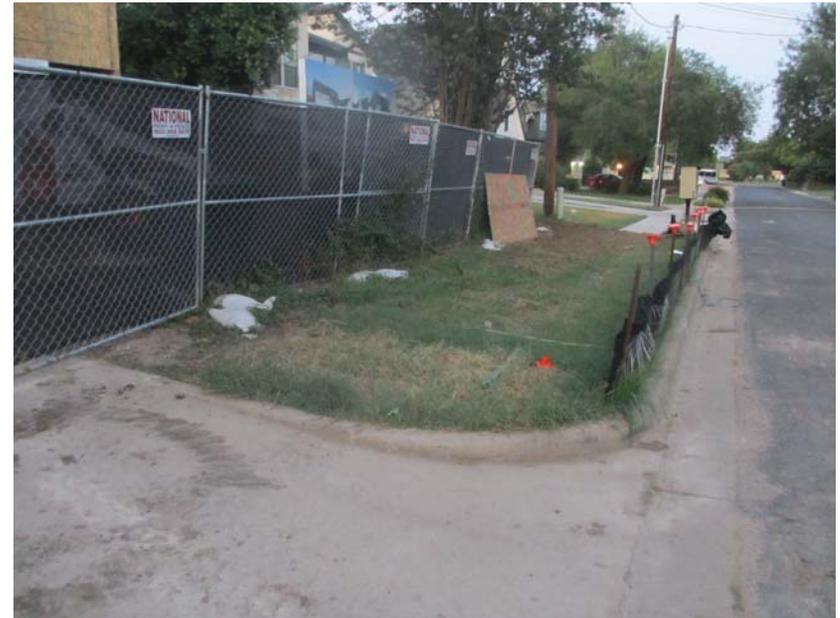
**1706-1716 Nash** -along Nash; no J-hook on silt fence

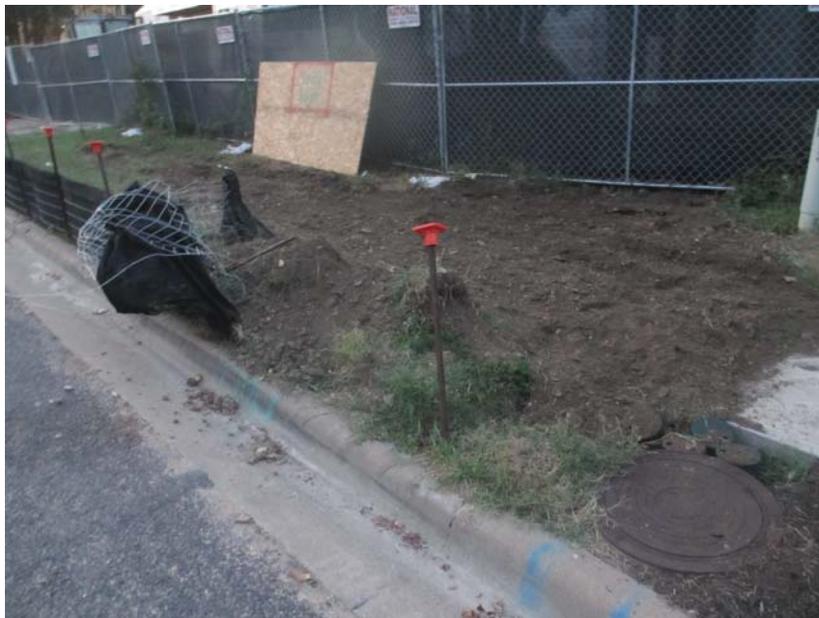
**1706-1716 Nash** - along Nash; silt fence mangled; inadequate erosion controls; sediment will easily escape

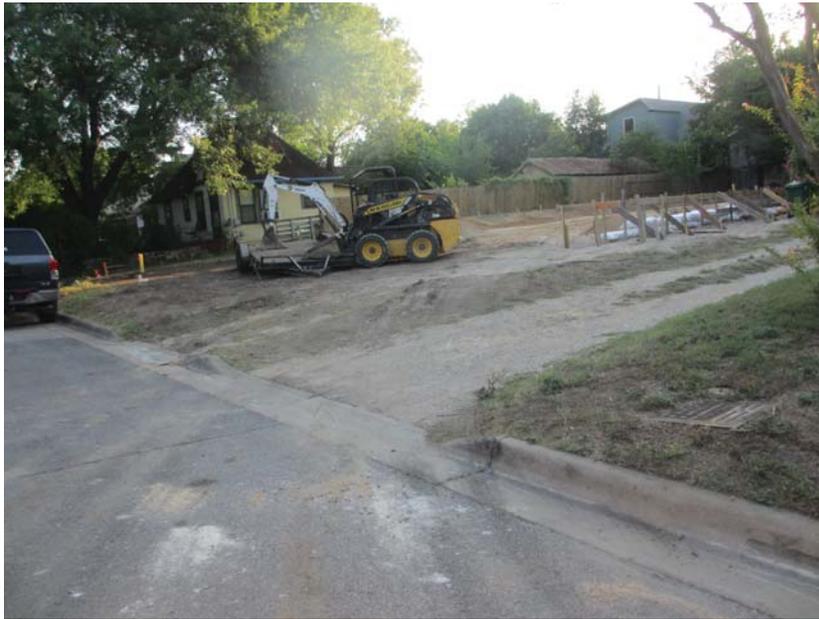
**2010 Oxford** - no controls at all

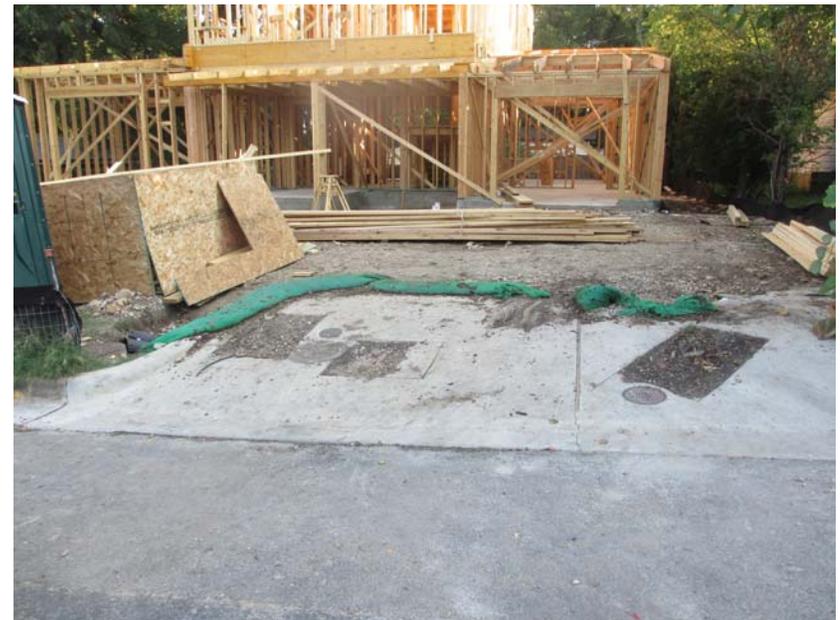
**2008 De Verne** - no J-hook on silt fence; flattened mulch sock with multiple gaps

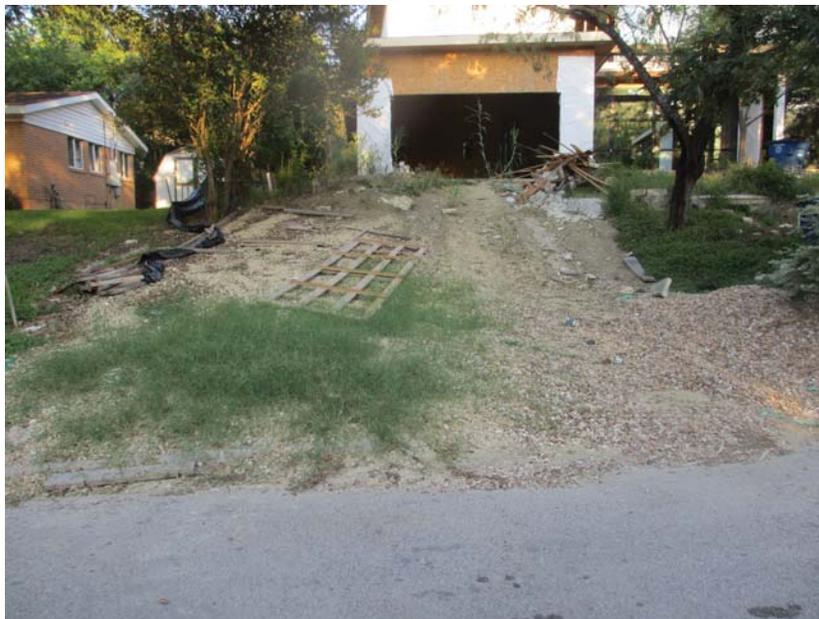
**2903 Oak Haven** - no controls and sediment in the street

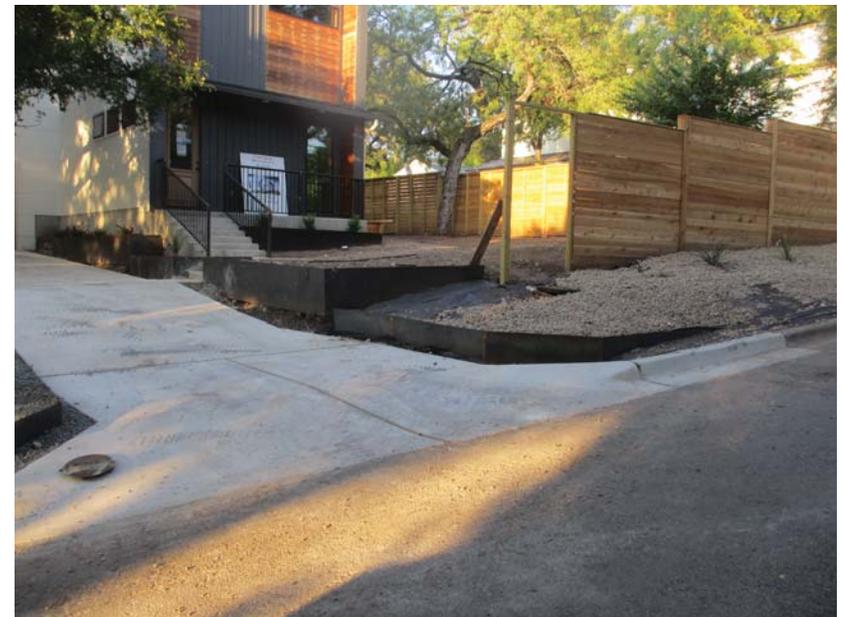
**2200 La Casa** - gravel will not control erosion of and runoff from bare dirt in yard behind privacy fence; see video from July 31

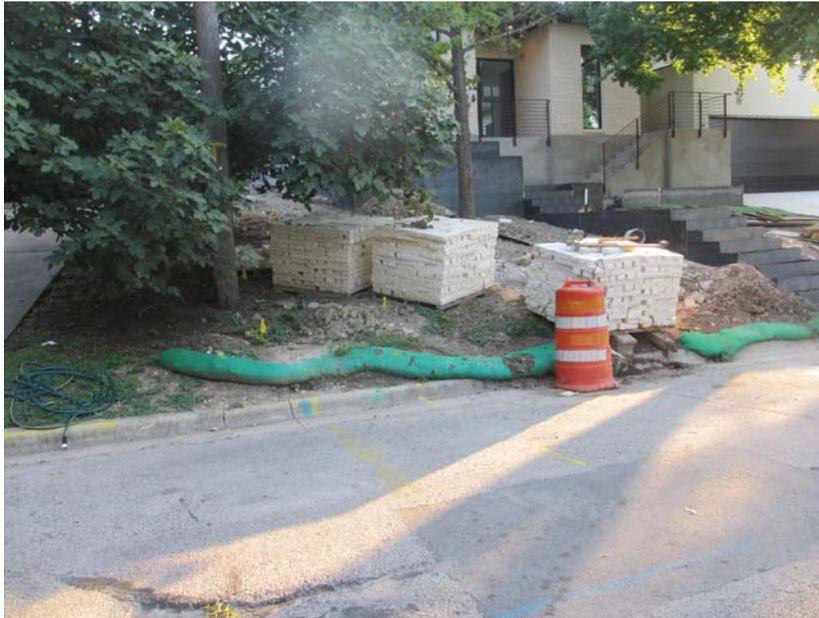
**2405 Elmglen** - mulch socks will not contain runoff on this steep slope; runoff will escape under pallet of stone

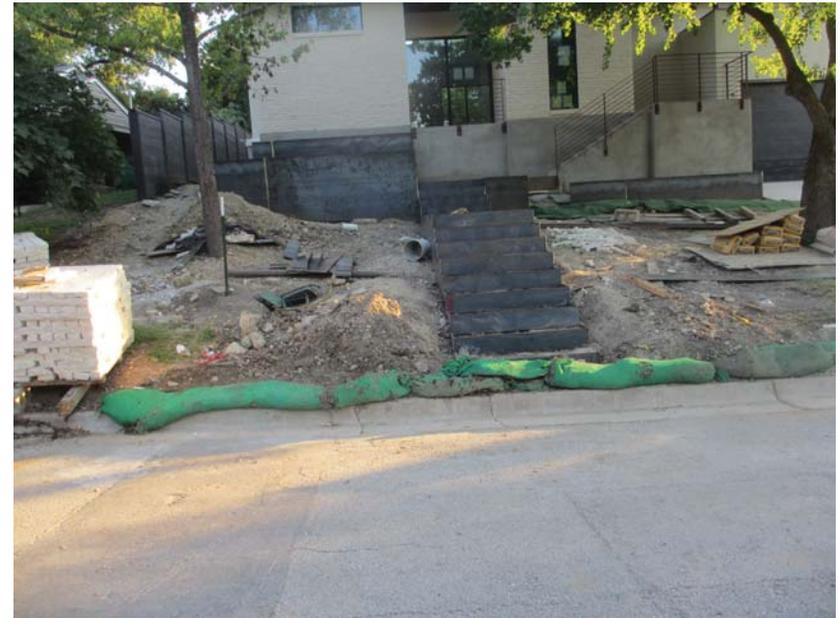
**2405 Elmglen** - mulch sock tattered and dirt piled to the top of it; slope too steep for mulch socks to work

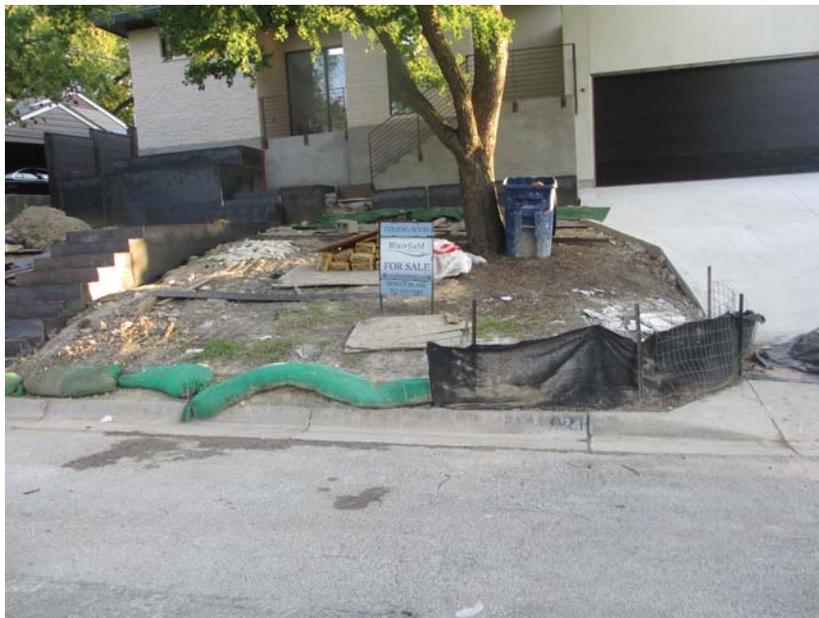
**2405 Elmglen** - mulch socks will not contain runoff on this steep slope; gap in mulch socks will allow sediment to escape

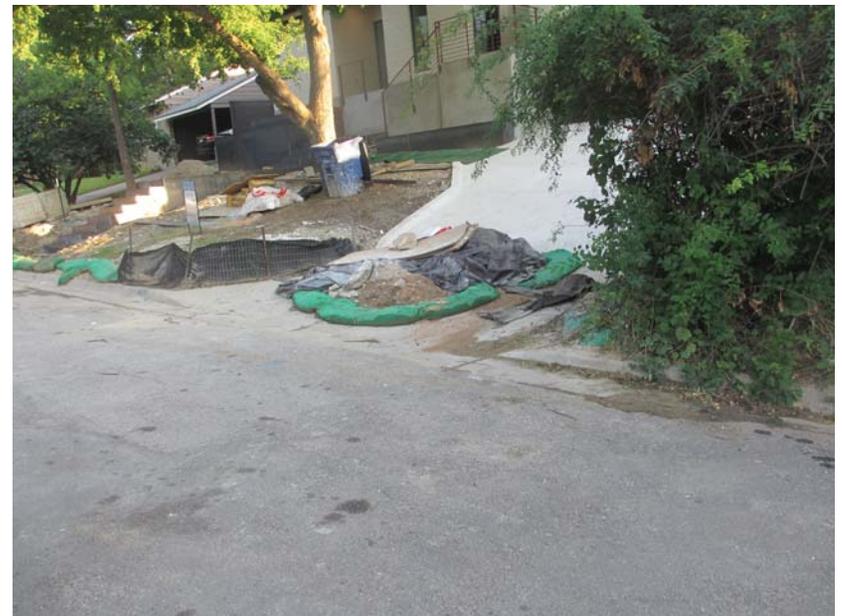
**2405 Elmglen** - inadequate controls around dirt in driveway; escaping dirt and sediment visible in driveway and gutter

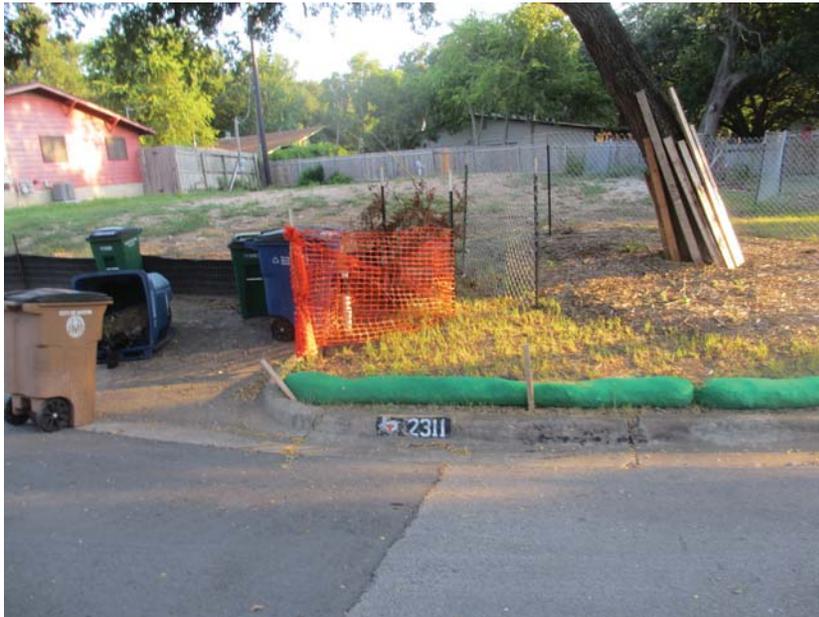
**2311 Montclair** - still no controls along right side of drive between silt fence and mulch sock; runoff will escape; see video from July 31

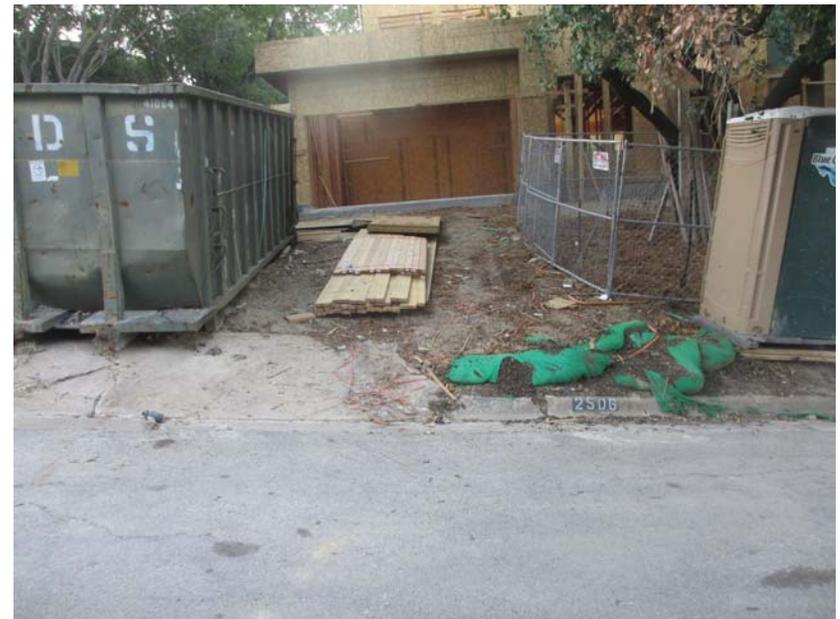
**2506 Cedarview** - inadequate controls; mulch socks in a pile but even if they were present, the slope is too steep for them to work

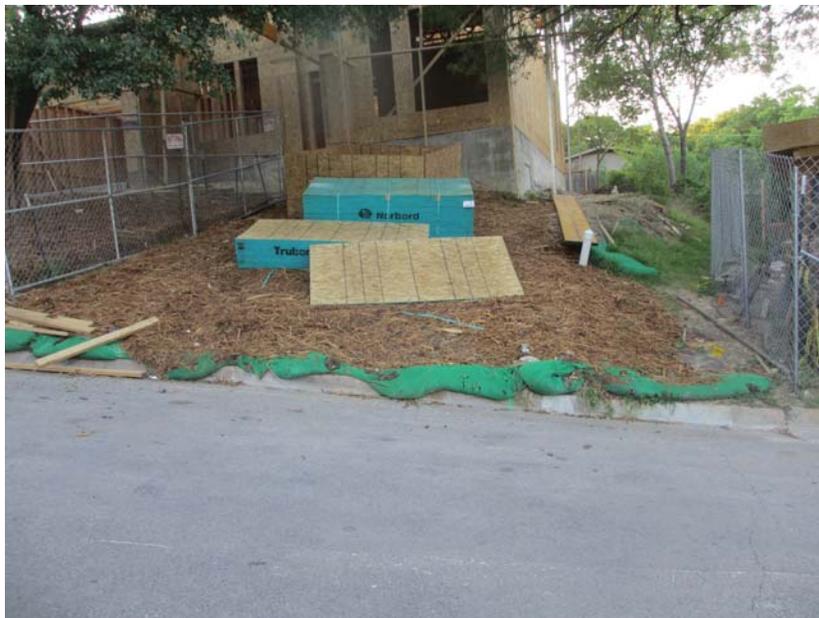
**2506 Cedarview** - mulch can prevent soil underneath it from eroding but will not control runoff from rest of yard; on this steep slope, much of the mulch will be washed into the storm drains

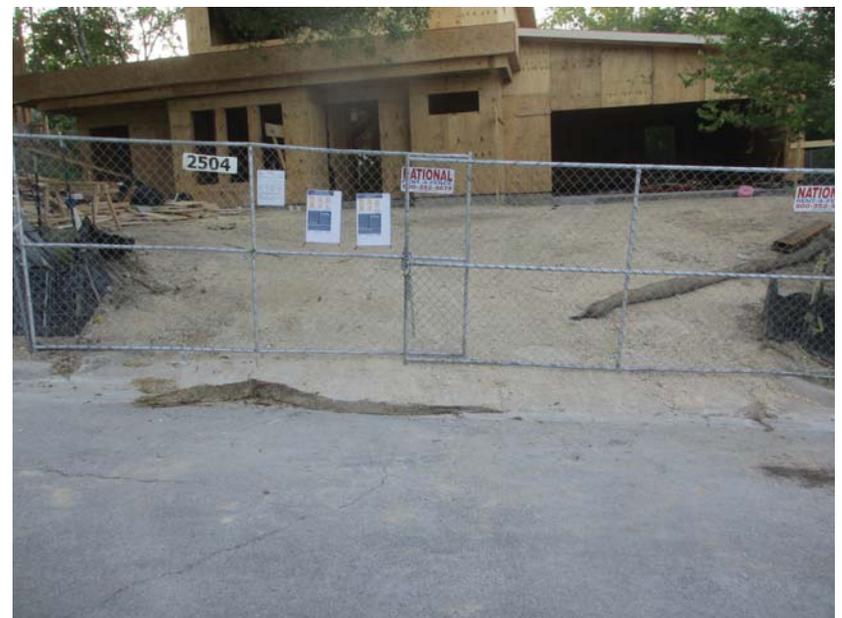
**2504 Cedarview** - no controls across this entrance; see video from July 31

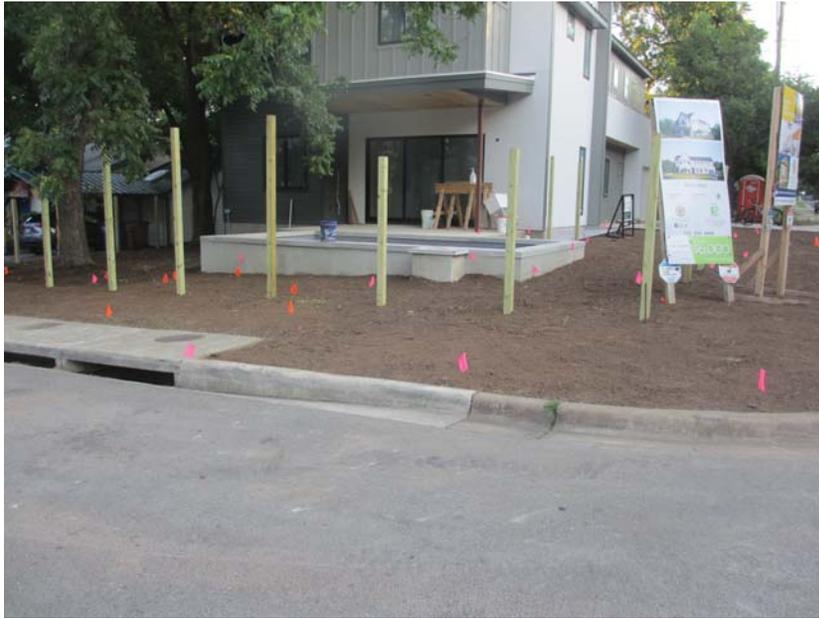
**2015 Arpdale** - controls must be maintained until vegetation has been established

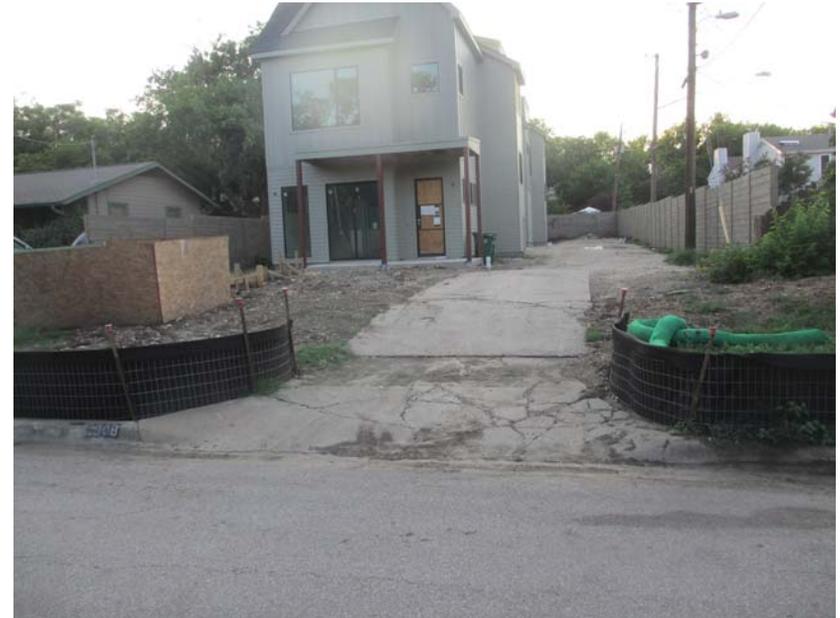
**1908 Goodrich** - no controls across entrance; mulch socks laying in a heap to the right

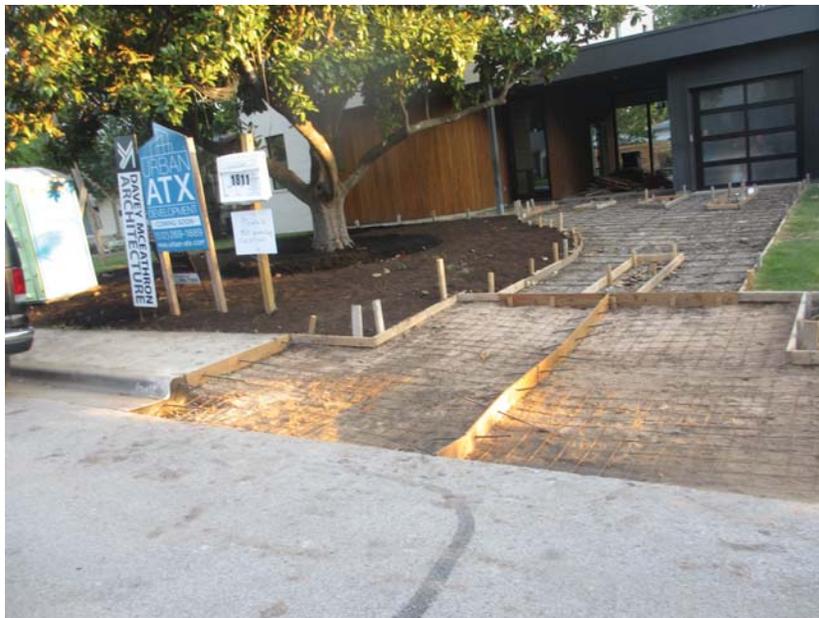
**1811 Ashby** - controls must be maintained until vegetation has been established; no controls for driveway

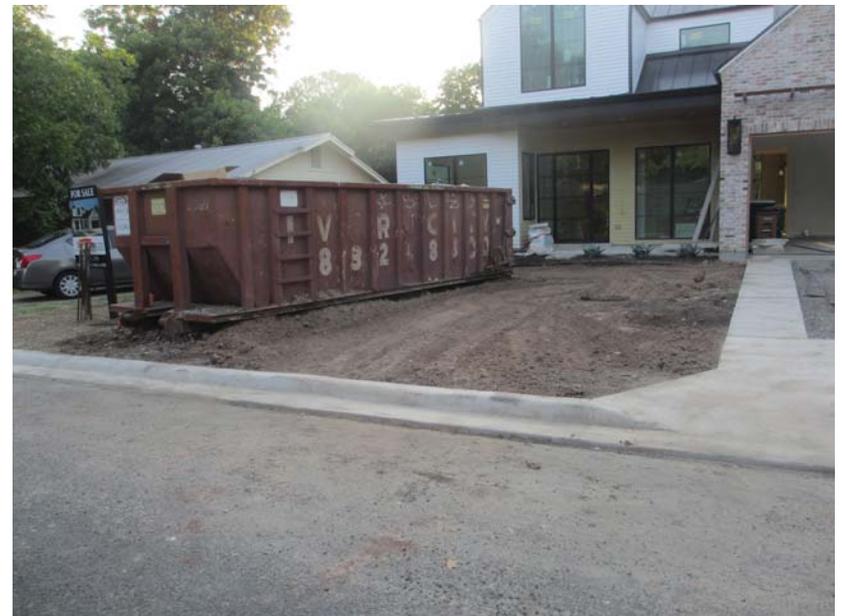
**1300 Folts** - controls must be maintained until vegetation has been established

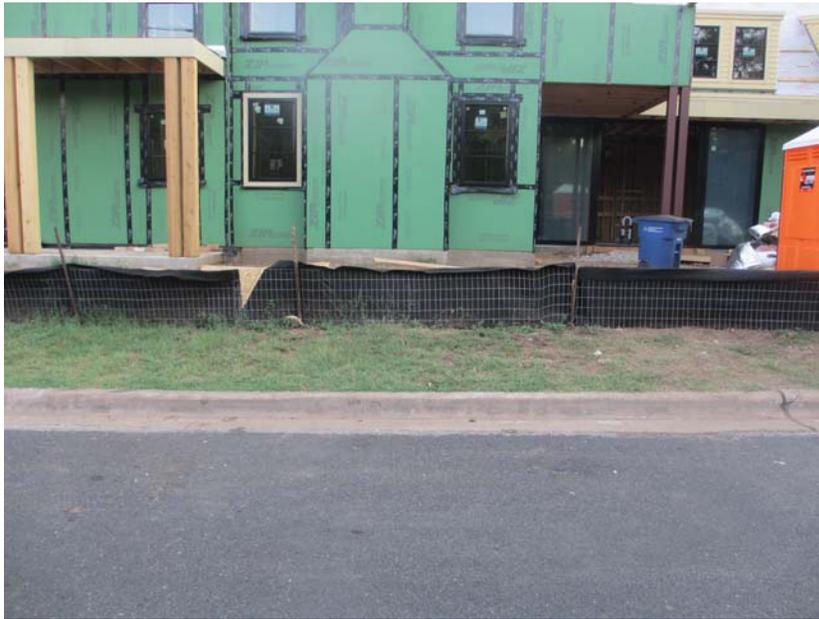
**700 Garner** - rip and gap in silt fence will render the silt fence ineffective in retaining runoff and sediment

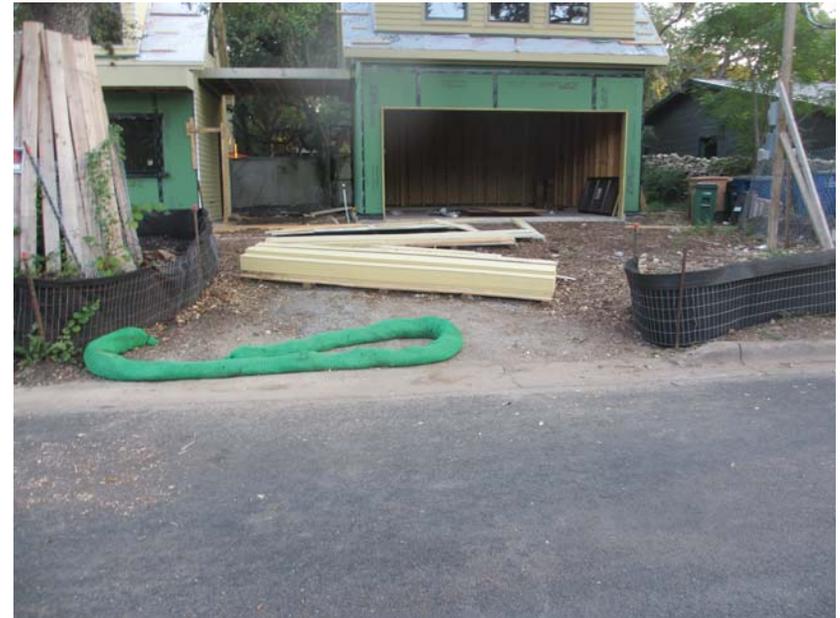
**700 Garner** - mulch sock not effectively positioned

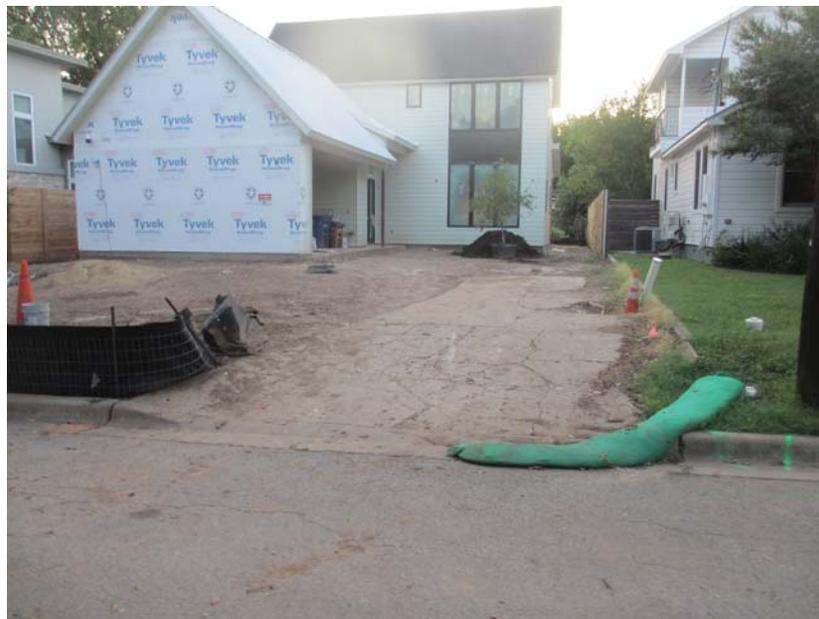
**1504 Garner** - no controls across drive; mulch sock is of no use when it is laying off to the side

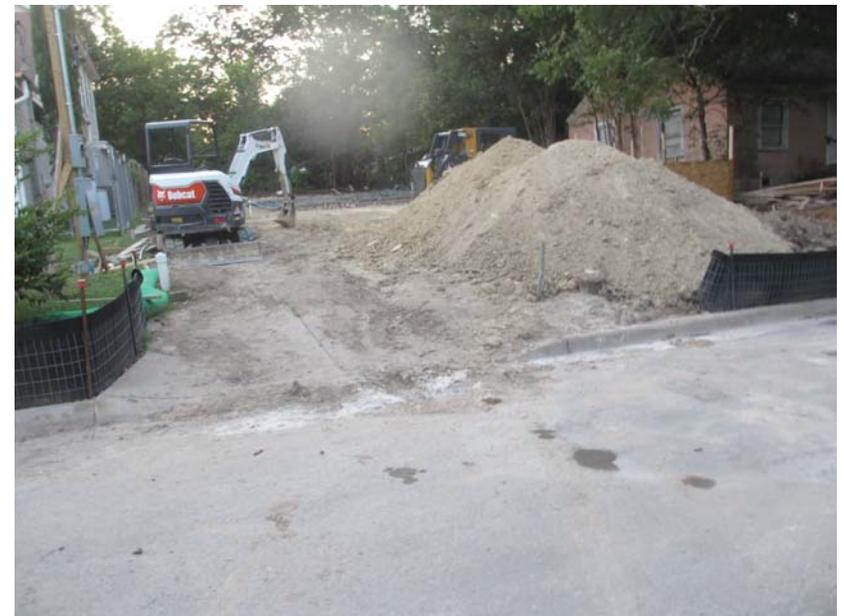
**1404 Oxford** - no controls for large piles of dirt; no J-hook on silt fence; sediment and dirt in gutter and street; see video from July 31

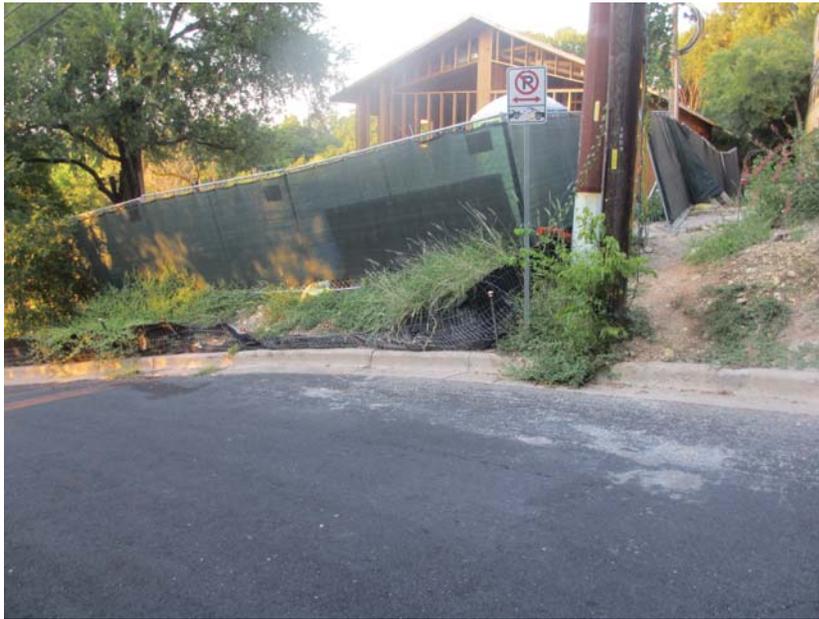
**809 Azie Morton** - along Lund; crushed and mangled silt fence allows runoff to escape from the side

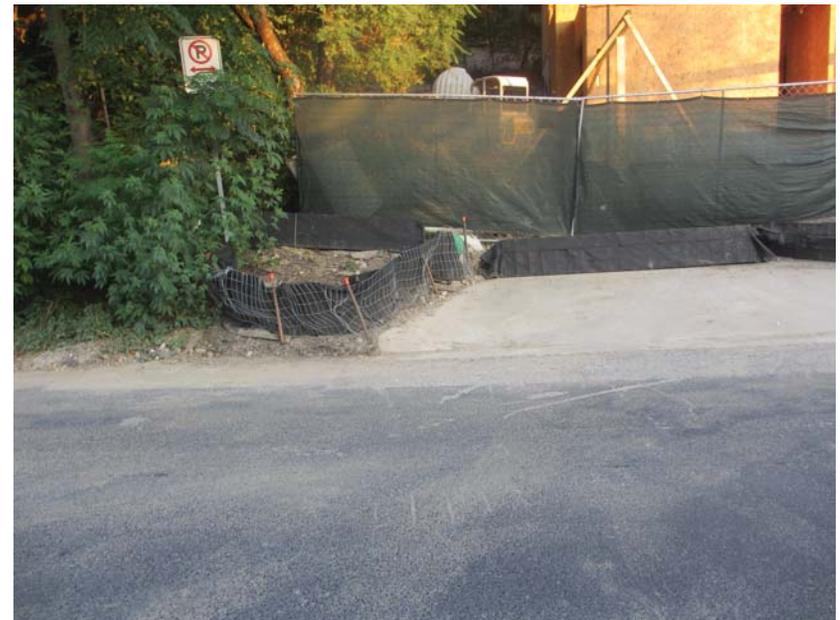
**809 Azie Morton** - this slope is simply too steep for these controls to work effectively; more is needed; see Jul 31, May 12, and Apr 3 videos

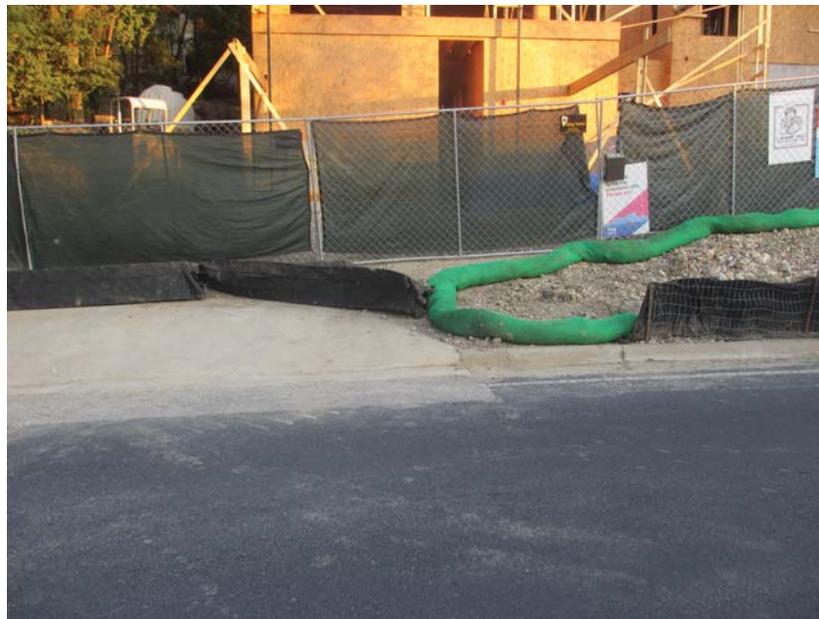
**809 Azie Morton** - the dike butts up against the mulch sock and will not prevent sediment from escaping between the two

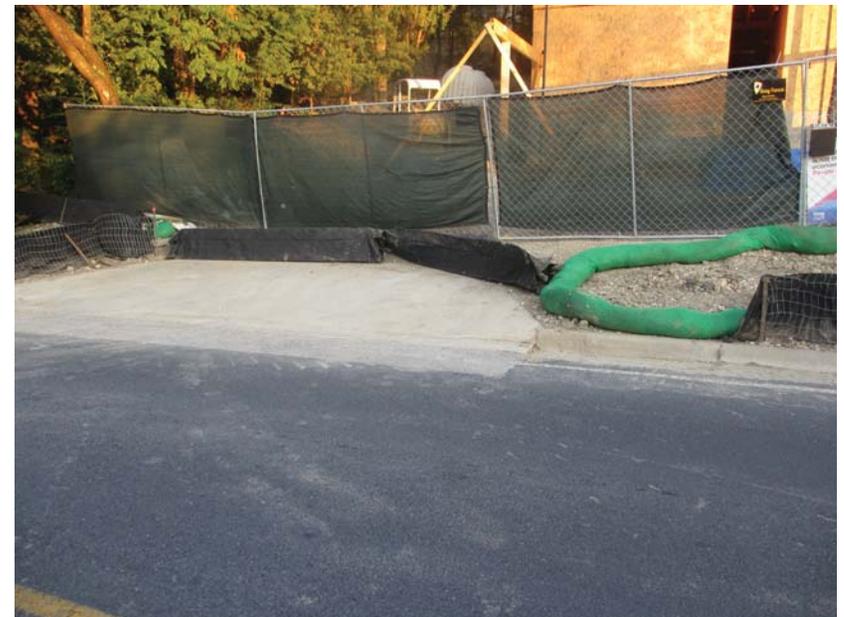
**809 Azie Morton** - from this angle, the gap between the silt fence on the left and the triangular dike is visible as is the gap between the two triangular dikes
