South Lamar Boulevard Corridor
Environmental Resources
Inventory

Riverside Drive to Ben White
Boulevard/State Highway 71
Austin, Texas

Environmental Resource Inventory

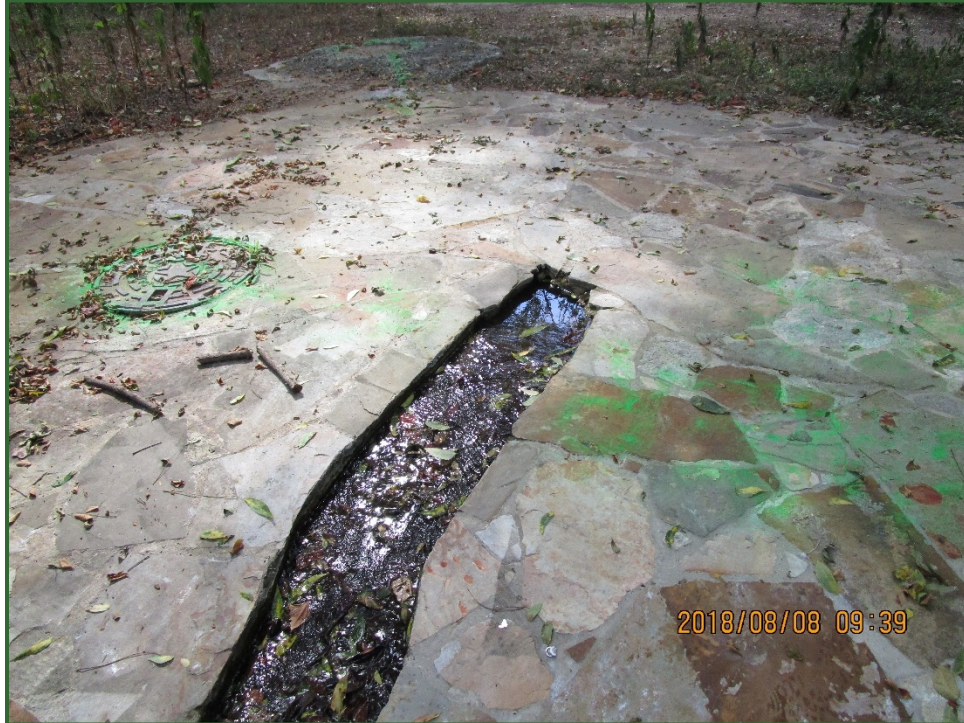
Photograph 1: CEF 1 (S-1) – Paving surrounding spring headwaters at COA-recorded Treadwell Spring (S-1). Water was clear and flowing.

CEF #1: COA-recorded Spring: (S-1) Baer Engineering confirmed the presence of COA-recorded spring ("Treadwell Spring", brg_id 16521) at Treadwell Street between South 6th and South 7th Streets. The area around the spring is clearly developed, with paving stones and concrete surrounding the spring. An approximately 12-inch wide paved channel carries the spring flow approximately 25 feet down to West Bouldin Creek. Water was flowing at a moderate rate from the spring. Vegetation outside of the paved area was dominated by *Ludwigia octovalvis* (OBL) and *Ambrosia trifida* (FAC), with some *Ruellia simplex* (FAC). Please refer to **Photographs 1-2**.

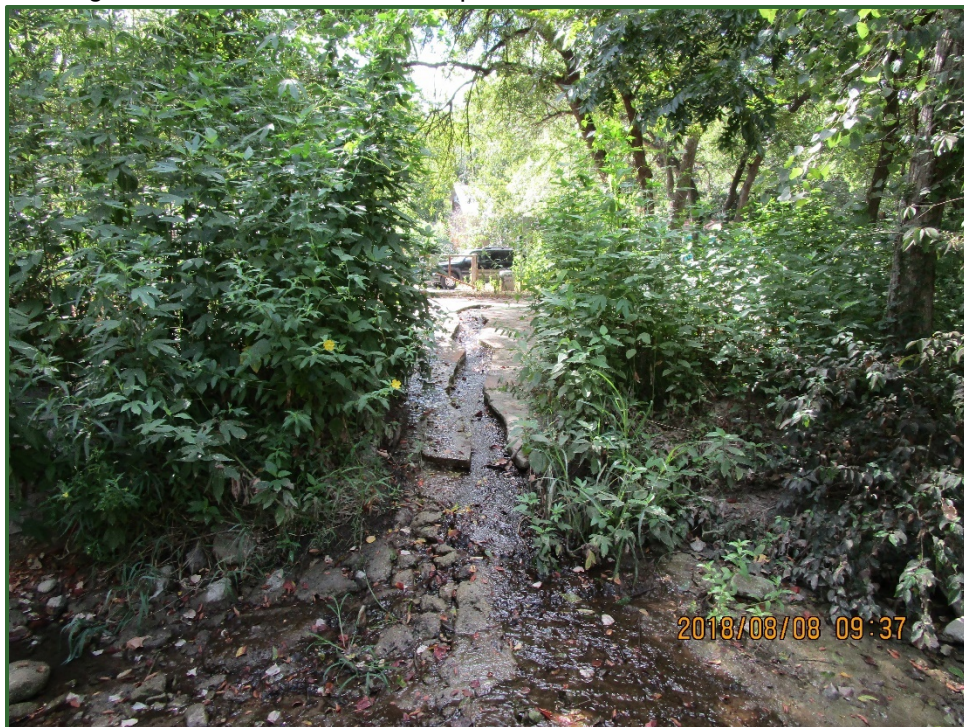
Photograph 2: CEF 1 (S-1) – Paved channel carries water from COA-recorded Treadwell Spring (S-1) to West Bouldin Creek, approximately 25 feet away. West Bouldin Creek can be seen in the foreground. *Ludwigia octovalvis* and *Ambrosia* species dominate.

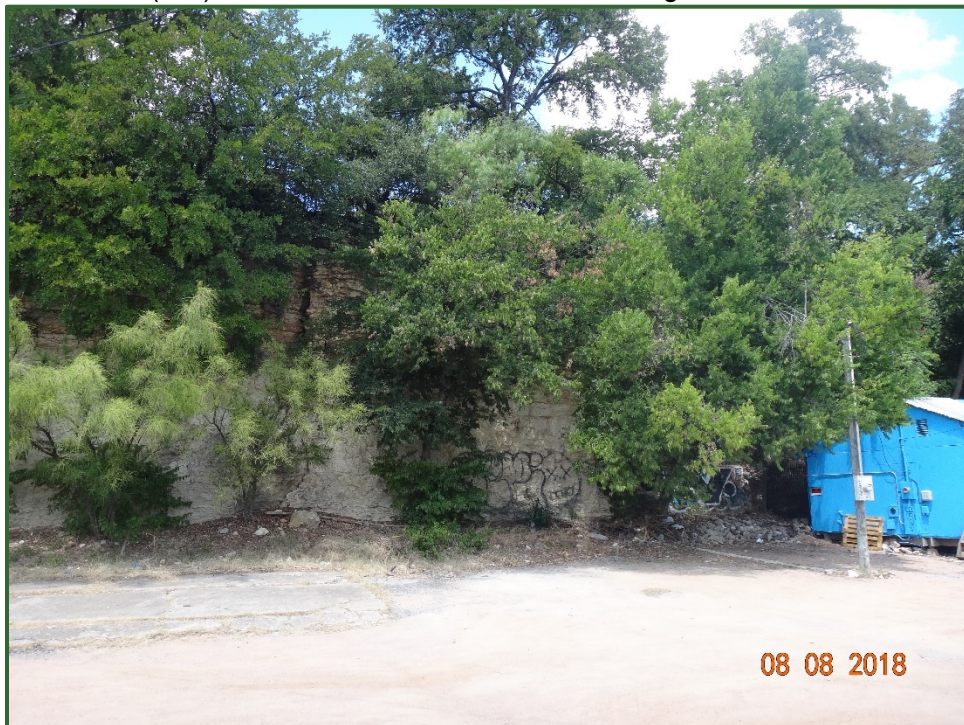
Photograph 4: CEF 2 (B-1) –View of the middle of the bluff along South Lamar Boulevard.

CEF #2: Baer-Identified Bluff: (B-1) A bluff was identified along the west side South Lamar Boulevard, north of Bluff Street. This bluff extends for approximately 360 feet parallel to South Lamar Boulevard, and is approximately 45 feet high. Please refer to **Photographs 3-5**.

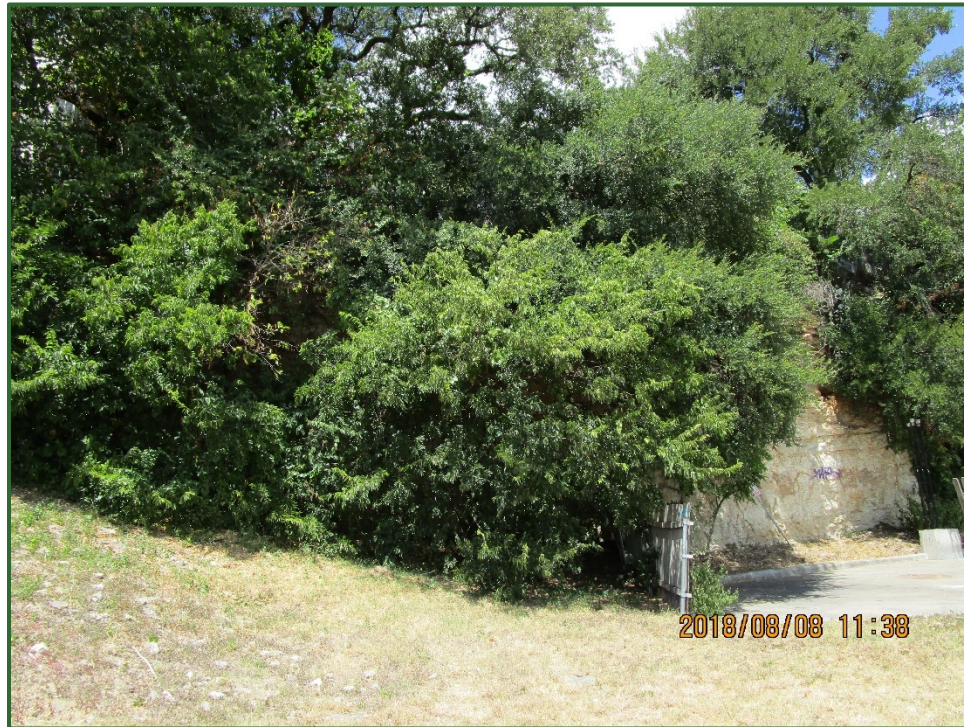
Photograph 5: CEF 2 (B-1) – Southern end of bluff along South Lamar Boulevard, just north of Bluff Street.

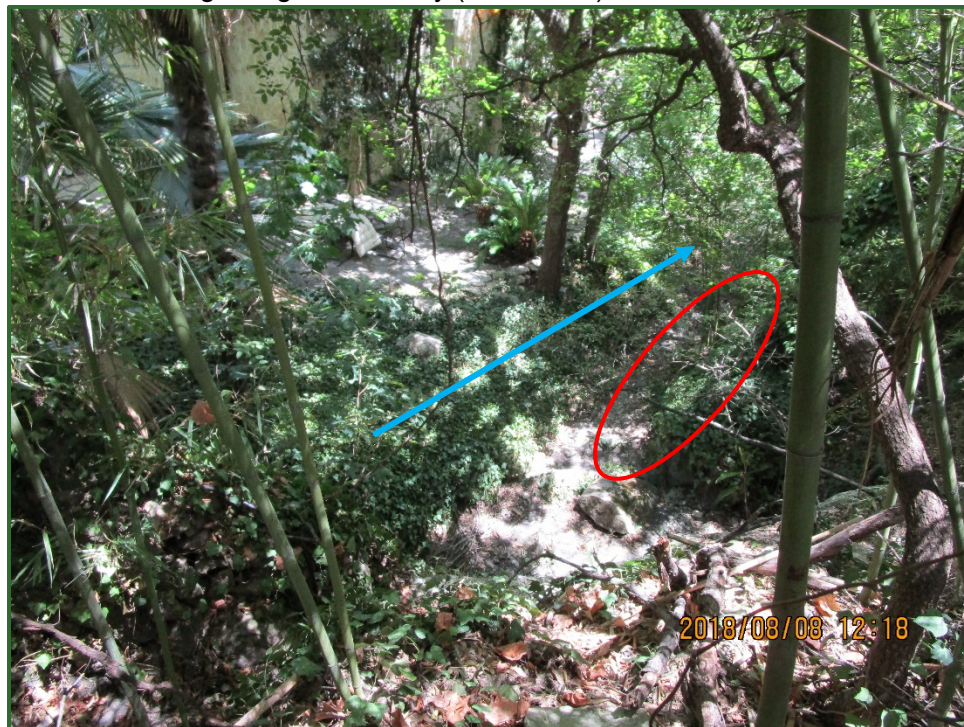
Photograph 6: CEF 3 (CR-1) – Canyon Rimrock on private property along tributary to West Bouldin Creek. Baer Engineering field scientists were unable to verify the measurements of the rimrock, circled in red and continuing along the tributary (blue arrow).

CEF #3: Baer-Identified Potential Canyon Rimrock: (CR-1) This canyon rimrock was observed along a tributary to West Bouldin Creek, within private property northeast of the intersection of West Mary Street and Evergreen Avenue. Baer Engineering was unable to access the feature to measure the dimensions but it appeared to be at least five feet high and 50 feet long which meets the COA definition of canyon rimrock. Please refer to **Photograph 6**.

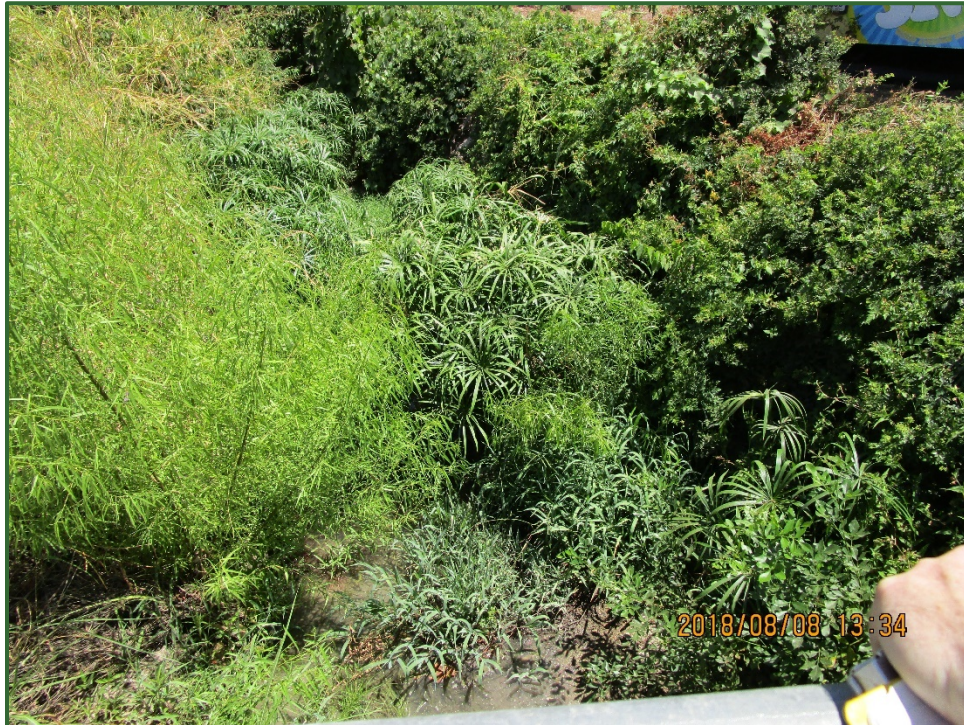
Photograph 7: CEF 4 (W-1) – View of wetland on West Bouldin Creek tributary. Photo taken from pedestrian bridge over stormwater culvert. *Salix nigra* and *Cyperus involucratus* can be seen along and within the tributary channel. *Ampelopsis arborea* dominates the right bank.

CEF #4: Baer-Identified Wetland: (W-1) This wetland was observed along a tributary to West Bouldin Creek, northeast of the intersection of South Lamar Boulevard and West Mary Street. Hydrophytic vegetation was observed extending 55 feet downstream from the culvert at South Lamar Boulevard; the wetland was approximately 15 feet wide. Dominant vegetation included *Cyperus involucratus* (FACW), *Salix nigra* (FACW) saplings, and *Fraxinus* sp. (FAC) saplings. Other hydrophytic vegetation included

Cyperus ochraceus (FACW) and *Paspalum dilatatum* (FAC). Please refer to **Photographs 7-8**.

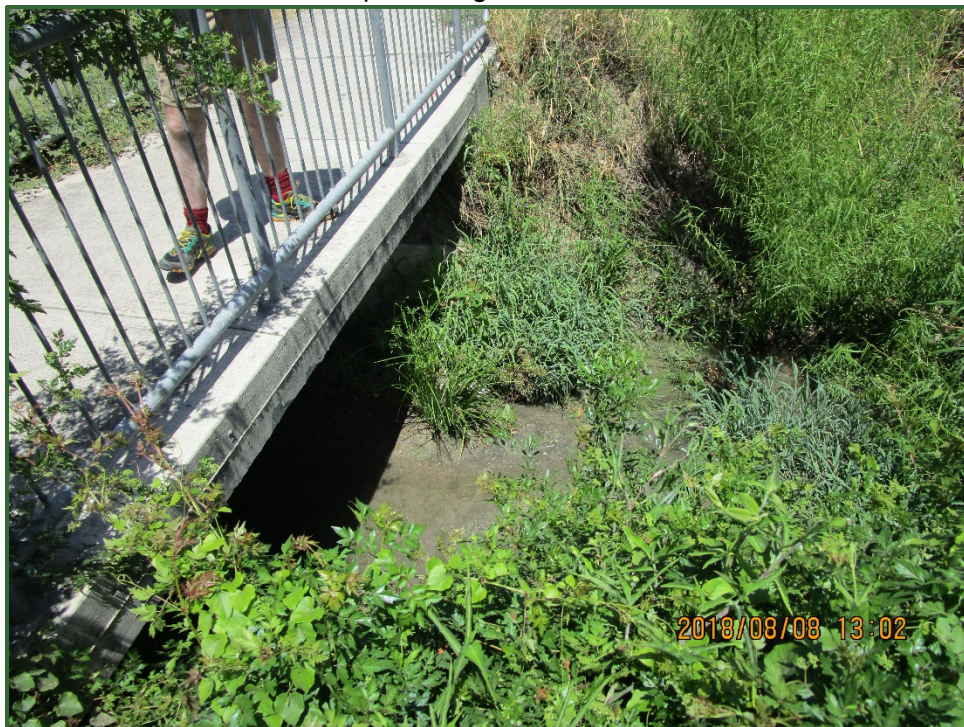
Photograph 8: CEF 4 (W-1) – Portion of wetland underneath pedestrian bridge. *Cyperus ochraceus* and *Paspalum dilatatum* dominate this upstream groundcover.

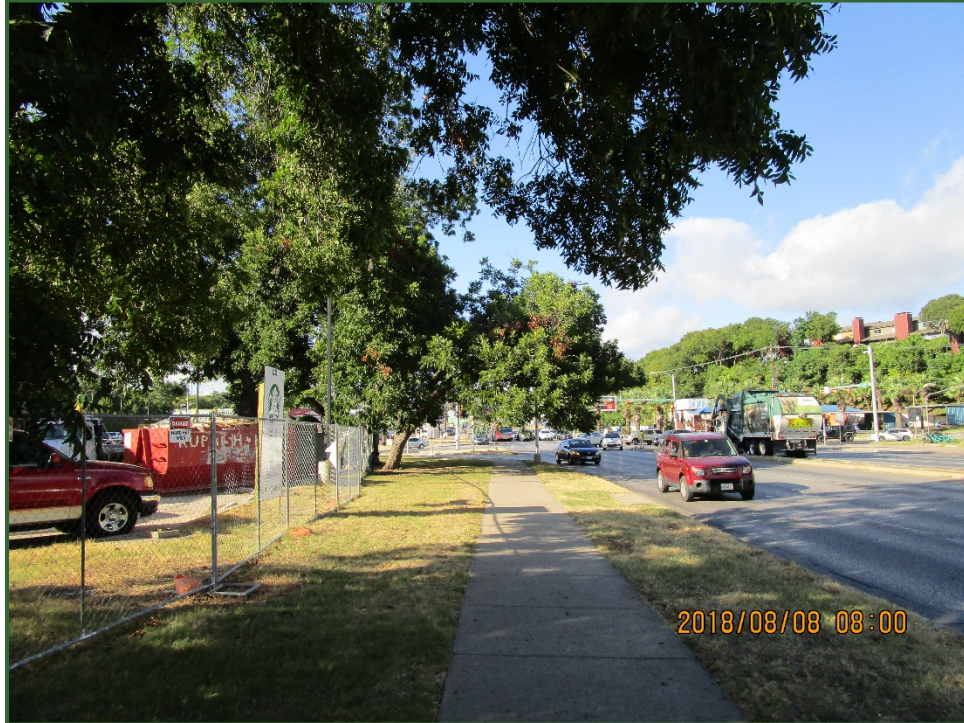
Photograph 9: Typical area of urban ROW in project area. Typical vegetation includes mowed grasses, pecan and oak trees, and other landscaping.

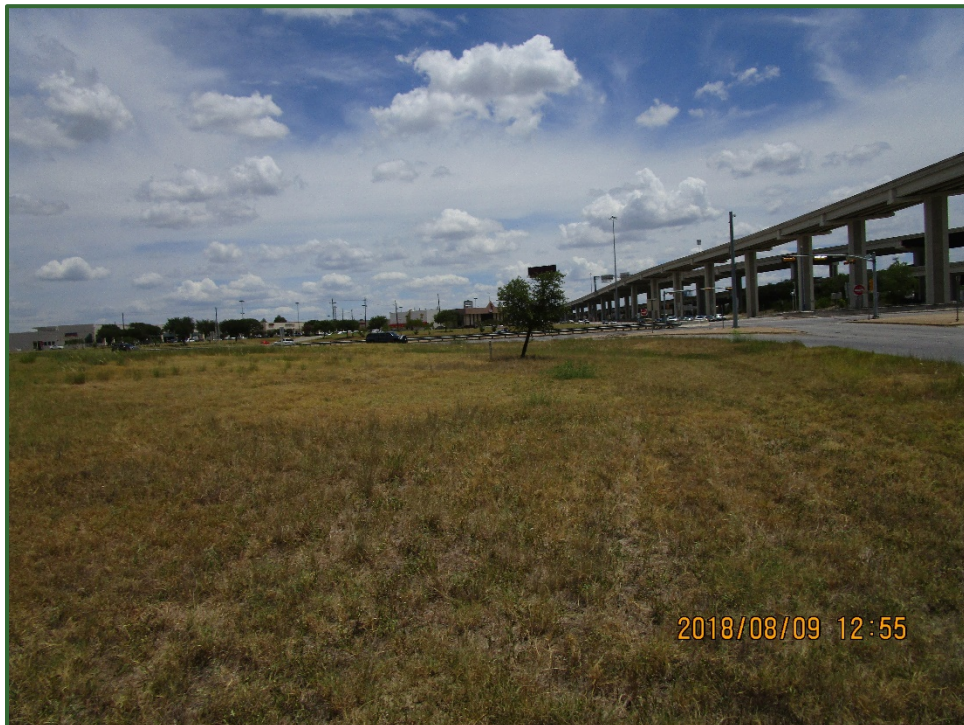
Photograph 10: Example of Maintained Grassland habitat. Grasses were mowed and trees were sparse.

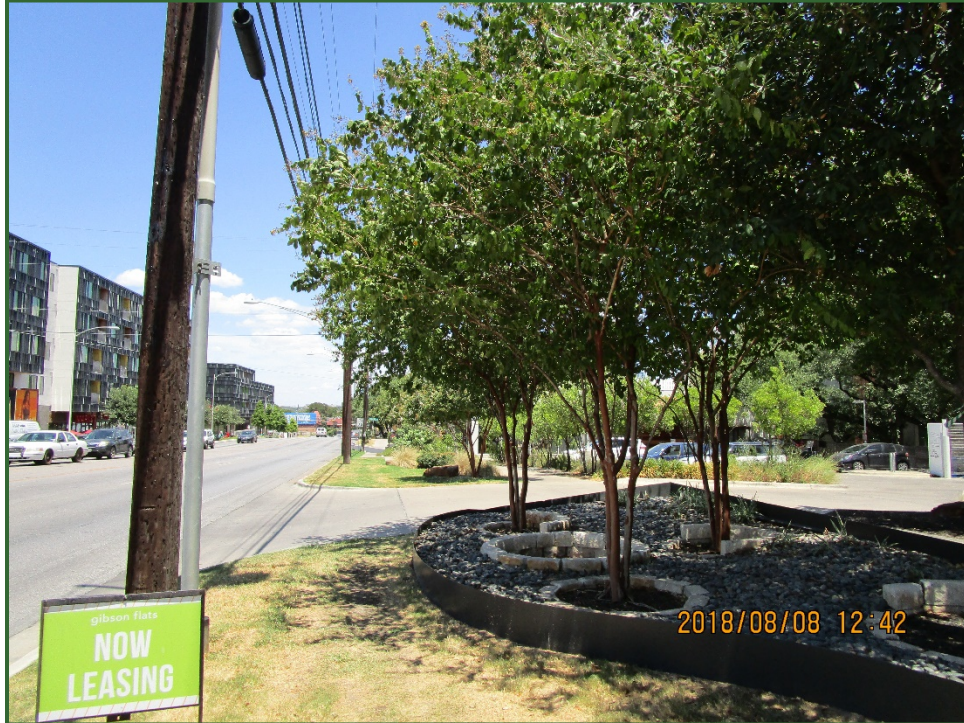
Photograph 11: Typical example of Urban Landscaping Habitat - crape myrtle and mowed bermudagrass.

The **Urban Landscaping** habitat was similar to the Maintained Grassland habitat in that ground cover was predominately bermudagrass or St. Augustine. This habitat was observed to have significantly greater vertical structure than the Maintained Grassland habitat. The habitat canopy layer was dominated by oaks (*Quercus* sp.), pecan (*Carya illinoensis*), crape myrtle (*Lagerstroemia indica*), redbud (*Cercis canadensis*), and desert willow (*Chilopsis linearis*). Shrubs included privet (*Ligustrum* sp.), Texas sage (*Leucophyllum frutescens*), yaupon holly (*Ilex vomitoria*), bamboo (*Bambuseae* sp.), and other landscaping species. Please refer to **Photograph 11**.

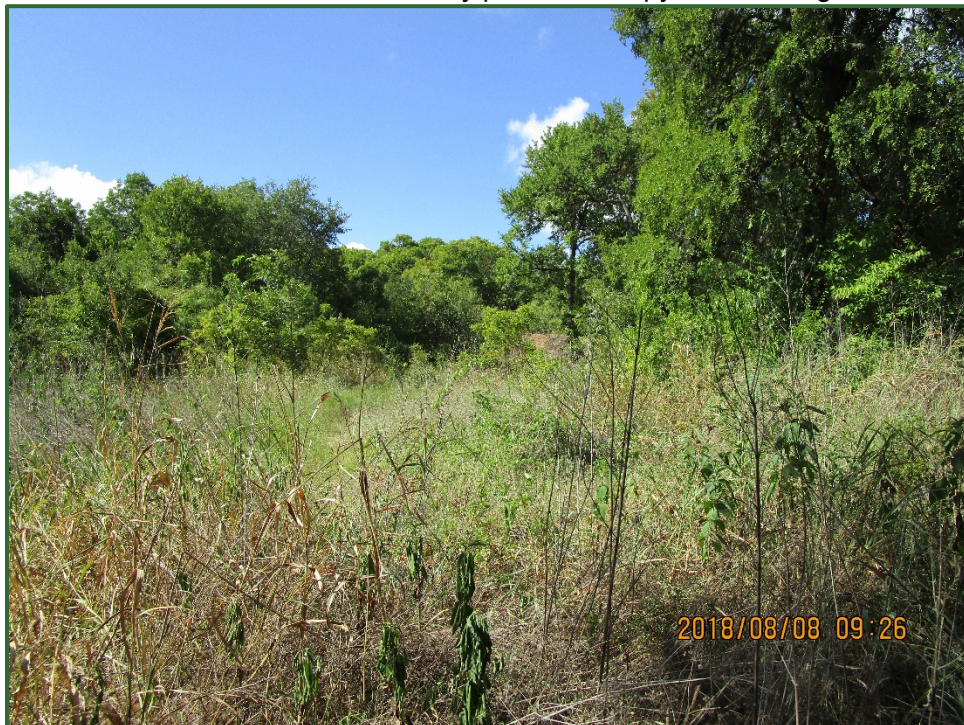
Photograph 12: A sunny break within the Upland Woods Habitat. Ragweed dominates the groundcover in this view; live oaks and hackberry provide canopy in the background.

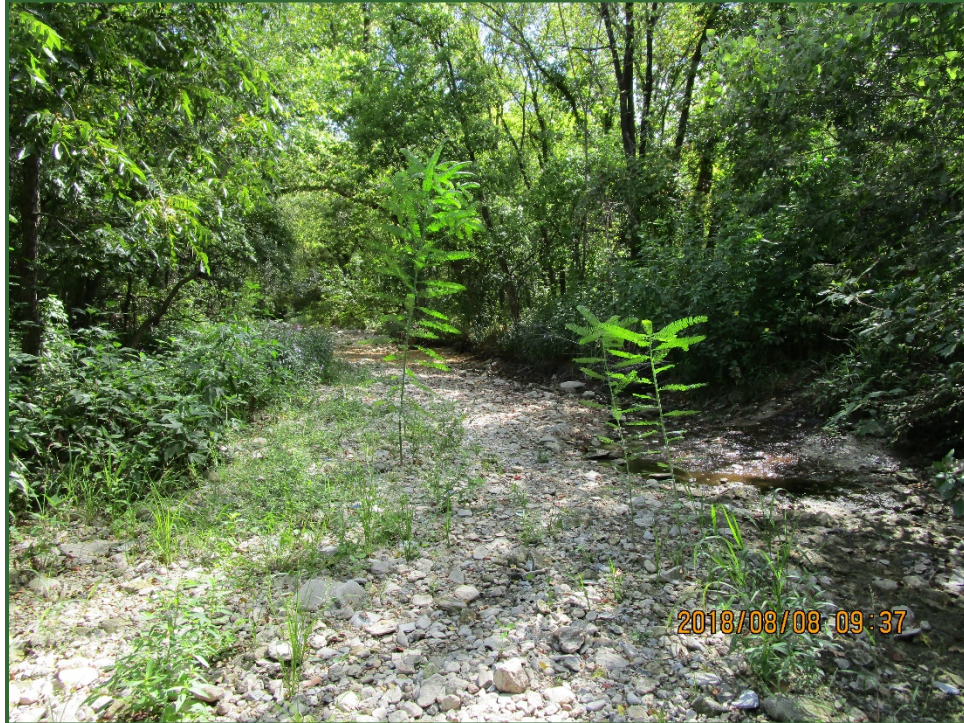
Photograph 13: Example of Wooded Riparian Habitat along West Bouldin Creek. Rattlebox and dayflower are growing within the gravel creek bed.

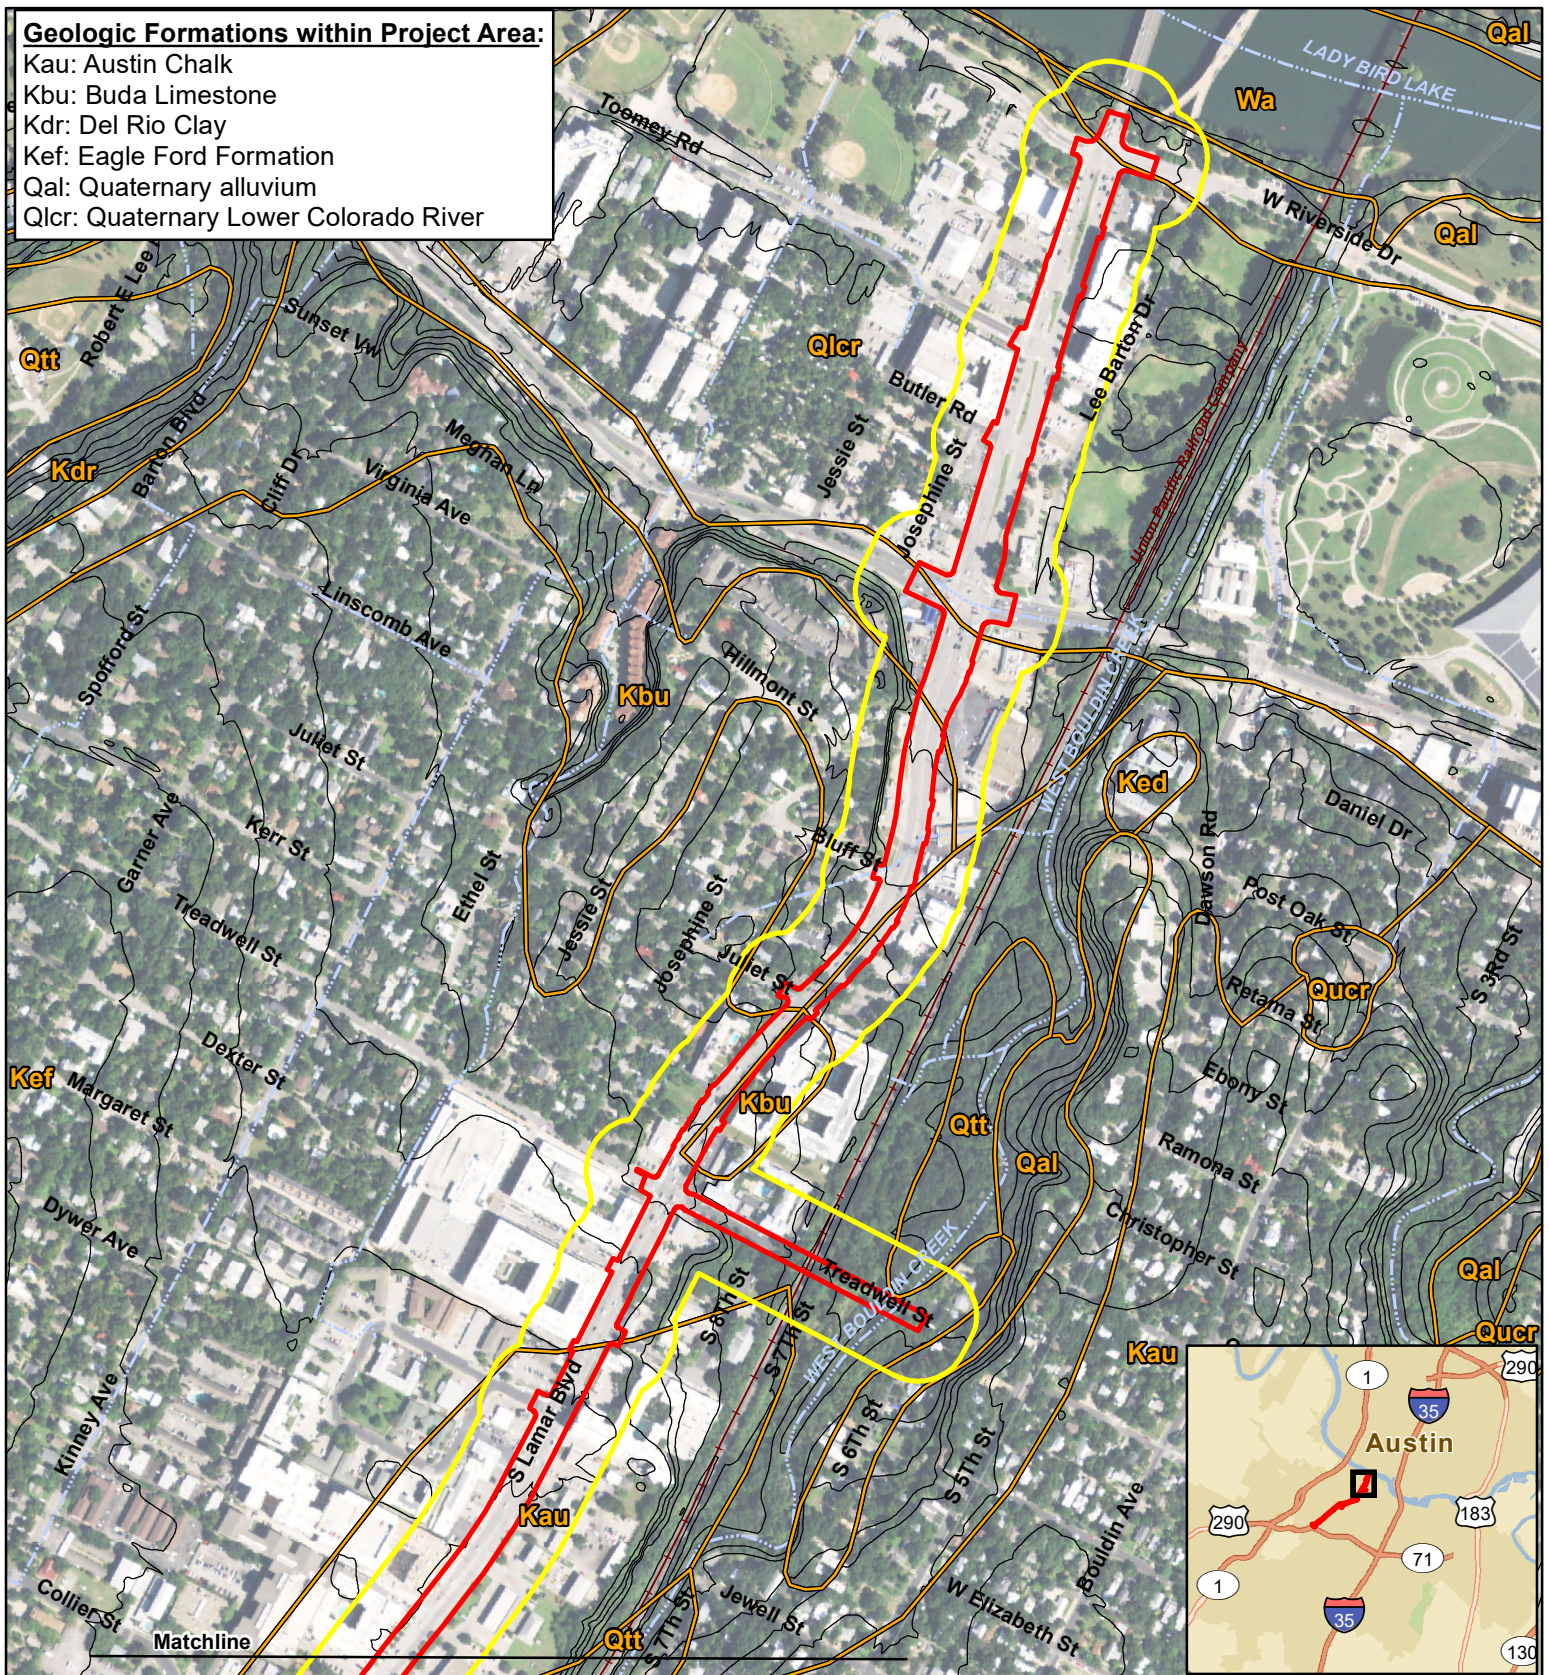
Qal: Quaternary alluvium

Qlcr: Quaternary Lower Colorado River

- COA Elevation Contour (10-ft)
- COA Creeks
- Geologic Formation Boundary (BEG 2018)
- Project Area
- Assessment Area (150-ft)

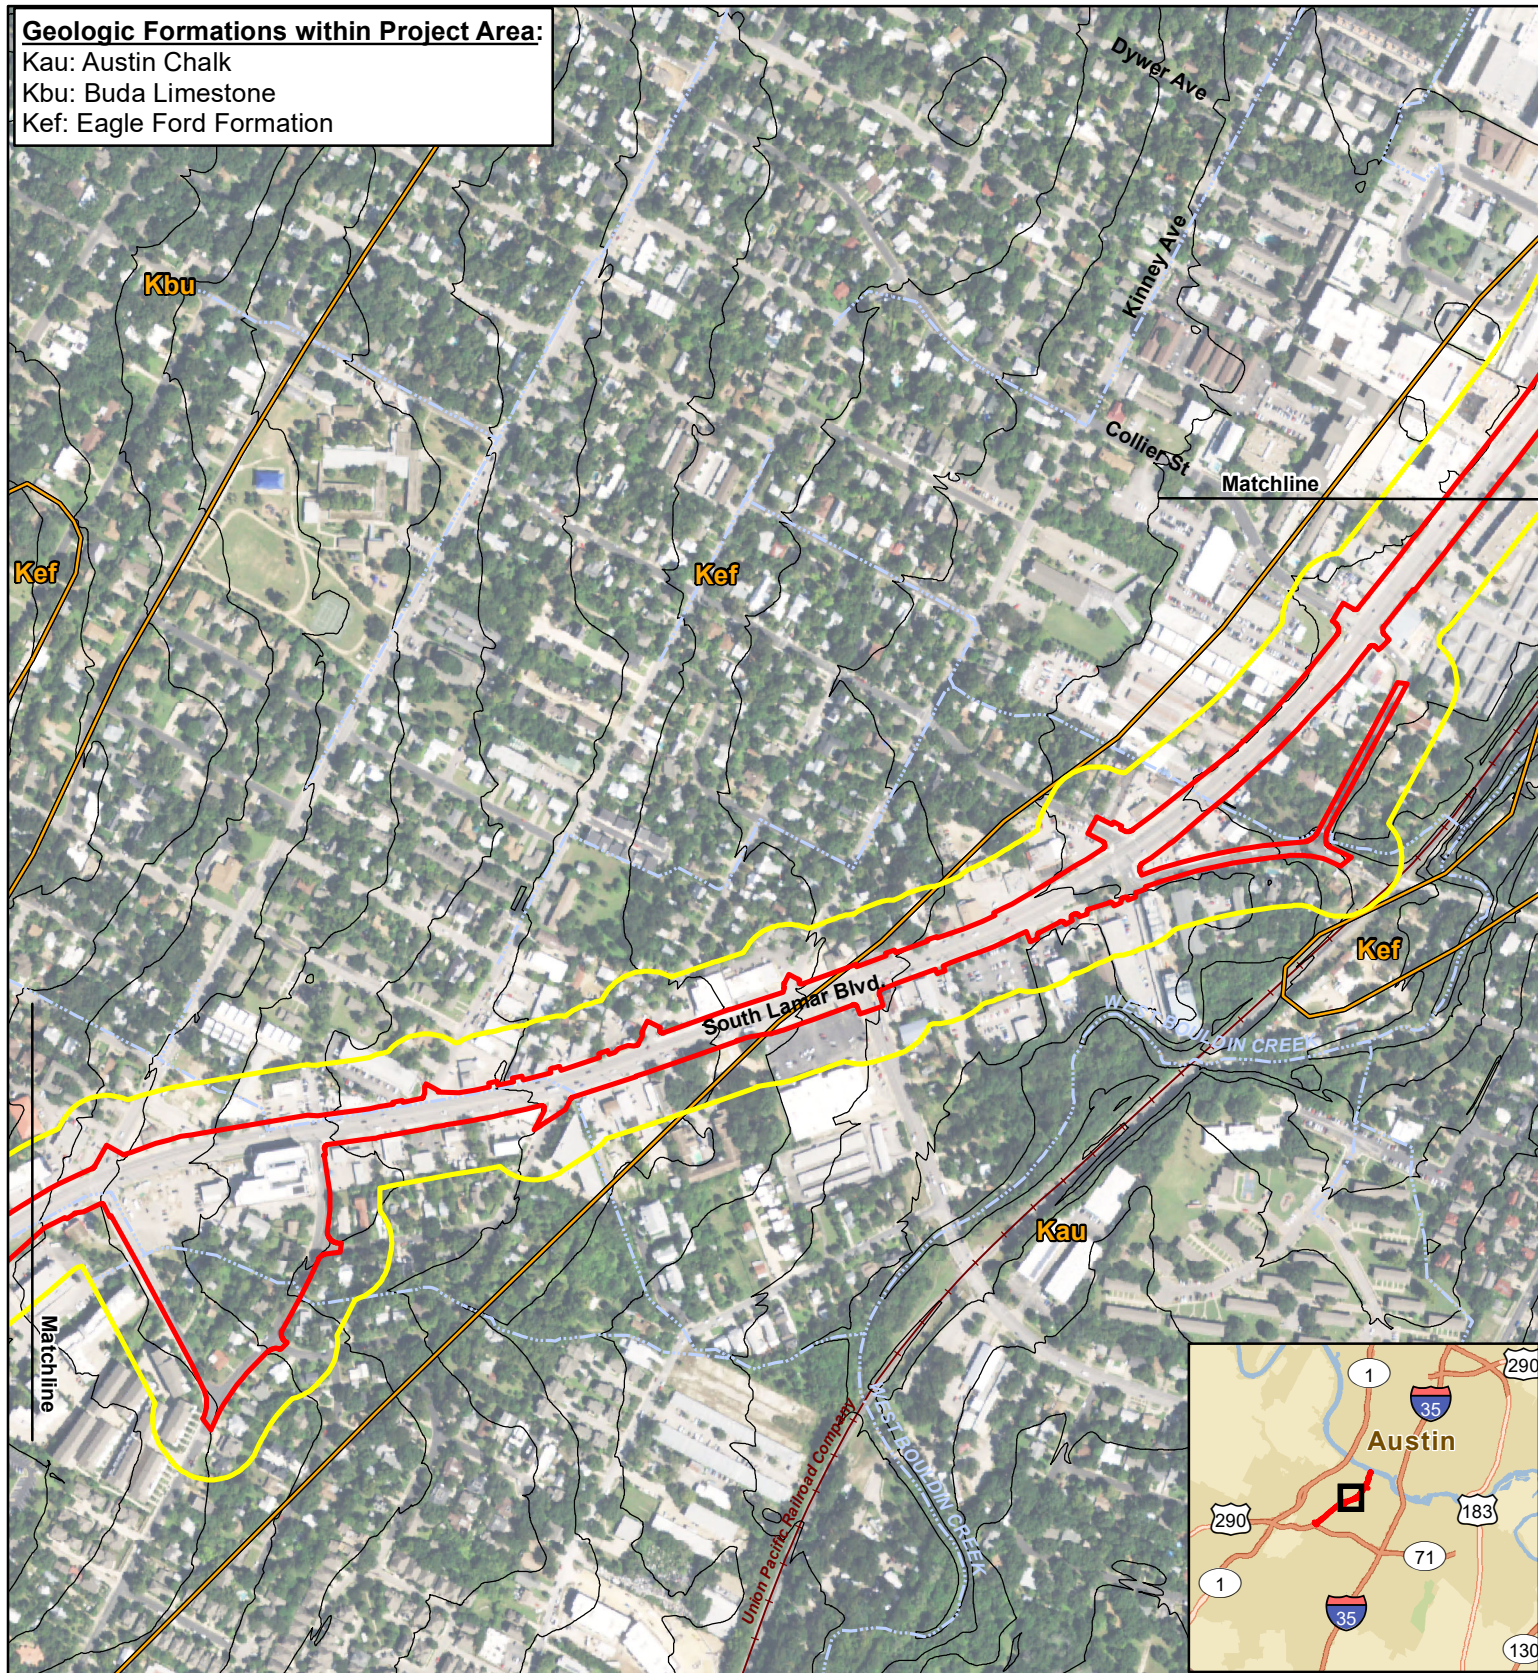
Kbu: Buda Limestone

Kef: Eagle Ford Formation

- COA Elevation Contour (10-ft)
- COA Creeks
- Geologic Formation Boundary (BEG 2018)
- Project Area
- Assessment Area (150-ft)
