LANDFILLS IN THE VICINITY OF AUSTIN, TEXAS

**THE CITY OF AUSTIN
Austin, Texas**

Underground Resource Management, Inc.
Austin, Texas

November, 1984

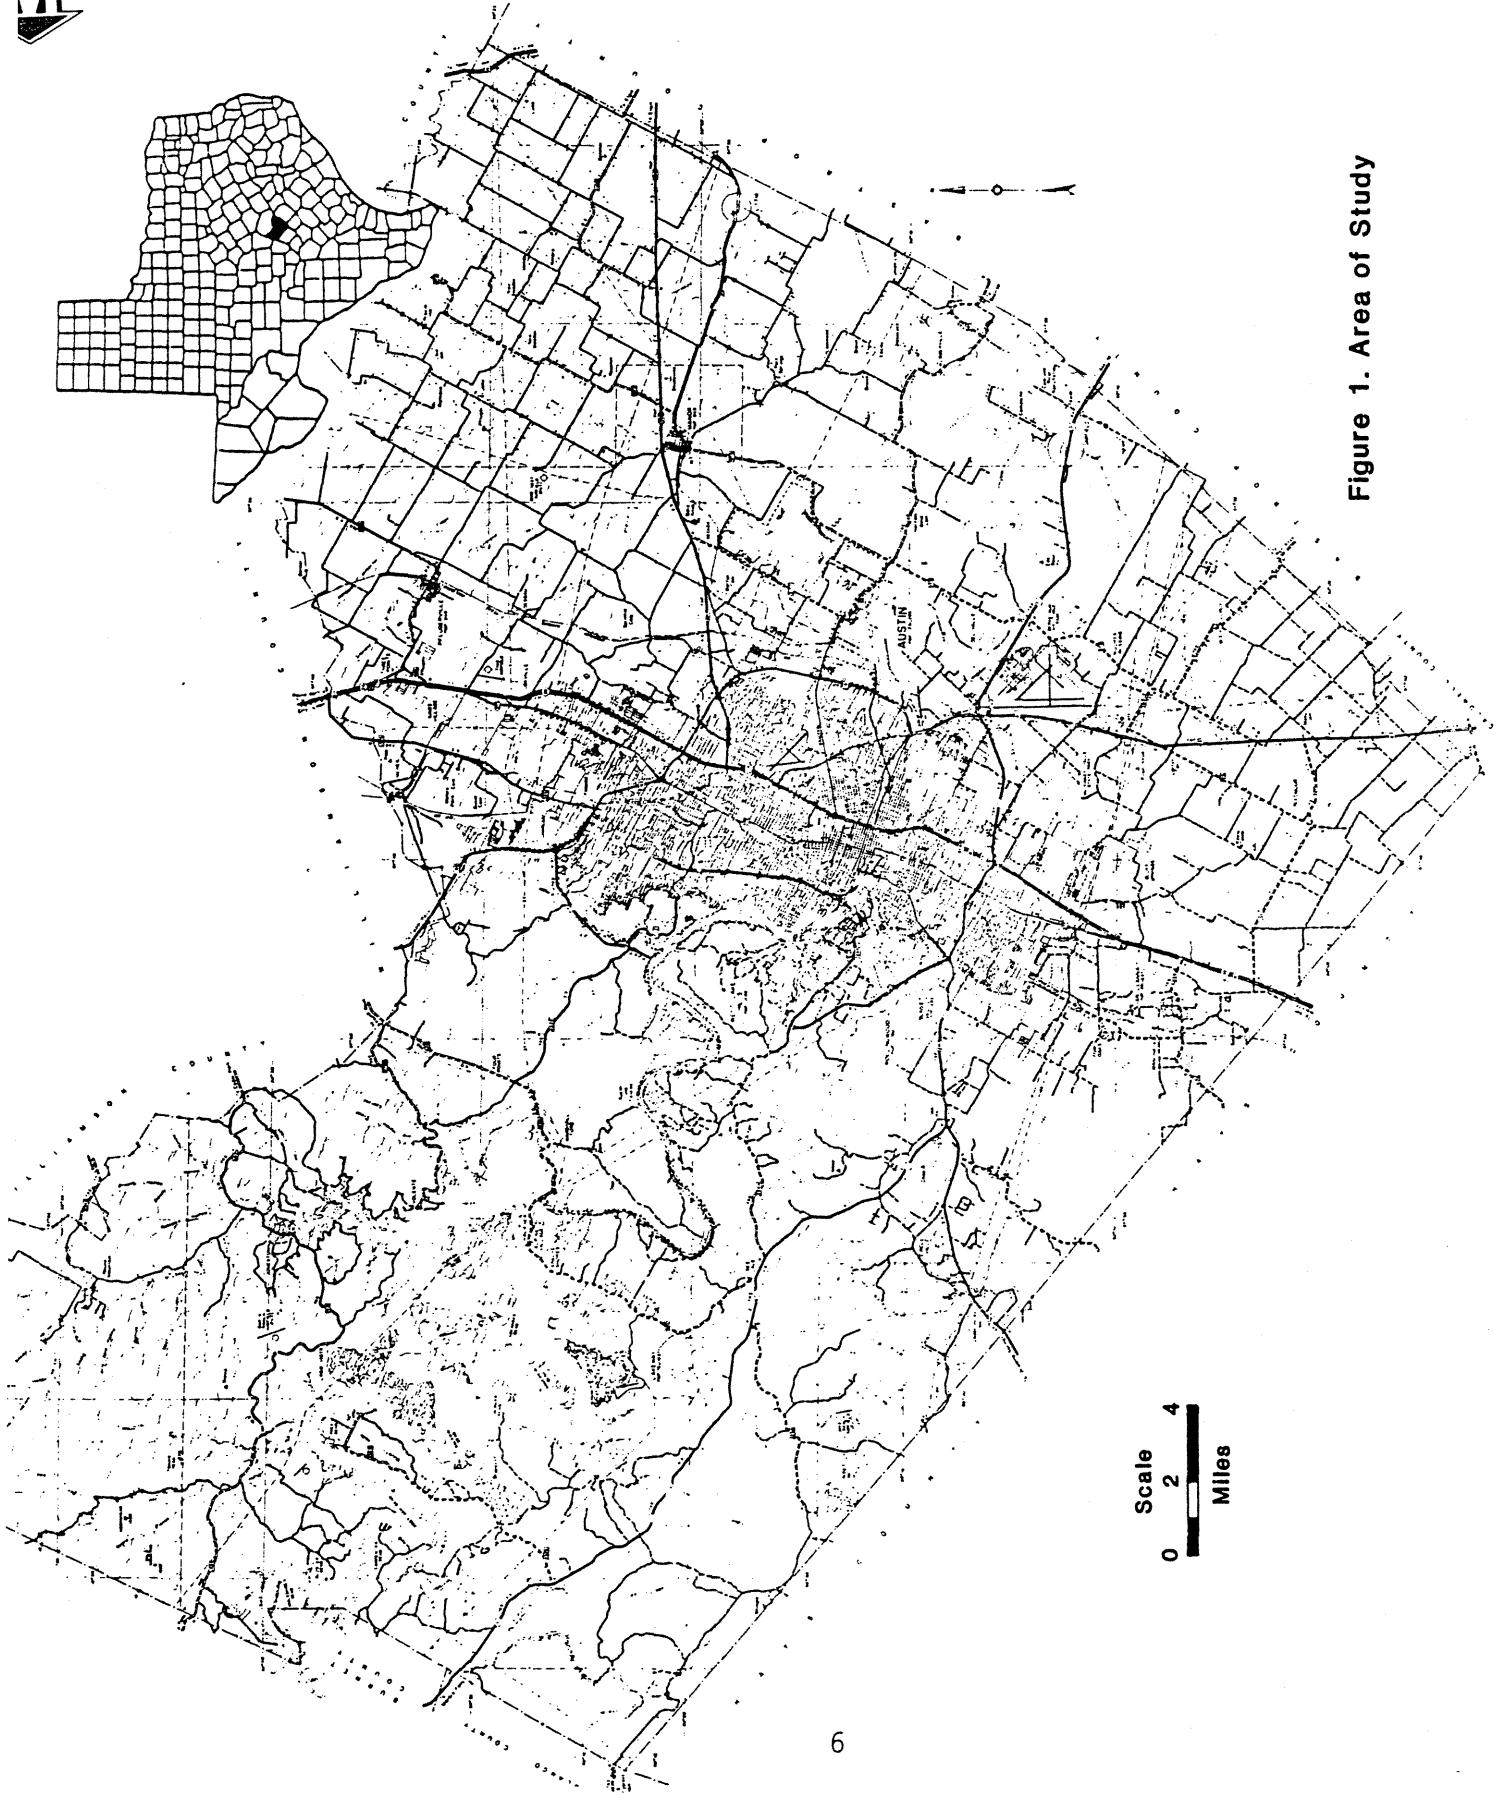
Figure 1. Area of Study

The area of study is shown on Figure 1. This is the second report presented to the City of Austin by URM for the Austin Closed Landfill Study. The first report was "Site-Specific Recommendations for the City of Austin Closed Sanitary Landfill Study", presented in January, 1984. In the first report, preliminary background information was presented, and recommendations were made for monitor well installations and sampling at Mabel Davis Park, Winn-Cook Park, the Butler Landfill in Zilker Park, and the Sprinkle Site. A recommendation was also made to sample leachate discharges to Little Walnut Creek from the Brinkley-Anderson landfill site.

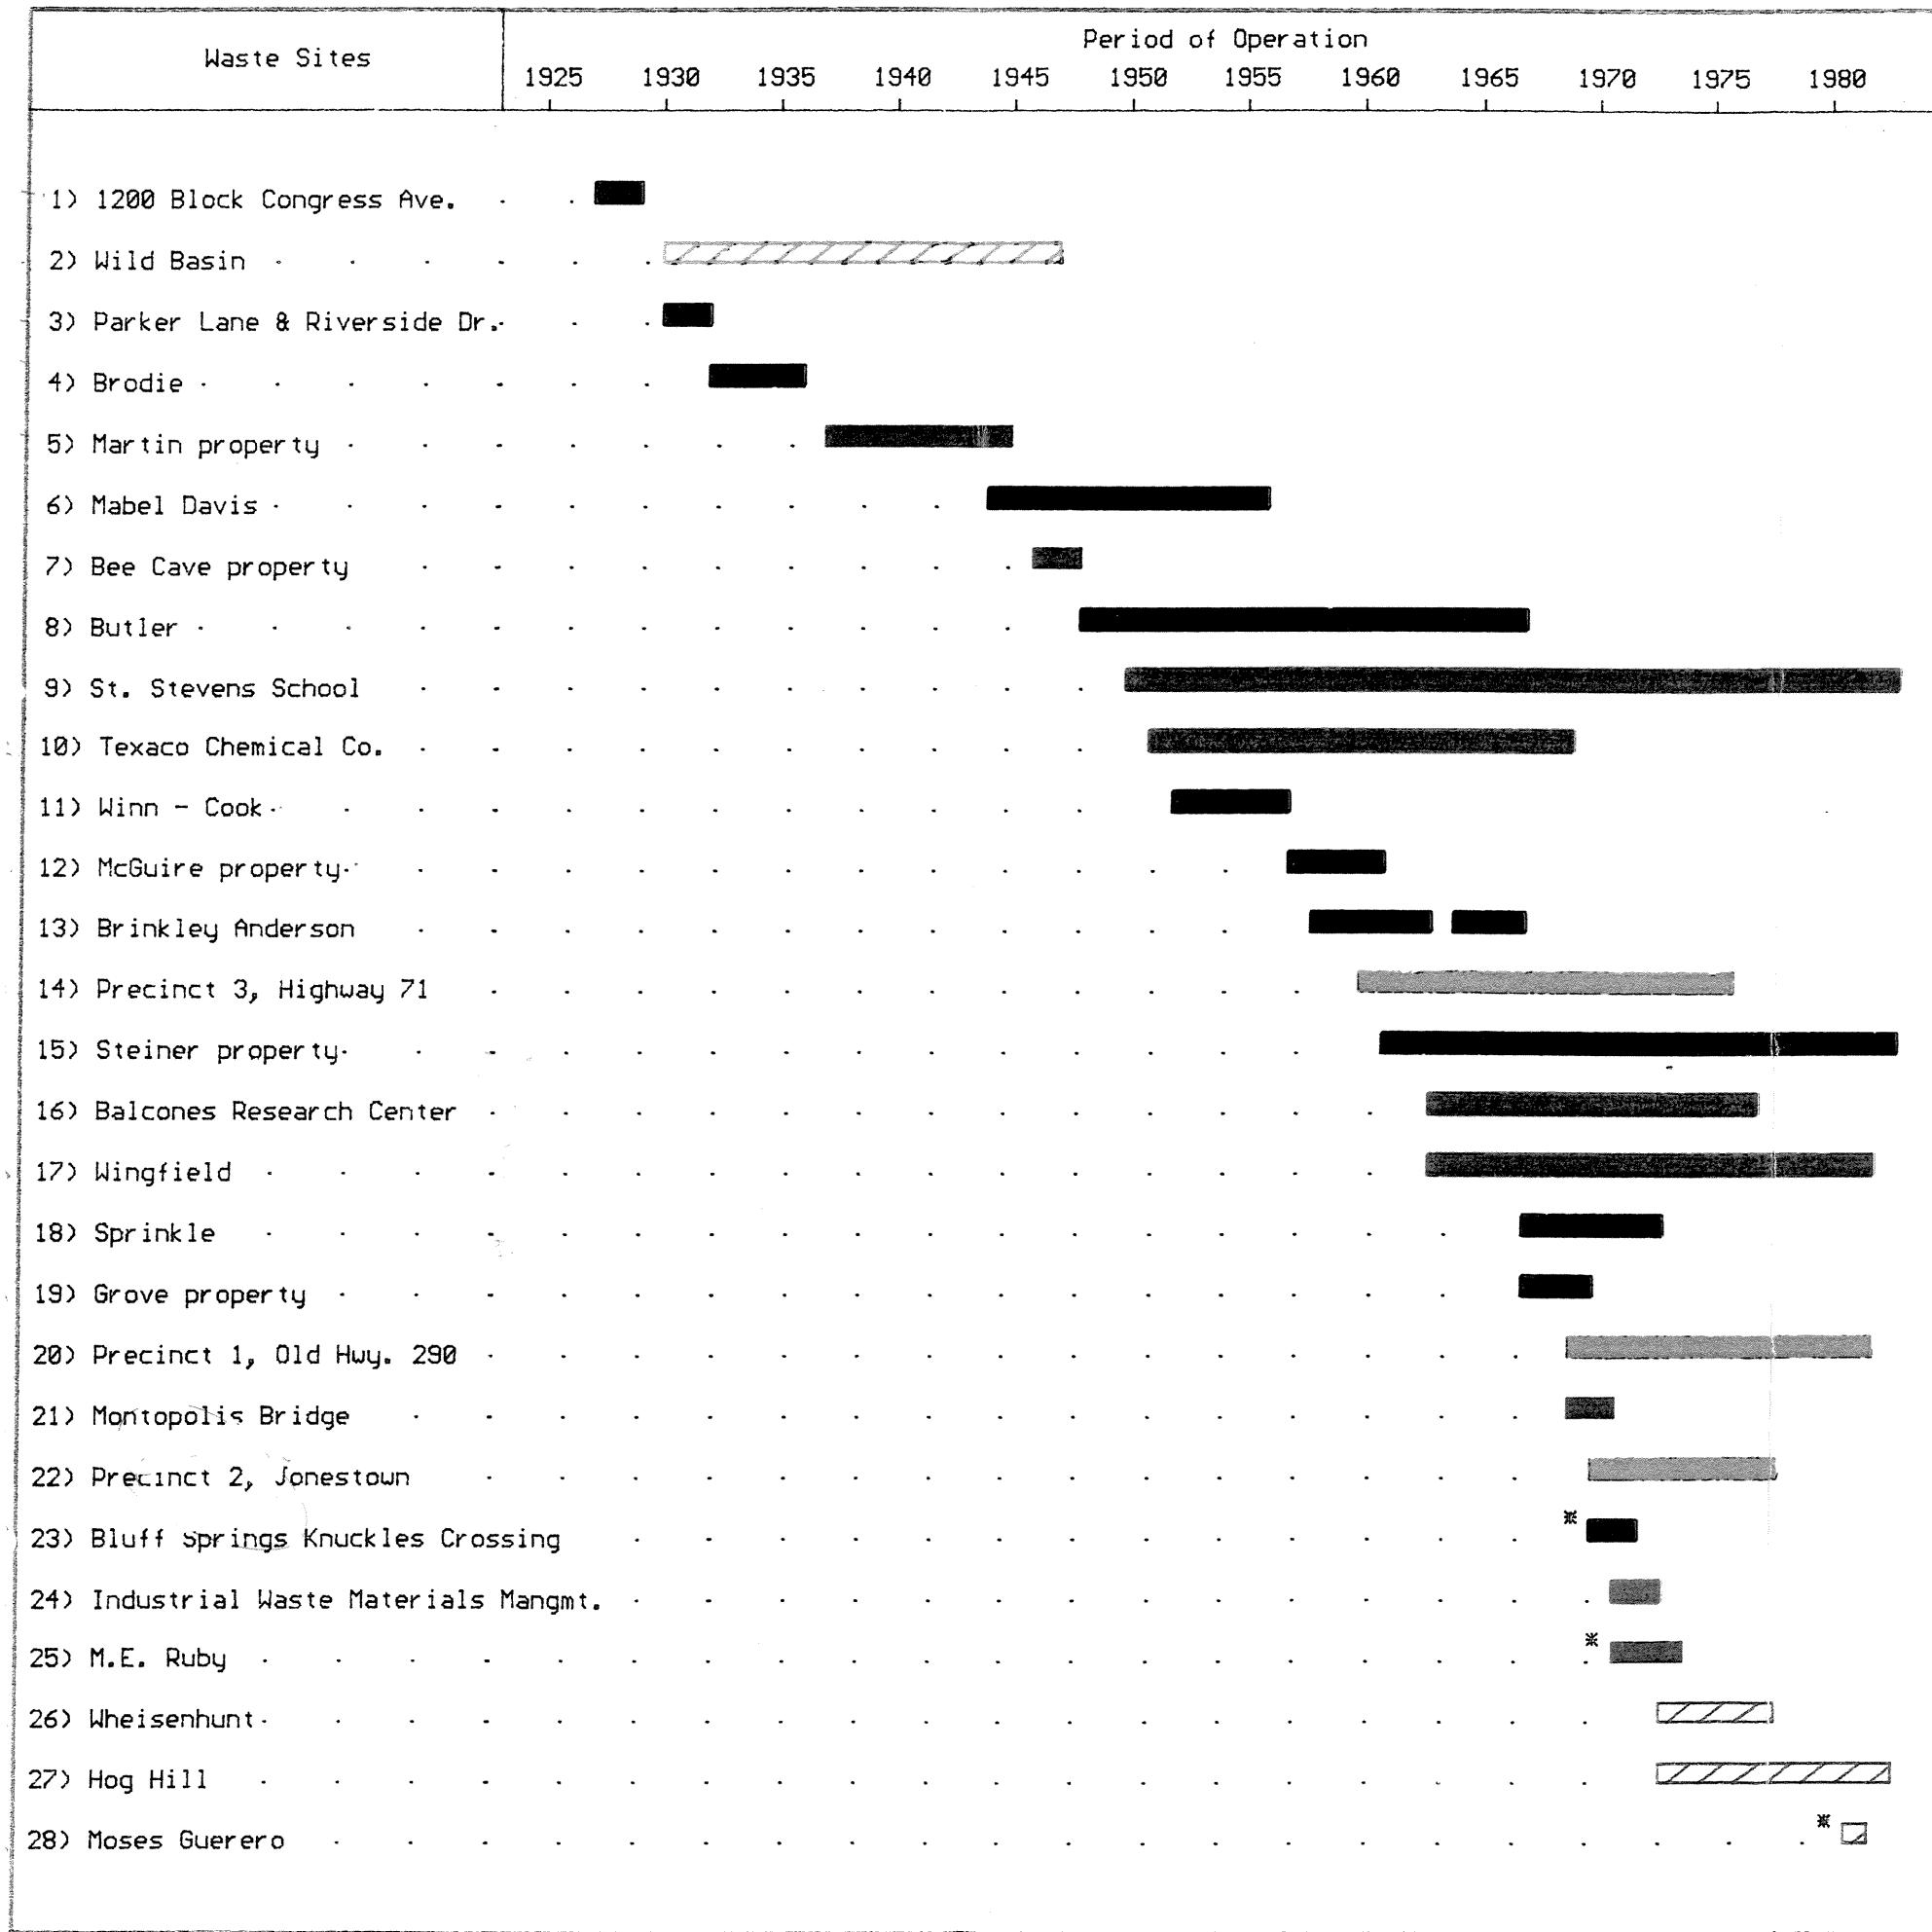
Figure 2: Chronology
of waste sites in
and around Austin.

A chronology of the waste sites in and around Austin for which operating dates are known is shown in Figure 2. The oldest dump site identified in this project operated in the 1200 block of South Congress Avenue from 1927 to 1929. At that time, only small amounts of trash were generated by city residents because garbage was often fed to hogs, and household trash was generally burned. When the City did begin organized trash collection, the volume collected was small and the service was not billed directly to the user. Funds came from general

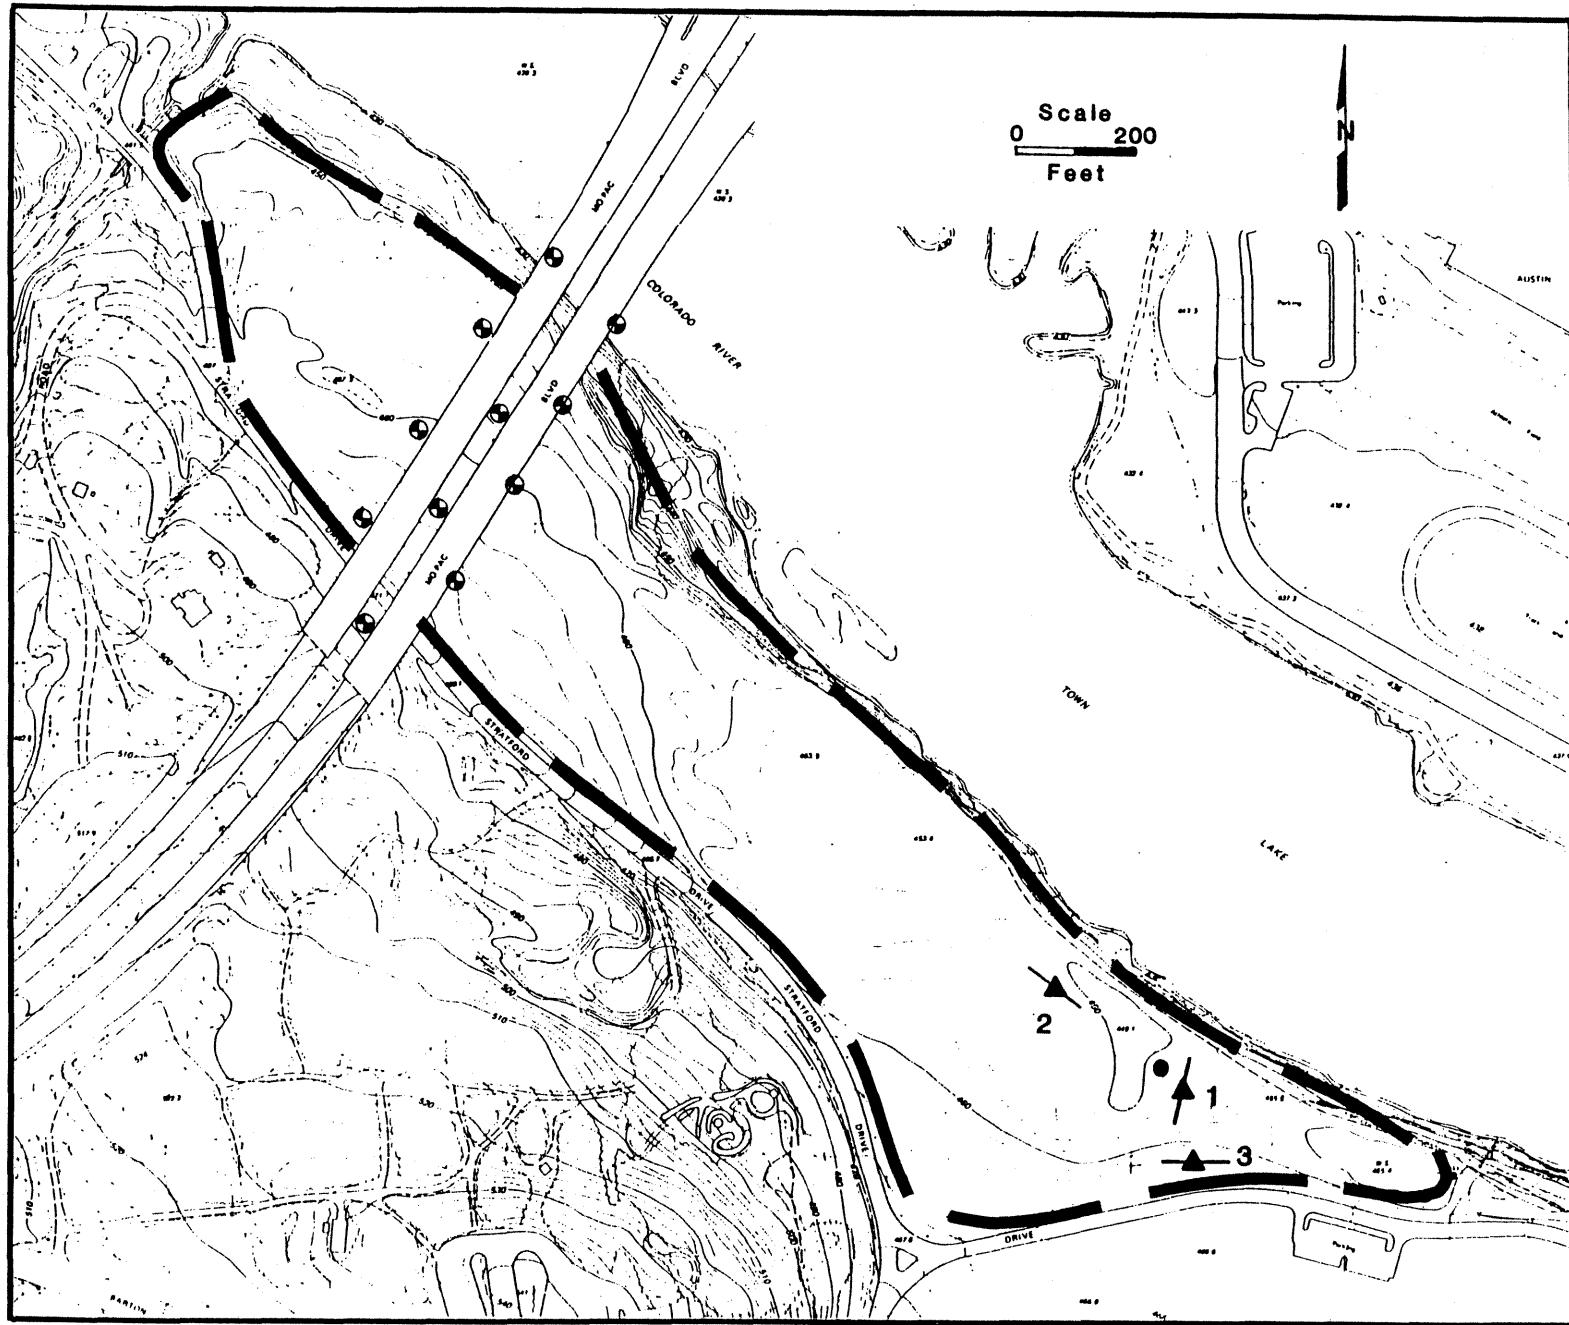
The well at Zilker Park is completed in fill material, and is located near the southeast end of the landfill (Figure 3). It was drilled February 21, 1984. During drilling, old rags, paper, plastic, and a light bulb were brought up with the cuttings, so it is fairly certain that the well is located on fill material. The bottom of the fill was at 19 feet. Sand and gravel were penetrated from 19 feet to the total depth of 26 feet. The Edwards Limestone underlies the landfill, but was not reached, although it is probably within a few feet of the total depth. During drilling, as the borehole was advanced, water was encountered at a depth of about 9 feet. Below that depth, the fill material became a spongy, muddy slurry created by the mixing action of

● Approximate Locations of Texas Highway Department Soil Borings

— Approximate Fill Boundary

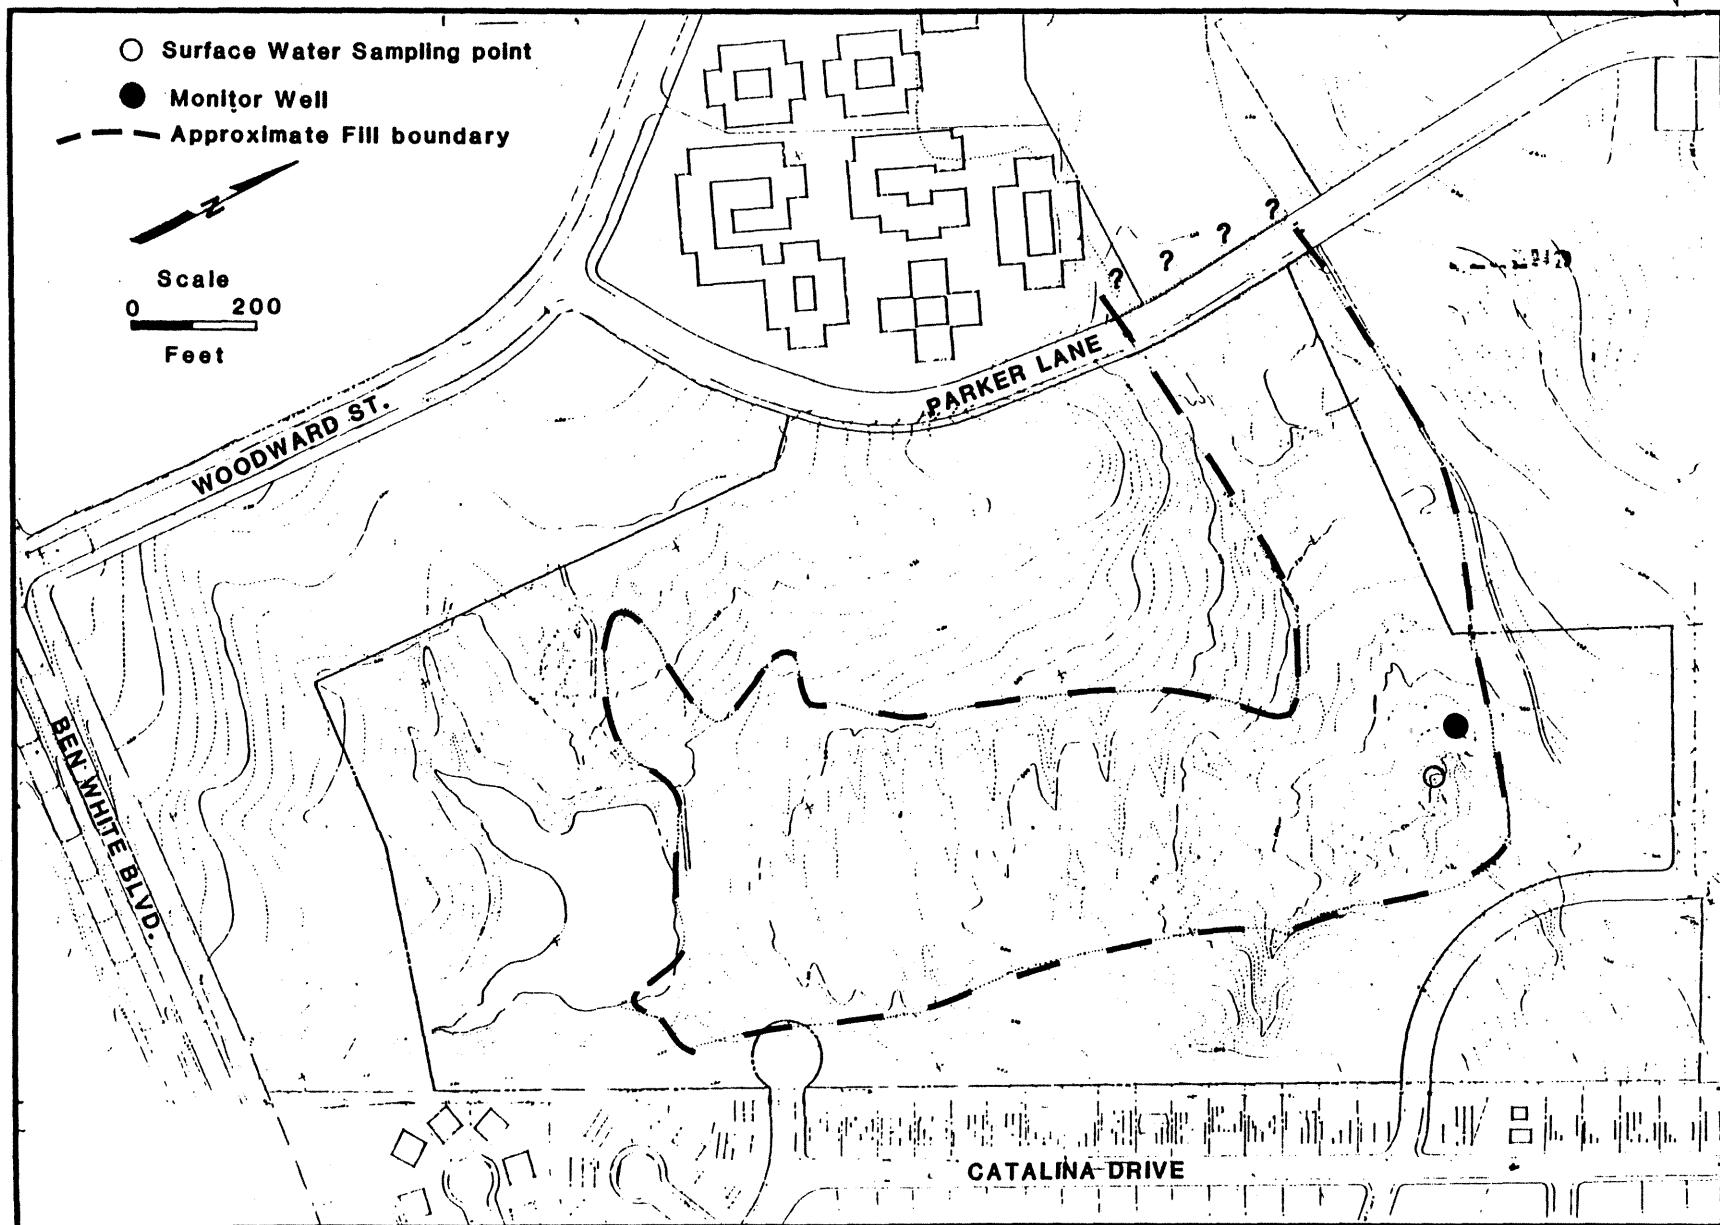
Figure 4. Mable Davis Monitor Well and Surface Water Sampling Locations.

At Mabel Davis Park, fill material is located in two converging valleys. The valleys are drained by perennial streams which have average flows of 5 to 10 gpm. The streams cross the surface of the fill material and join below the filled areas. The well at Mabel Davis is located on fill material near the toe of the northwest waste body (Figure 4). At the well, fill material extends from the surface to a depth of 10 feet. Underlying the fill is the Taylor Clay, which is a shaley, yellow-gray, fossiliferous clay. The hole was advanced through the fill and an additional 5 feet into the clay to a total depth of 15 feet. Well construction is similar to that described for the Zilker Park well. The well screen is set from 5 to 15 feet below the land surface. Static water level is 5.7 feet below the land surface. Well construction is

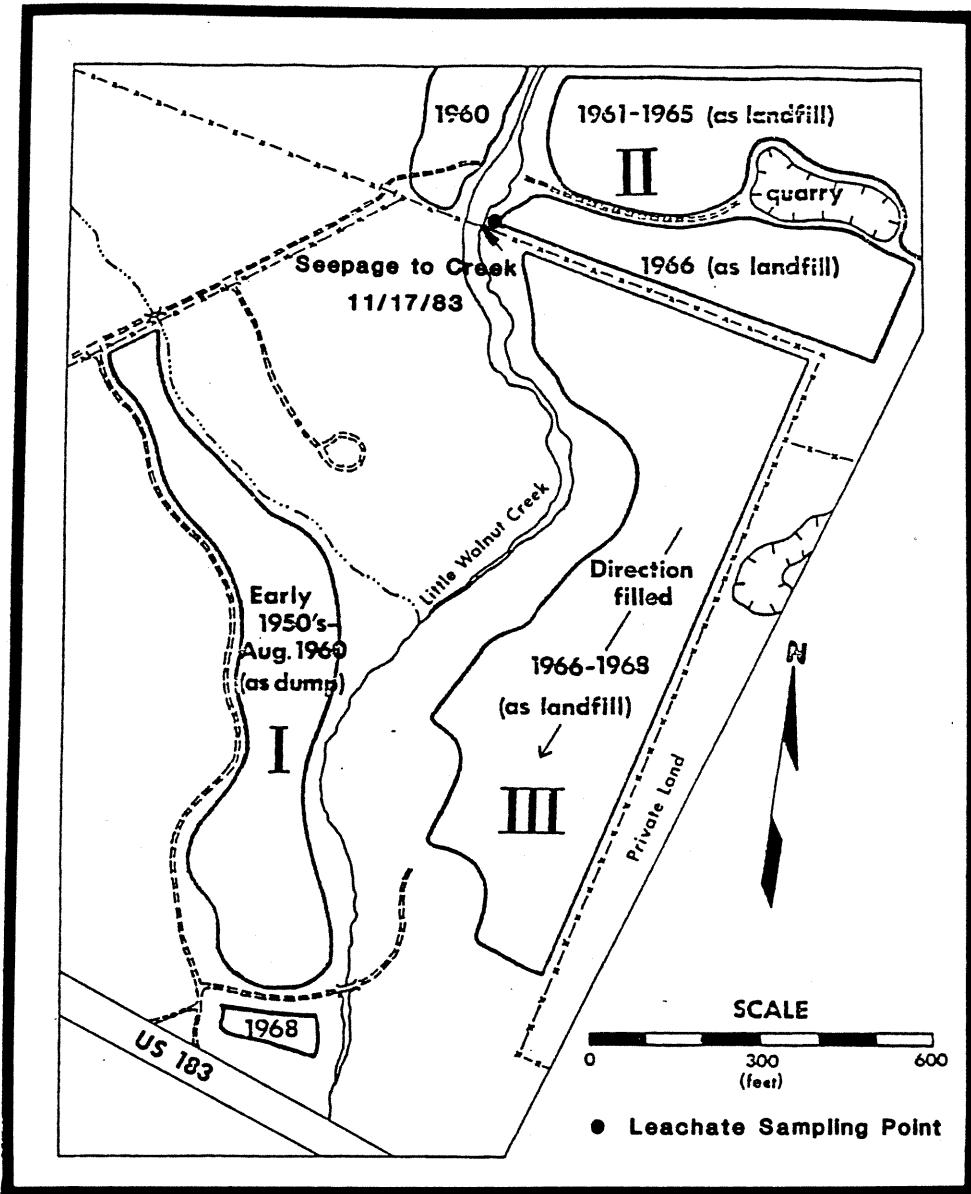
Figure 5. Location of Leachate Sampling Point, Brinkley-Anderson

A seep sample was collected on June 1, 1984 after a period of several weeks without rain, near the east bank of Little Walnut Creek. The sample was taken at a point about 1,700 feet upstream of the Rt. 183 bridge (straight-line distance). The seep drains a part of the landfill that was used between 1961 and 1965. The seep issues from the bottom of the refuse material at the contact with the underlying bedrock. At the time of the sampling, the discharge of the seep was much less than a gallon per minute. The leachate was collected from a small pool located about 10 feet away from the creek. Flow was not entering the creek because it was evaporating as it crossed the bedrock ledge separating the pool from the creek. The water in the pool was brown colored and had a slight odor.

Seeps were observed entering the creek from the opposite (west) bank about 50 feet downstream of where the east bank seep sample was collected. They were flowing approximately 1 gallon per minute and were draining material that was emplaced in 1960. The seeps were clear, but dense orange, filamentous algae was observed at the point of discharge,

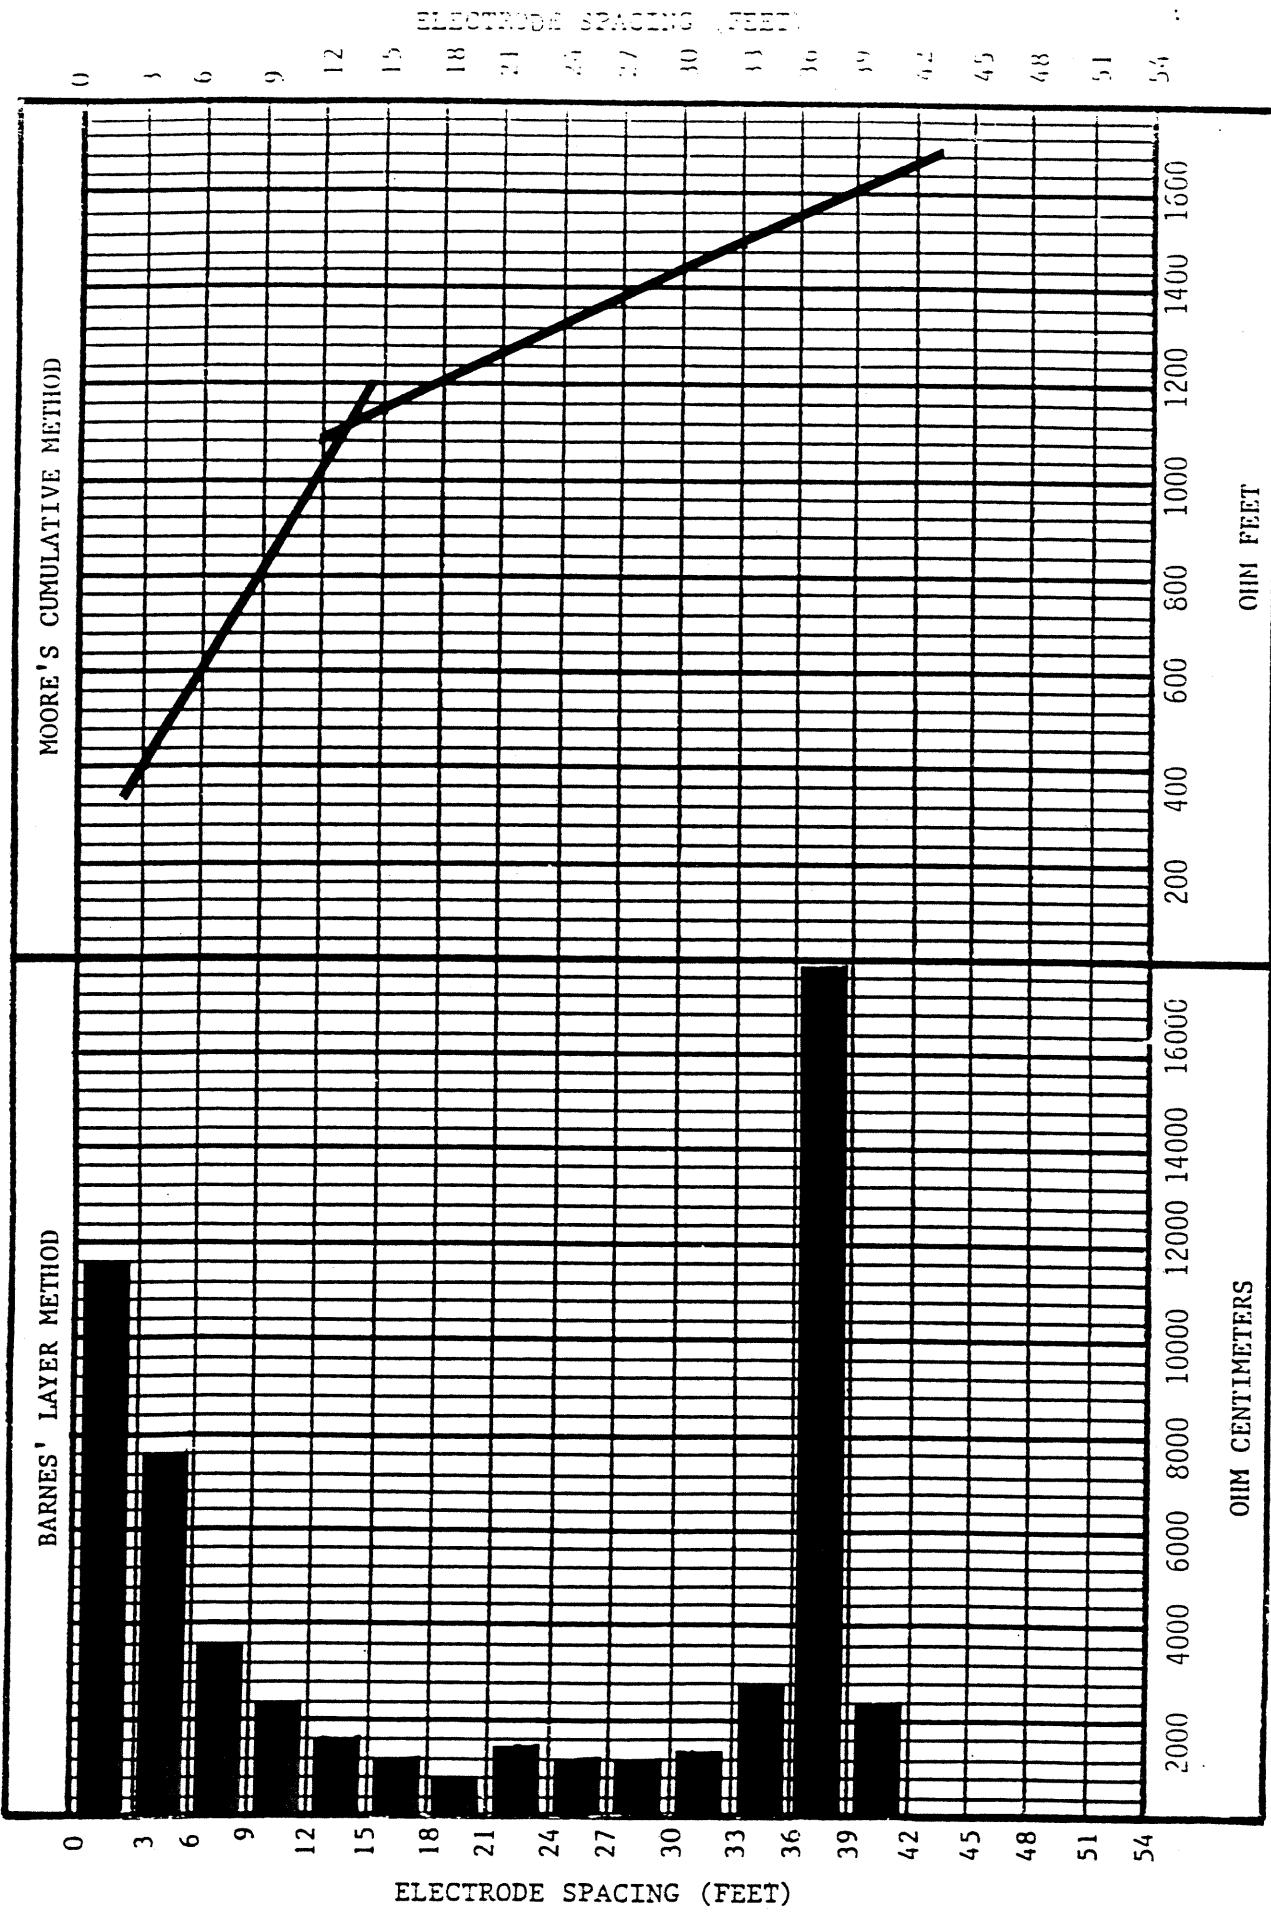
SOUNDING NO. 1

Graph For Resistivity Sounding

BARNES' LAYER METHOD

MOORE'S CUMULATIVE METHOD

slope break at an electrode spacing of about 12 feet, and probably indicates the top of the saturated zone. The Barnes' plot shows a zone of low resistivity extending from an electrode spacing 12 to 30 feet, and this may correspond to the layer of saturated fill material. That interpretation does not totally agree with what was found at the nearby monitor well, where drilling samples indicated the bottom of the fill to be at about 19 feet below land surface. Beyond an electrode spacing of 33 feet, the Barne's plot indicates a zone of high resistivity which may correspond to the top of the underlying Edwards Limestone.

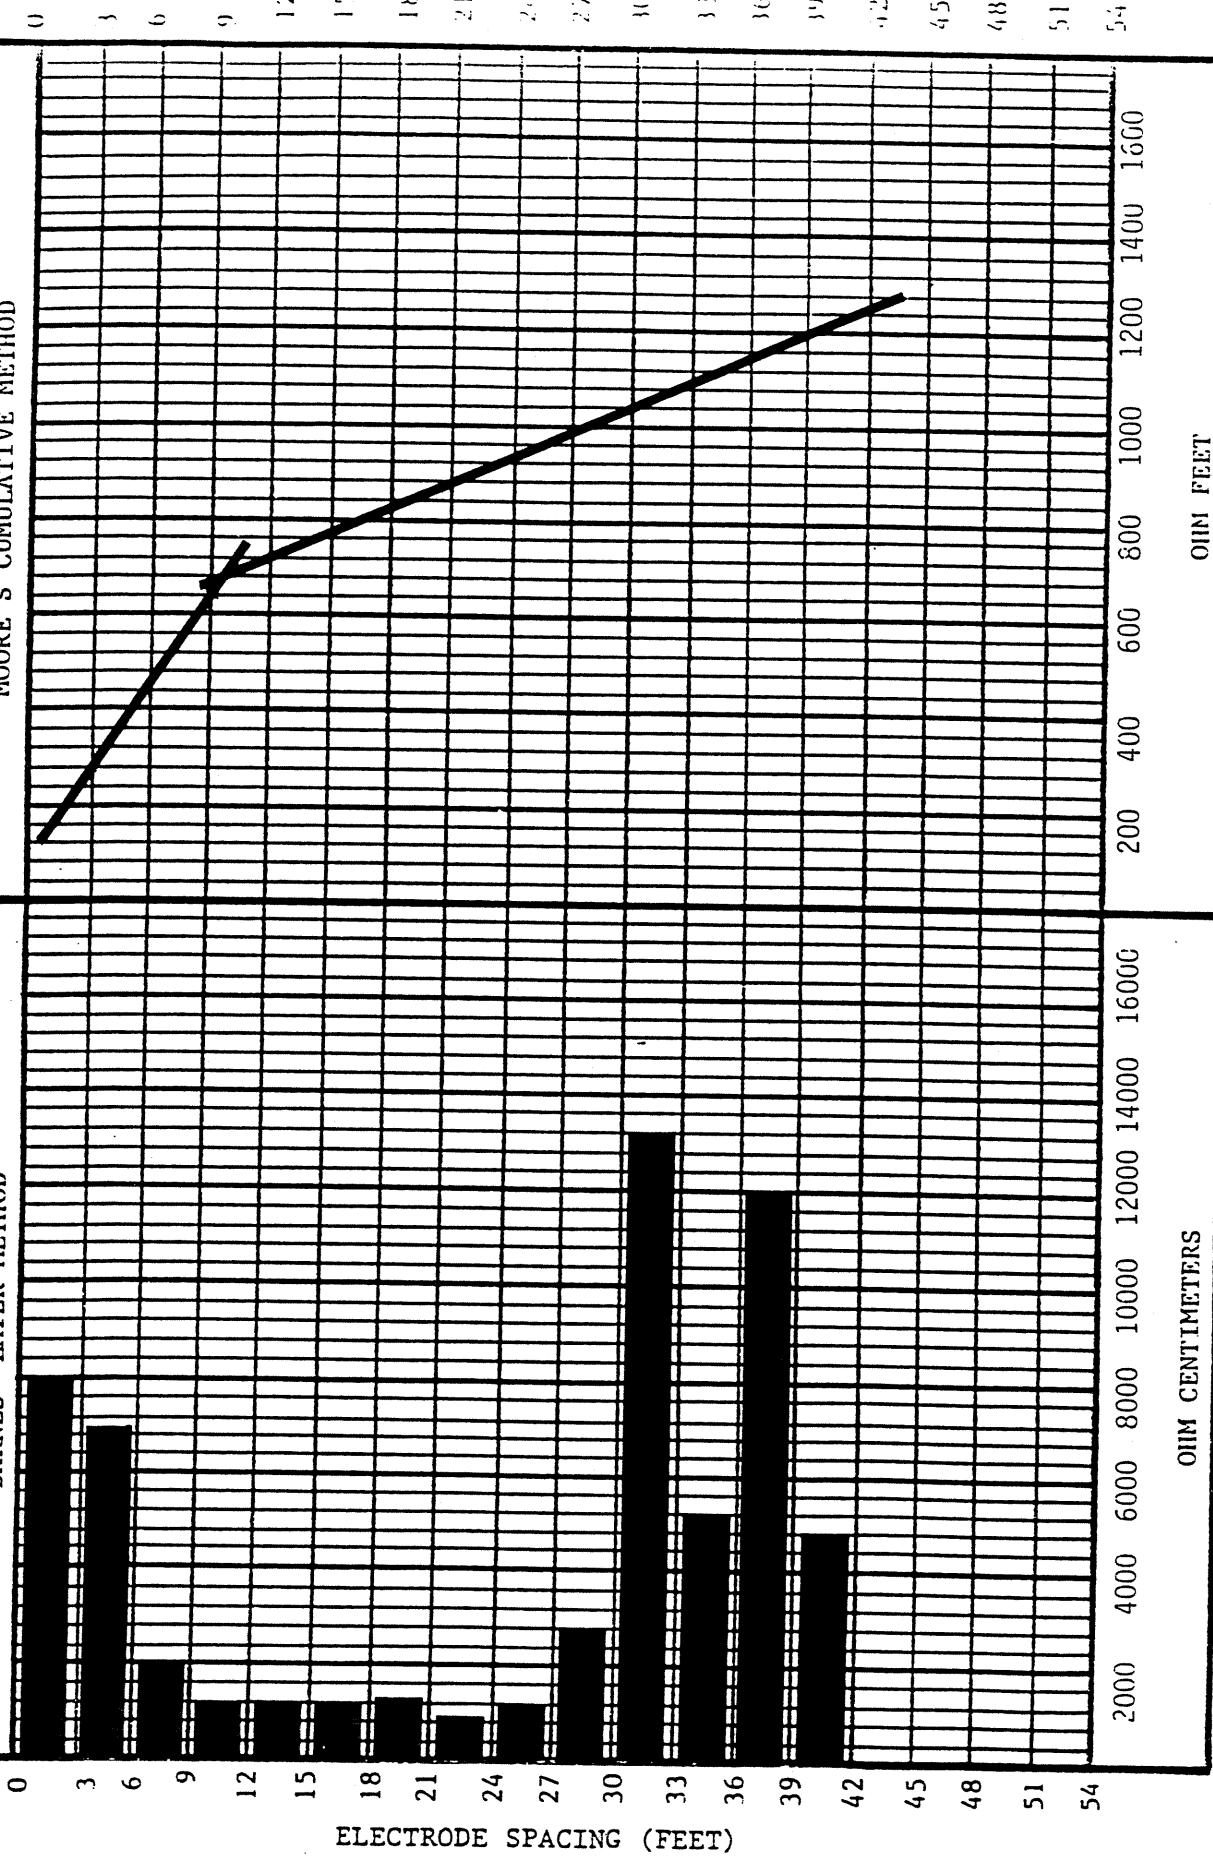
OUNDING NO. 2

Graph For Resistivity Soundings
