# Hydrogeological Study of Airmen’s Cave, Travis County, Texas

Balcones Canyonland Preserve Investigative Report IP 202103

Nico Hauwert, Ph.D. Professional Geoscientist 5171  
Program Manager Austin Water Balcones Canyonland Preserve  
December 16, 2021

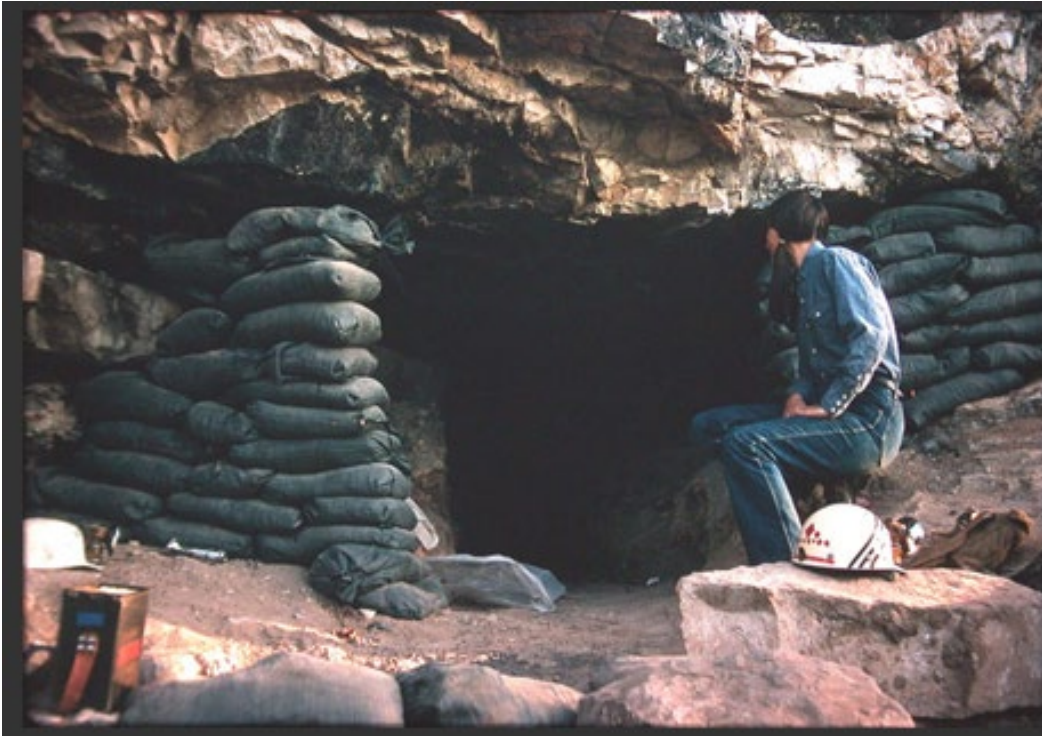
**Figure 2.** Mark Sanders entering entrance squeeze into Airmen's Cave, December 29, 1995 (photo credit: Nico Hauwert).

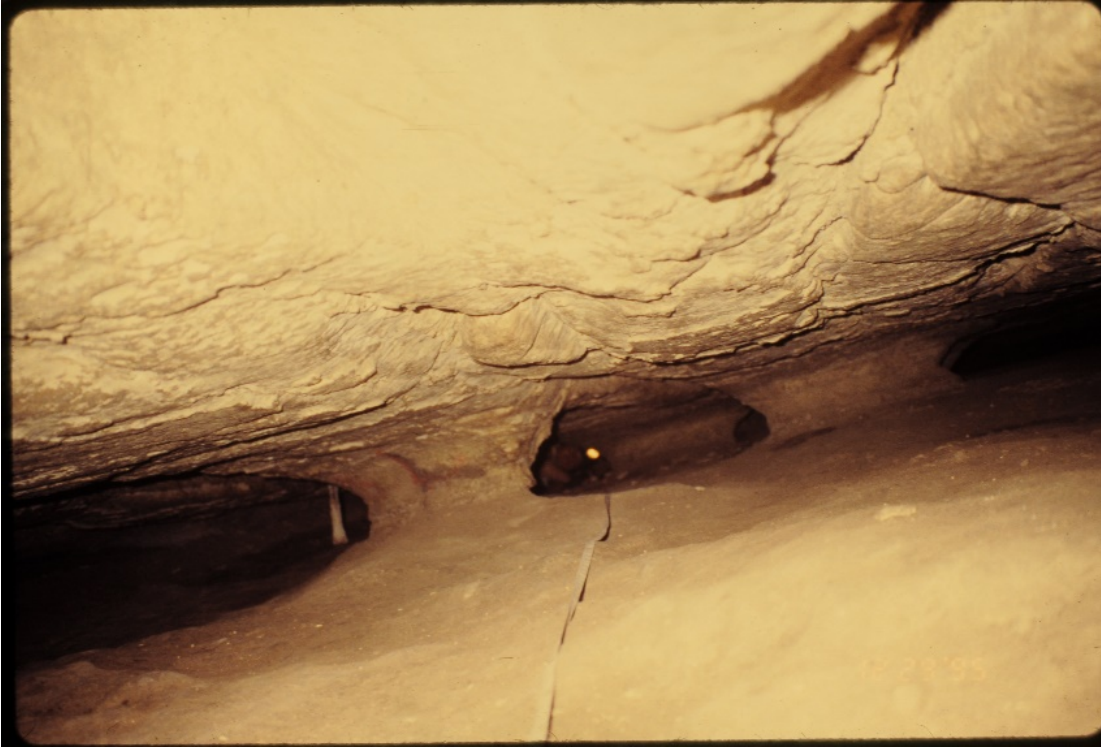
**Figure 4.** Bypass Squeeze, December 29, 1995 (photo credit: Nico Hauwert).

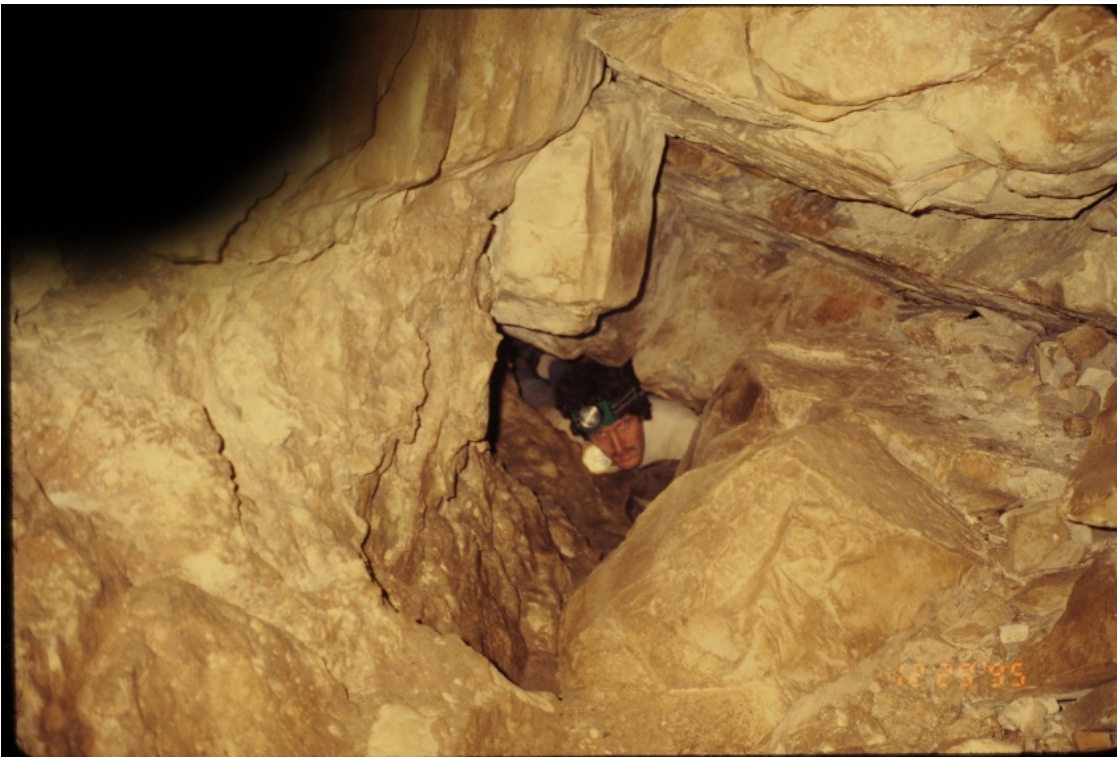
**Figure 5.** Mark Sanders at top of pit leading to Breakdown Room, December 29, 1995 (photo credit: Nico Hauwert).

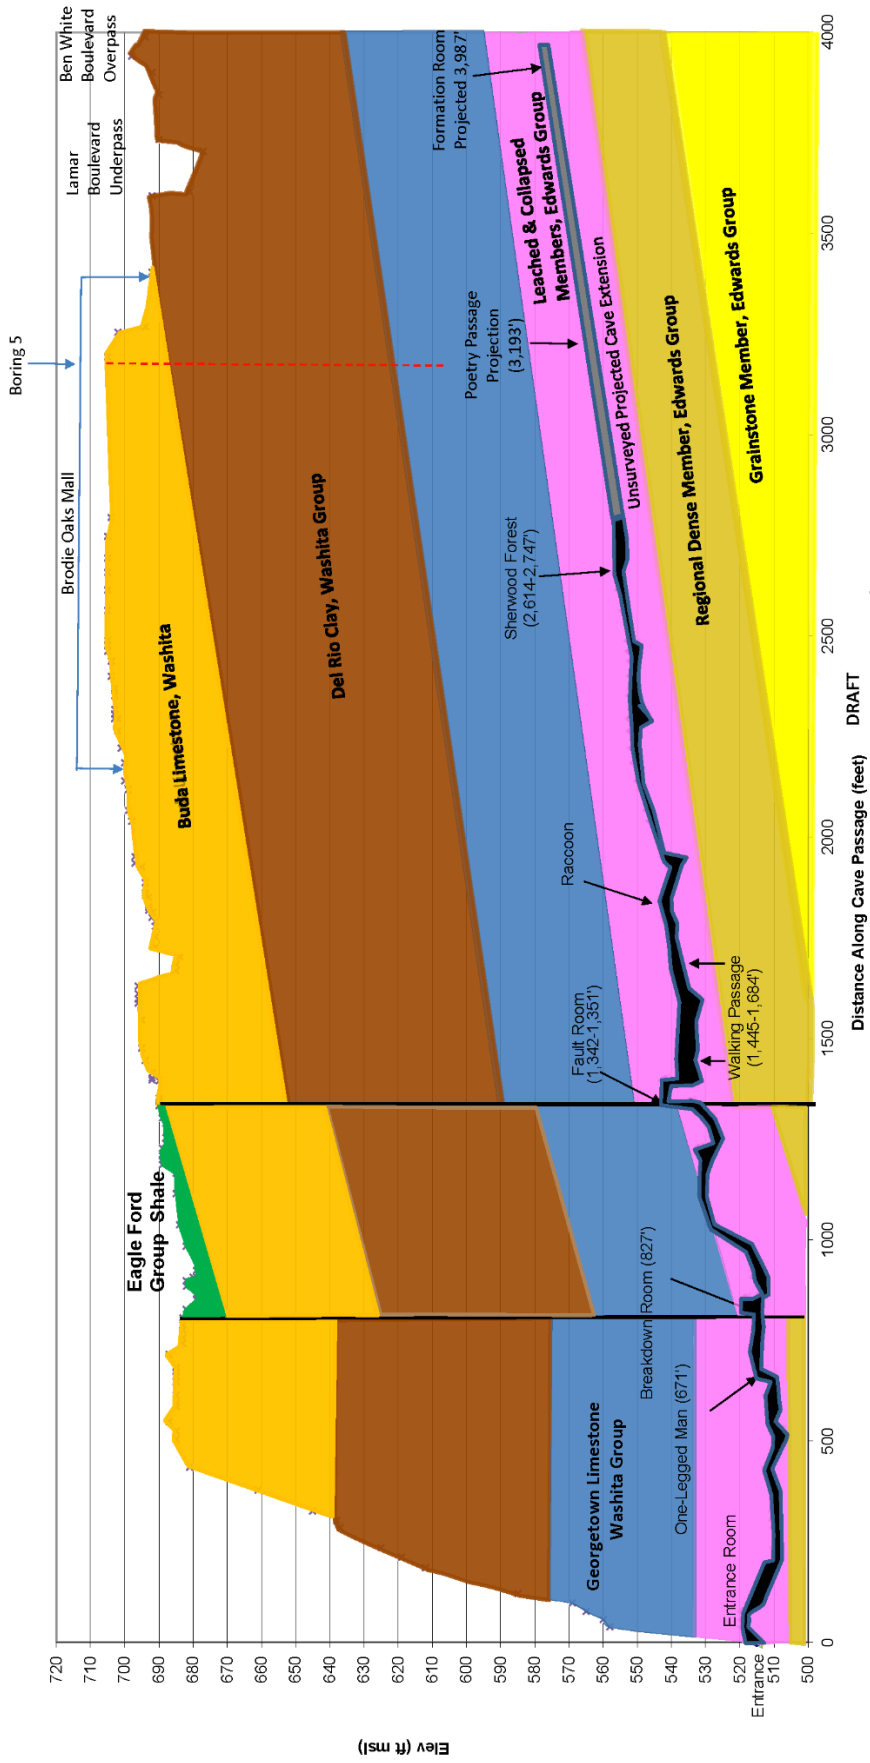
Figure 14. Geological Profile Along Airmen's Cave

DRAFT  
 Nico Hauwert, Ph.D., PG 5171  
 July 19, 2021  
 Based on 1995/1996 survey and projected 1974 cave map beyond Sherwood Forest

The general structure is interpreted to be subparallel scissor faults with a bedding dip to the north. The pronounced stratigraphic dip of more soluble hydrostratigraphic members (Leached and Collapsed Members) of the Edwards Group to the northeast and orientation of geologic faults strongly influenced the localization and dissolution of Airmen's Cave. The cave passages are perched above the Regional Dense Member of the Edwards Group, which is more clay-rich and thin bedded, and unlikely to develop extensive horizontal conduits, but may form pits connecting to underlying conduit systems within the lower Grainstone and Kirschberg Members.

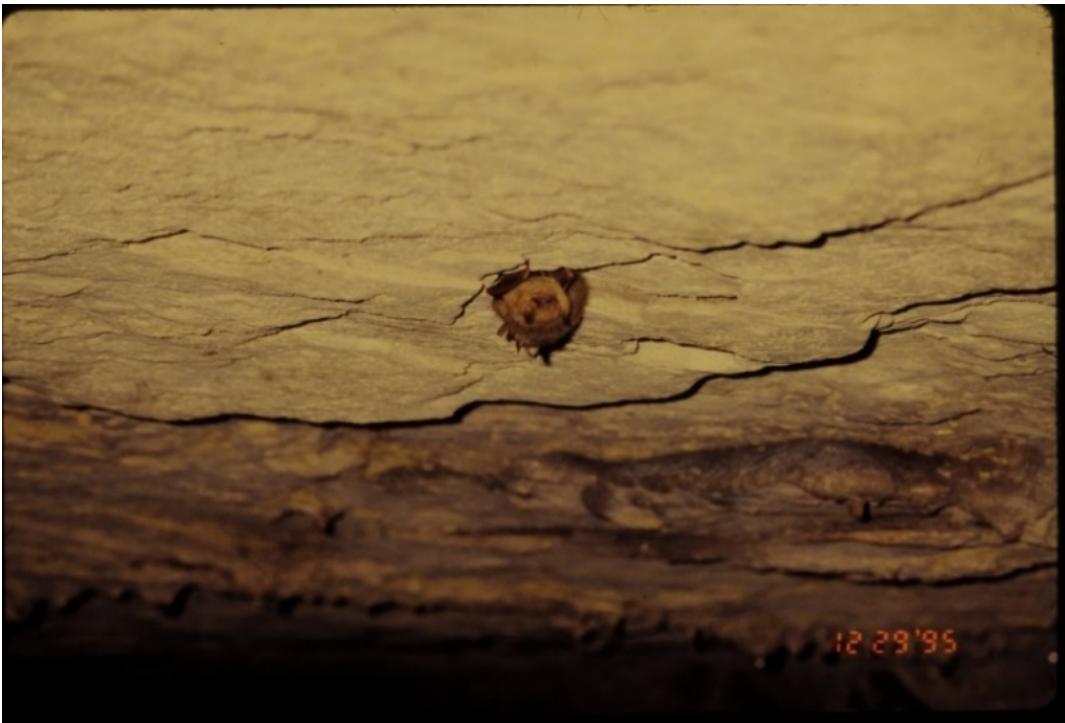
**Figure 16.** Entrance Room on with tricolor bat and drips in background, December 29, 1995 (photo credit: Nico Hauwert).

**Entrance or Big Room:** The Entrance Room has numerous dispersed ceiling drips and abundance of life including tricolored bats hibernating through the winter, raccoons observed on game cameras entering the cave, and a porcupine observed in July 2020 at the nearby cave extension conduit on Barton Creek bluff. In the initial 1971-1974 exploration of Airmen's Cave, Wes Loder noted this "Big Room" was the only place in the cave where active formations were found, likely prior to the later discovery of the Formation Room at the end of Airmen's Cave.

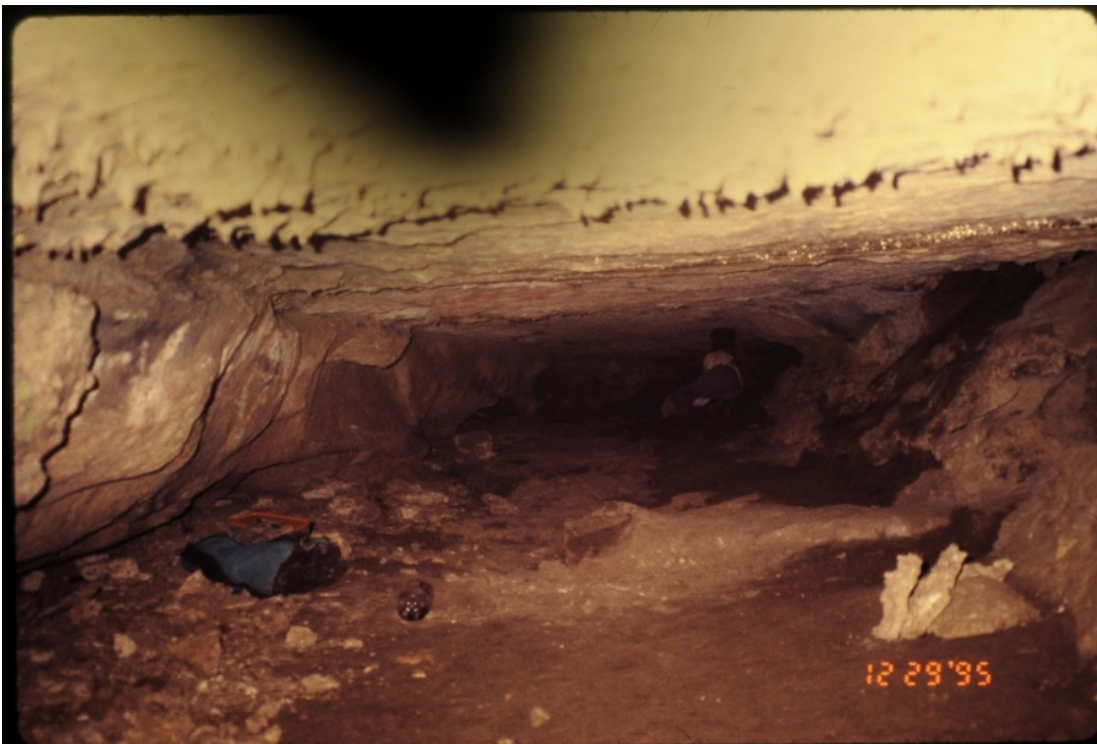
**Figure 17.** Expanded view of Entrance or “New” Room, December 29, 1995 (photo credit: Nico Hauwert).

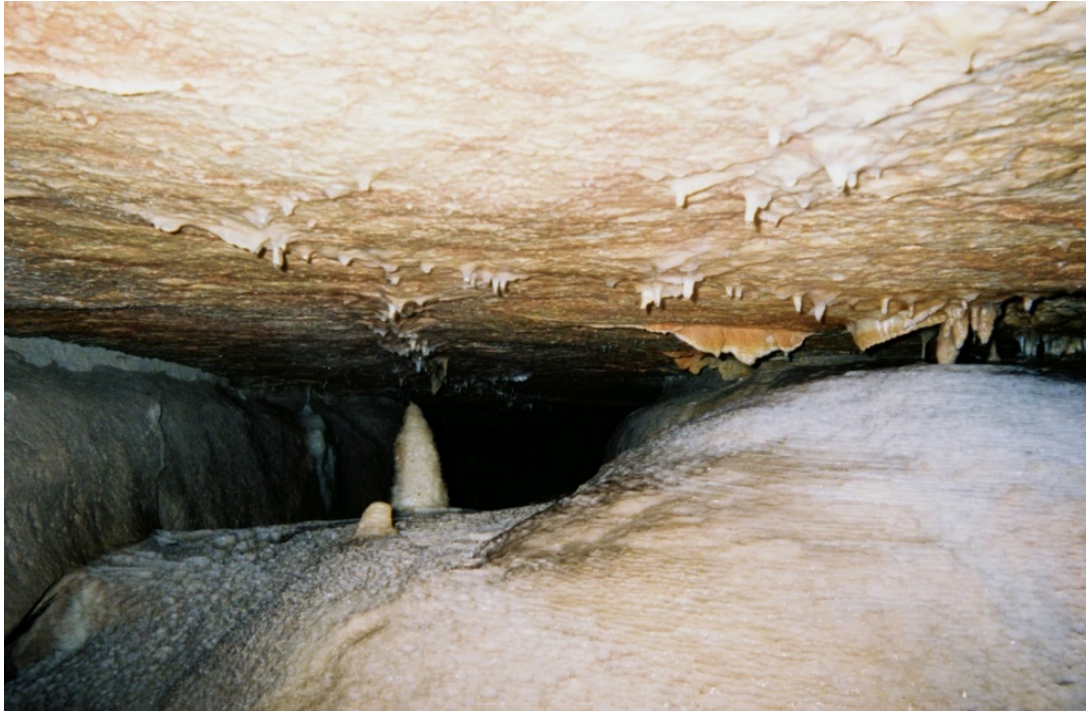
**Figure 19.** Formation Room, September 3, 2004 (photo credit: Scott Serur).

**Formation Room:** The Formation Room is the farthest explored extent in Airmen's Cave. Photographs of the Formation Room from February 11, 2021 by Ethan Perrine are presented in Appendix B. A pool of water was sampled on August 16, 2021 by Ethan Perrine and submitted to LCRA lab for analysis (Appendix D). Active drips were observed both from a ceiling fissure and stalactites although the drip rate was not measured. The water-quality results show very high sulfate (1500 mg/l) and high chloride concentrations (91.3 mg/l) compared to typical levels for both parameters of 10-40 mg/l in the Edwards Aquifer. Calcium concentrations of 535 mg/l was higher than typical Edwards Aquifer concentration of about 300 mg/l. Low concentrations were found of constituents that are associated with urban contamination such as *E. coliform* < 1 colony/100 ml, ammonia 0.086 mg/l, phosphorus <0.008 mg/l. The water quality results are consistent with seepage through the Del Rio Clay, which is known to contain highly soluble gypsum (calcium sulfate). The projected surface area over this location is the northeast corner of Lamar Boulevard and Ben White Boulevard/Highway 290, where Hauwert observed shallow surface exposure of the Del Rio Clay associated with Ben White Boulevard improvements around 1995. A surface drainage overlies this area (Figure 13). Although the drip rate may be low, the appearance of formations (soda straws, stalactites, bacon rinds, stalagmites, rimstone dams) and water pools suggest a discrete source of overlying water such as the surface, Buda Limestone groundwater, or moisture drainage from the Del Rio Clay possibly along an extrapolated fault. It is estimated that the Del Rio Clay extends to the surface and the Buda Limestone is absent above the Formation Room. However, a U.S. Geological Survey monitoring well (state well number 58-50-216) located about 1,100 feet southeast of the Formation Room, within the Ben White Boulevard underpass, has about 40 feet of Buda Limestone (top of Del Rio Clay elevation about 649 ft msl), according to geophysical logs. Likely a down-dropped fault parallels Lamar Boulevard east of the Formation Room. The Buda Limestone further east or south of the Formation Room could be a water source for the Formation Room drips. There is outcrop of Georgetown Formation in a drainage about 800 feet northwest of the Formation Room according to the 1974 Airmen's Cave map projection and about 1,100 feet west of the 1995/1996 map projection. This outcrop of Georgetown Formation northwest of the Ben White Boulevard and Lamar Boulevard intersection has an estimated maximum elevation of about 640 feet msl is higher and potentially updip of the Formation Room at projected 560 feet msl and could potentially be a source of water for the drips there. Attempts could be made to test various hypothesized sources to the Formation Room using organic dyes or chemical tracers (Hauwert and Cowan 2013), if access permission could be gained. Any attempts to trace through the Del Rio Clay with organic dyes would likely be unsuccessful as the dyes would be much more easily sorbed by the overlying clays than the water flushed with it, and a non-detection might be inconclusive regarding hydraulic connection.

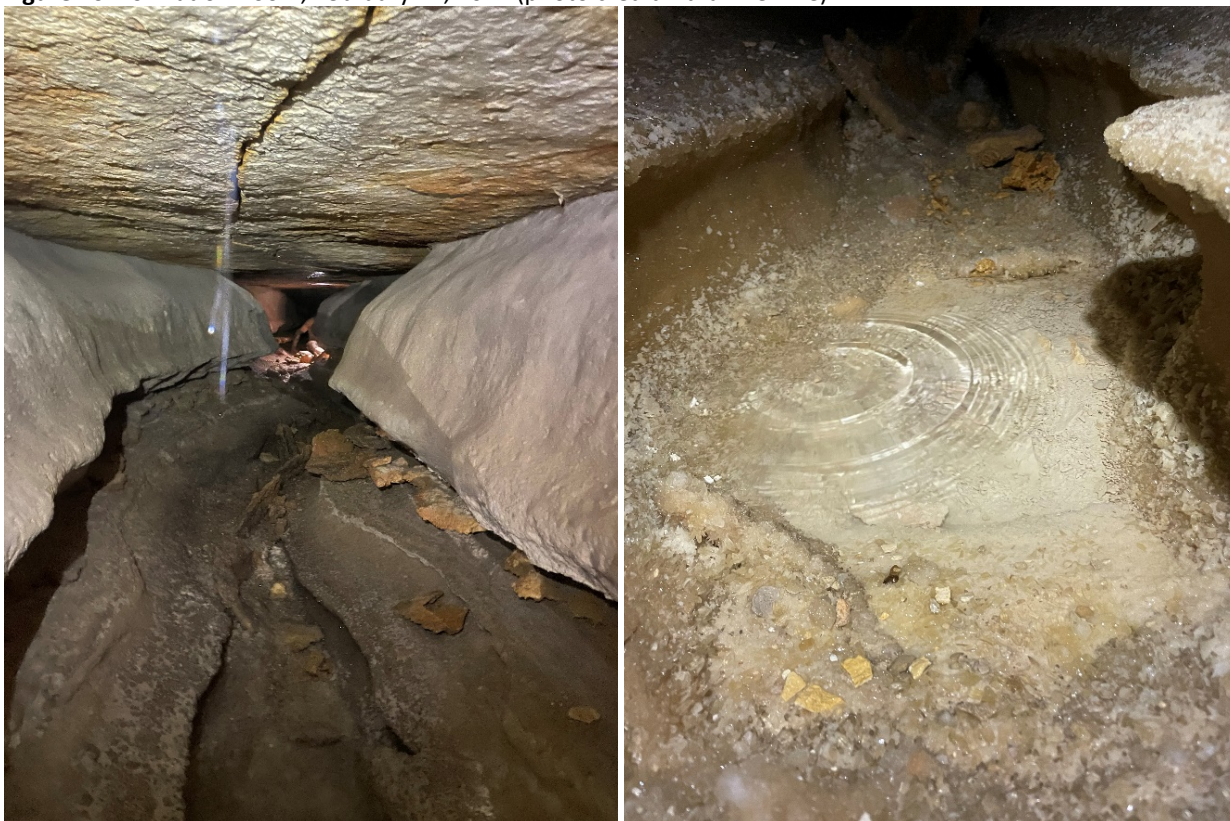
**Figure 20.** Formation Room, February 11, 2021 (photo credit: Ethan Perrine).

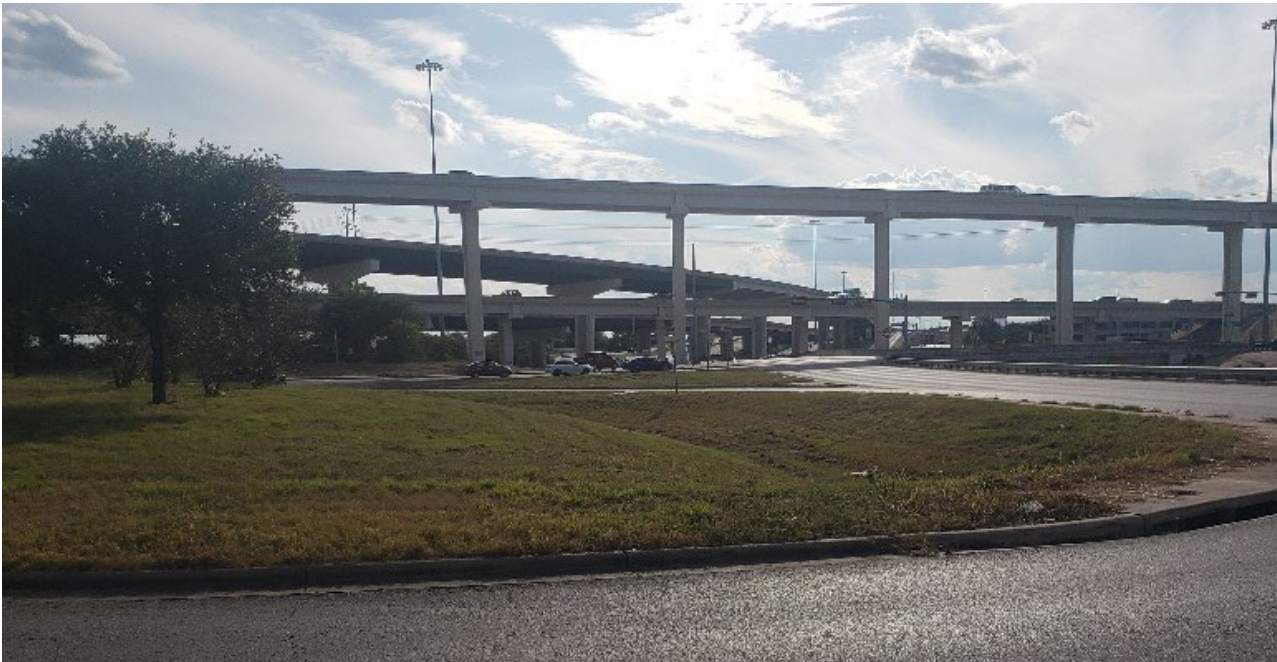
**Figure 22.** A surface drainage overlying the Formation Room of Airmen’s Cave where active drips are observed. Del Rio Clay was observed in excavations on this side of the intersection around 1995, October 5, 2021 (photo credit: Nico Hauwert).

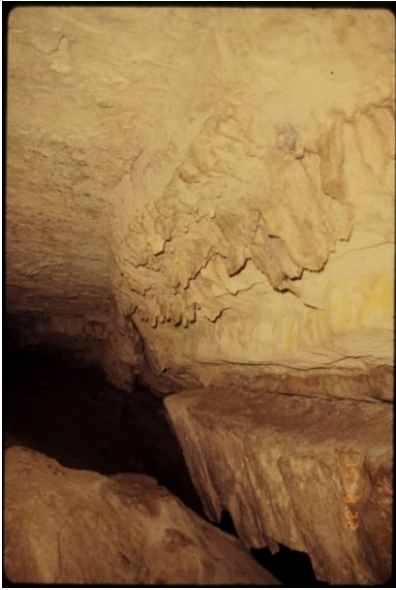
**Figure 24.** Inactive drapery formations along apparent fault about 1,400 feet into Airmen's Cave, December 29, 1995 (photo credit: Nico Hauwert).

**Inactive Drapery Formations:** Draperies are similar to stalactite in origin but calcium is precipitated against a wall rather than from an open ceiling. Drapery formations are visible along a fault in Airmen's Cave. They show no sign of recent flow, even in 1995 photos.

When phreatic groundwater flows through Airmen's Cave, such as the time period from approximately December 1991 to December 1992, and in 2016, the main discharge of the cave stream does not pass through the main entrance, which historically was probably a smaller side in feeder, but from a conduit on a cliff of Barton Creek about 200 feet north of the Main Entrance. Likely this lesser known conduit was the historic main cave passage (Figure 24).

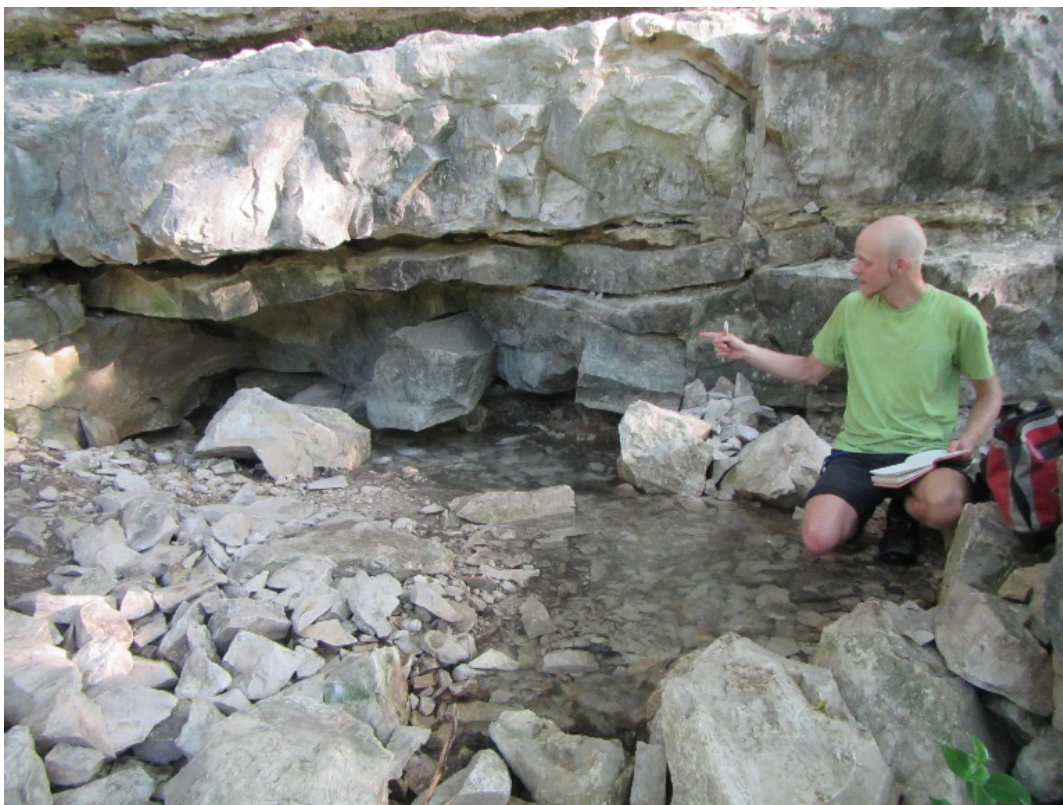
**Figure 25.** Justin Shaw indicating main groundwater discharge from Airmen's Cave about 200 feet downstream of the cave's entrance, July 23, 2016 (photo credit: Drew Thompson).

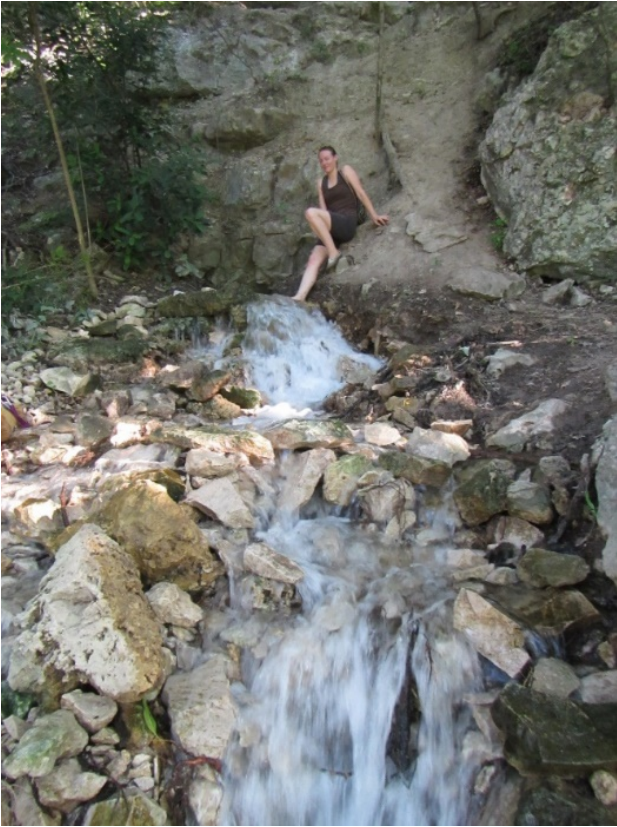
**Figure 26.** Patti Calabrese observing groundwater discharging from the south bluff into the Barton Lodge Tributary near its mouth, July 23, 2016 (photo credit: Drew Thompson).

Some of the flow along Airmen's Cave is likely through conduits that parallel a smaller offset fault further east. On May 17, 1992, Nico Hauwert measured 2 springs within 30 feet of the mouth of Barton Lodge Tributary assumed to be northmost discharges of Airmen's Cave flow, at over 13 gallons/minute. Three springs discharging on the north bluff of Barton Lodge tributary, flowing south into the tributary measured a higher rate at 35 gallons/min, 8.8 gallons/min and 7.5 gallons/min. The springs seemed to be discharging localized flow from both directions along a fault into Barton Lodge Tributary.

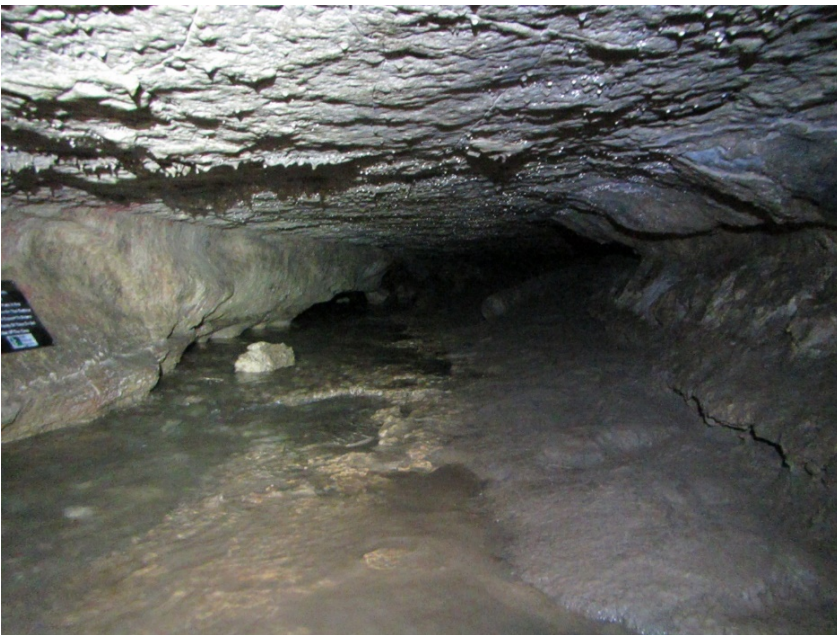
**Figure 27.** Groundwater flows through the Entrance (New) Room, July 23, 2016 (photo credit: Drew Thompson).

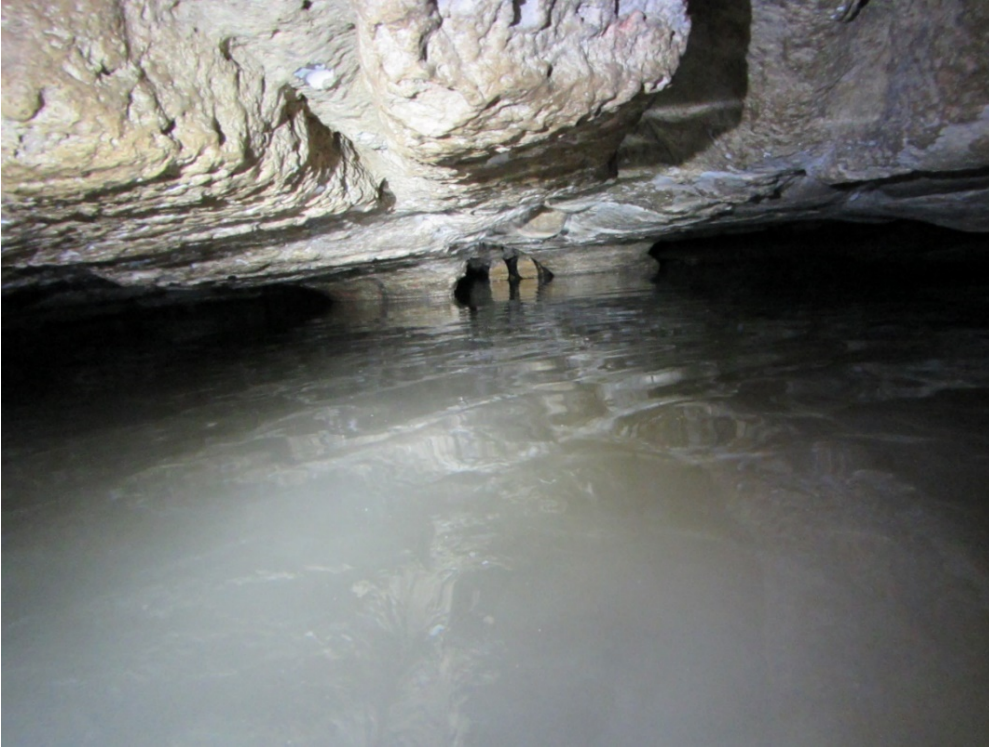
**Figure 28.** Groundwater flows Upstream from the Entrance (New) Room, July 23, 2016 (photo credit: Drew Thompson).

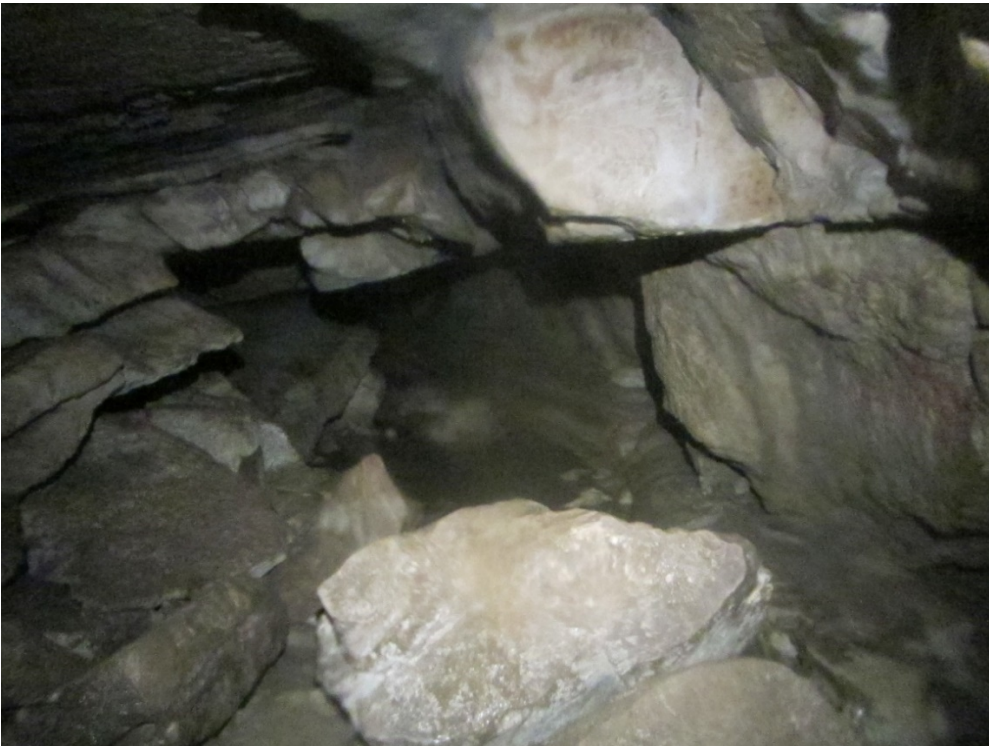
**Figure 29.** Water Flowing through the Bypass Squeeze, July 23, 2016 (photo credit: Drew Thompson)

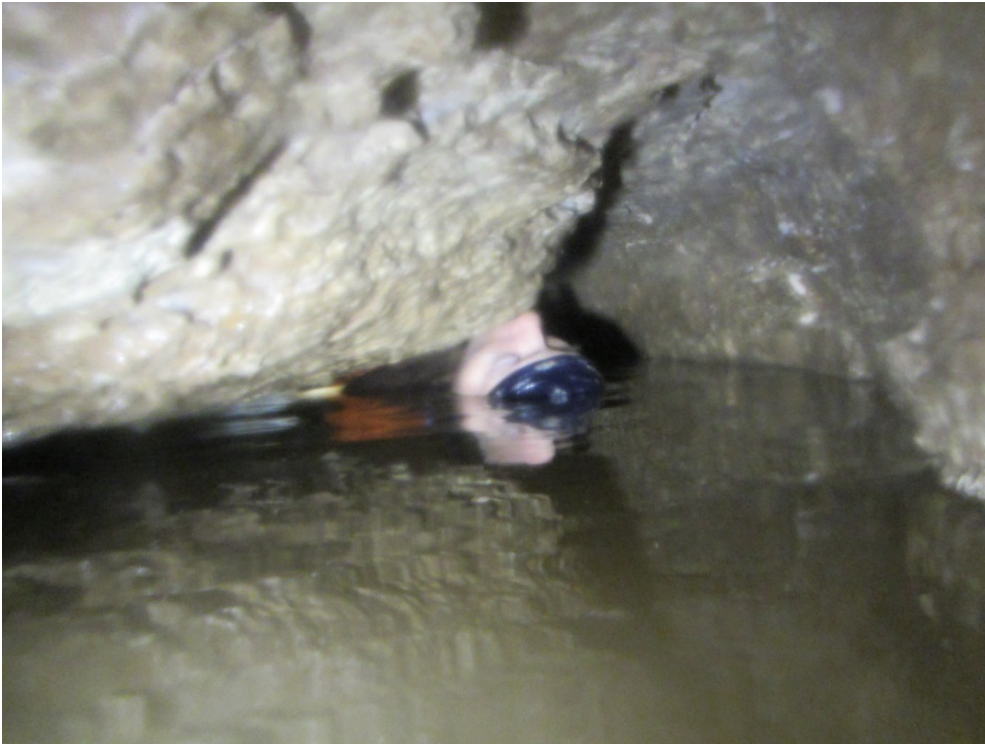
**Figure 30.** Patti Calabrese passes a low air space passage, July 23, 2016 (photo credit: Drew Thompson).
