PHASE I ENVIRONMENTAL SITE ASSESSMENT

**Zilker Metropolitan Park
Barton Springs Road
Austin, Texas**

October 2019

Prepared For:
Austin Brownfields Revitalization
Office
PO Box 1088
Austin, Texas, 78767

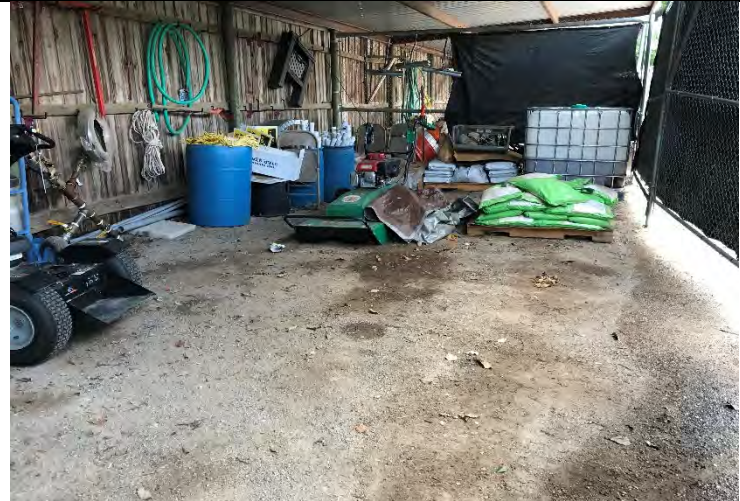
Photo 6: View of *de minimis* staining inside of equipment and materials storage shed on the east side of the Maintenance Barn area. Facing south.

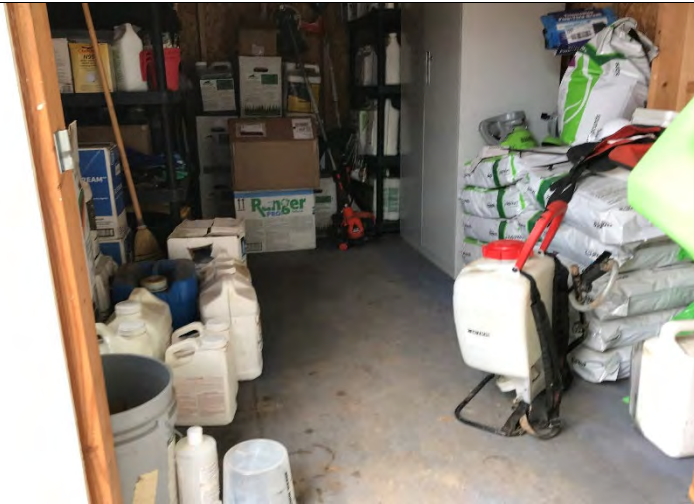
Photo 7: View of interior of storage area at the northeast corner of the equipment and materials storage shed on the east side of the Maintenance Barn area. Facing north.

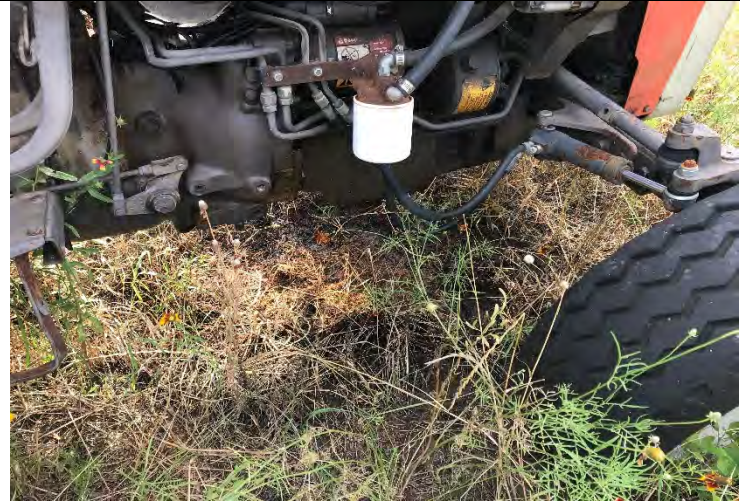
Photo 12: View of de minimis staining beneath a tractor (pictured on the right side of Photo 11) in the northeast portion of the Bone Yard. Facing north.

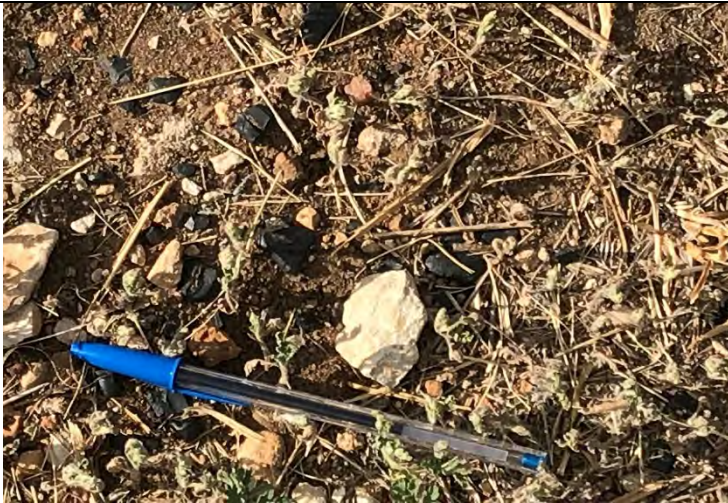
Photo 31: View of black shards of cementitious clay observed in the north central portion of the Pistol Range area (consistent with clay pigeon materials) just south of the stockpiles pictured in Photo 30. Facing north.

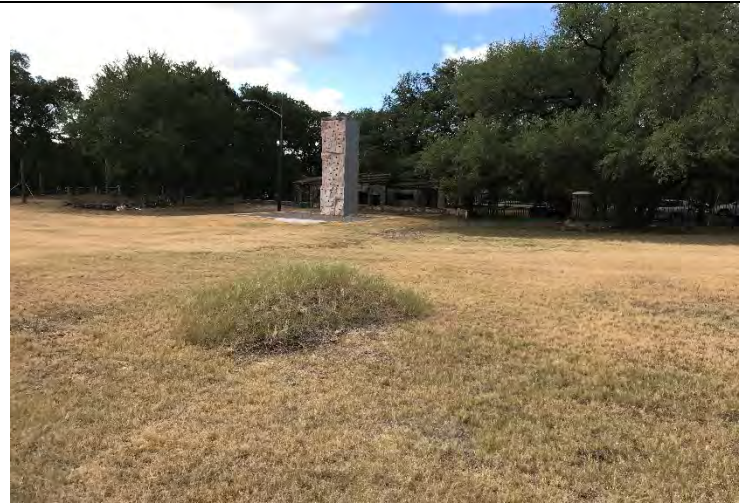
Photo 32: View of Pistol Range area. The covered shooting tables were formerly located between the climbing tower and the rock building. Facing southeast.

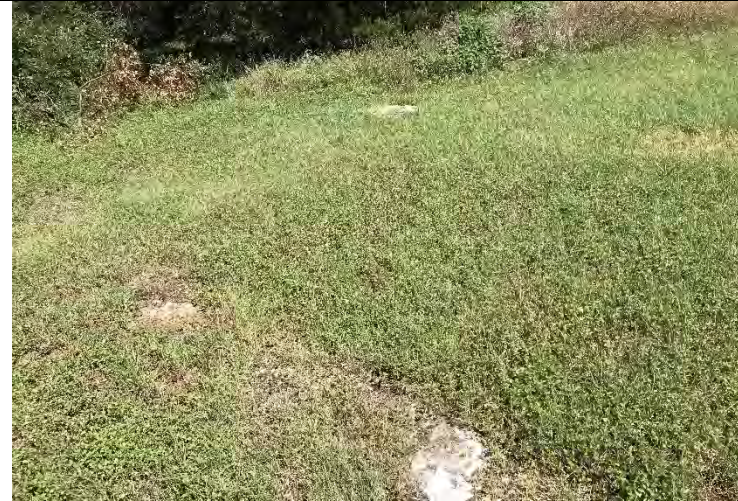
Photo 40: View of concrete and rock visible in the western portion of the former Skeet Range area, assumed to be the remnants of the foundation of the skeet building. Facing west.

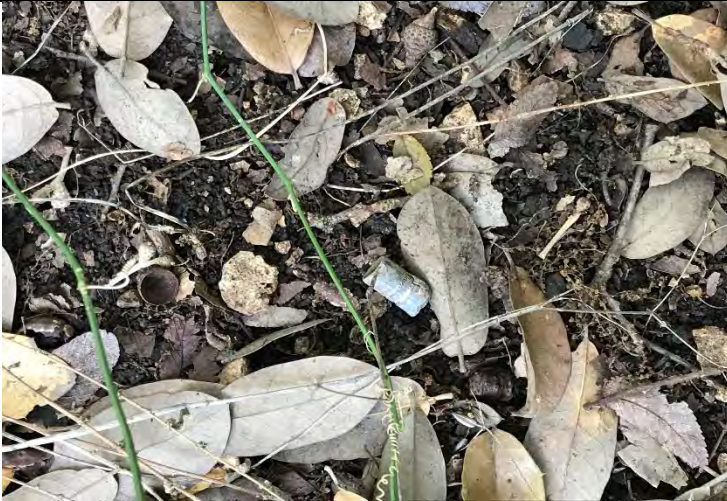
Photo 45: View of bullet observed in the area of trees to the north of the Skeet Range. Facing north.

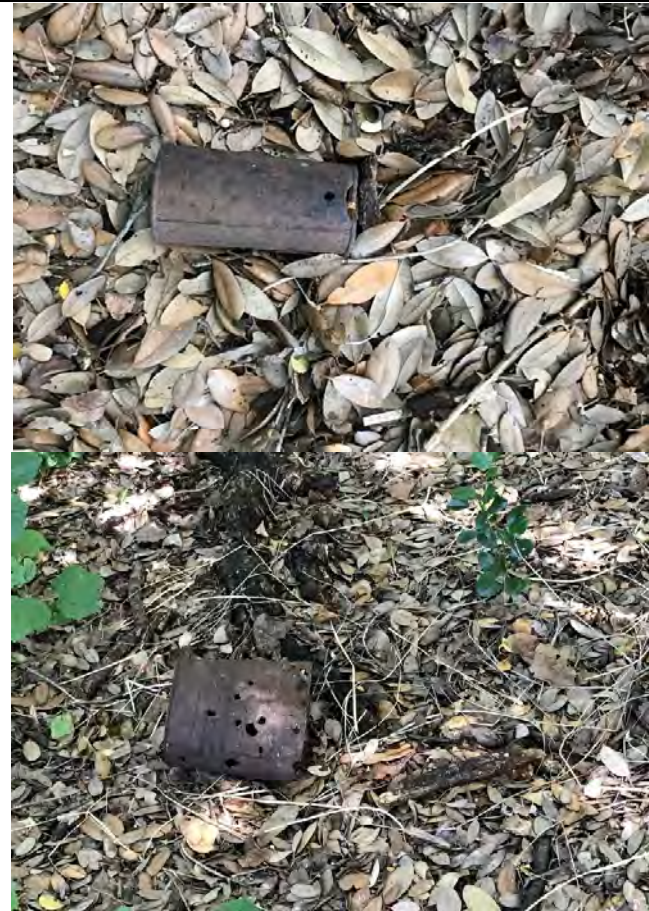
Photo 46: View of a metal cans with bullet holes observed in the area of trees to the north of the Pistol Range. Facing north.

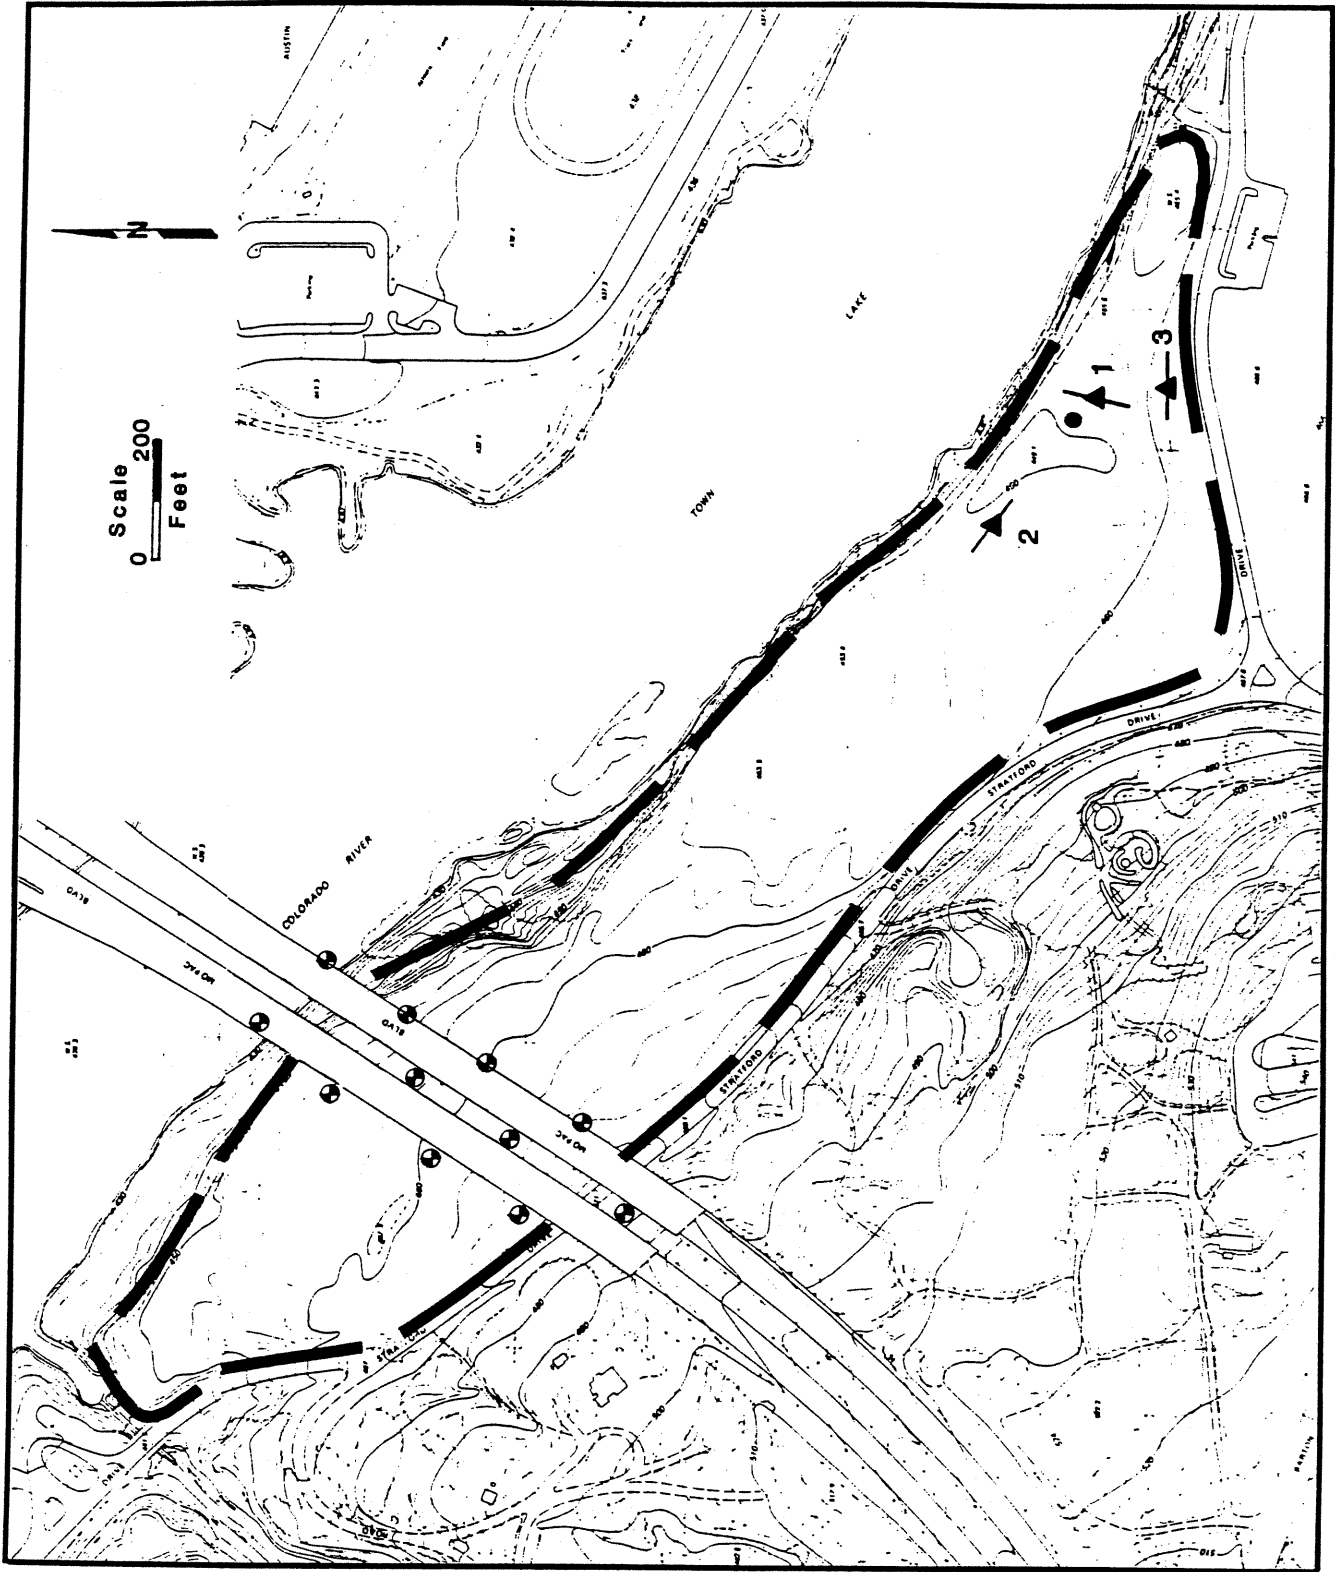
Fig. 3. Location of Monitor Well, Butler Landfill

The well at Zilker Park is completed in fill material, and is located near the southeast end of the landfill (Figure 3). It was drilled February 21, 1984. During drilling, old rags, paper, plastic, and a light bulb were brought up with the cuttings, so it is fairly certain that the well is located on fill material. The bottom of the fill was at 19 feet. Sand and gravel were penetrated from 19 feet to the total depth of 26 feet. The Edwards Limestone underlies the landfill, but was not reached, although it is probably within a few feet of the total depth. During drilling, as the borehole was advanced, water was encountered at a depth of about 9 feet. Below that depth, the fill material became a spongy, muddy slurry created by the mixing action of
