**CITY OF AUSTIN  
ENVIRONMENTAL ASSESSMENT REPORT**

**VRI SITE  
1201 ROBERT E. LEE ROAD  
AUSTIN, TEXAS 78704**

**RANGER PROJECT NO. 4120**

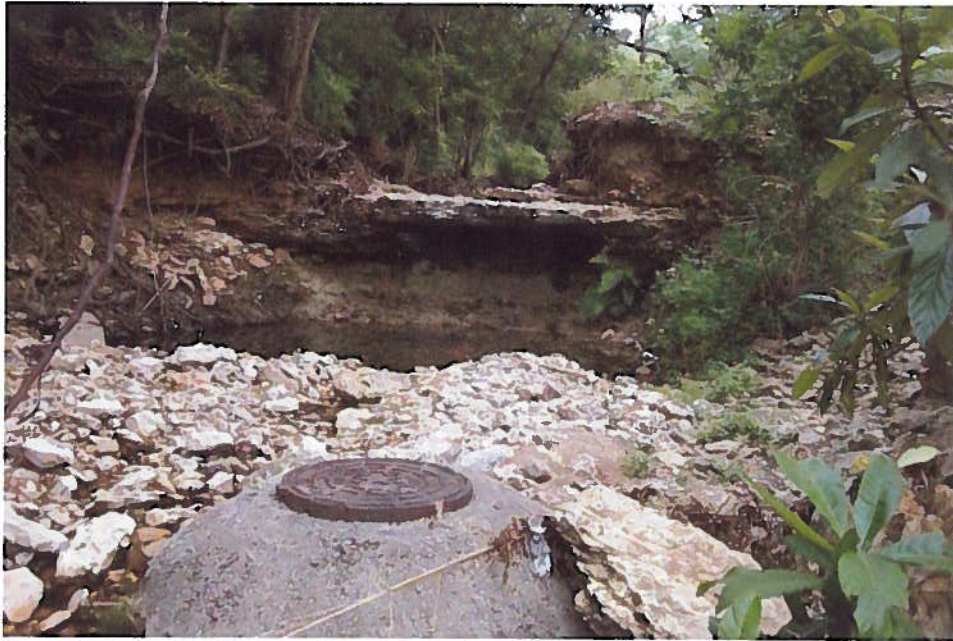
Photo 1 – Scour pool and manway in unnamed tributary to Barton Creek.  
The Buda Limestone and Del Rio Clay contact is exposed.

- The Buda Limestone and Del Rio Clay contact is exposed. There is no spring flow at the contact.
- The utilities below the creek appear to be acting like a french drain, collecting surface water and the water is following the backfill material of the new and abandoned waste water lines.

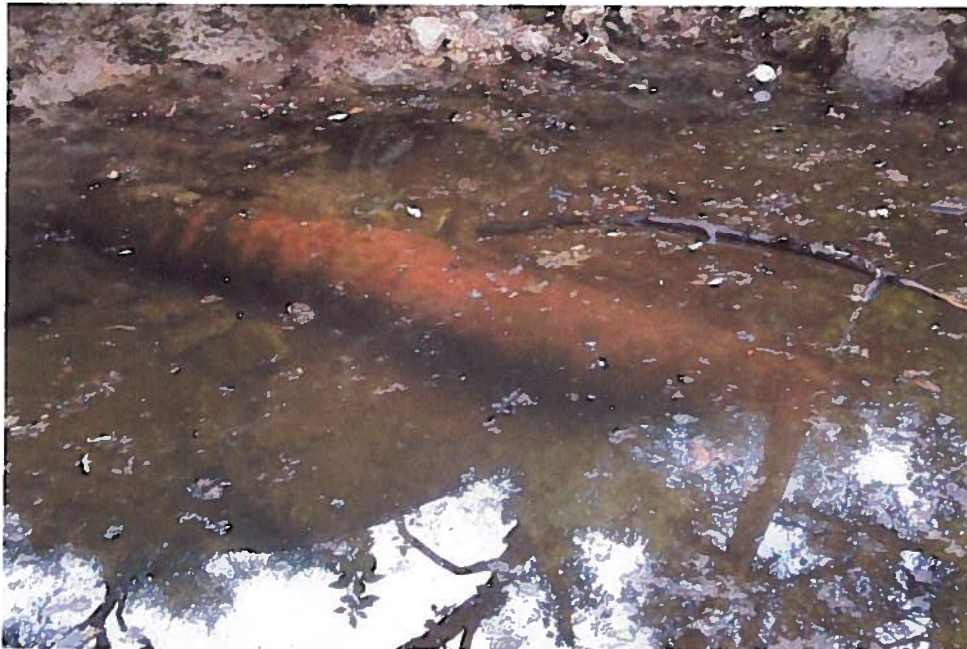
Photo 2 – Waste water line in scour pool.

Exposed within the scour pool is a City of Austin 8-inch diameter waste water line. The City of Austin construction plans were obtained and reviewed. Copies of the plans are provided in Attachment H. The waste water line appears to have been installed in 1988. In this area of the creek, the line was bored below the creek bed and installed. An old 8-inch diameter waste water line was also located in the creek bed and was abandoned in place.

The plans indicate that the waste water line was placed approximately two feet below the bottom of the scour pool. Erosion has caused the waste water line to be exposed. The plans indicate that the line was placed by boring below the creek, while 280 feet upstream, it is encased in concrete.

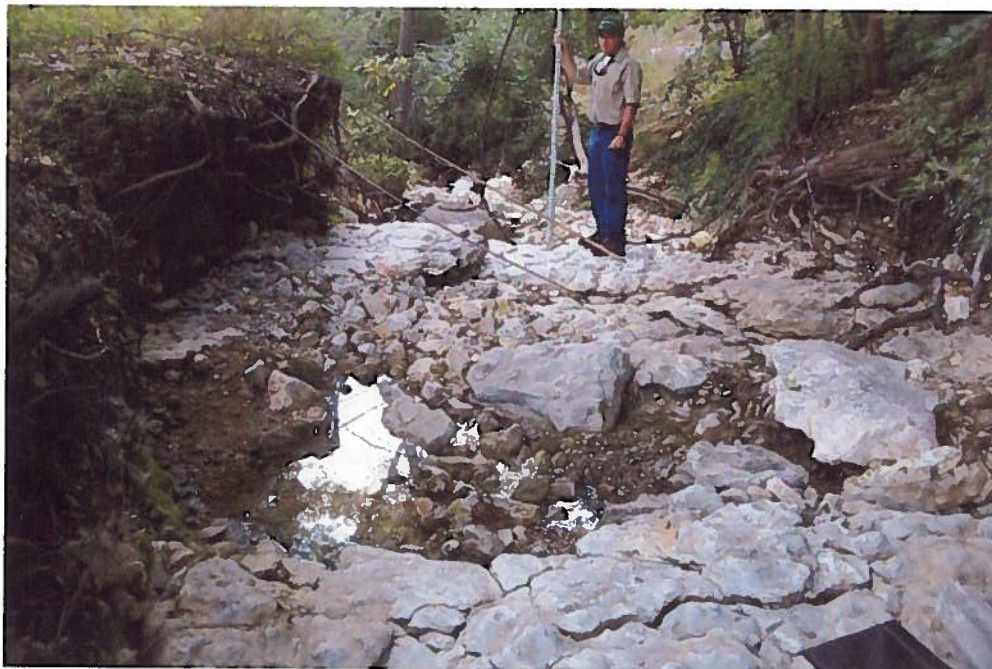
Photo 3 – Typical view of the creek upstream of the scour pool. Note the fractured limestone.

- The limestone exposed above the scour pool is fractured, therefore allowing surface water to communicate with the utility corridor.
- The City of Austin reportedly conducted a camera survey of the line approximately two years ago. No holes were observed. The positive *E. coli* tests suggest that water and waste water can migrate along the backfill of the waste water lines. The source of the *E. coli* (e.g. manway, line, service line, etc.) is unknown. If there is no hole in the line, then there has to be an avenue of transport along the line, (i.e., utility backfill).

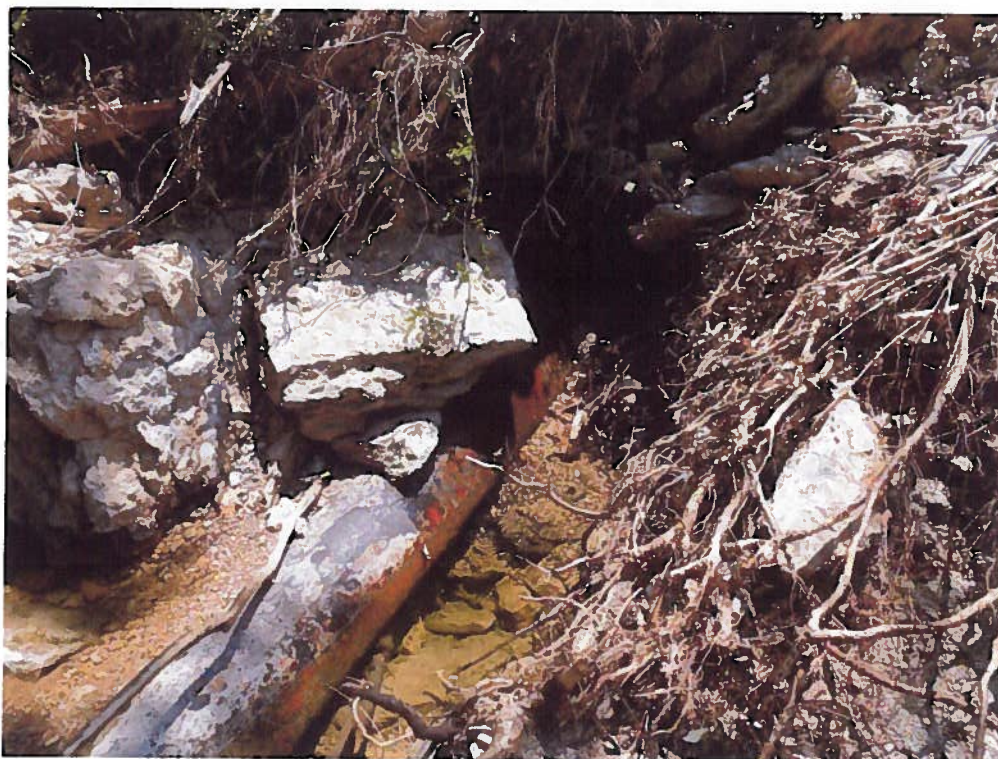
Photo 4 – Exposure of active 8-inch waste water line downstream of scour pool.

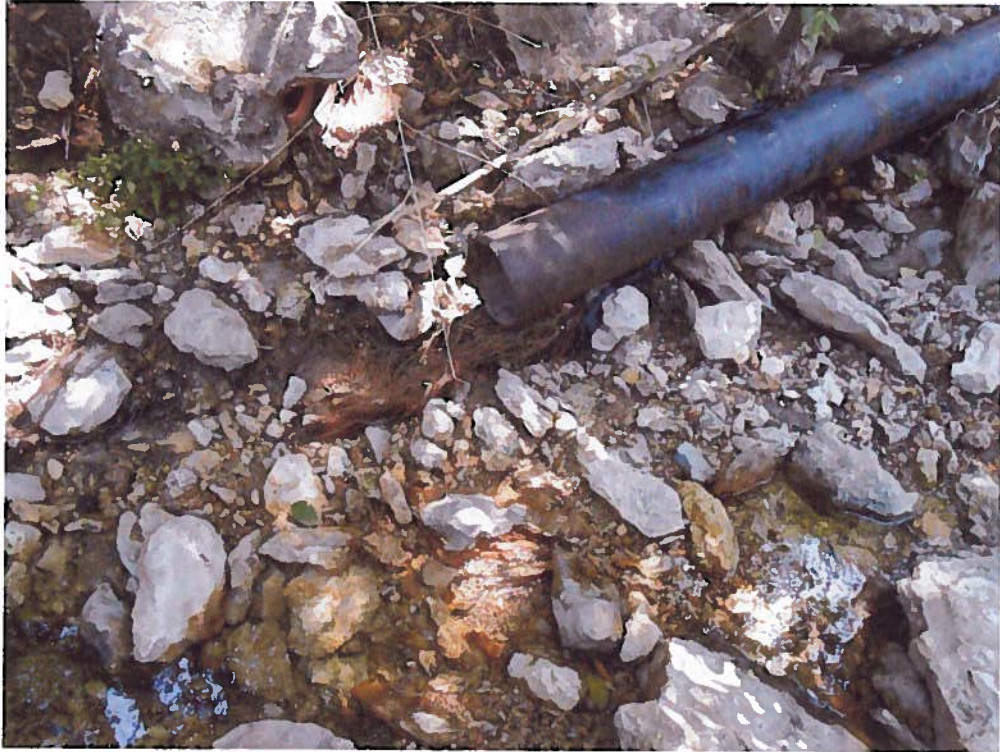
Photo 5 – Abandoned 8-inch waste water line.

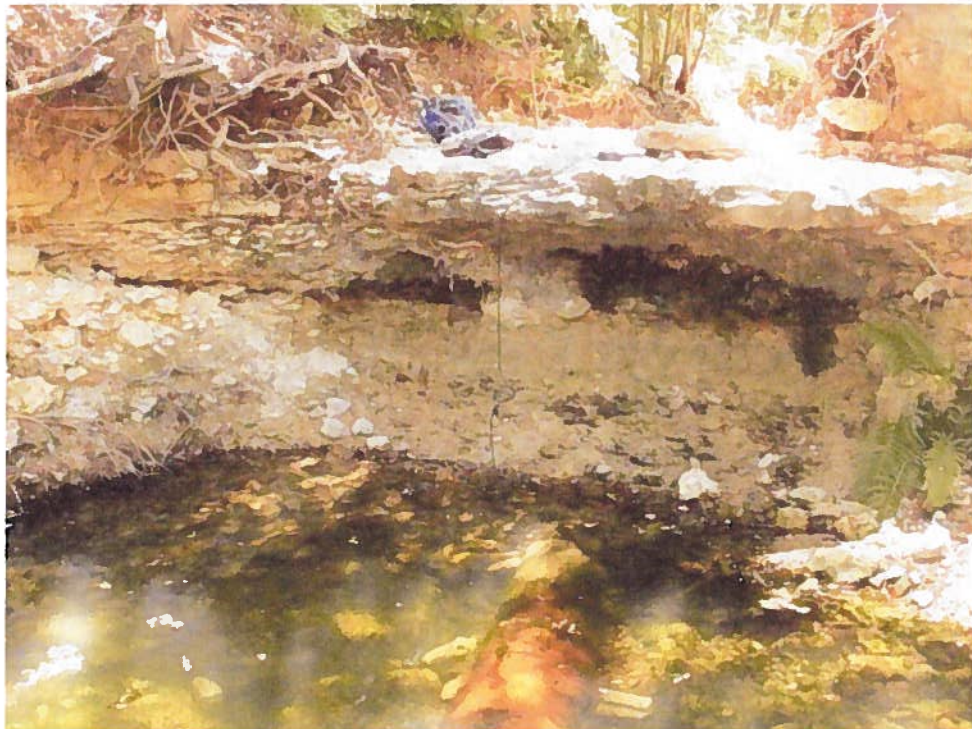
Figure 1. Photo taken June 28, 2013 showing moist headwall of grotto, “Little Zilker” pool, and submerged wastewater line.

- 2) In agreement with the EA, it does appear that the pre-1986 wastewater line trench may divert some of the groundwater. A hole visible at the top of the abandoned wastewater line sleeve or underlying trench visibly discharges a smaller portion of the entire discharge. However, given the boring and associated disturbance with the installation of two wastewater lines in the late 1980’s and earlier, it would be hard to imagine that this level of disturbance would not affect the spring by diverting at least a portion of the springflow, if only a few feet away from its original discharge orifice. The smaller water discharging from the sleeve appears to be groundwater and not wastewater. Even if the spring outlet was impacted by infrastructure, it still functions as a spring.

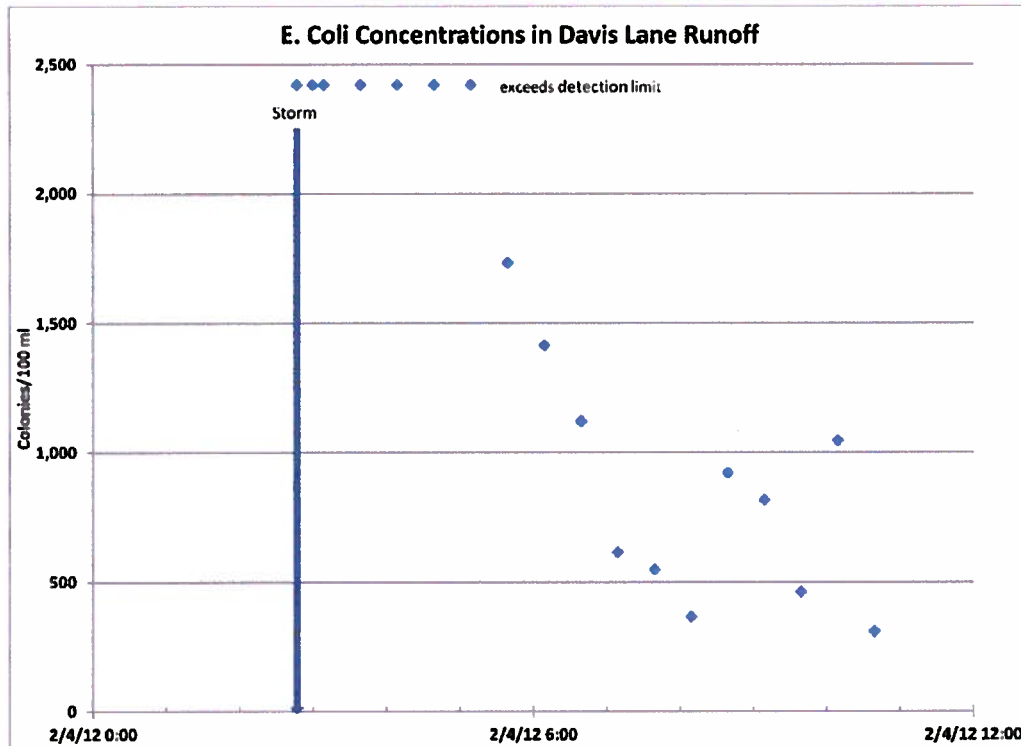
Figure 2. Comparison measurements of E. Coli from roadway runoff of Davis Lane in South Austin with no wastewater contribution. The level of E. Coli measured in roadway runoff is similar to concentrations measured in “Little Zilker” pool, and are typical for urban runoff and groundwater.

- 3) At this time we have not detected a leak of wastewater into the “Little Zilker” pool. *E. coliform* has been measured in 2013 ranging from 214 to 1,553 colonies/100 ml. These levels are common for urban source springs and urban runoff. For comparison, attached is the measured concentration of *E. coli* in runoff from Davis Lane in South Austin, where the source is roadway

and residential yards with no wastewater system leak source. As mentioned in 1c above the specific conductance of Little Zilker pool (721 to 844  $\mu\text{S}/\text{cm}$ ) is similar to Barton Springs (679  $\mu\text{S}/\text{cm}$ ) but is significantly higher than wastewater upstream in a Little Zilker Creek manhole (554  $\mu\text{S}/\text{cm}$ ). In May, 2013 Austin Water Utility conducted a dye trace of the active wastewater line in Little Zilker Creek and a television survey and discovered no leaks of wastewater into the creek. In urban areas it can be expected that tap and wastewater leaks may occur, although any amount of wastewater contribution to Little Zilker spring would be small.
