# Zilker Park Bathhouse Zone Feasibility Study

City of Austin  
Parks + Recreation Department

## MWM Design Group

June 10, 2016

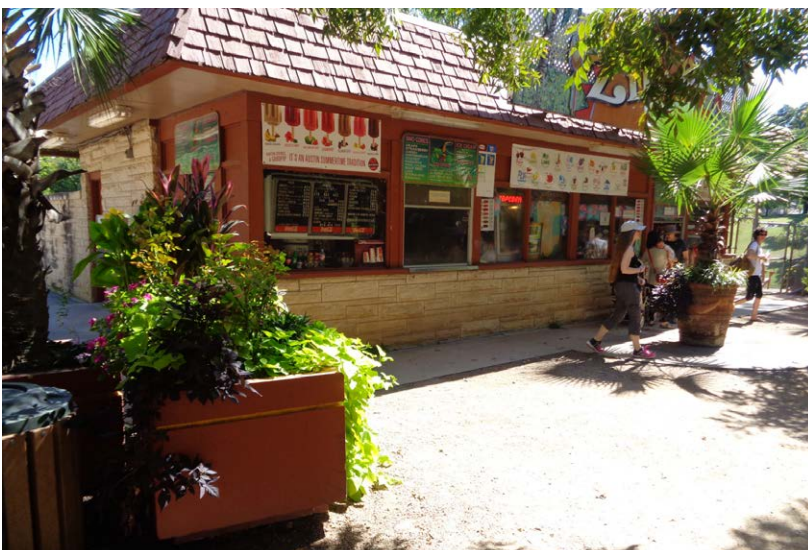
**Zilker Café:** The fabric of the Zilker Café dates to the early 1960s, when it was constructed to replace a predecessor damaged beyond repair by flooding.

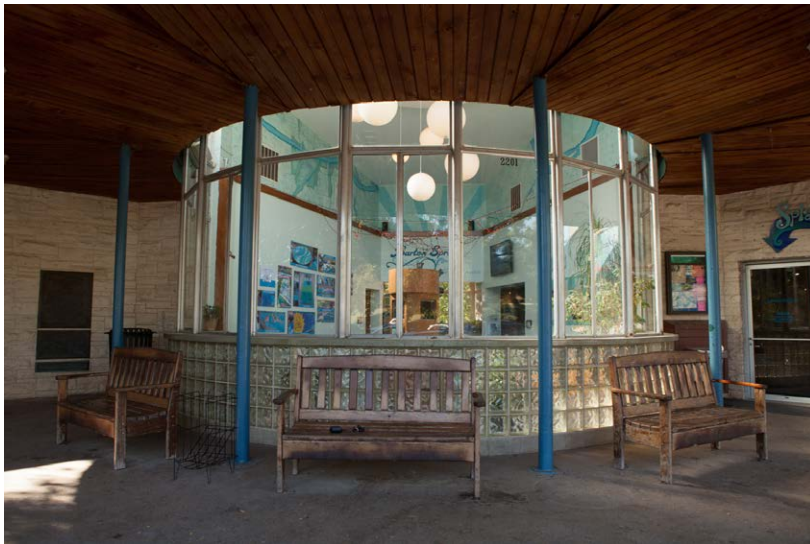
**Bathhouse Rotunda:** The Bathhouse Rotunda, built as the Service Office, retains much of the historic building fabric, although the interior of this space has been substantially altered over the years.

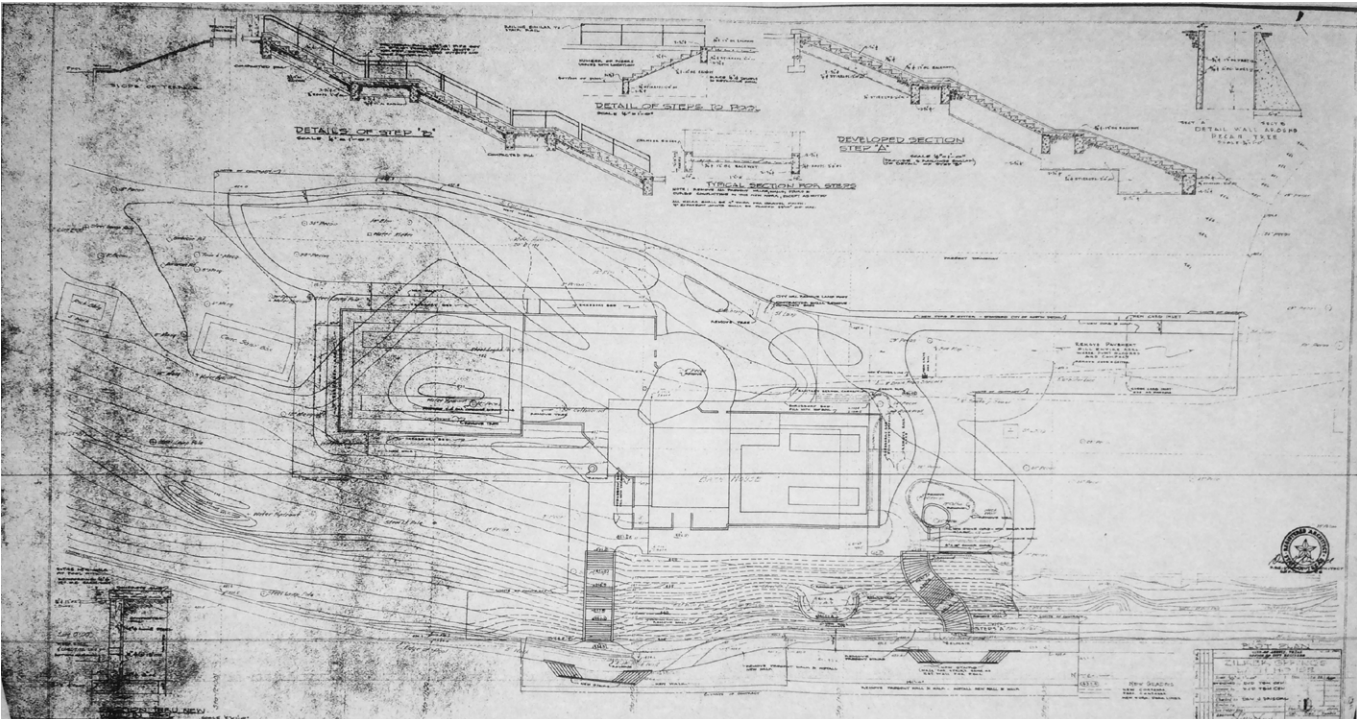
**Pool Enclosure and Bathhouse:** Original Construction Plan dated 1945. Of note are the fact that the fence enclosing the pool was not included in the original design, that the present Spectator's Gallery is a legacy of the preceding bathhouse (and preserves intact a portion of the foundation of that destroyed building), and that the reconfiguration of the northeast corner of the existing parking lot was anticipated in the design of the current building.

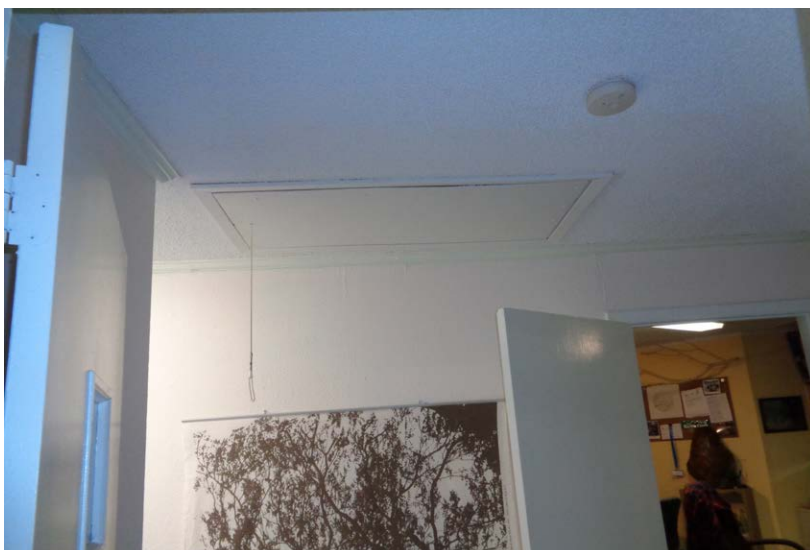
**Sheffield Center Storage Space:** Operation of the Sheffield Center is facilitated by the utilization of a mezzanine above the classrooms, accessible through this pull-down ladder.
