BARTON SPRINGS ROAD OVER BARTON CREEK

Bridge Inspection and Condition Assessment Report

Bridge 14-227-0-B002-26-001
Austin, Texas
January 2017

2016 Bridge Inspection Report
Barton Springs Road over Barton Creek
Bridge 14-227-0-B002-26-001

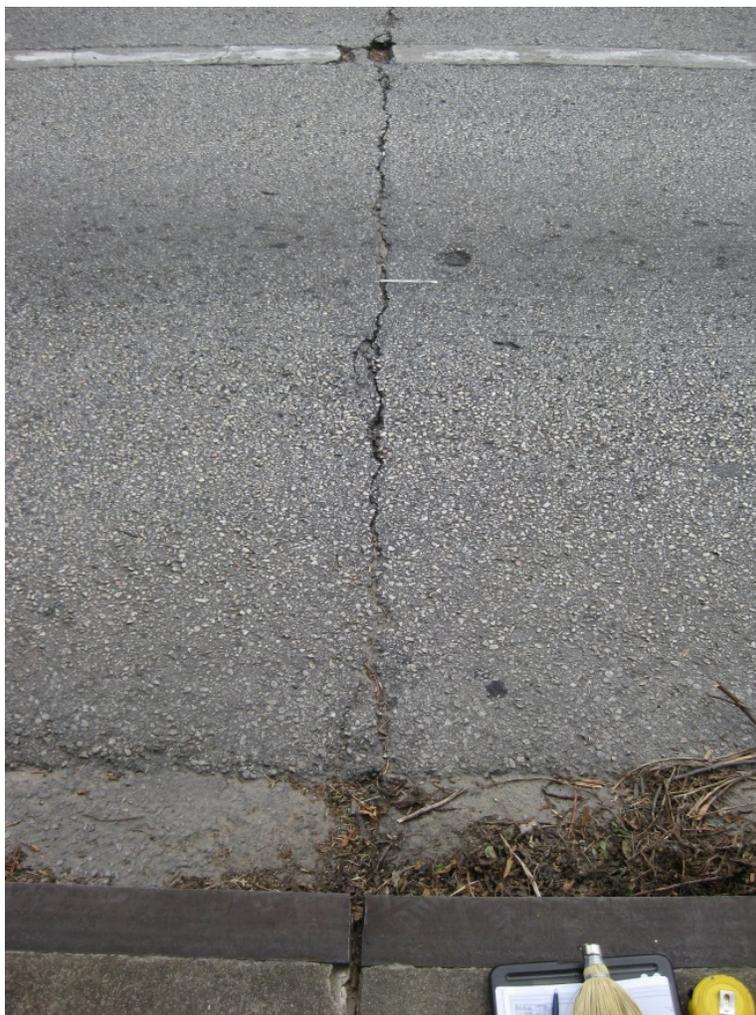
2. There is a full-length longitudinal joint separating the North and South Structures. There are also two full-width transverse deck expansion joints centered about the crown in each span. In the North Structure, the transverse expansion joints are spaced 11'-3" apart, whereas in the South Structure, the transverse expansion joints are spaced 19'-10" apart. The expansion joints are typically paved over with asphalt. However, the asphalt wearing surface exhibits reflective cracking, up to 1½ inches wide, and edge spalling for the full length and width at all the deck expansion joint locations (see **Photos 11 and 12**).

Photo 12: Typical reflective cracking in transverse deck joint

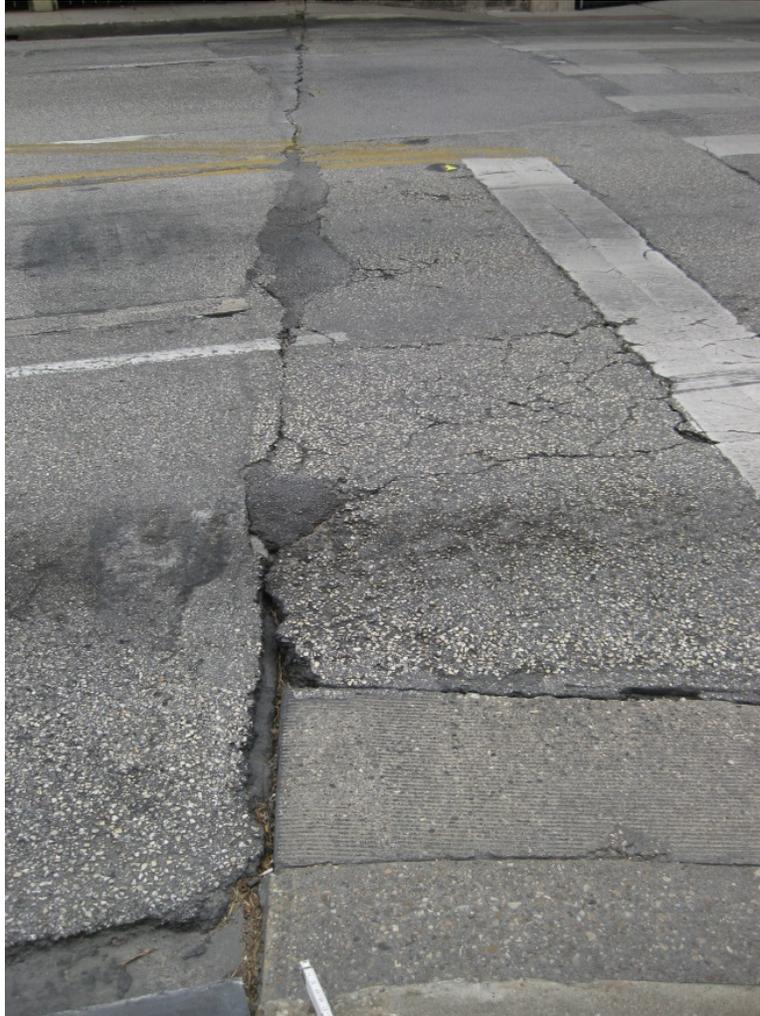
4. In the South Structure East Approach Transition, there is a crack in the wearing surface up to 6 inches wide and up to 4 inches deep along the joint that has been patched with asphalt at several locations. Some of the patches are failing or have failed (see **Photo 14**).

Photo 14: South Structure East Approach Transition

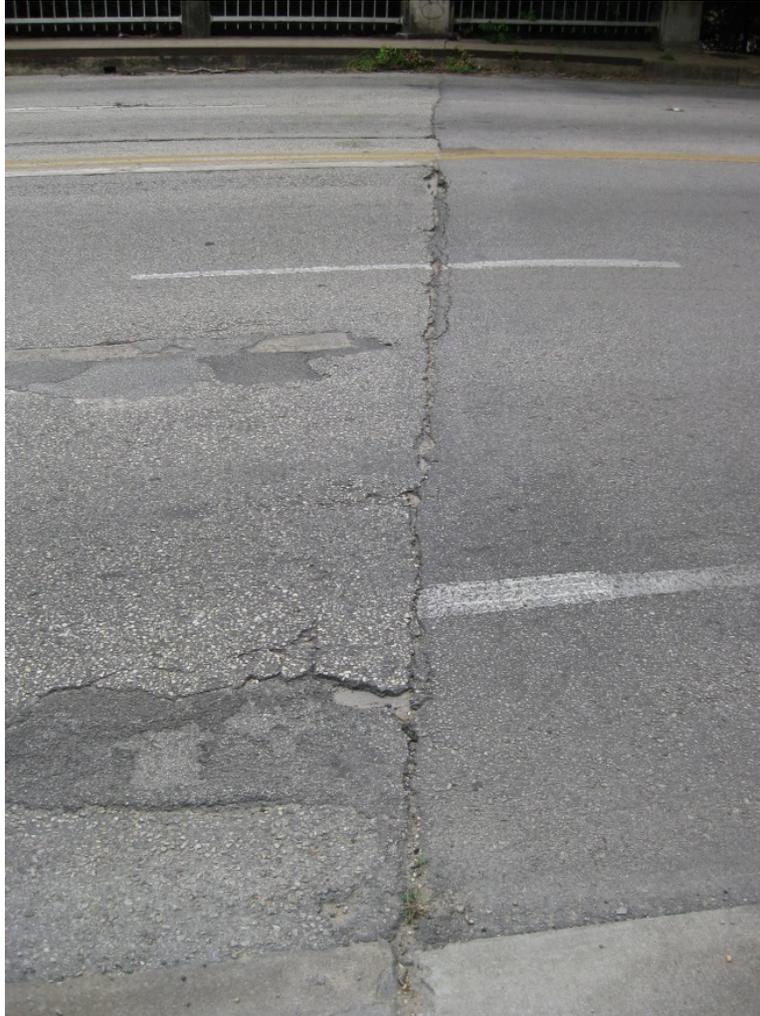
6. In the North Structure, the wearing surface has a full width crack with edge spalling up to 4 inches wide at the West Approach Transition Joint exposing the top of the concrete deck (see **Photos 16 and 17**).

7. In the North Structure, the wearing surface has a 3 ft. long by 1.5 ft. wide pothole in the north shoulder at the West Abutment which is failing (see **Photos 16 and 18**).

Photo 16: North Structure West Approach Transition

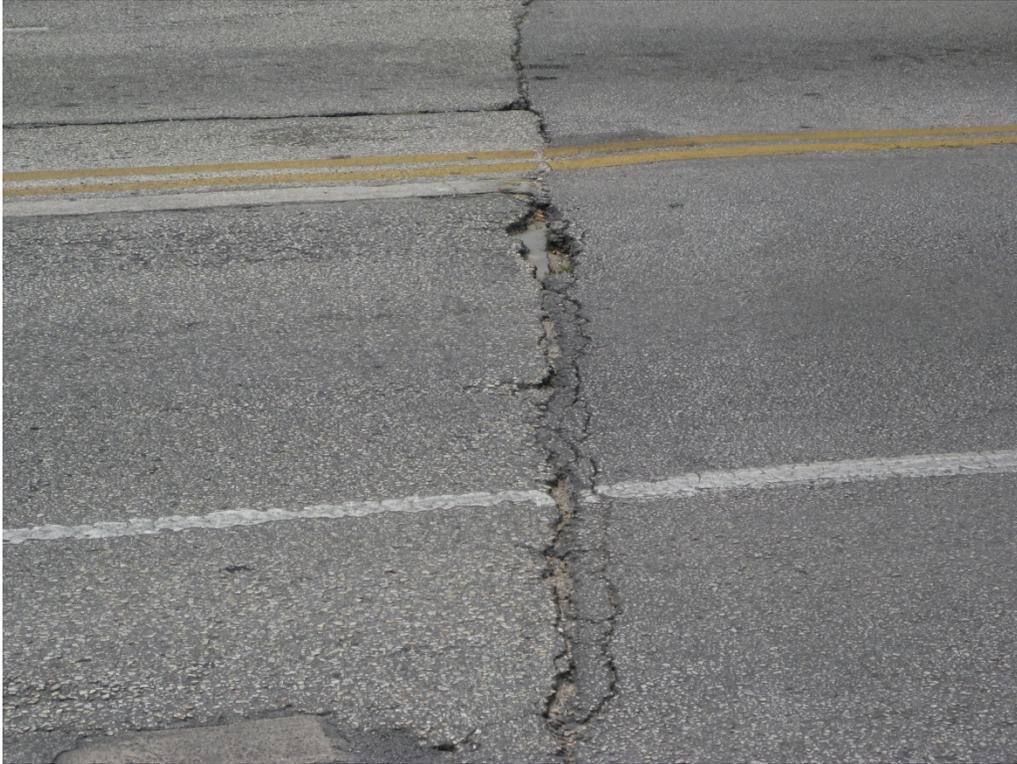
Photo 17: Exposed concrete deck at the North Structure West Approach Transition

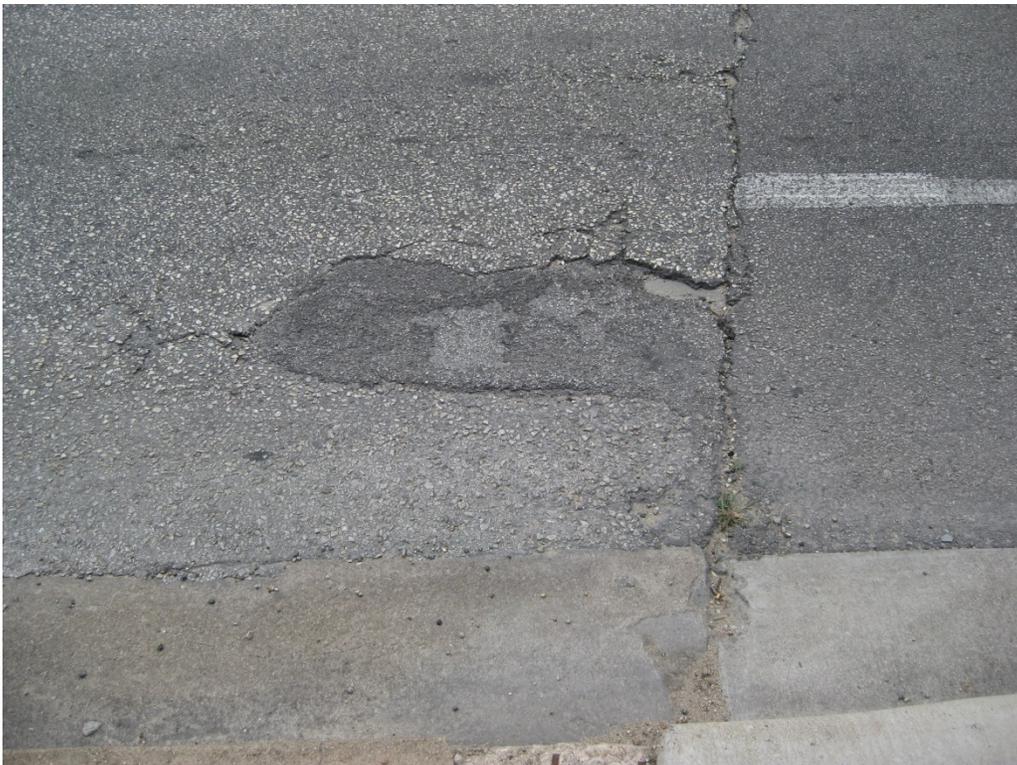
Photo 18: Pothole at the North Structure West Approach Transition

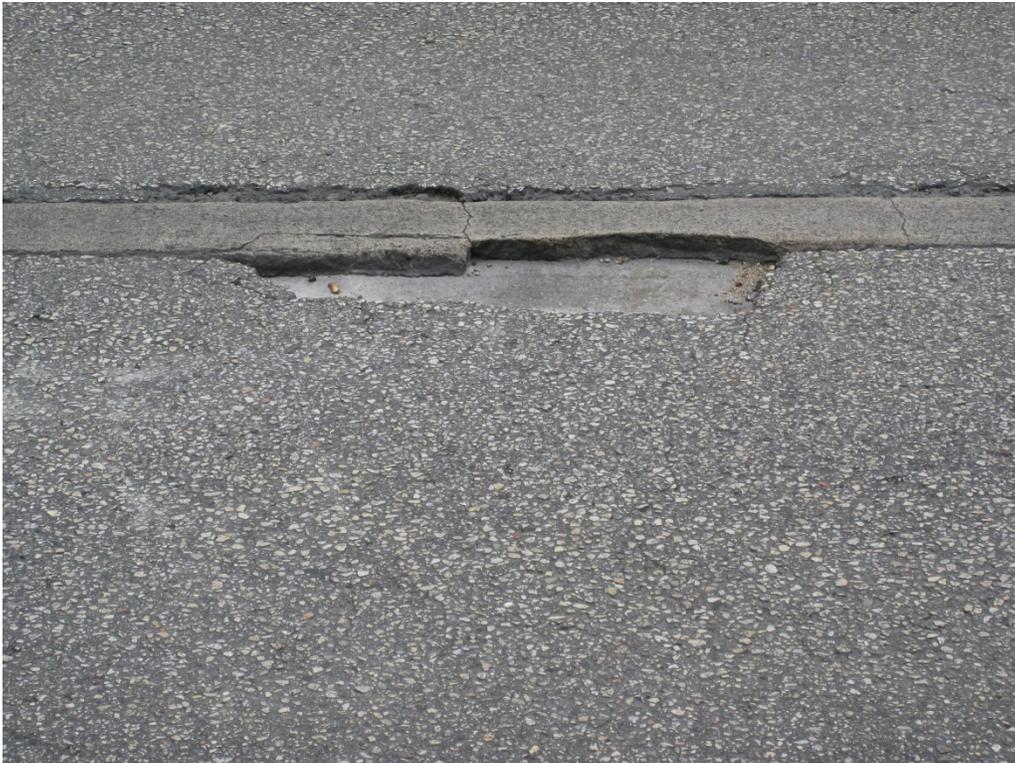
9. In the North Structure, the asphalt wearing surface adjacent to the concrete traffic stripe bump-out is spalled resulting in a 2 ft. long by 1 ft. wide pothole, located 72 feet east of the West Abutment (see **Photo 20**).

Photo 20: Pothole in North Structure wearing surface 72' east of the West Abutment

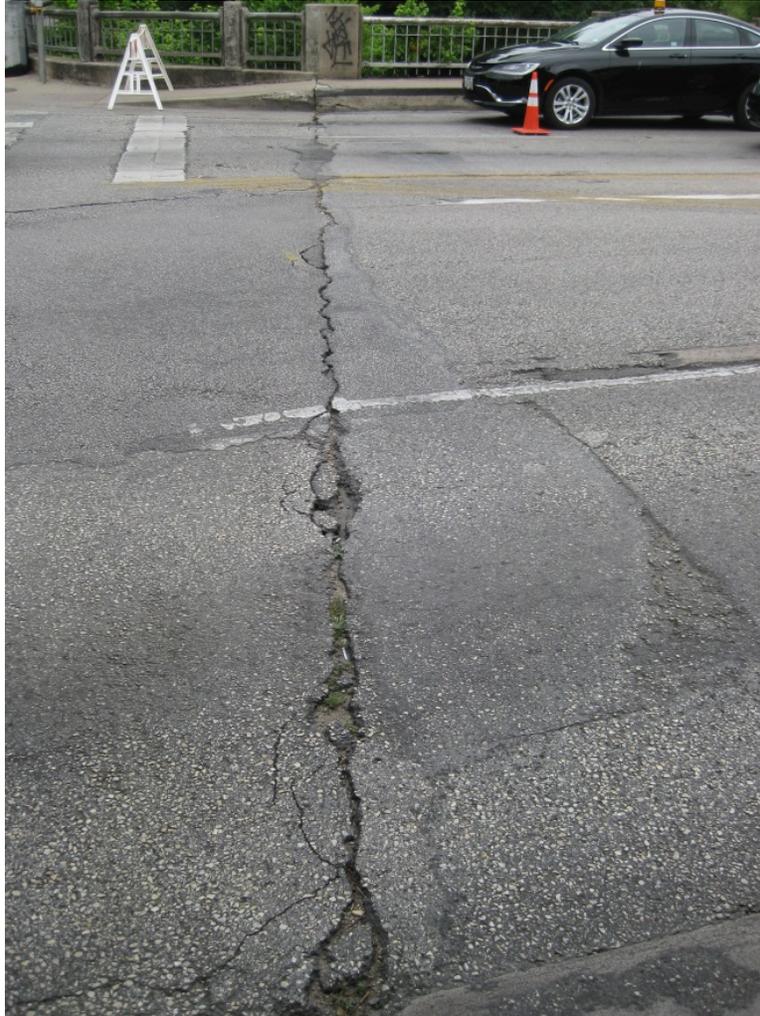
10. In the North Structure, the asphalt wearing surface at the East Approach Transition Joint is cracked with edge spalling similar to that observed in the South Structure East Approach Transition as described in Item 4 above (see **Photo 21**).

Photo 21: North Structure East Approach Transition

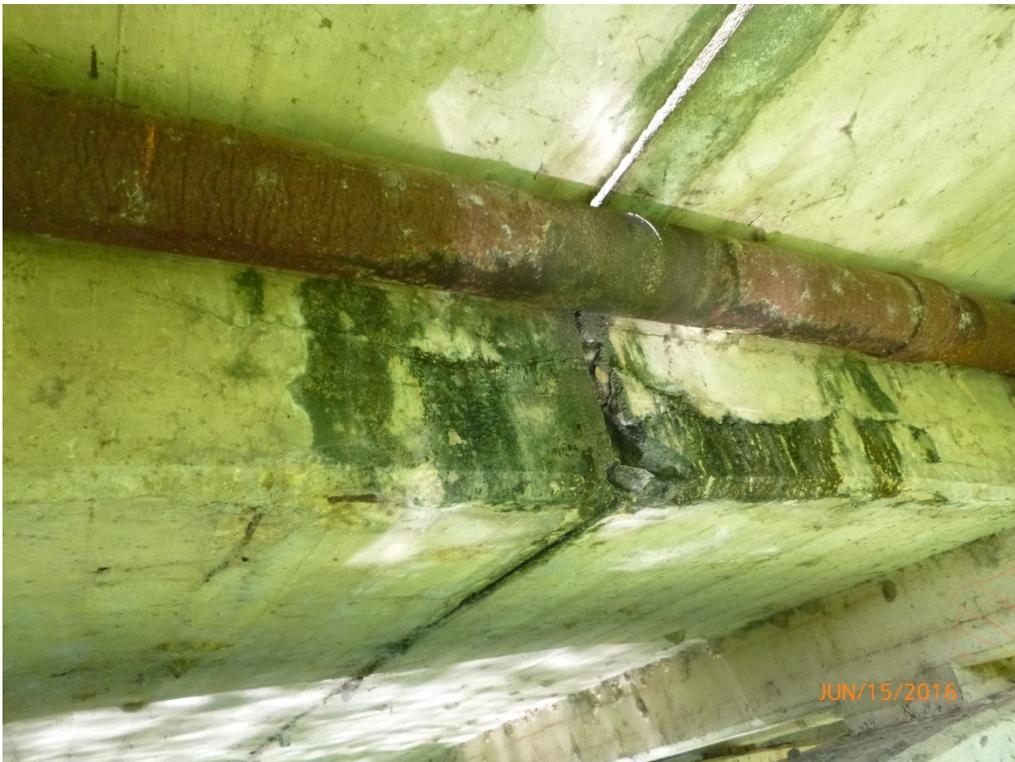
- In Span 2 between Floorbeam 11 and Floorbeam 12 extending eastward for a length of 4'-0" from the expansion joint (see **Photo 24**)
 - In Span 3 between Floorbeam 16 and Floorbeam 17 extending eastward and westward from the expansion joint for a length of 4 feet for a total length of 8 feet (see **Photo 25**)

Photo 25: Crack in Span 3 south slab edge between Floorbeams 16 and 17

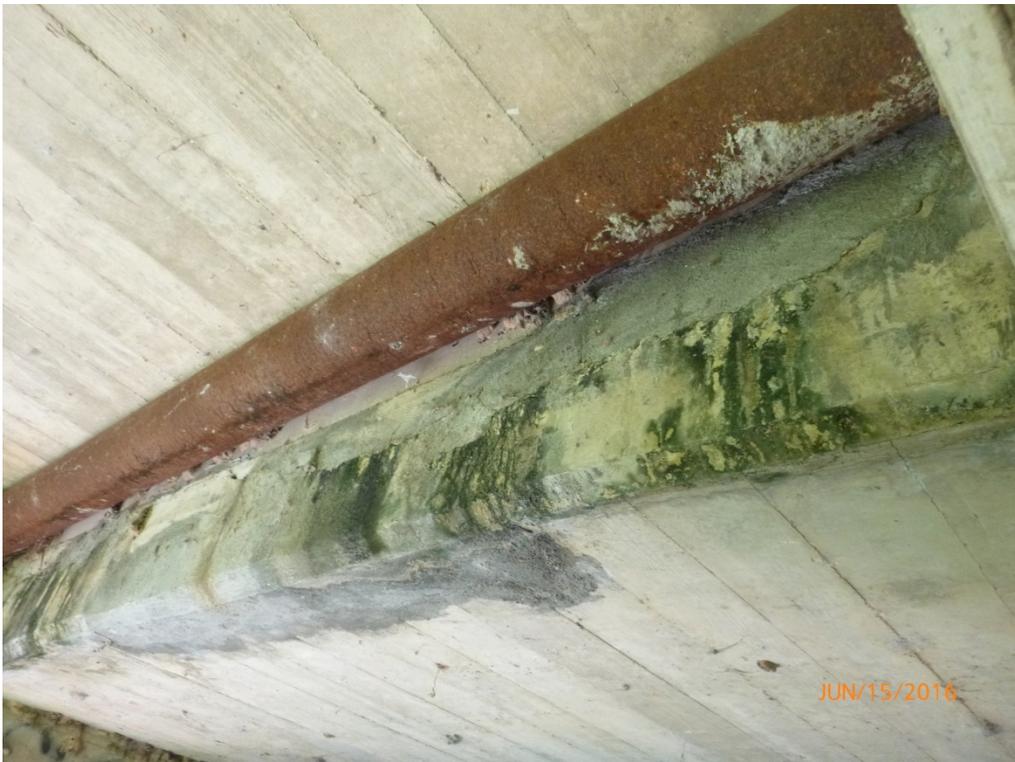
- In Span 3 between Floorbeam 19 and Floorbeam 20 for a length of 6'-0" (see **Photo 27**).
2. The underside of the deck (South Structure) is spalled directly over Arch Rib 4 near the expansion joint located midway between Floorbeam 4 and Floorbeam 5 measuring 12 inches square by 1 inch deep. There are four badly corroded reinforcing bars exposed in this spall. There are also three other smaller spalls approximately 3 inches wide by 6 inches long by 1 inch deep with a reinforcing bar exposed in this area (see **Photo 28**).

Photo 27: Crack in Span 3 south slab edge between Floorbeams 19 and 20

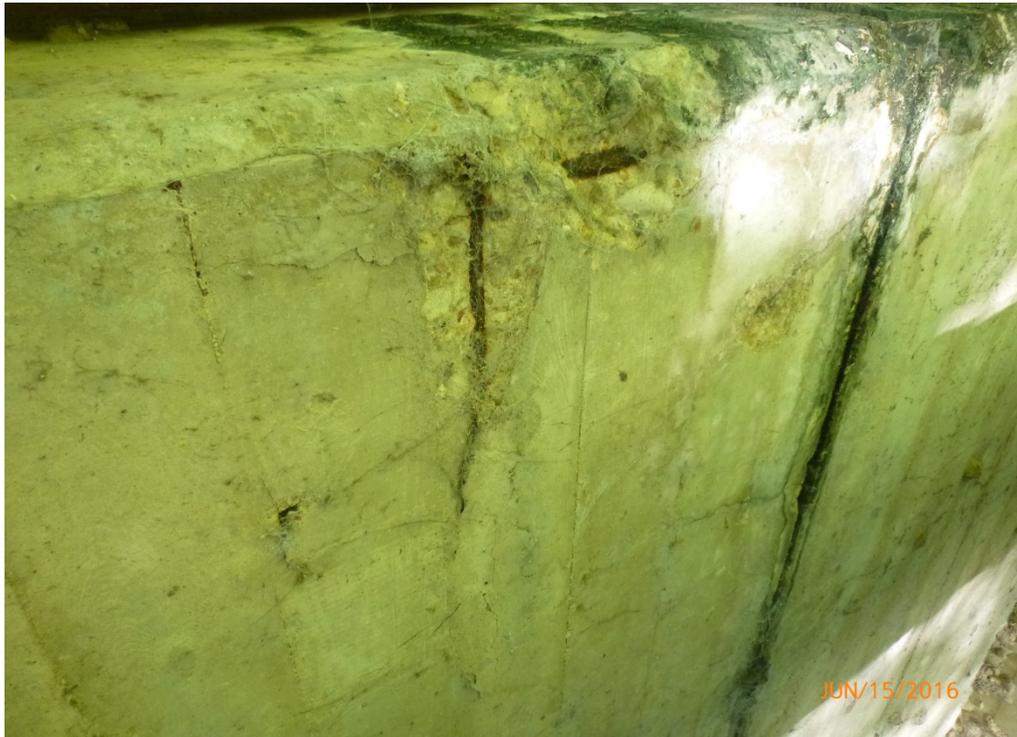
11. The underside of the deck (South Structure) is spalled with corroded reinforcing bars exposed along the south edge located near the expansion joint between Floorbeam 16 and Floorbeam 17 measuring 15 inches long by up to 15 inches wide by 2 inches deep (see **Photo 38**).

Photo 38: Spall in Span 3 South Structure deck along the south lower edge at the expansion joint between Floorbeams 16 and 17

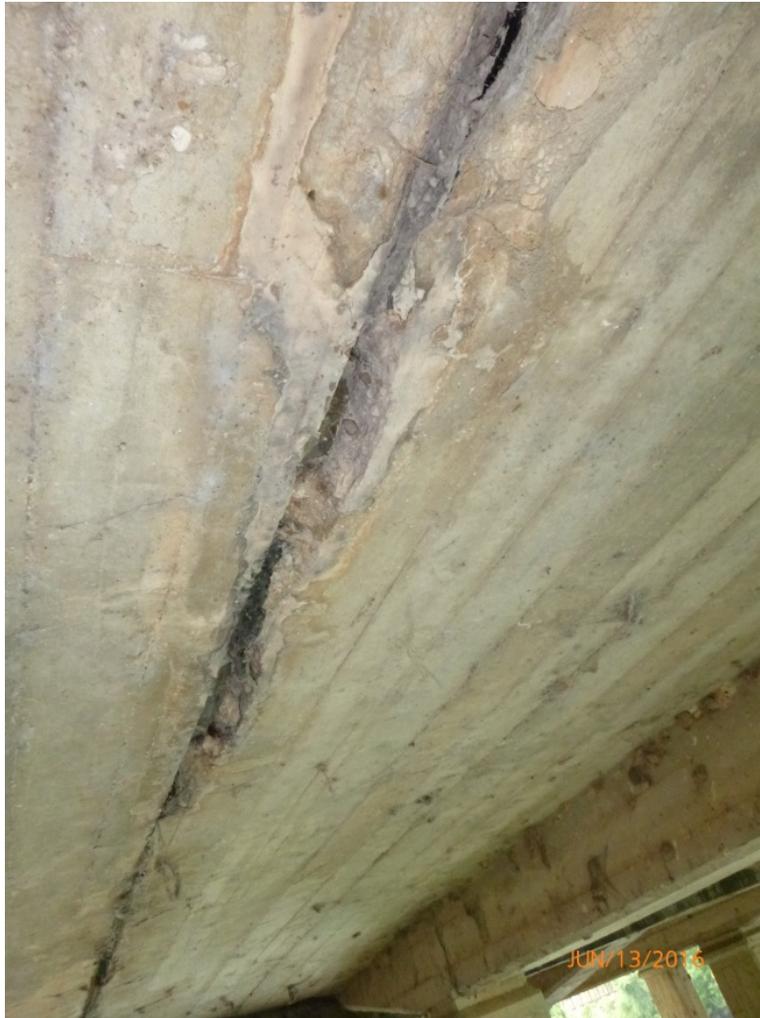
In Span 1, the edges of the deck along the expansion joint (South Structure) located midway between Floorbeam 4 and Floorbeam 5 exhibit spalling up to 3 inches wide by 2 inches deep at several locations along the joint. The expansion joint filler material is badly weathered and is disintegrating within the joint (see **Photo 39**).

Photo 39: Edge spalls along expansion joint in Span 1 of the South Structure midway between Floorbeams 4 and 5

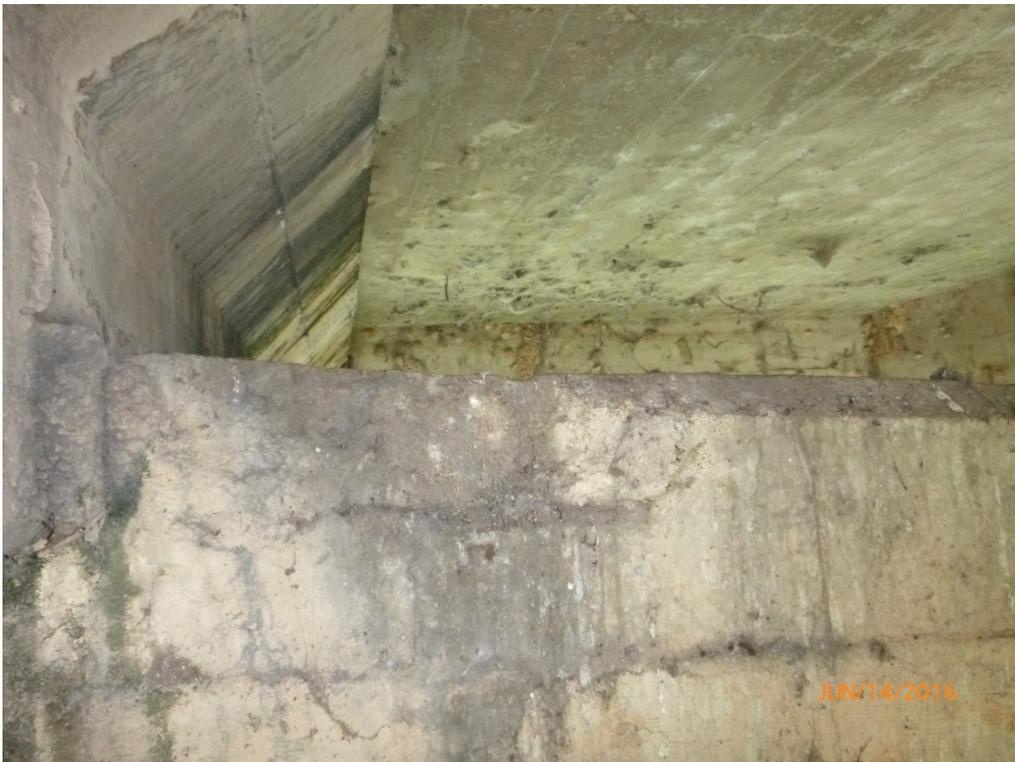
5. In Span 2, the top north corner of Arch Rib 2 is spalled measuring 10 inch wide by 4 inches high by 1 inch deep, located just west of Floorbeam 10 (see **Photo 45**).

Photo 45: Spall in top north corner of Arch Rib 2 in Span 2 just west of Floorbeam 10

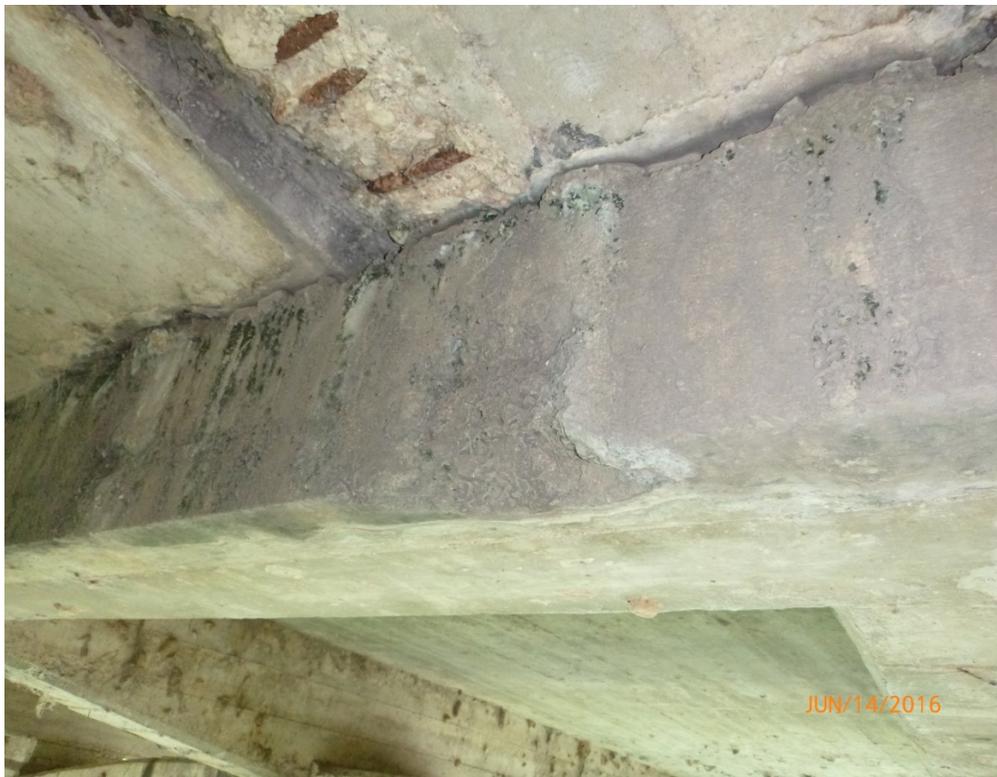
Photo 58: Spalls in lower south edge of longitudinal beam in Span 2 below the expansion joint between Floorbeams 11 and 12

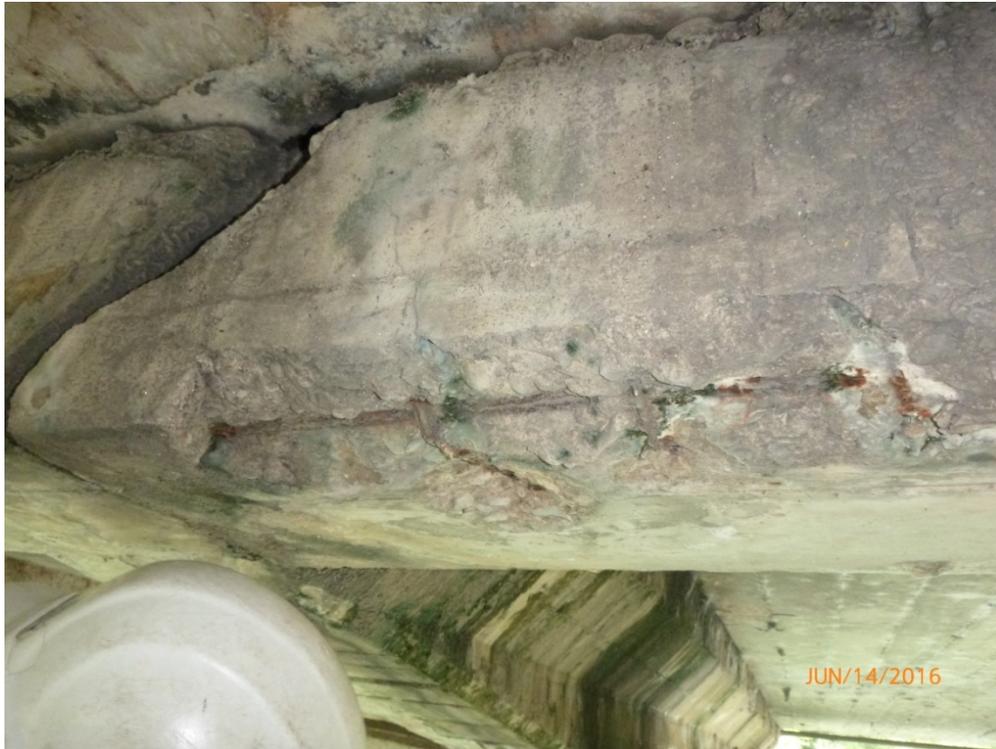
Photo 59: Spall with exposed rebar and ties in lower south edge of longitudinal beam in Span 2 adjacent to expansion joint at the North Structure Floorbeam 11

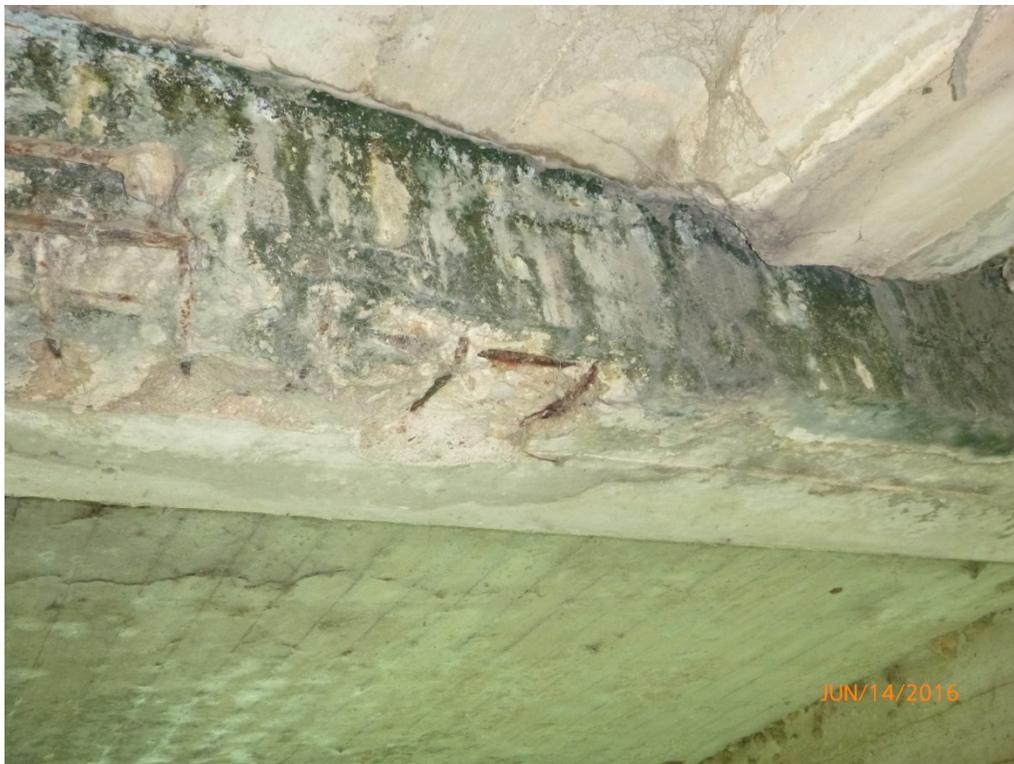
Photo 60: Deterioration in lower south face and corner of longitudinal beam with exposed rebar in Span 2 between Floorbeams 13 and 14

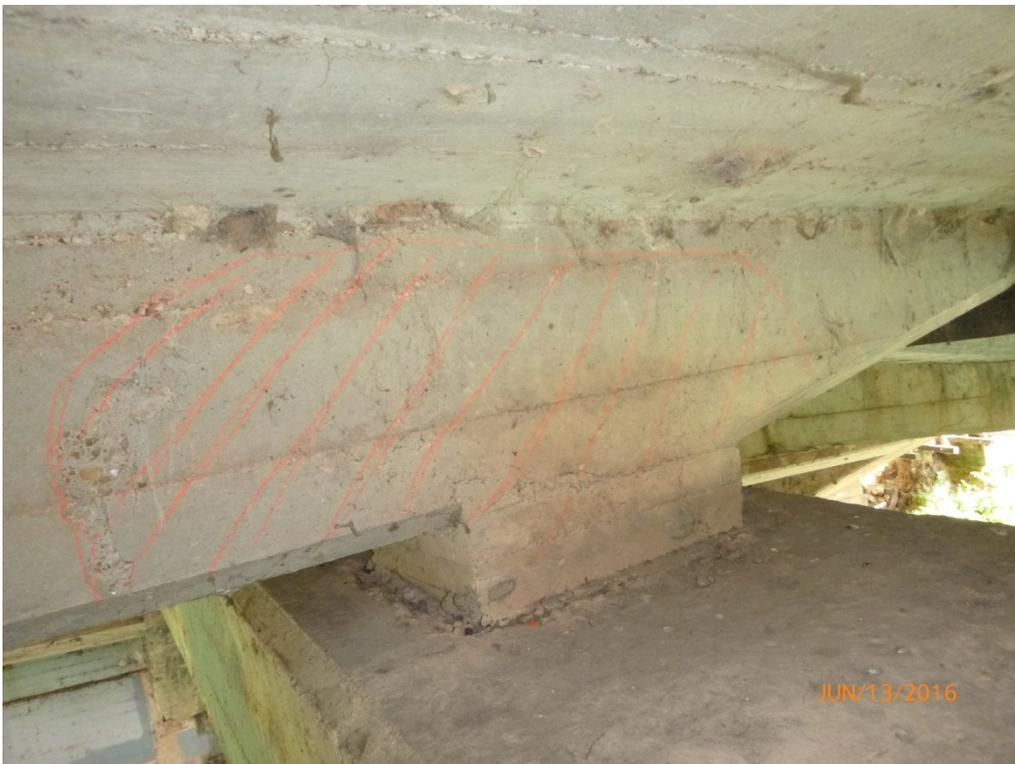
Photo 68: Delamination in east face of Floorbeam and Spandrel Column 4 at Arch Rib 3

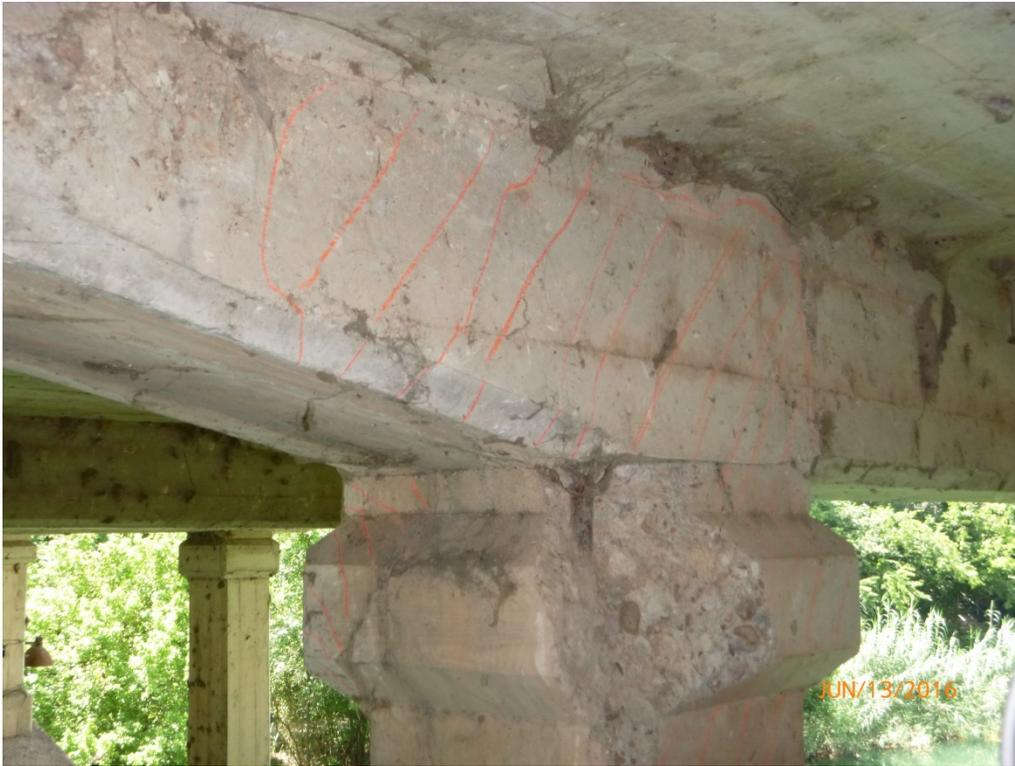
Photo 69: Delamination in west face of Floorbeam 5 at Arch Rib 3

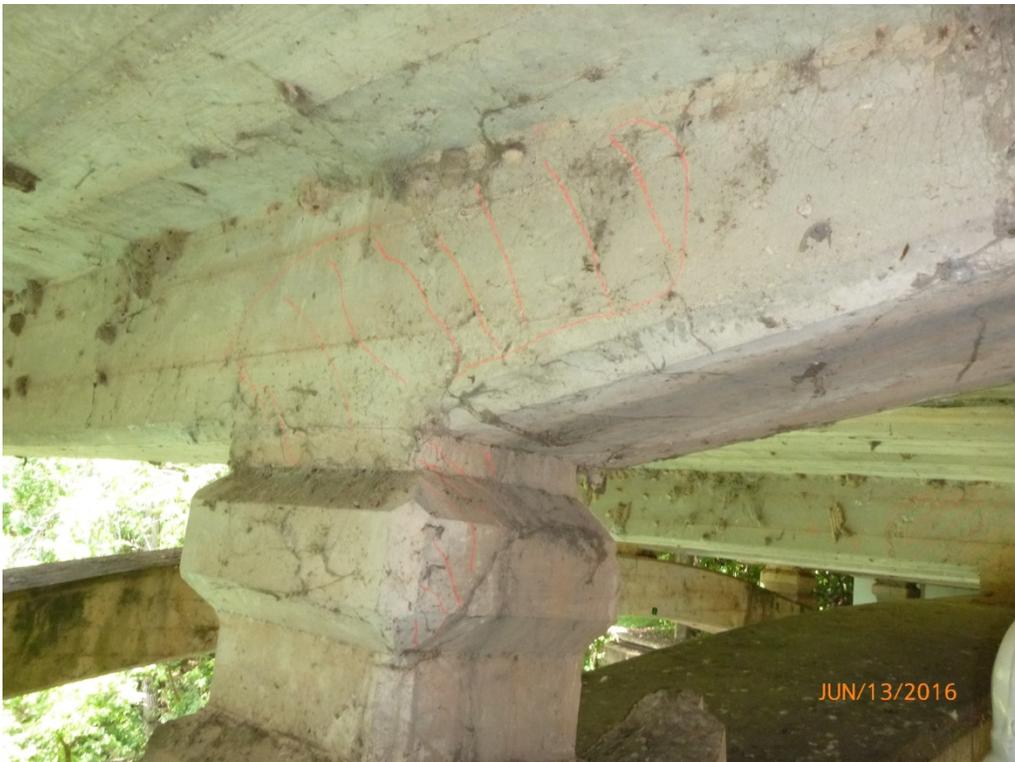
Photo 70: Delamination in east face of Floorbeam 5 at Arch Rib 3

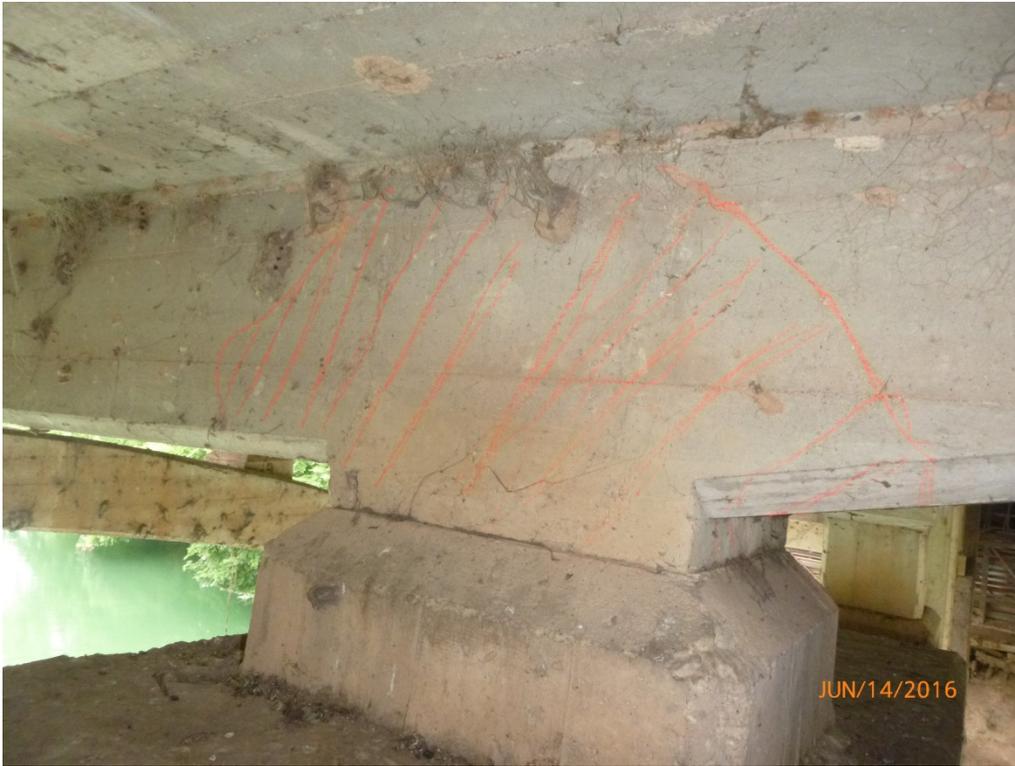
Photo 71: Delamination in east face of Floorbeam 10 at Arch Rib 3

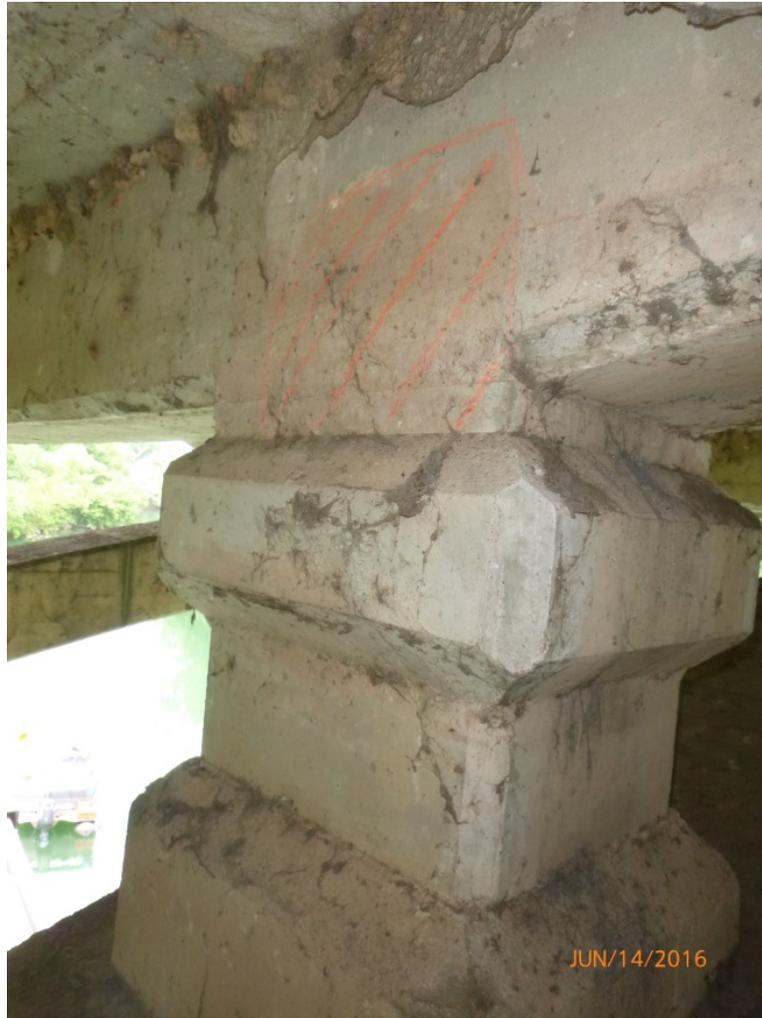
Photo 72: Delamination in east face of Floorbeam 12 at Arch Rib 3

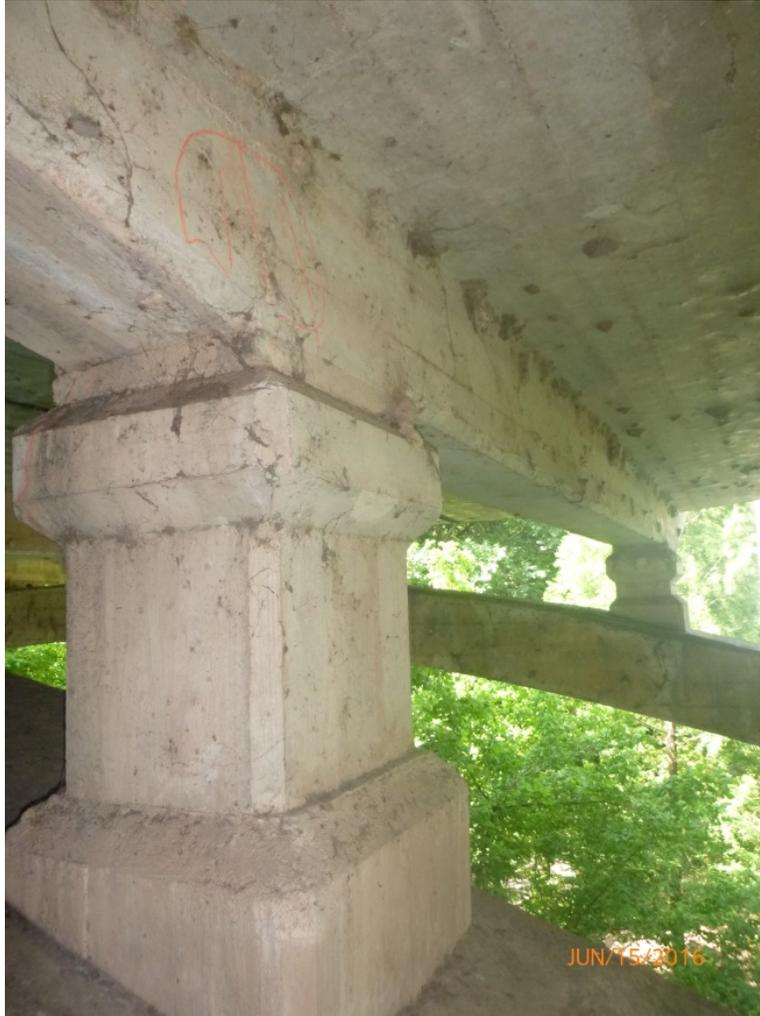
Photo 73: Delamination in west face of Floorbeam 16 at Arch Rib 3

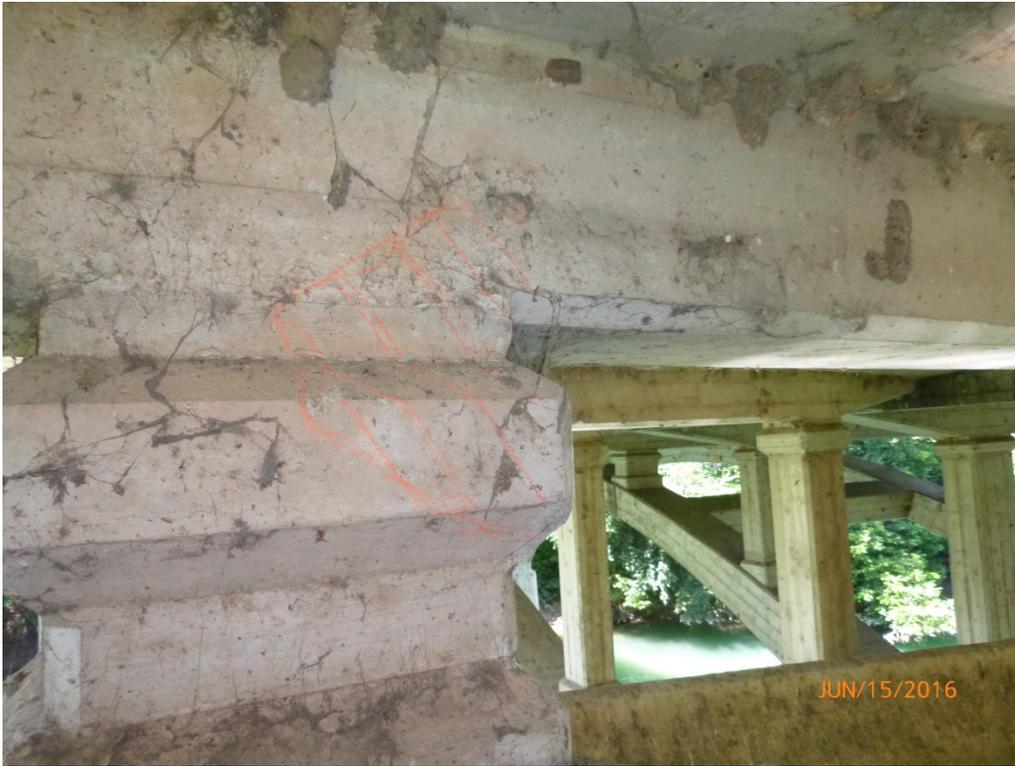
Photo 74: Delamination in east face of Floorbeam 16 at Arch Rib 4

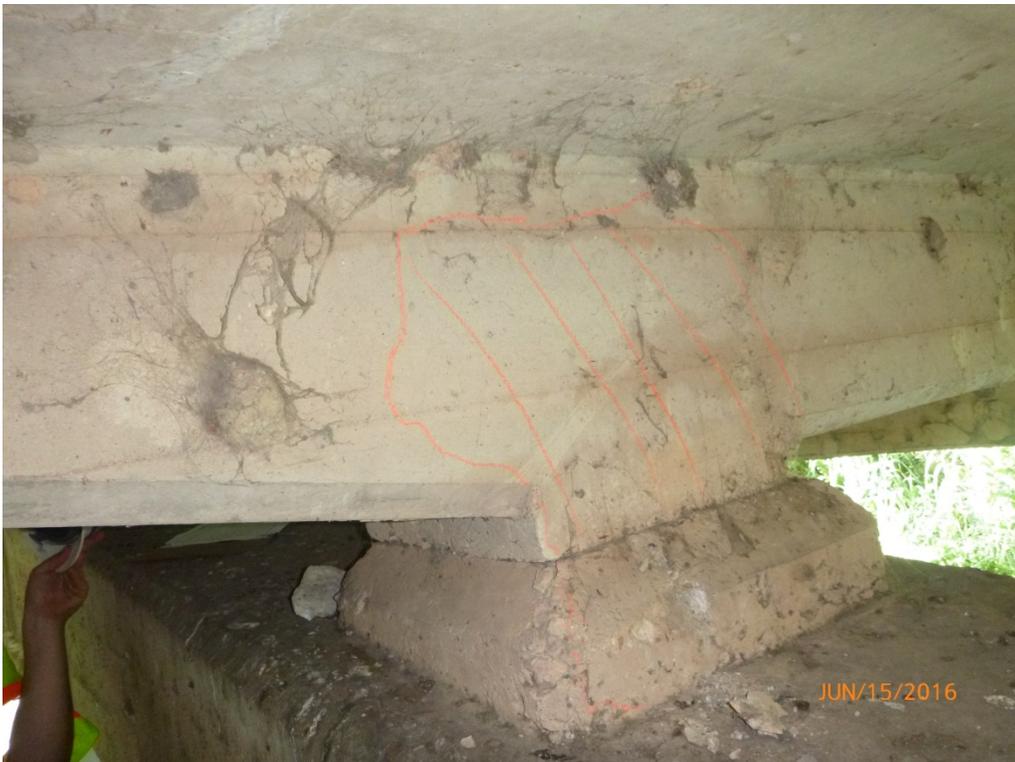
Photo 75: Delamination in west face of Floorbeam and Spandrel Column 17 at Arch Rib 3

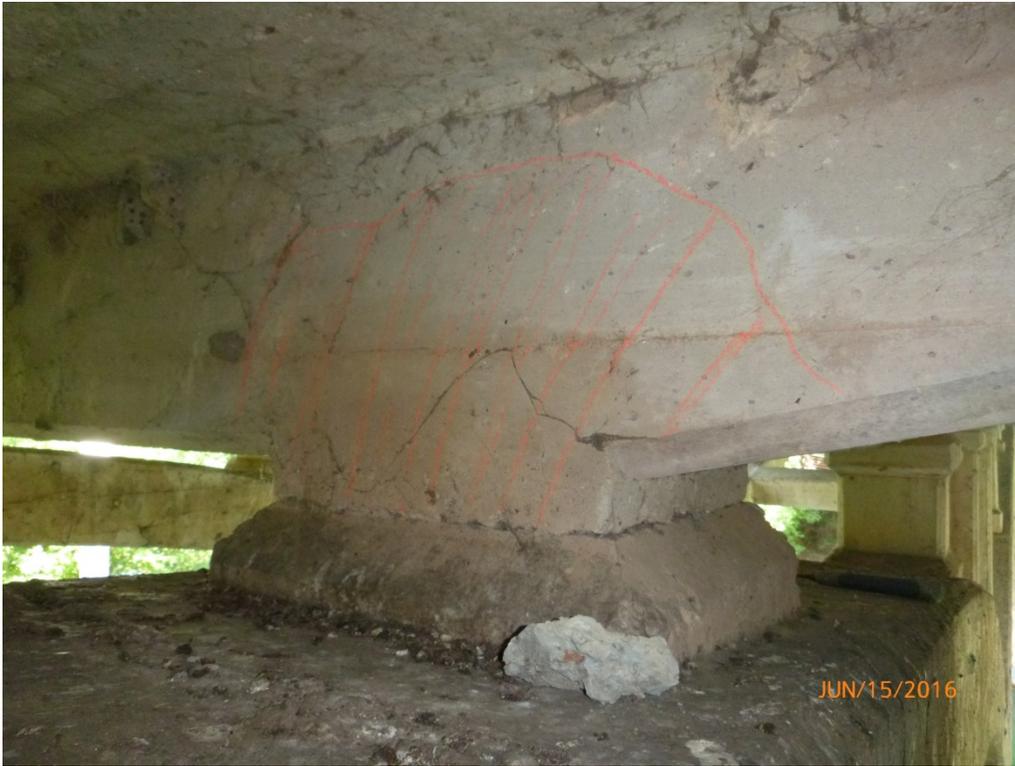
Photo 76: Delamination in east face of Floorbeam 17 at Arch Rib 3

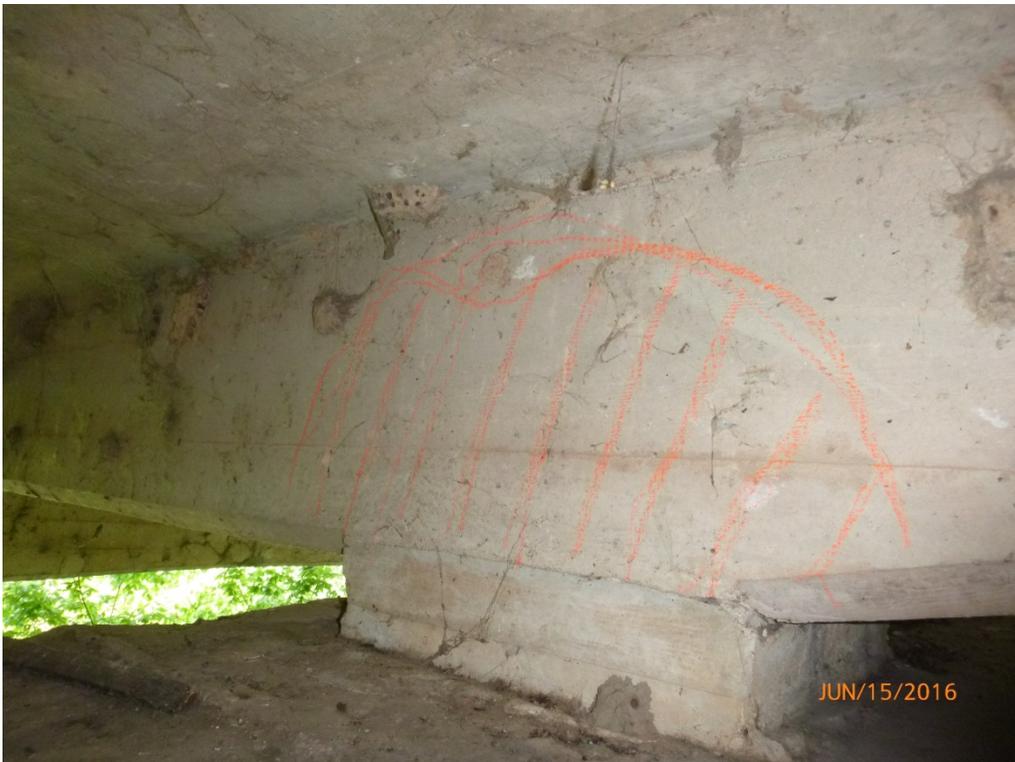
Photo 77: Delamination in east face of Floorbeam 18 at Arch Rib 3

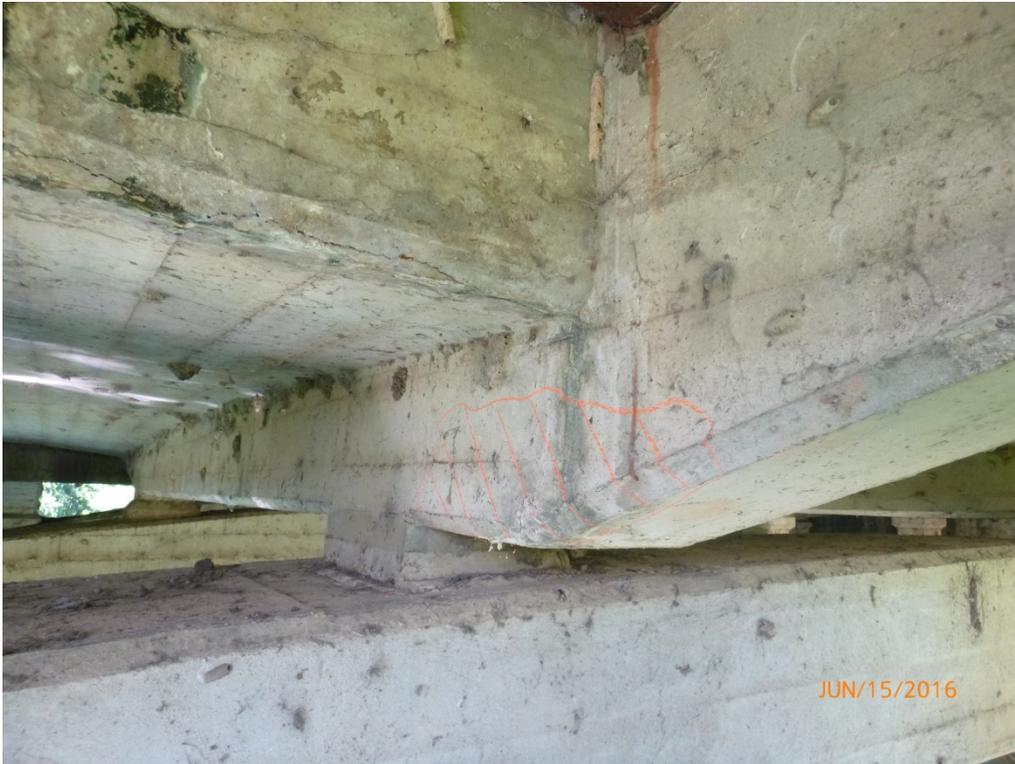
Photo 78: Delamination in lower west face of south cantilever of South Structure Floorbeam 17

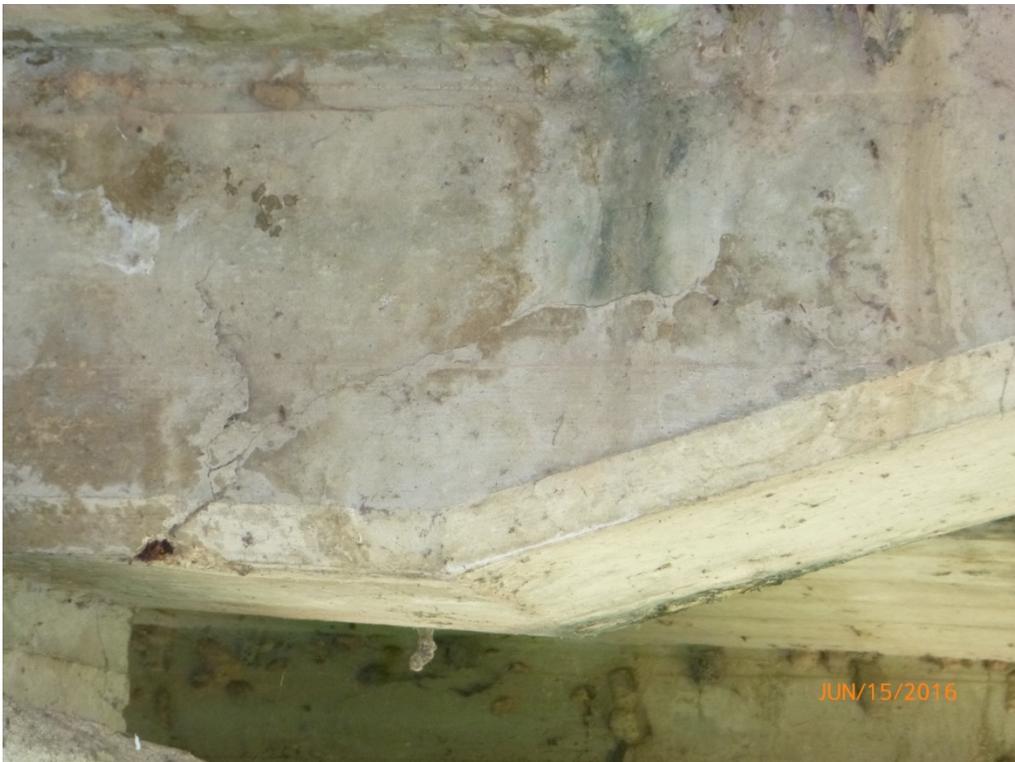
Photo 79: Crack (up to 1/64") located in lower west face of south cantilever of South Structure Floorbeam 18

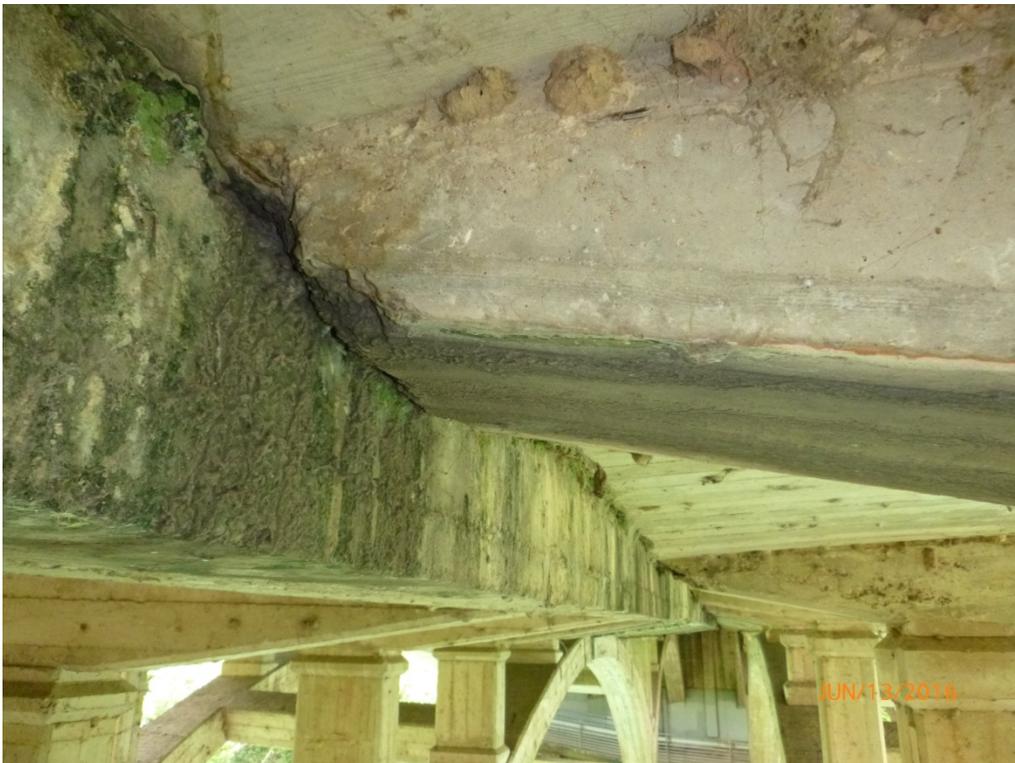
Photo 81: Typical minor deterioration of north end north cantilever of South Structure
