BARTON SPRINGS ROAD OVER BARTON CREEK

Bridge Inspection and Condition Assessment Report

Bridge 14-227-0-B002-26-001
Austin, Texas
January 2017

2016 Bridge Inspection Report
Barton Springs Road over Barton Creek
Bridge 14-227-0-B002-26-001

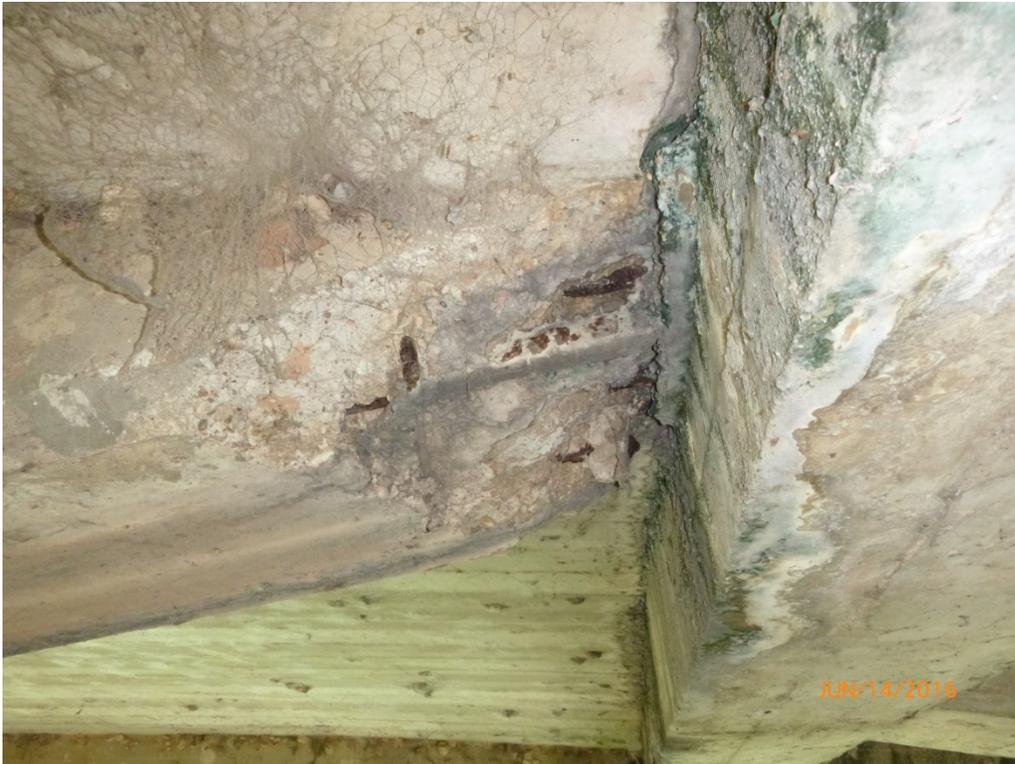
Photo 82: Typical severe deterioration of north end north cantilever of South Structure

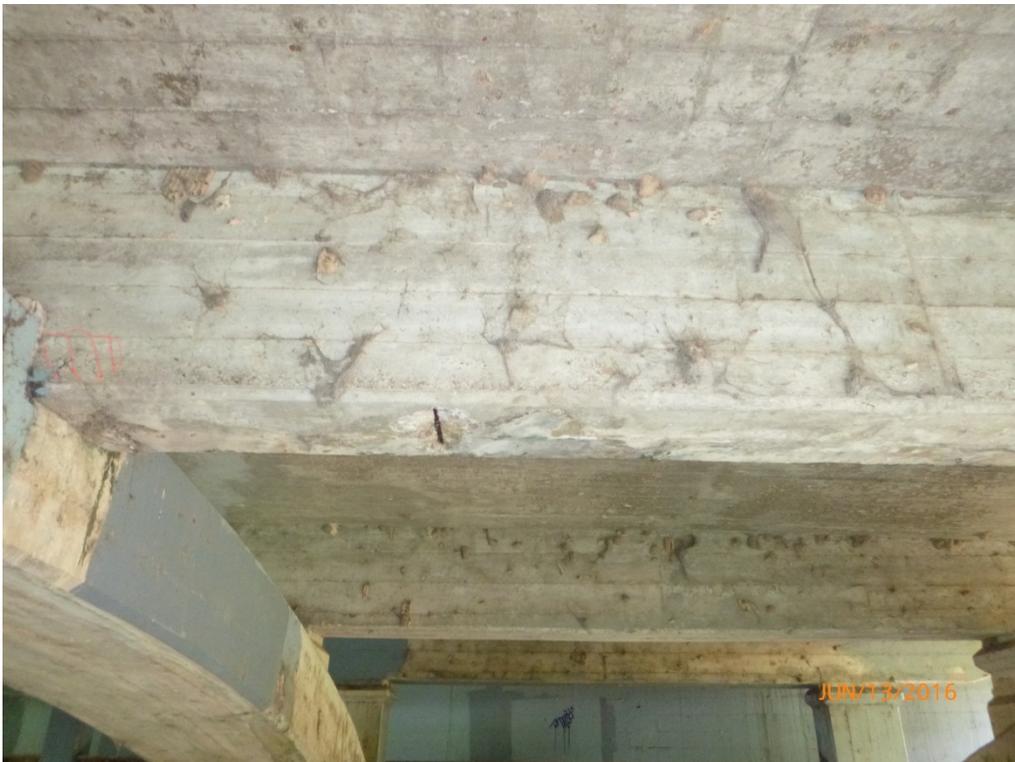
Photo 83: Delamination and spalling with exposed rebar on underside and east face of Floorbeam 3 between Arch Ribs 1 and 2

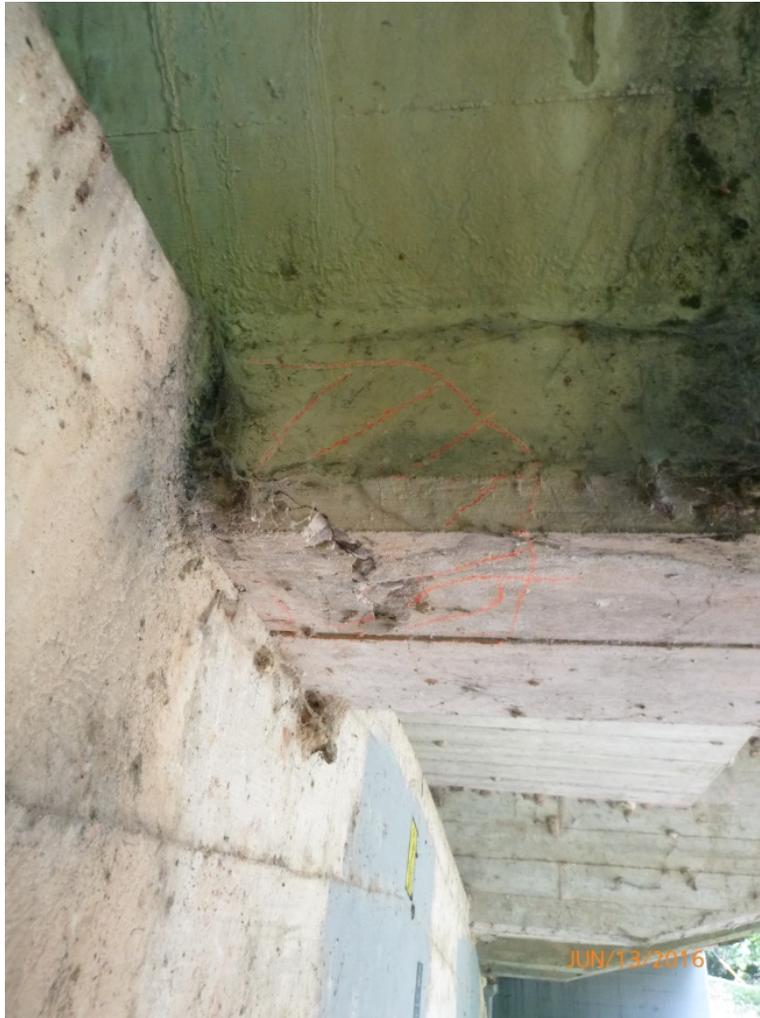
Photo 84: Delamination with shallow spalling on lower corner of east face of Floorbeam 4 on the north side of Arch Rib 1

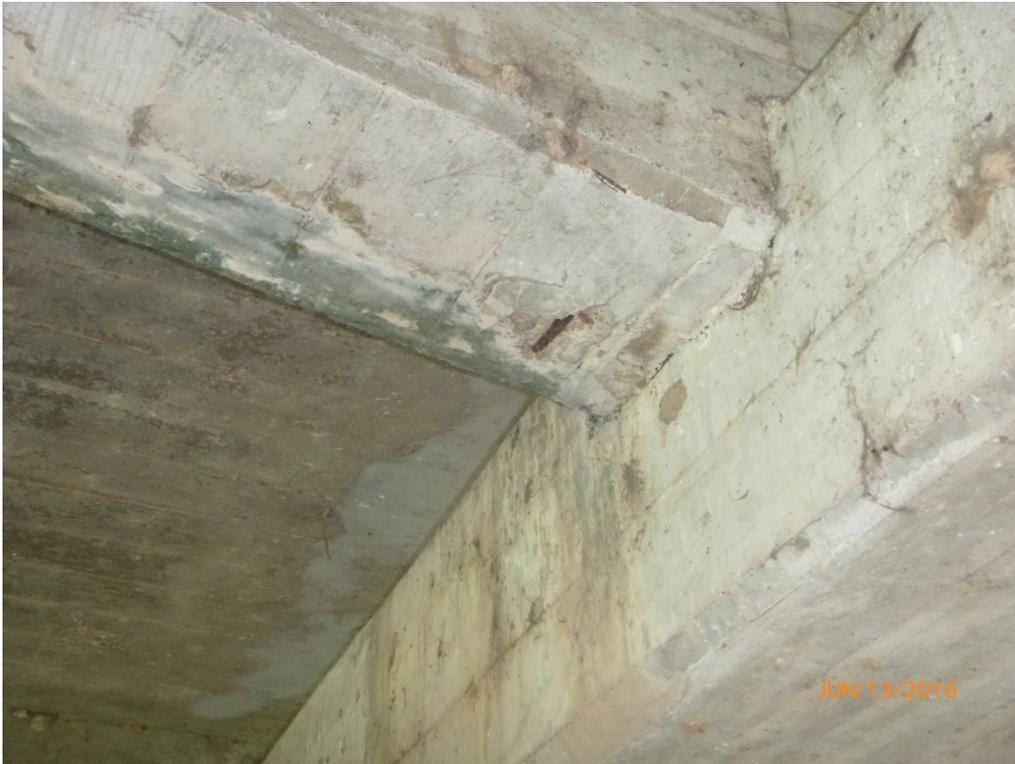
Photo 85: Spall in underside of south cantilever of Floorbeam 3 at Arch Rib 2

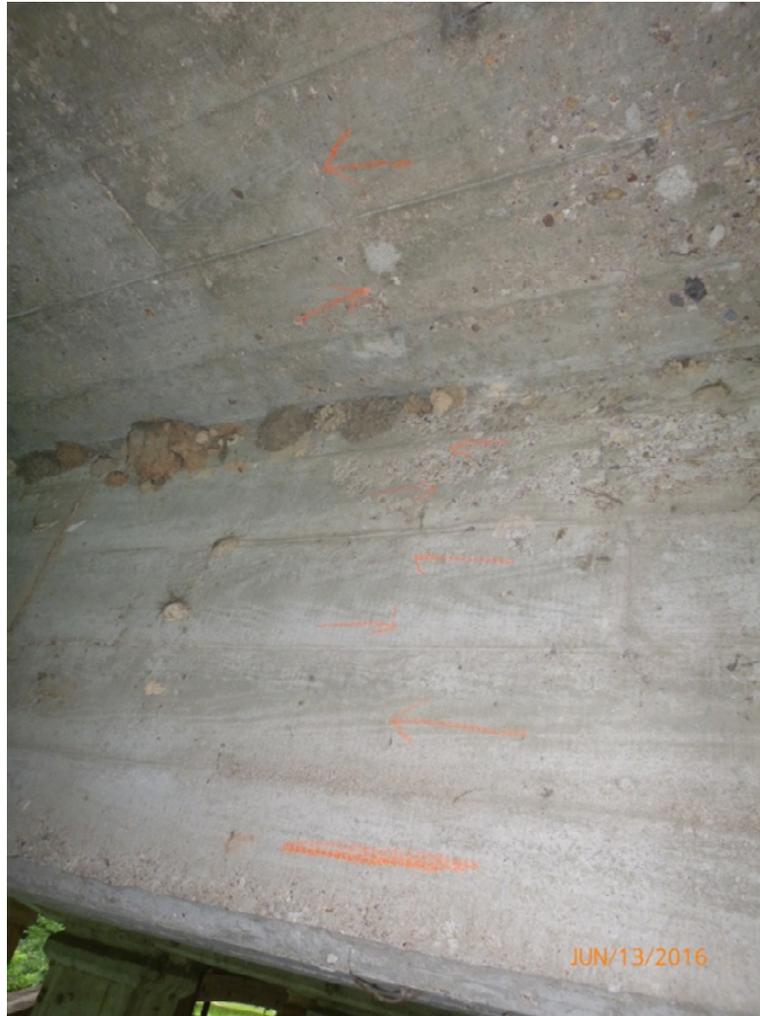
Photo 86: Hairline crack on east and west faces of Floorbeam 8 located 6' south of Arch Rib 1 and continuing on the underside of the deck on either side of floorbeam

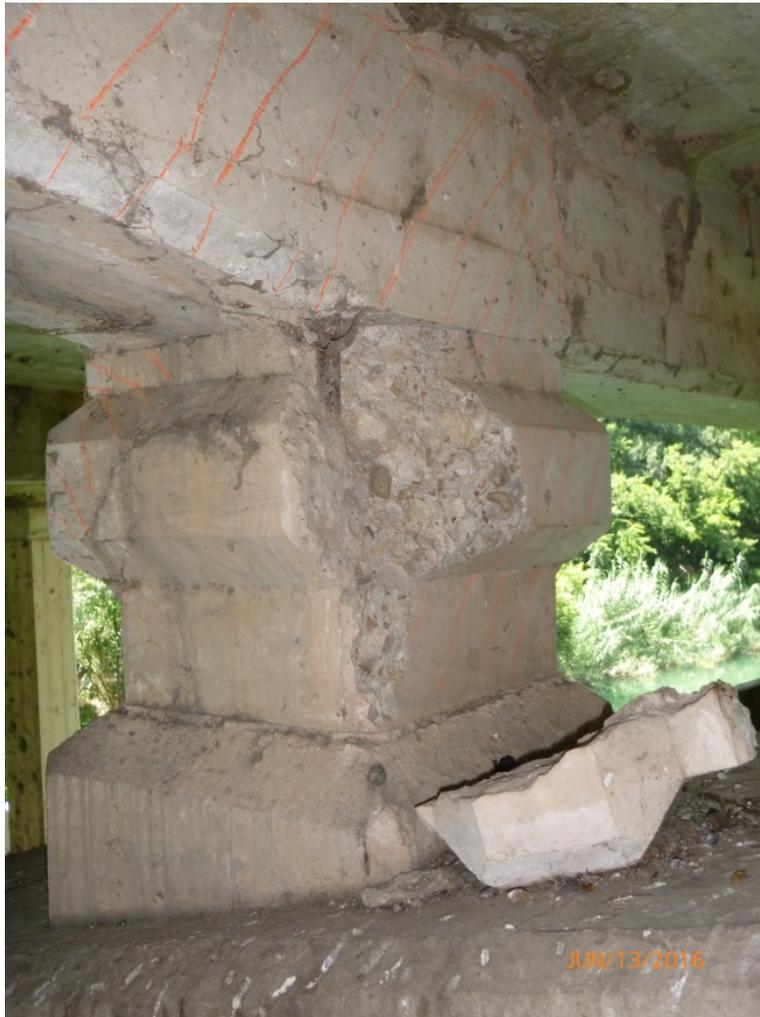
Photo 93: Spalling in northwest corner of Spandrel Column 5 over Arch Rib 3

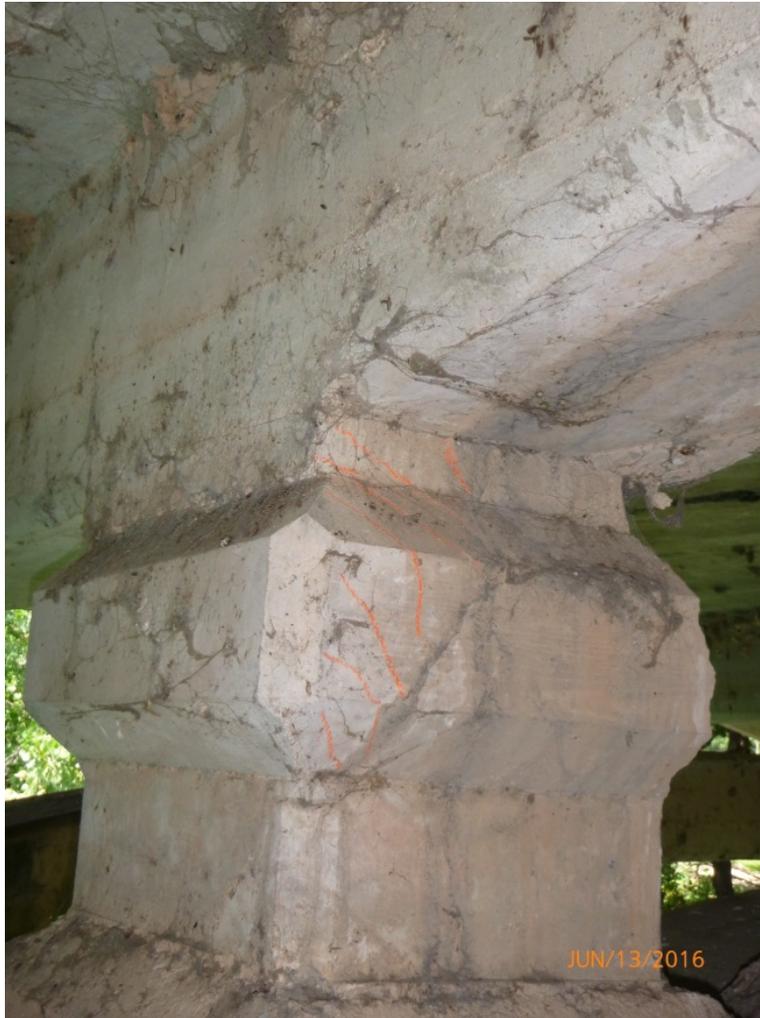
Photo 94: Delamination in northeast corner of Spandrel Column 5 over Arch Rib 3

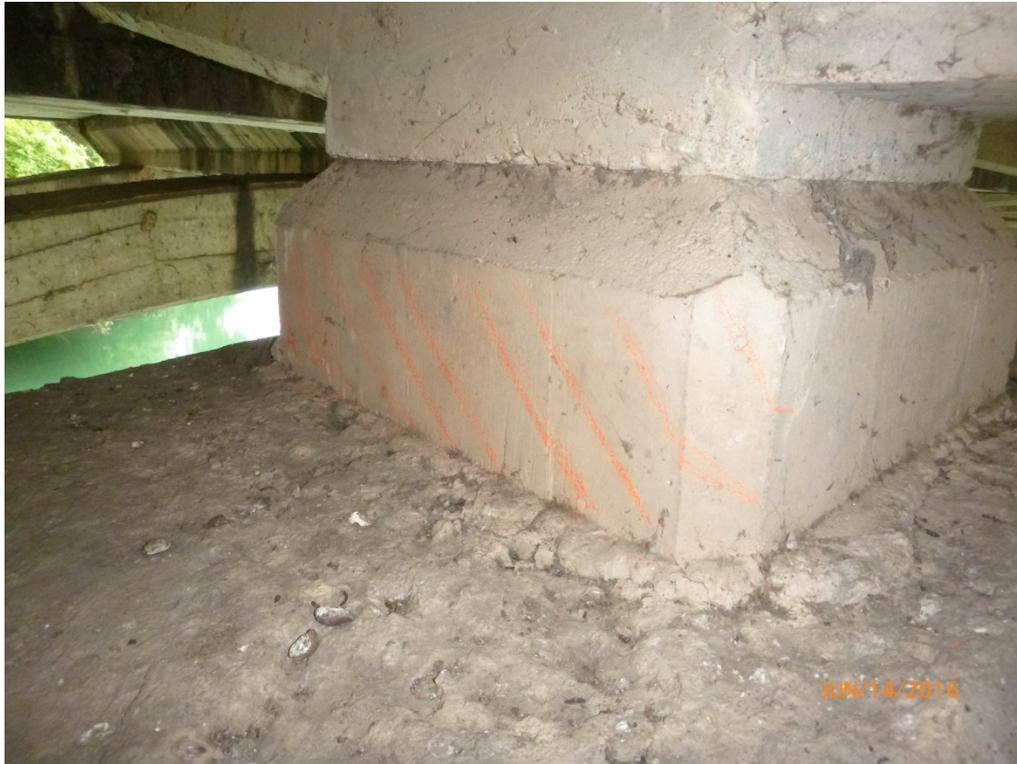
Photo 95: Delaminated pedestal at west face of Spandrel Column 10 over Arch Rib 3

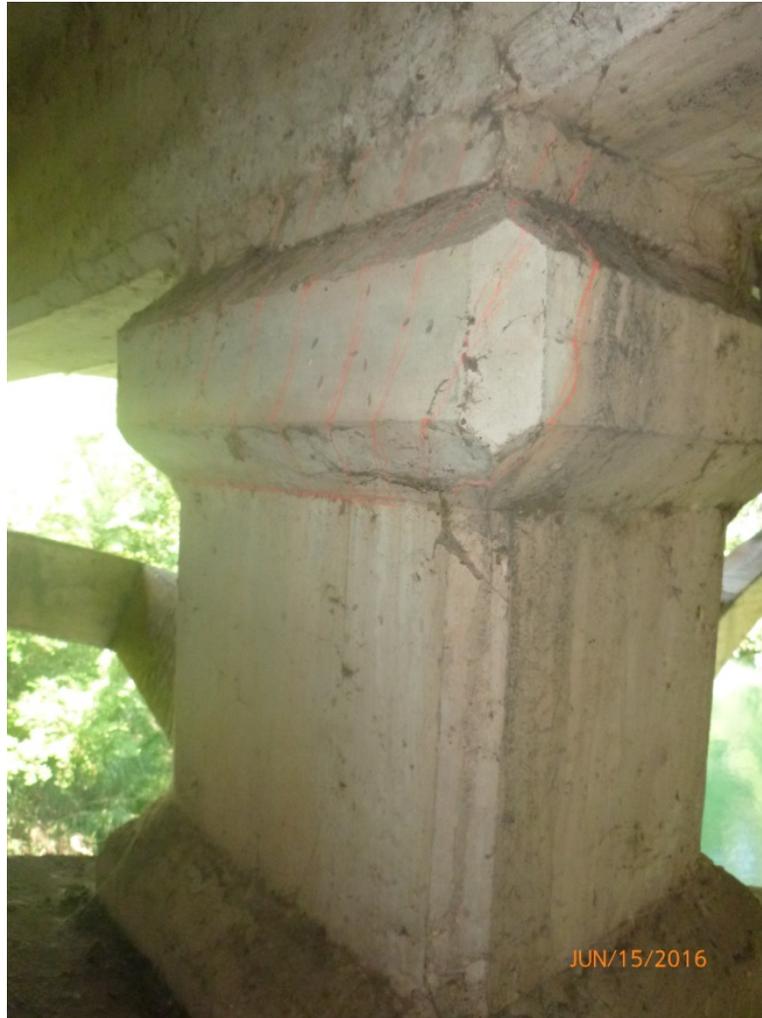
Photo 96: Delamination in east face of upper collar of Spandrel Column 16 over Arch Rib 3

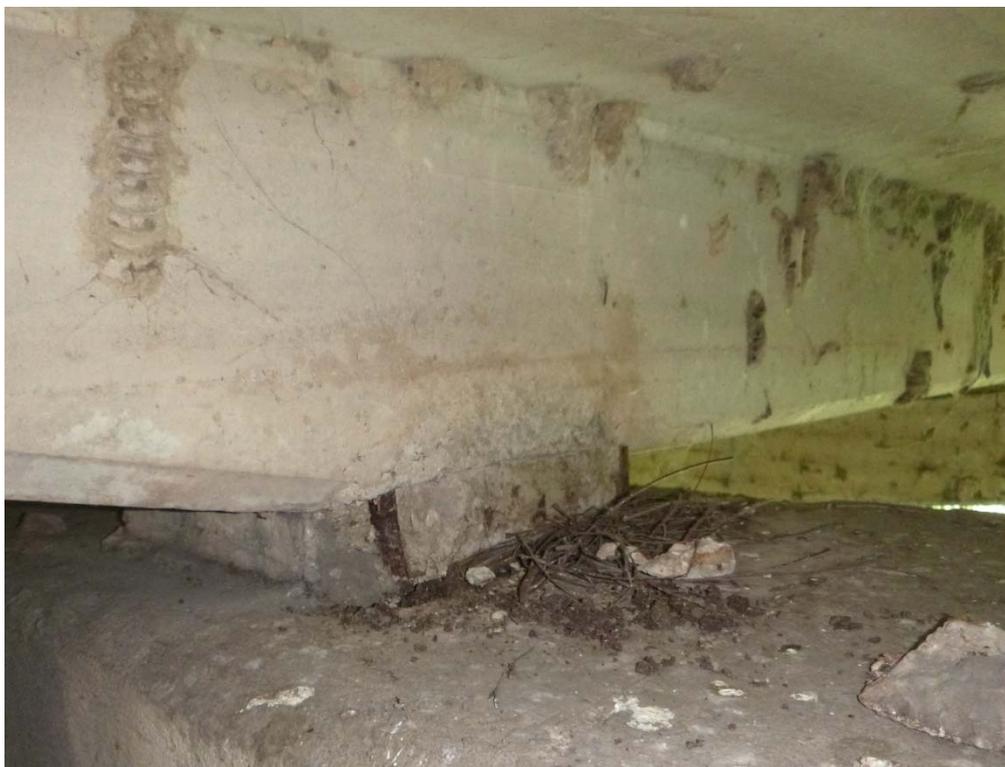
Photo 97: Spall on west face of Spandrel Column 18 over Arch Rib 3

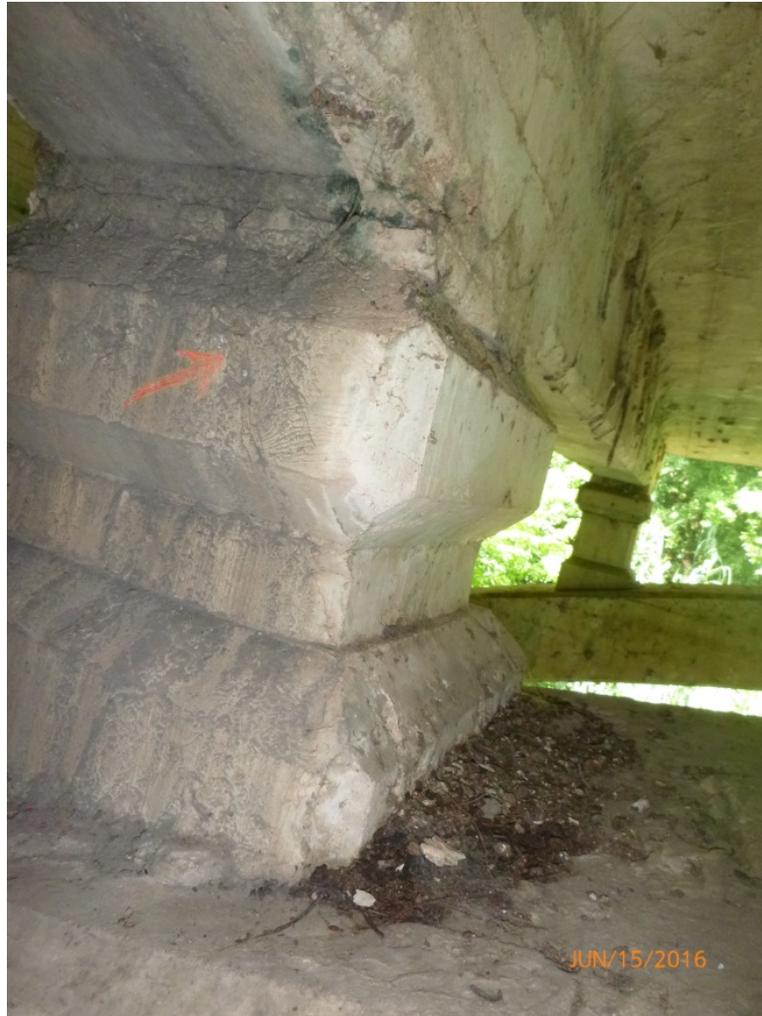
Photo 98: Diagonal crack on north face of Spandrel Column 19 over Arch Rib 3

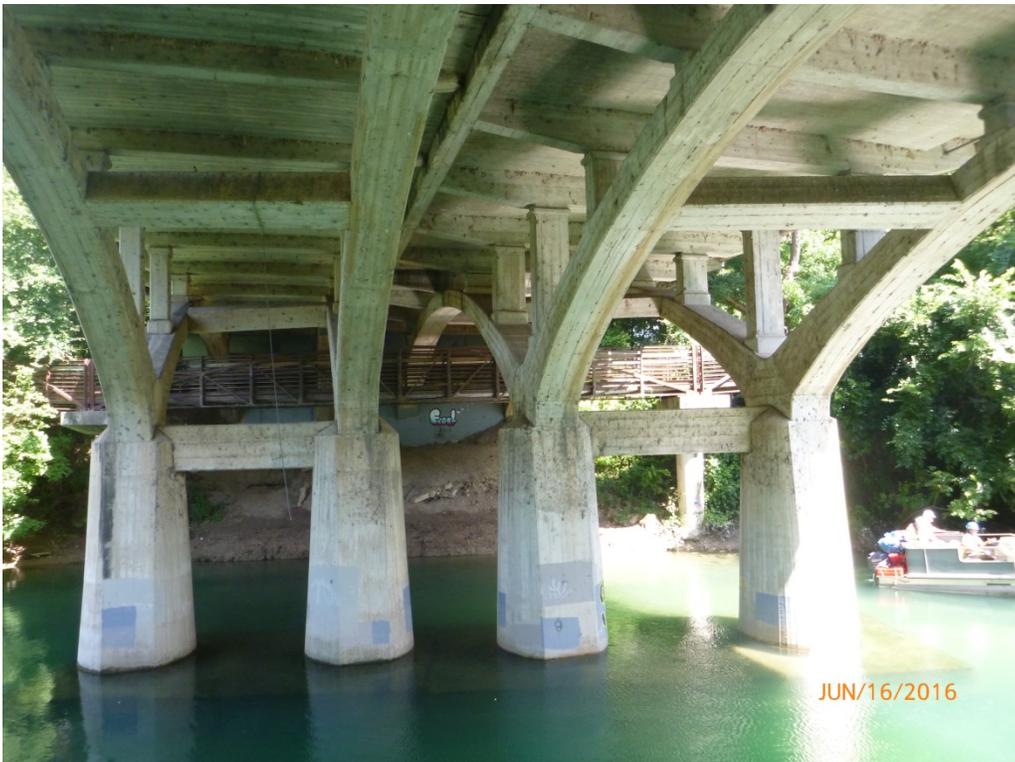
Photo 100: Typical condition of Pier 1 – east face shown

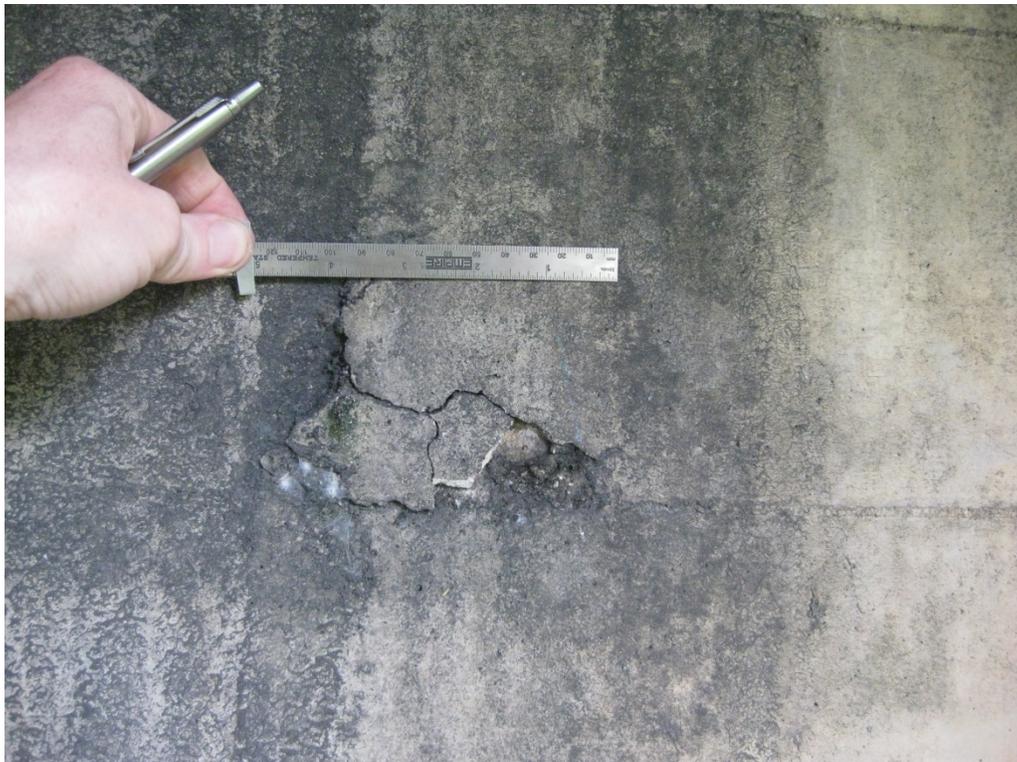
Photo 102: Delamination in West Abutment 35" north of Arch Rib 1

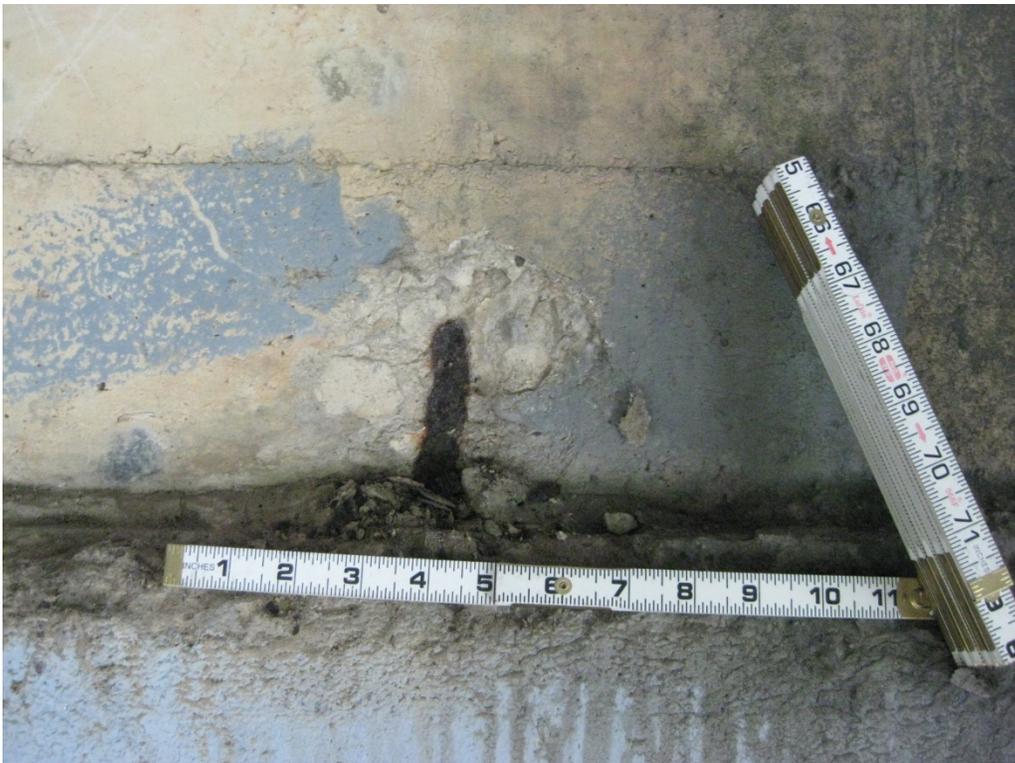
Photo 104: Spall with exposed rebar at West Abutment Backwall seat 28" north of Arch Rib 3

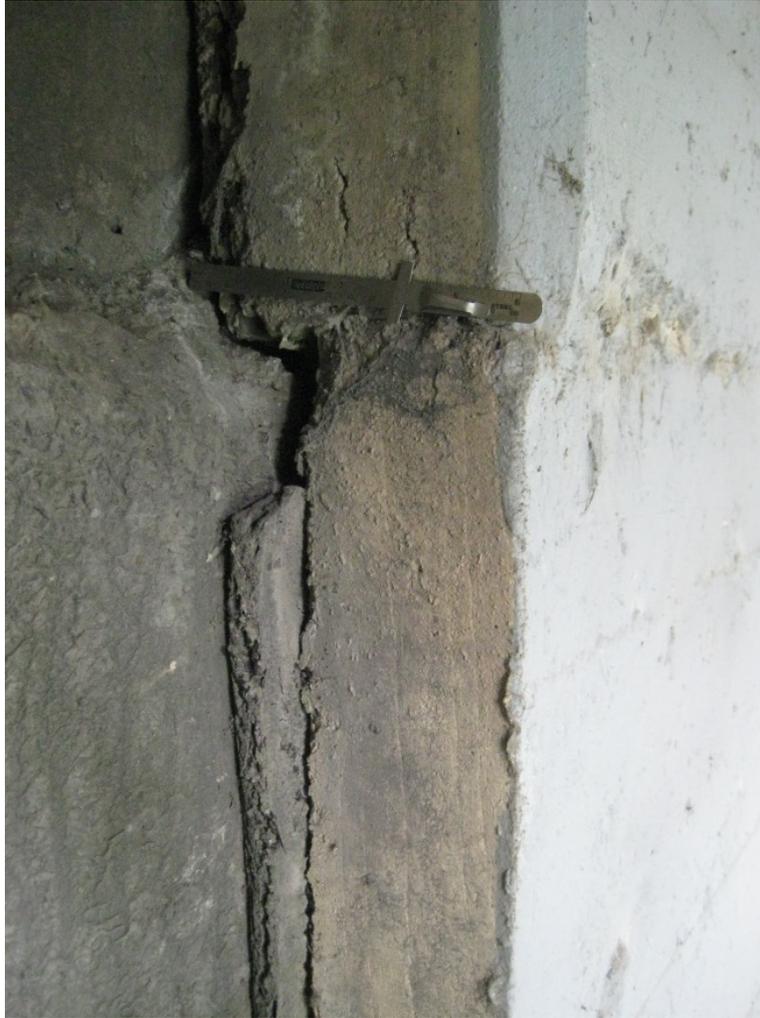
Photo 105: Expansion joint material at the North/South Structure joint at the West Abutment

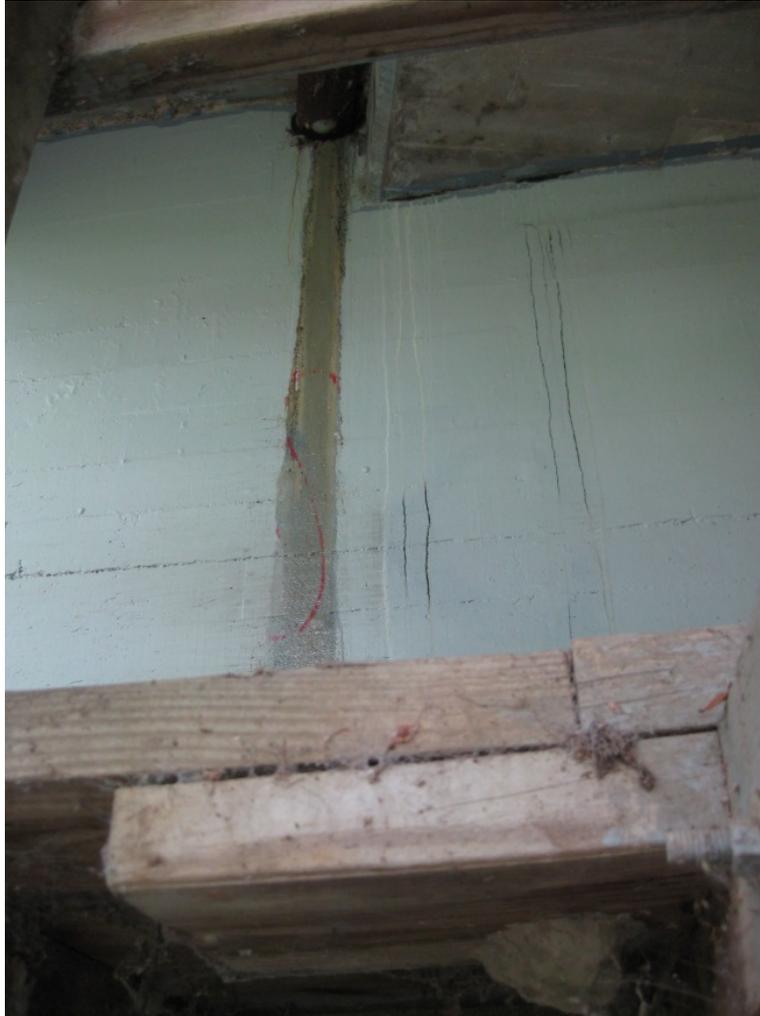
Photo 106: Leaking utility pipe at the south end of the West Abutment

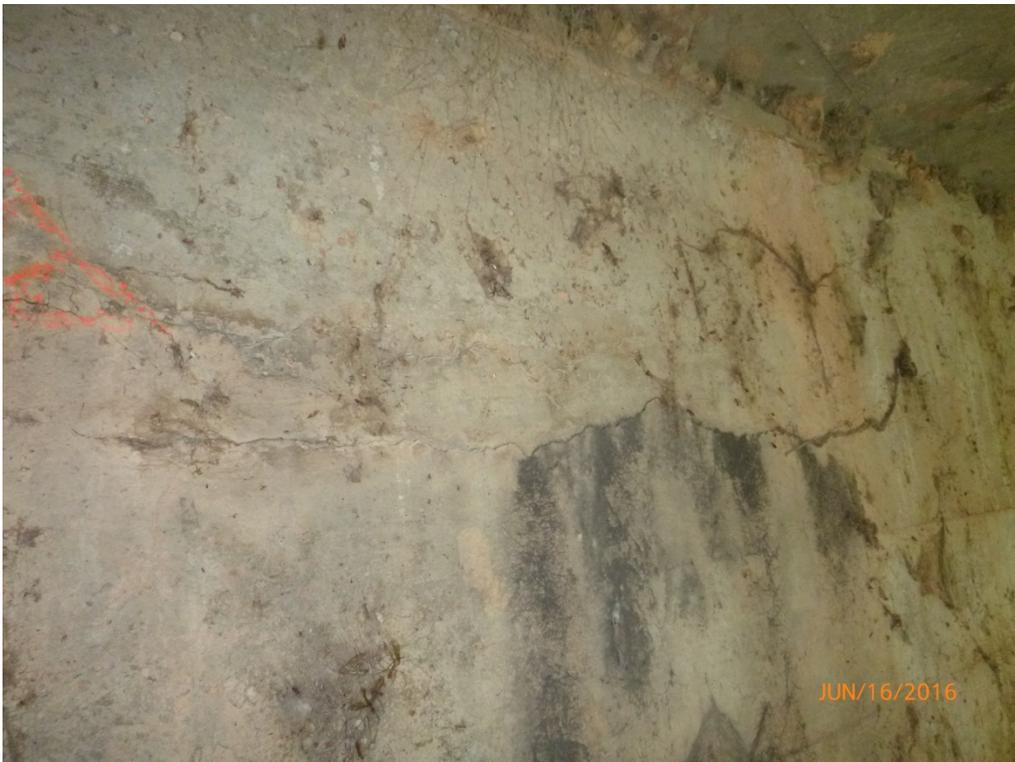
length of approximately 4 ft. past the longitudinal beam from a point below the longitudinal beam (see **Photos 110 and 111**).

Photo 110: Cracks in East Abutment backwall propagating from the delamination below the longitudinal edge girder

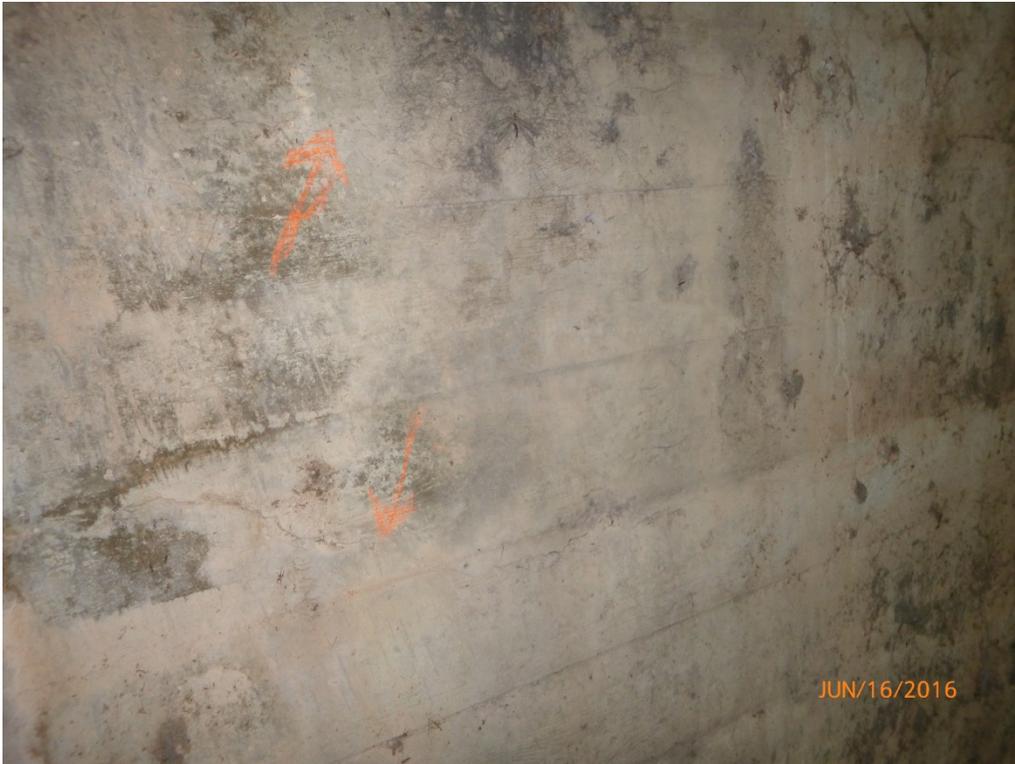
Photo 111: Cracks in East Abutment backwall propagating from the delamination below the longitudinal edge girder

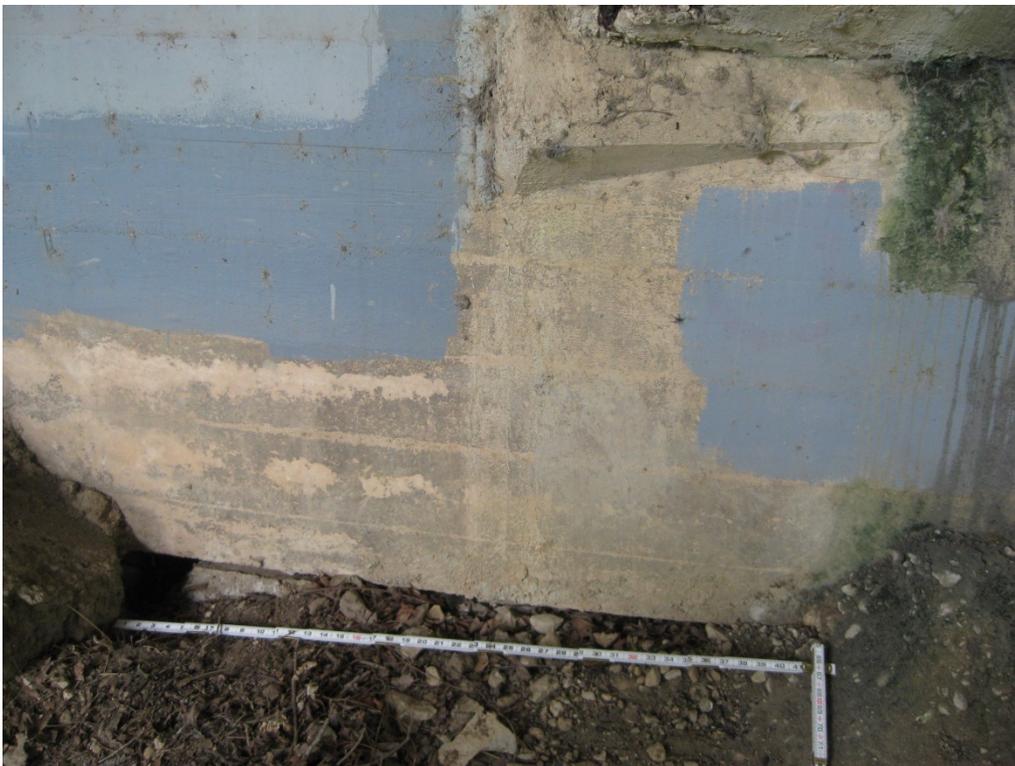
Photo 114: Undermining of West Abutment between Arch Ribs 3 and 4

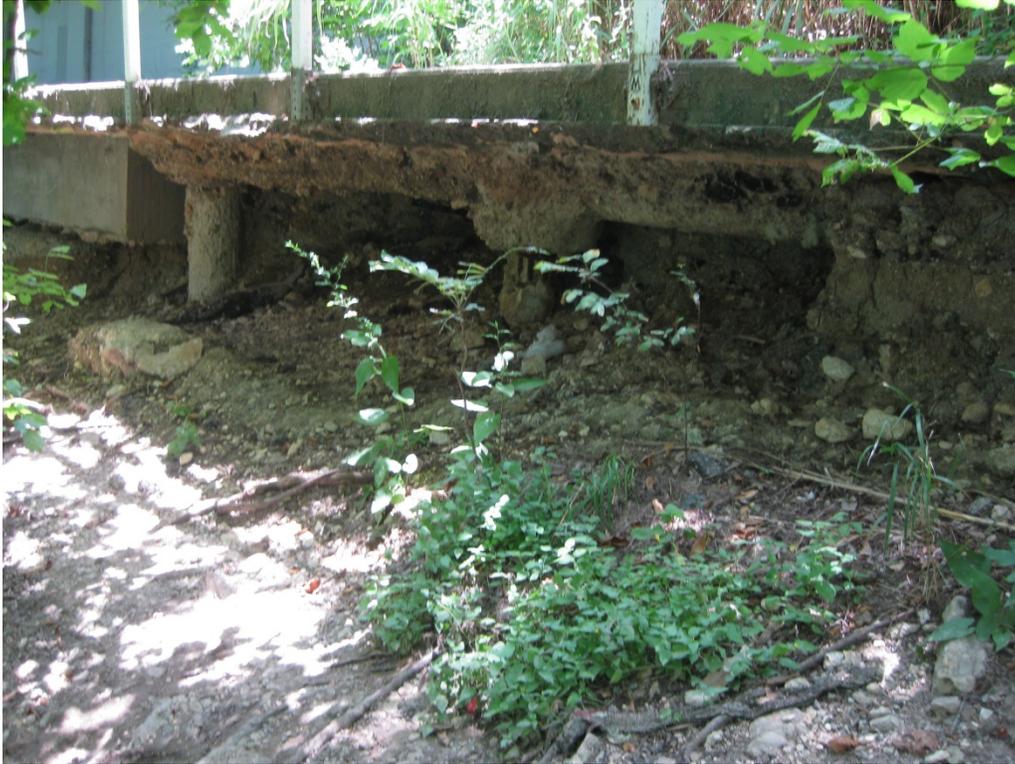
Photo 115: Severe erosion and undermining of pedestrian path adjacent to the East Abutment

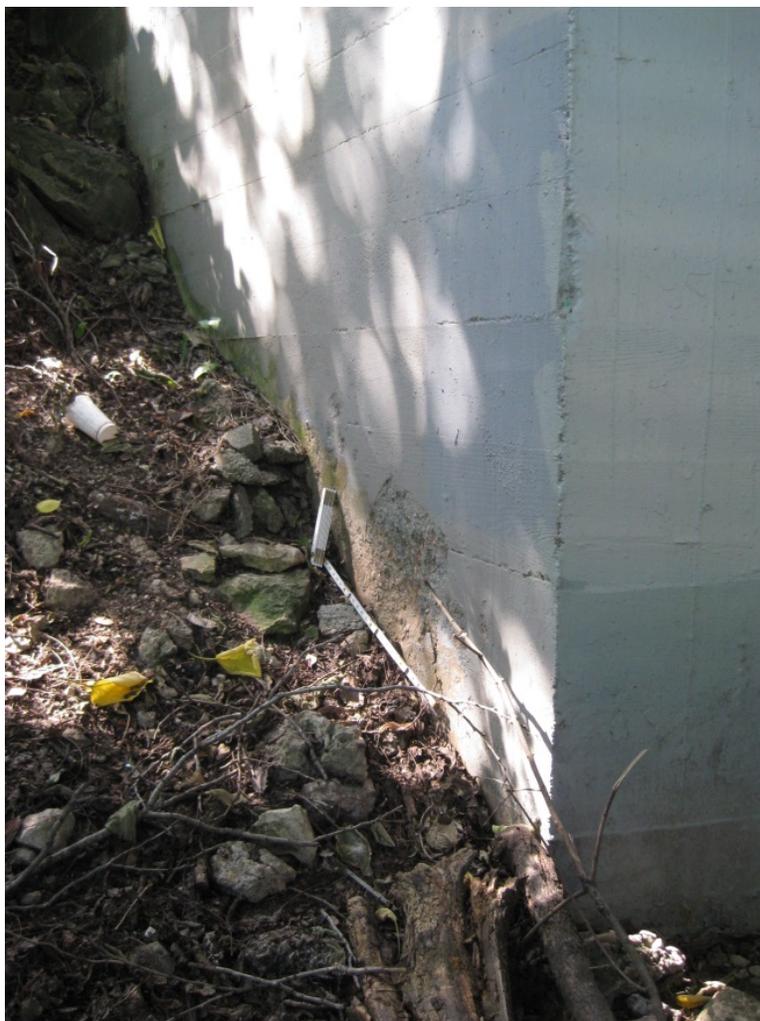
Photo 116: Erosion at the Northeast Wingwall

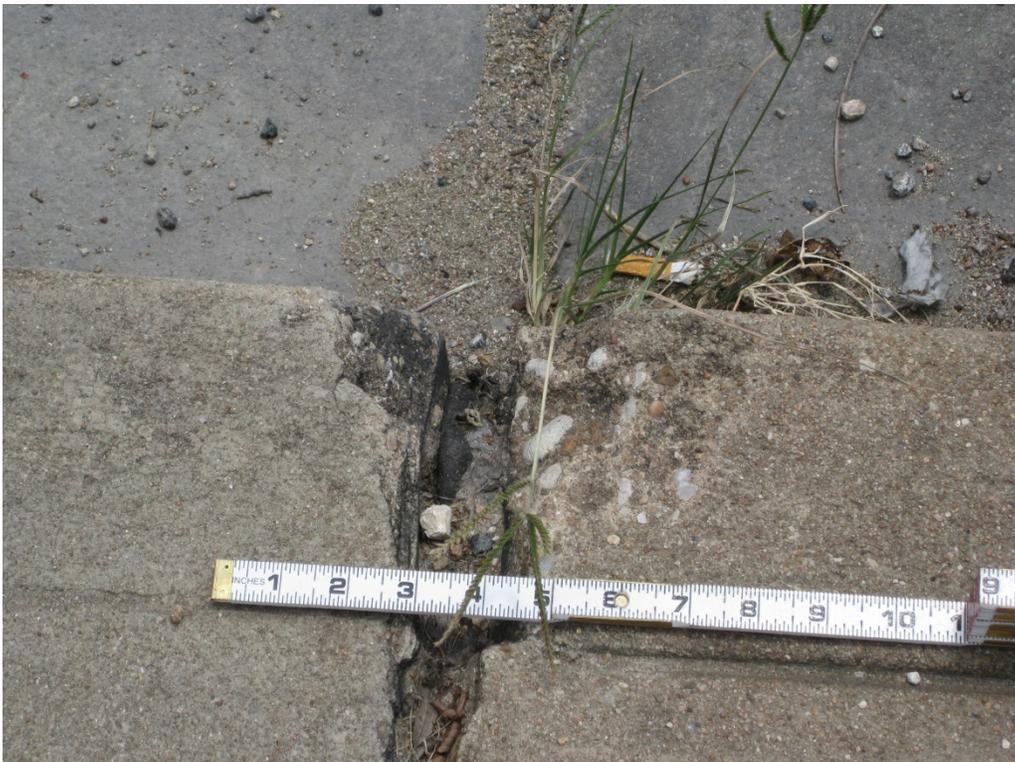
Photo 118: Spall in North Sidewalk curb 104'-4" east of the West Abutment

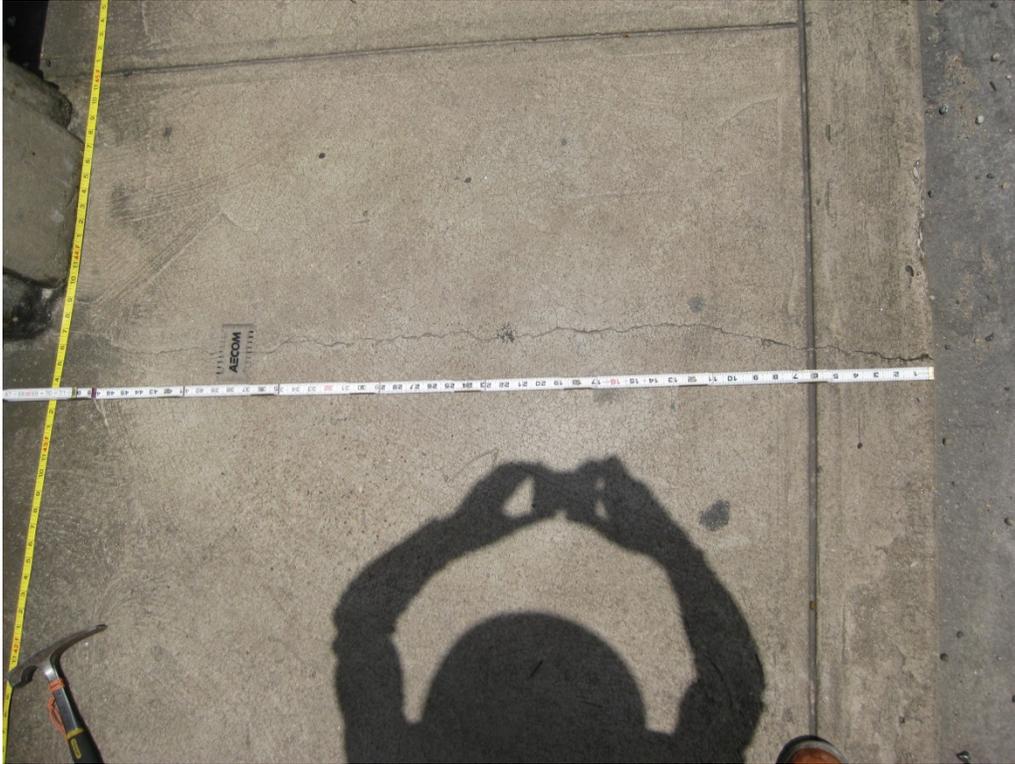
- There are typical cracks up to 3/8" wide located at the bridge expansion joints (see **Photo 121**).
2. The South Sidewalk has a 3/4" concrete overlay and metal armoring on the sidewalk curb corners. The concrete overlay is delaminating throughout the length of the South Sidewalk from the concrete overhang below. The following additional defects are noted:

Photo 121: Typical full-width transverse cracks in the North Sidewalk located at transverse bridge expansion joints

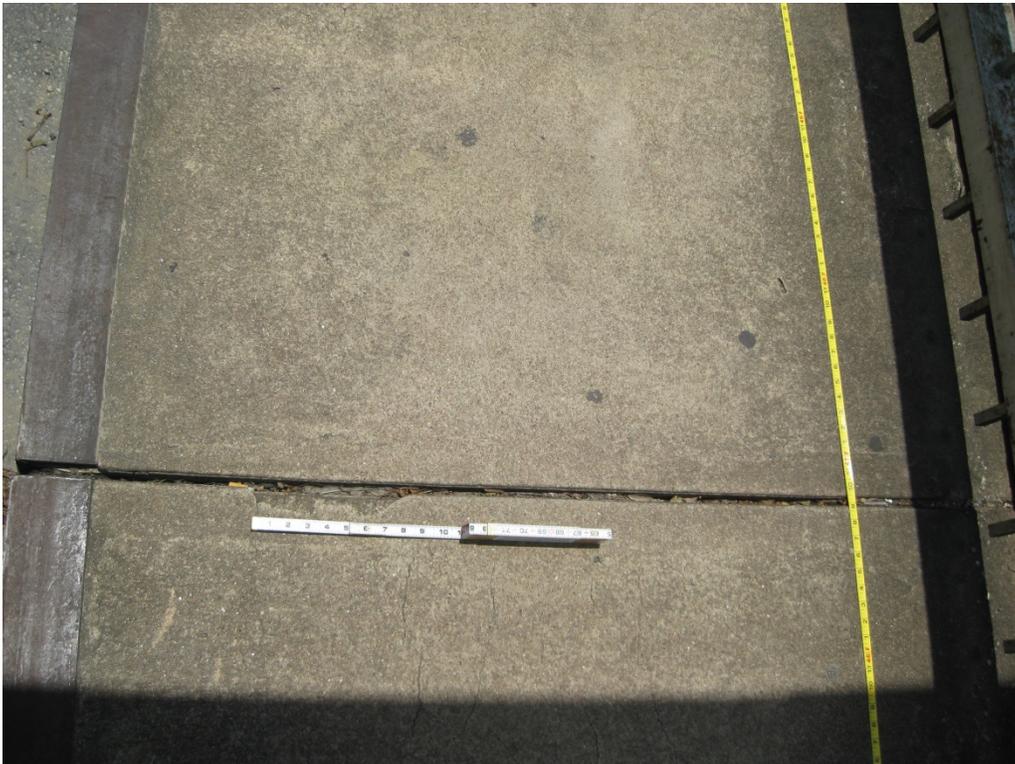
- There is a 7" long by 1" wide spall at the sidewalk slab joint 47' east of the West Abutment (see **Photo 122**)
 - A 26" long by 3" wide spall at the sidewalk slab joint 97' east of the West Abutment (see **Photo 123**) is observed

Photo 122: Spall in South Sidewalk overlay 47' east of the West Abutment

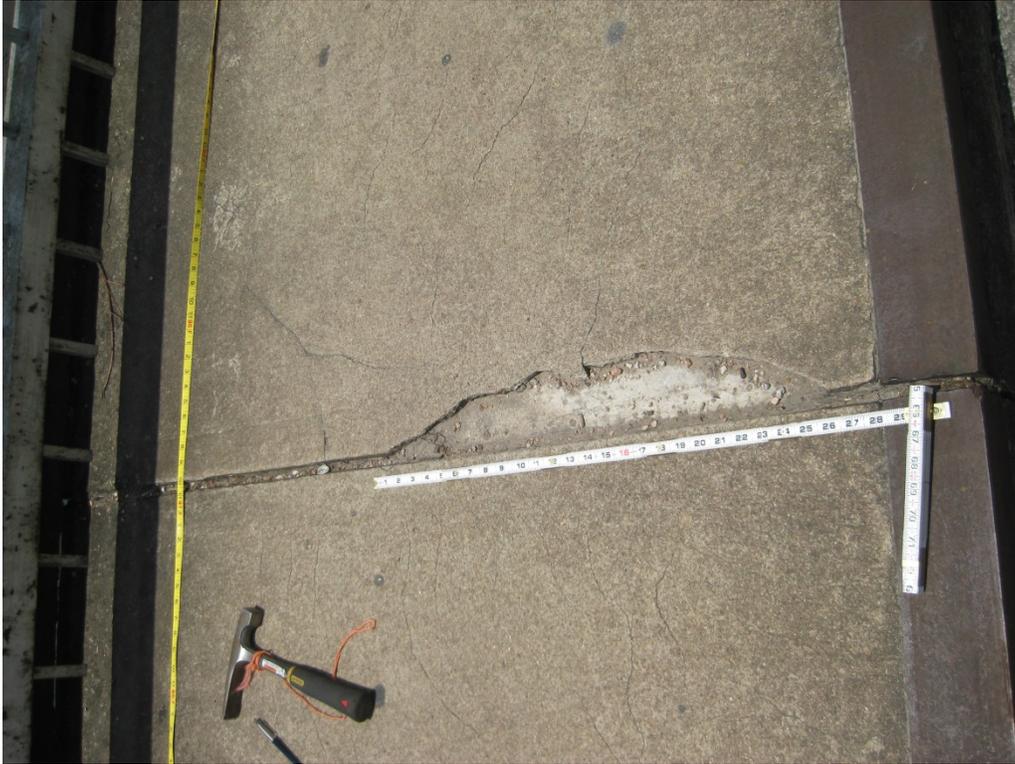
Photo 123: Spall in South Sidewalk overlay 97' east of West Abutment

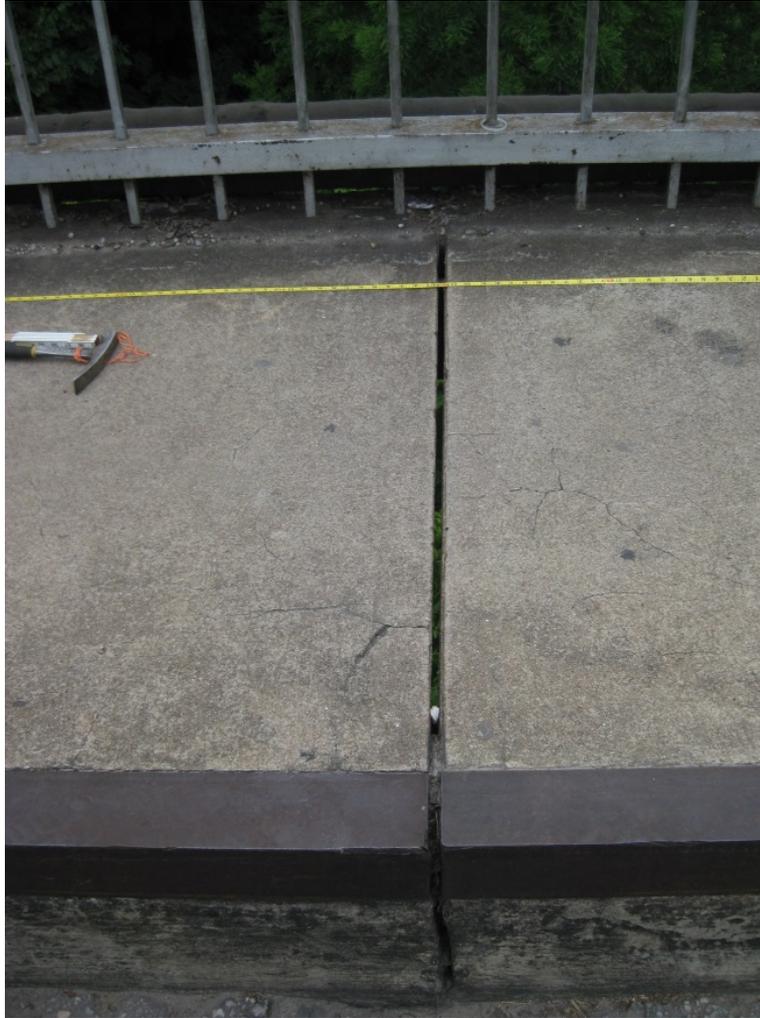
- There is a 30" long by 8" wide spall at the sidewalk slab joint 117' east of the West Abutment (see **Photo 124**)
 - There is a 29" long by 11" wide spall at the sidewalk slab joint at the face of the East Abutment (see **Photo 125**). The expansion joint material in the sidewalk 167' east of the West Abutment has failed and is dislodged leaving a 1/2" gap (see **Photo 126**).

Photo 126: Missing expansion joint material in South Sidewalk 167' east of the West Abutment resulting in a 1/2" gap

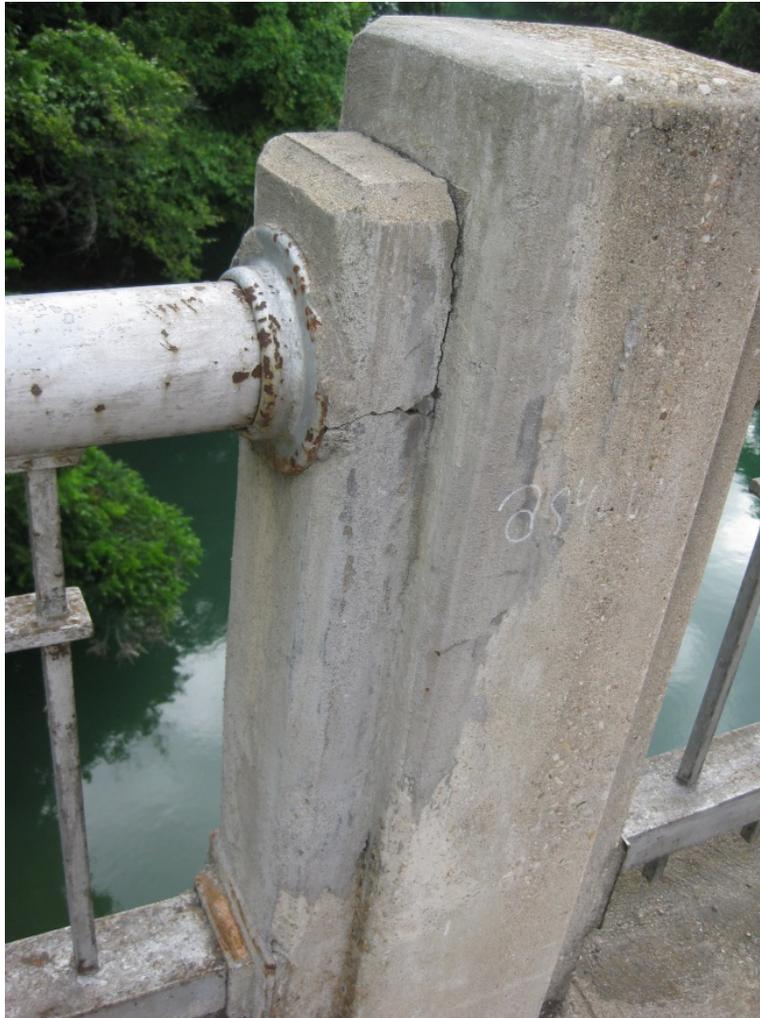
- Similarly to the North Sidewalk, there are typical cracks, up to 3/8" located at the bridge expansion joints.
 3. The railings on the bridge are in good condition. The concrete pilasters sound solid and the steel pipes and pickets experience light surface rust. There is impact damage to the north steel rail and pickets 139'-8" from the West Abutment (see **Photo 127**). Three pickets are bowed north away from the bridge. The 7th pilaster from the Northwest corner of the bridge is cracked at the rail connection (see **Photo 128**). There is an existing patch to repair the defect which sounds solid.

Photo 128: Failed patch with cracking in the 7th pilaster from the west of the North Railing

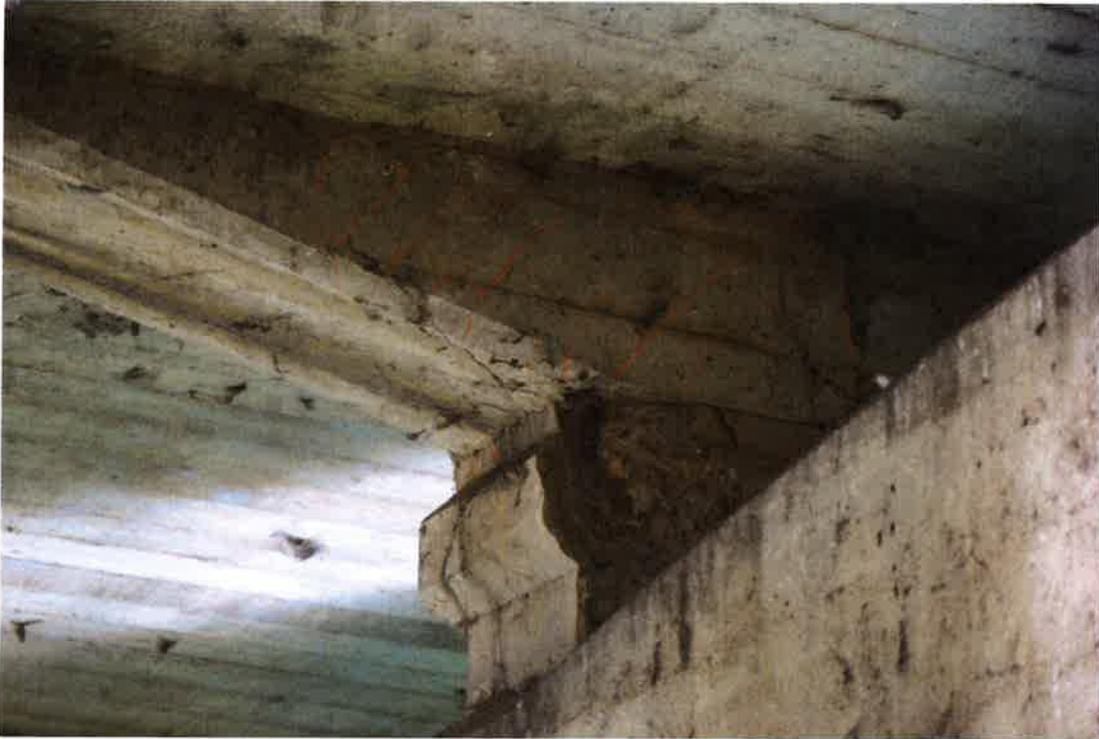
AECOM performed distress mapping and hammer sounding of the bridge to identify areas of delamination. Potential areas of delamination were identified and marked with chalk (Figure 3). Concrete cover was visibly spalled and the steel reinforcement was exposed at multiple locations (Figure 4). The steel reinforcement was corroded at these locations.

Figure 3 – Delaminated area as identified by AECOM
