BARTON SPRINGS ROAD OVER BARTON CREEK

Bridge Inspection and Condition Assessment Report

Bridge 14-227-0-B002-26-001
Austin, Texas
January 2017

2016 Bridge Inspection Report
Barton Springs Road over Barton Creek
Bridge 14-227-0-B002-26-001

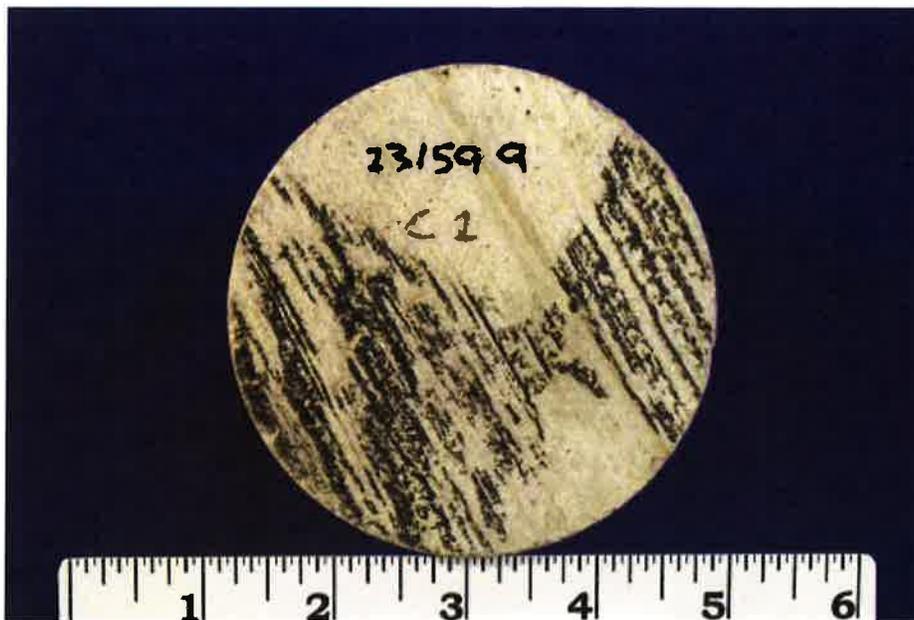
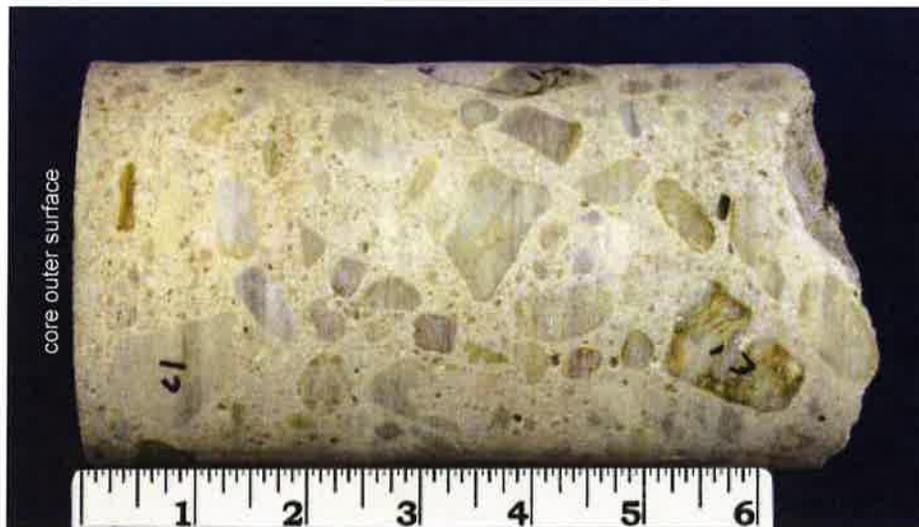
Photo C1-1 Core C1, as received for testing.

C1-1a. Core (concrete) outer surface. The surface is a somewhat worn, fairly flat and striated, formed concrete surface.

C1-1b. Side view of core.

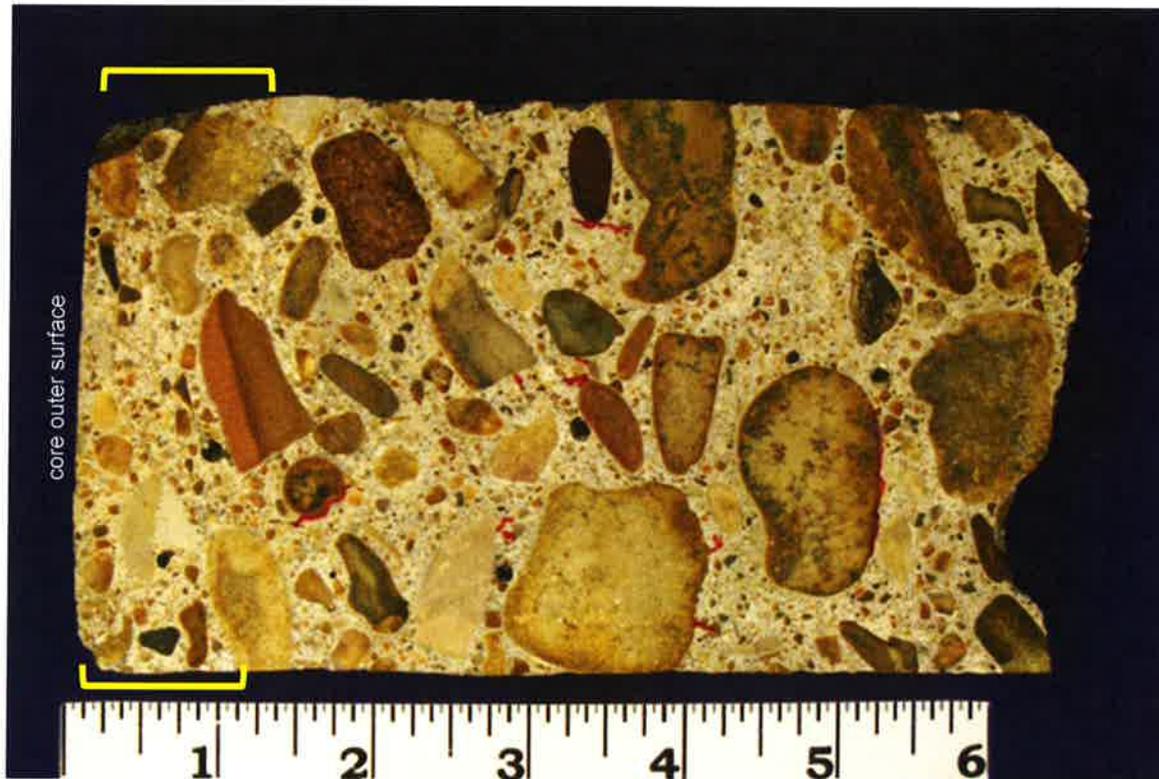
Photo C1-2 Lapped, cross-sectional (longitudinal) concrete surface of Core C1.

Paste carbonation is to a depth of 1.2 in. (yellow brackets) from the outer concrete surface.

The microcracks in the concrete are highlighted with red marker to depict their visibility in the image; the actual microcracks are much narrower. The concrete contains very few microcracks with no general orientation, throughout the core. Microcracks extend around all aggregate particles.

The natural gravel coarse aggregate has an observed top size of 1.2 in., is rounded to subangular in shape, and uniformly distributed in the concrete.

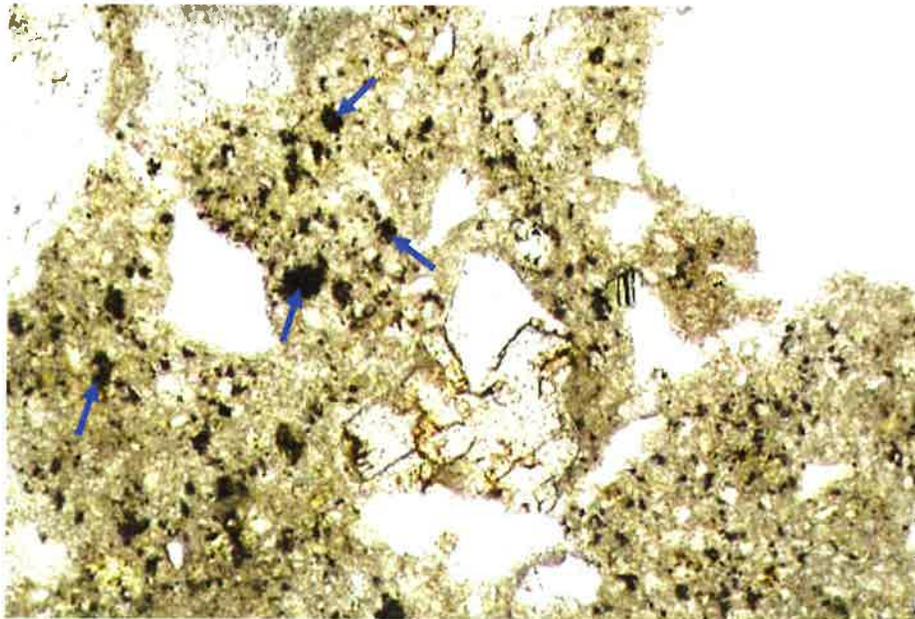
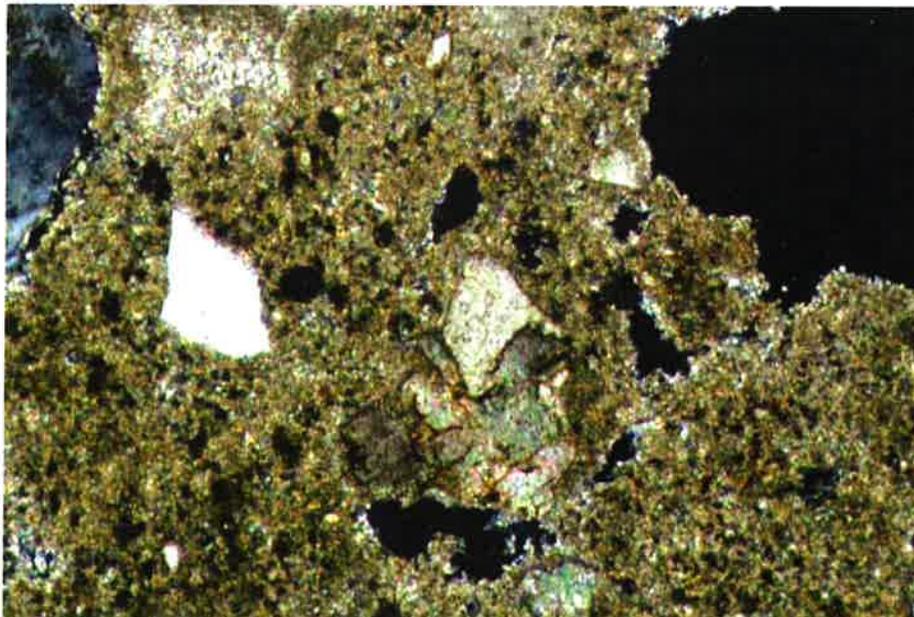
Photo C1-3. Thin section photomicrographs of Core C1, illustrating features in the paste. Both images show the same field of view but under different lighting. Length of field, left to right, is approximately 0.78 mm (0.03 in.).

C1-3a. Plane-polarized light. Blue arrows depict several residual/relic portland cement grains.

C1-3b. Cross polarized light. Paste is completely carbonated, shown by its bright tan/brown color.

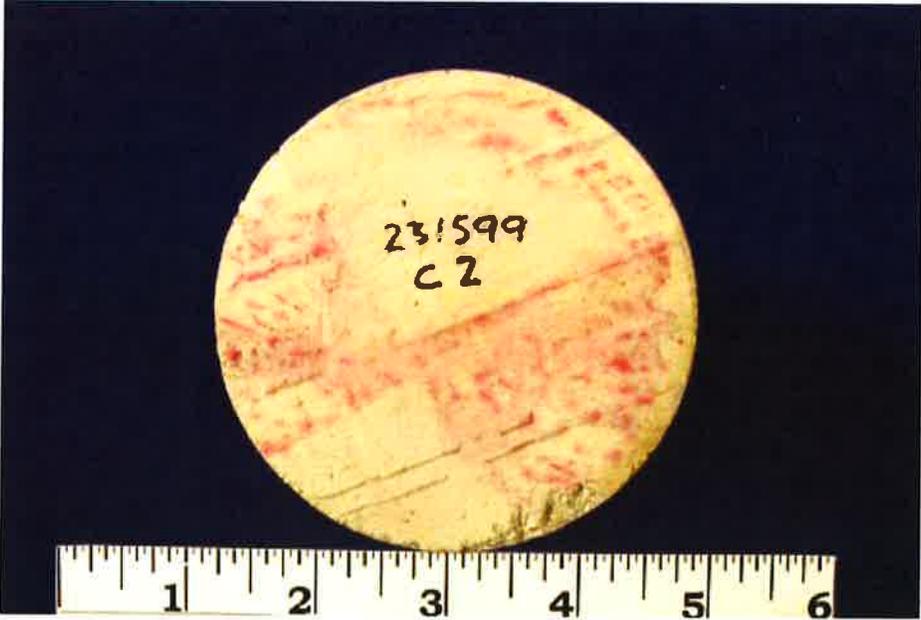
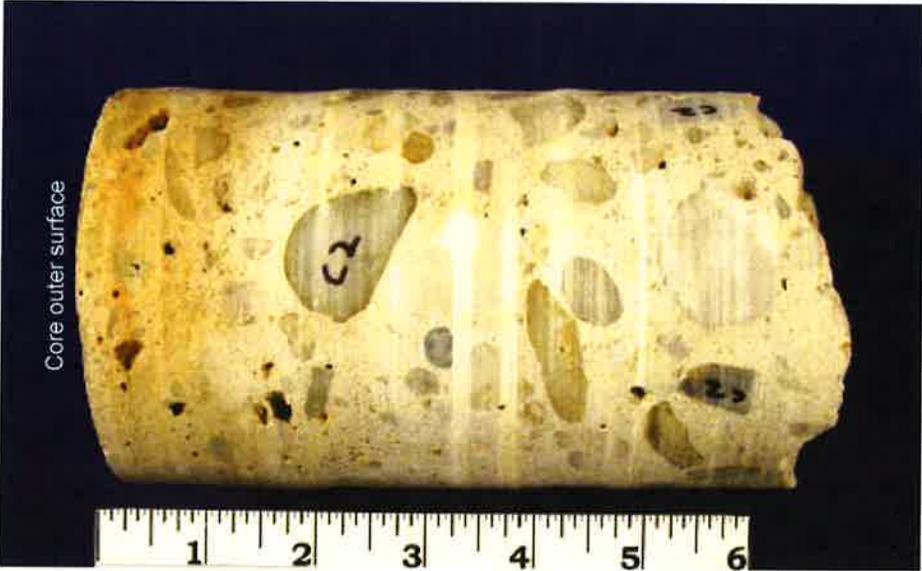
Photo C2-1 Core C2, as received for testing.

C2-1a. Core (concrete) outer surface. The surface is a somewhat worn, fairly flat and striated, formed concrete surface.

C2-1b. Side view of core.

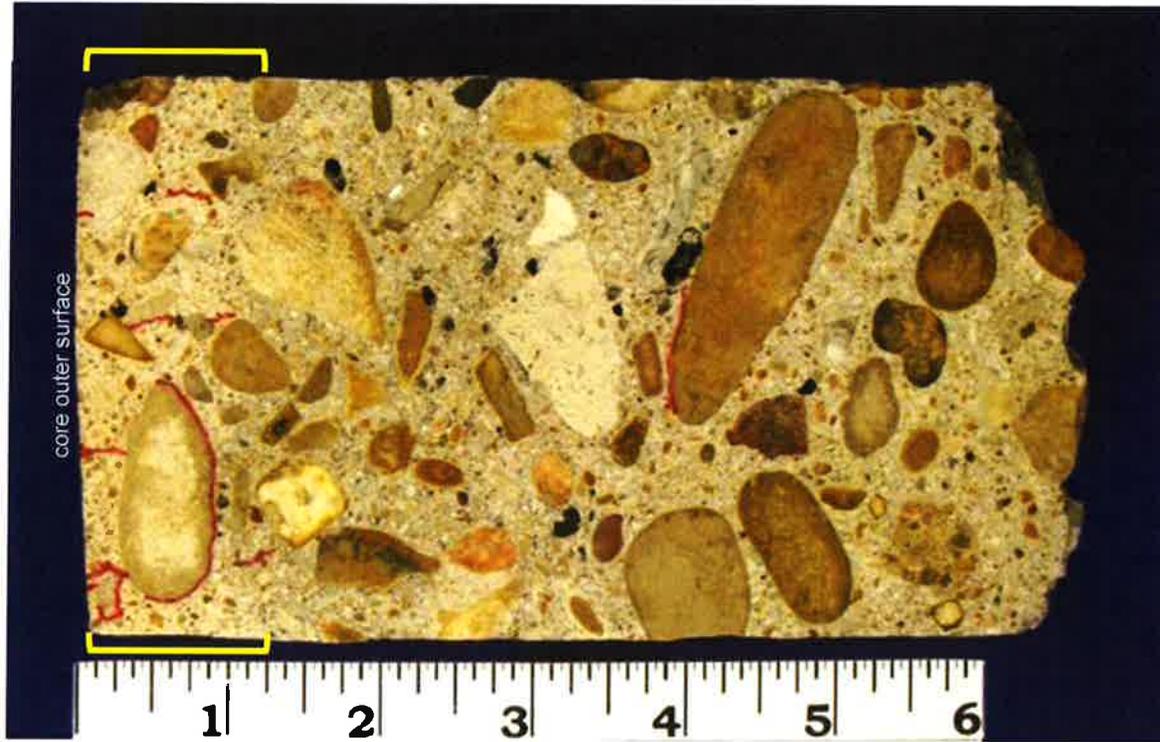
Photo C2-2 Lapped, cross-sectional (longitudinal) concrete surface of Core C2.

Paste carbonation is to a depth of 1.0 to 1.3 in. (yellow brackets) from the outer core surface.

The microcracks in the concrete are highlighted with red marker to depict their visibility in the image; the actual microcracks are much narrower. The concrete contains a few microcracks throughout the core, mainly present within the outer 1.2 in. of the core. Microcracks extend around all aggregate particles.

The natural gravel coarse aggregate has an observed top size of 0.8 in., is rounded to subangular in shape, and uniformly distributed in the concrete.

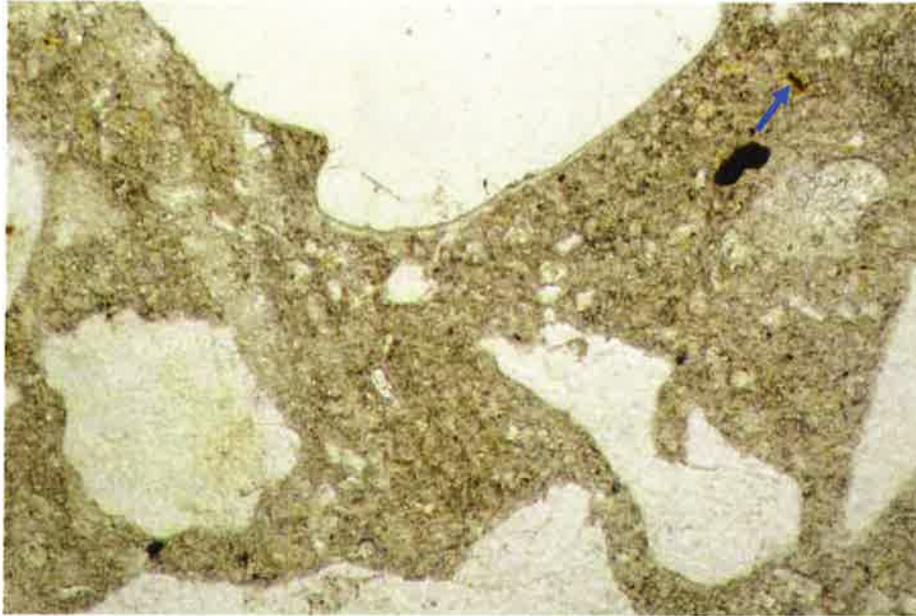
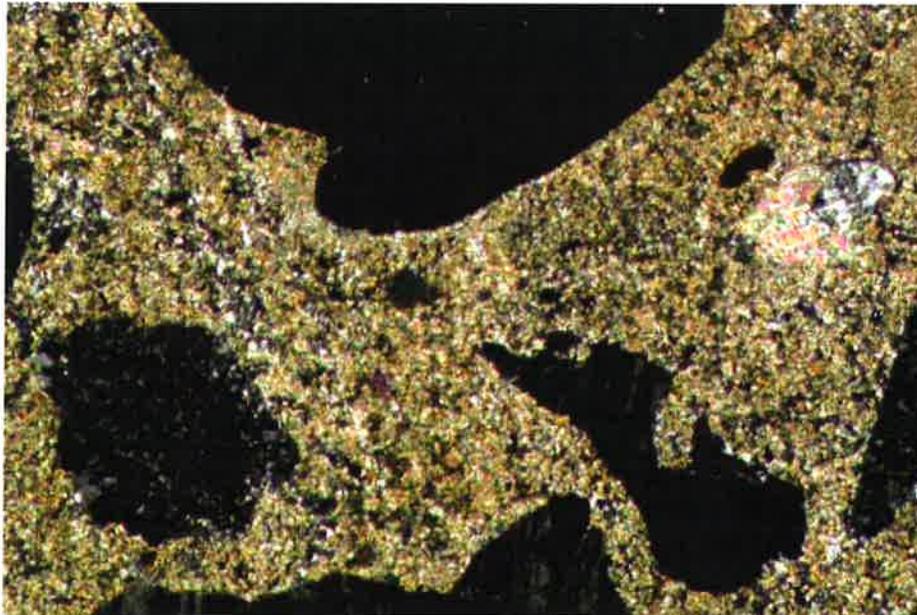
Photo C2-3 Thin section photomicrographs of Core C2, illustrating features in the paste. Both images show the same field of view but under different lighting. Length of field, left to right, is approximately 0.78 mm (0.03 in.).

C2-3a. Plane-polarized light. Very few residual/relic portland cement grains (blue arrow) are observable.

C2-3b. Cross polarized light. Paste is completely carbonated, shown by its bright tan/brown color.

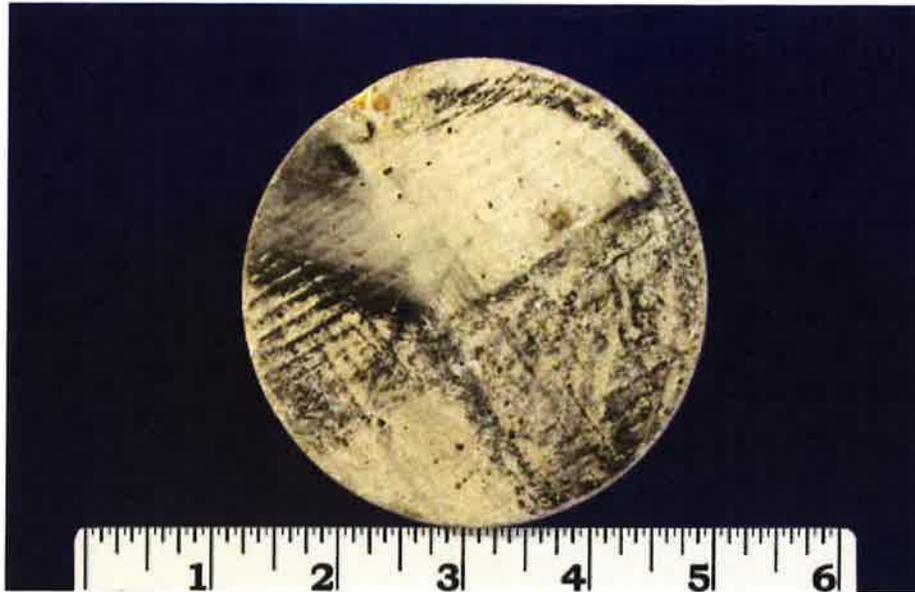
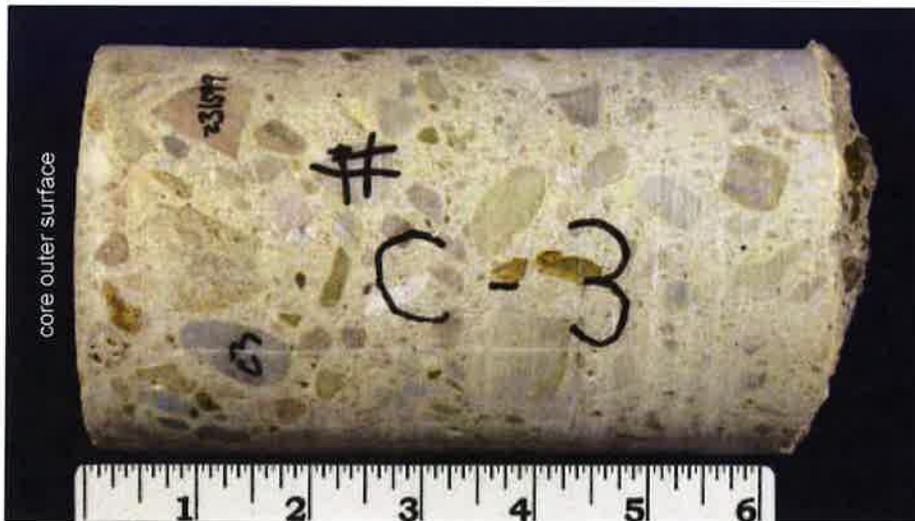
Photo C3-1 Core C3, as received for testing.

C3-1a. Core (concrete) outer surface. The surface is a mostly flat and smooth, slightly worn, surface with remnants of a striated finish and some exposed small air voids.

C3-1b. Side view of core.

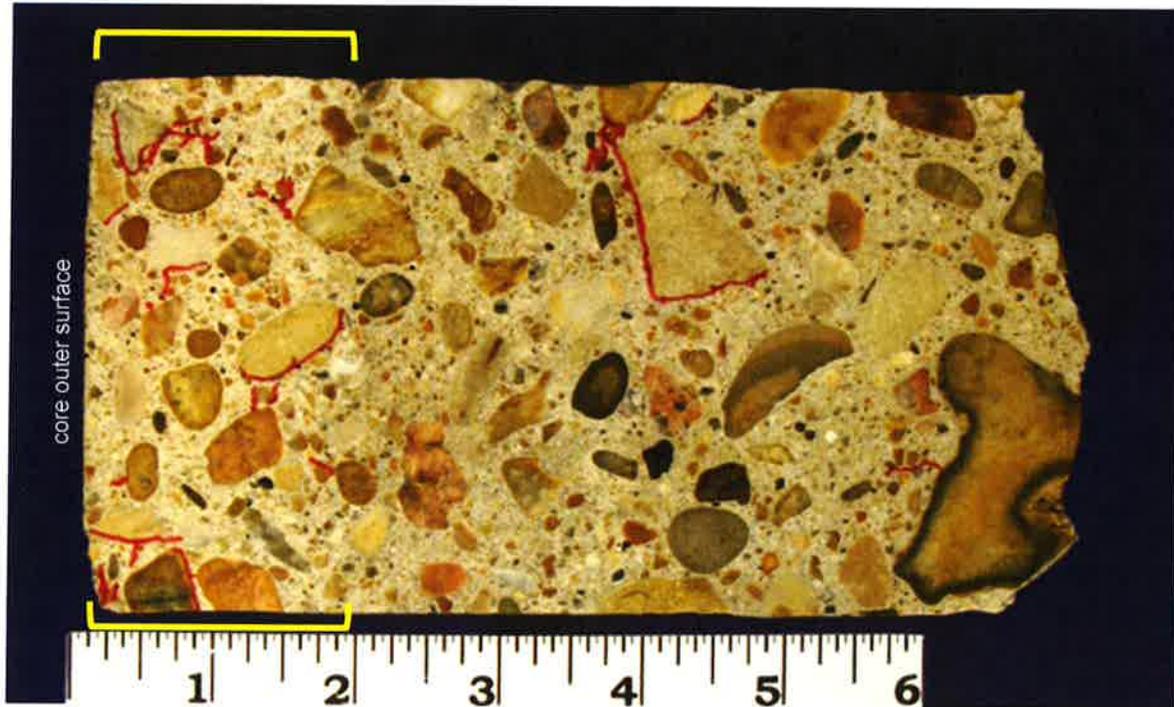
Photo C3-2 Lapped, cross-sectional concrete surface of Core C3.

Paste carbonation is to a depth of 1.5 to 1.7 in. (yellow brackets) from the outer core surface.

The microcracks in the concrete are highlighted with red marker to depict their visibility in the image; the actual microcracks are much narrower. The concrete contains several microcracks with no general orientation, throughout the core, but mainly within the outer 1.8 in. of the core. Microcracks extend around all aggregate particles.

The natural gravel coarse aggregate has an observed top size of 0.9 in., is rounded to subangular in shape, and uniformly distributed in the concrete.

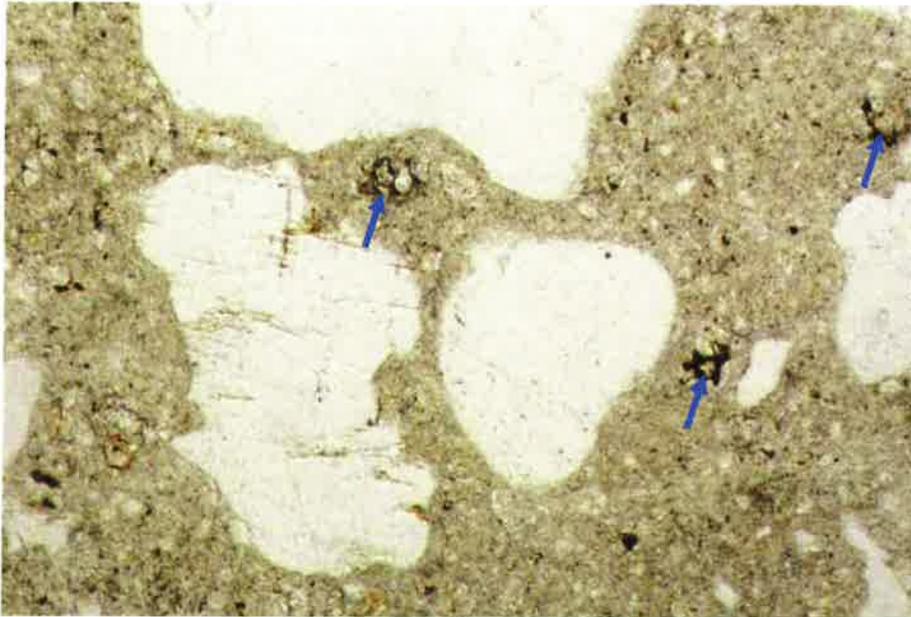
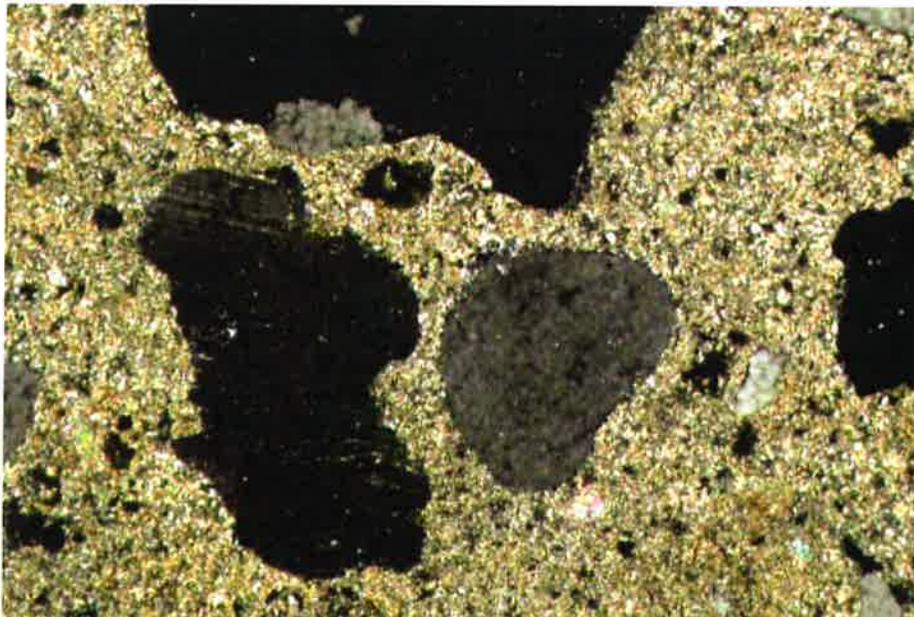
Photo C3-2 Thin section photomicrographs of Core C3, illustrating features in the paste. Both images show the same field of view but under different lighting. Length of field, left to right, is approximately 0.78 mm (0.03 in.).

C3-2a. Plane-polarized light. Blue arrows depict several residual/relic portland cement grains.

C3-2b. Cross polarized light. Paste is completely carbonated, shown by its bright tan/brown color.

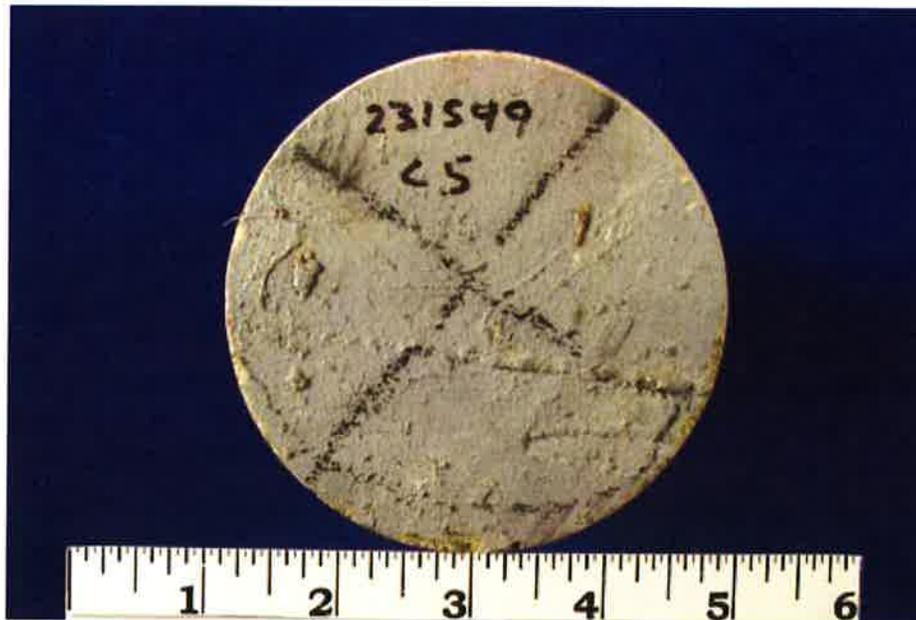
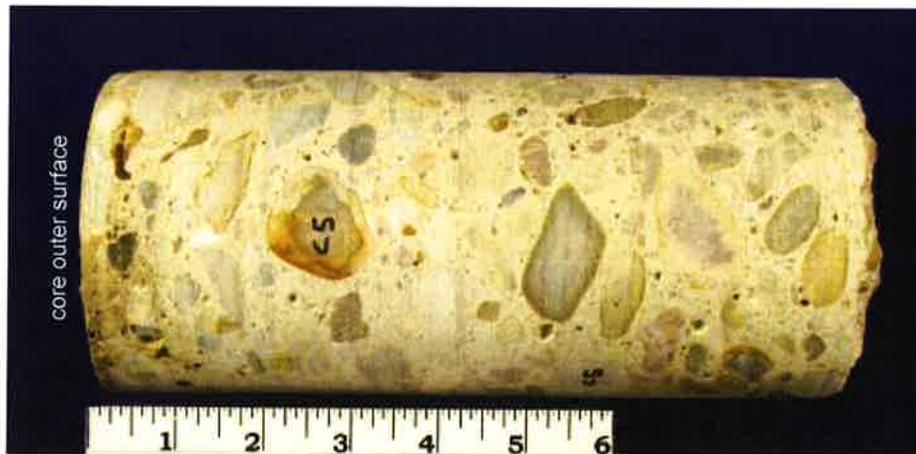
Photo C5-1 Core C5, as received for testing.

C5-1a. Core (concrete) outer surface. The surface is a mostly flat surface covered by gray paint layer.

C5-1b. Side view of core.

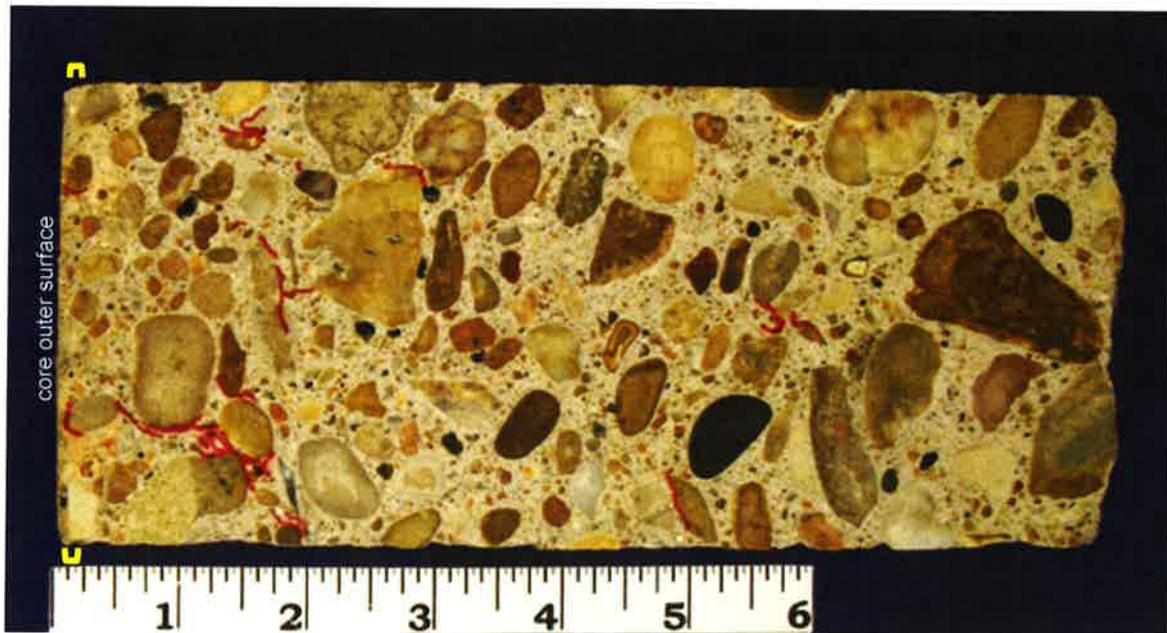
Photo C5-2 Lapped, cross-sectional (longitudinal) concrete surface of Core C5.

Paste carbonation is to a depth of 0 to 0.08 in. (2 mm) (yellow brackets) from the outer core surface.

The microcracks in the concrete are highlighted with red marker to depict their visibility in the image; the actual microcracks are much narrower. The concrete contains several microcracks with no general orientation, throughout the core, but mainly within the outer 2.0 in. of the core. Microcracks extend around all aggregate particles.

The natural gravel coarse aggregate has an observed top size of 1.1 in., is rounded to subangular in shape, and uniformly distributed in the concrete.

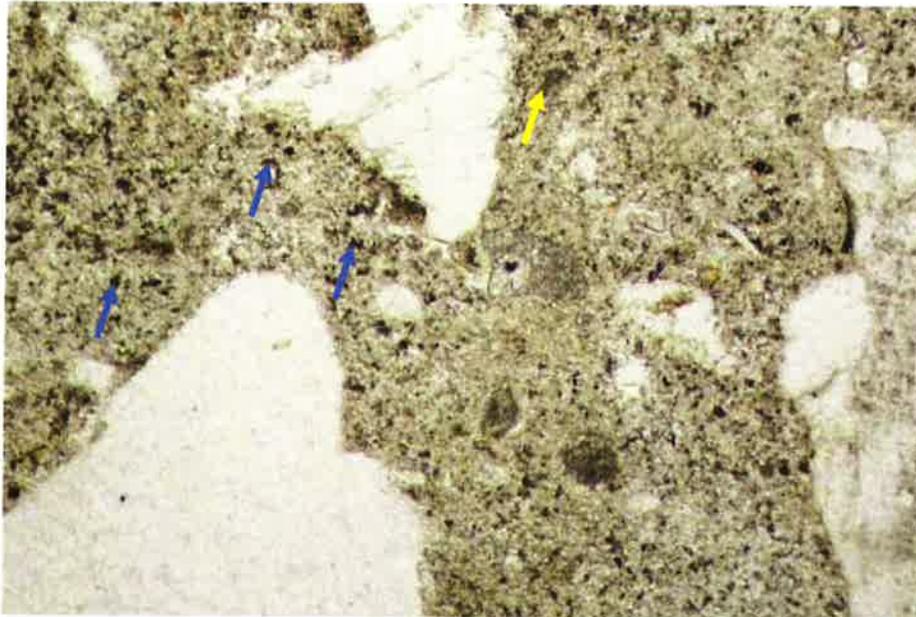
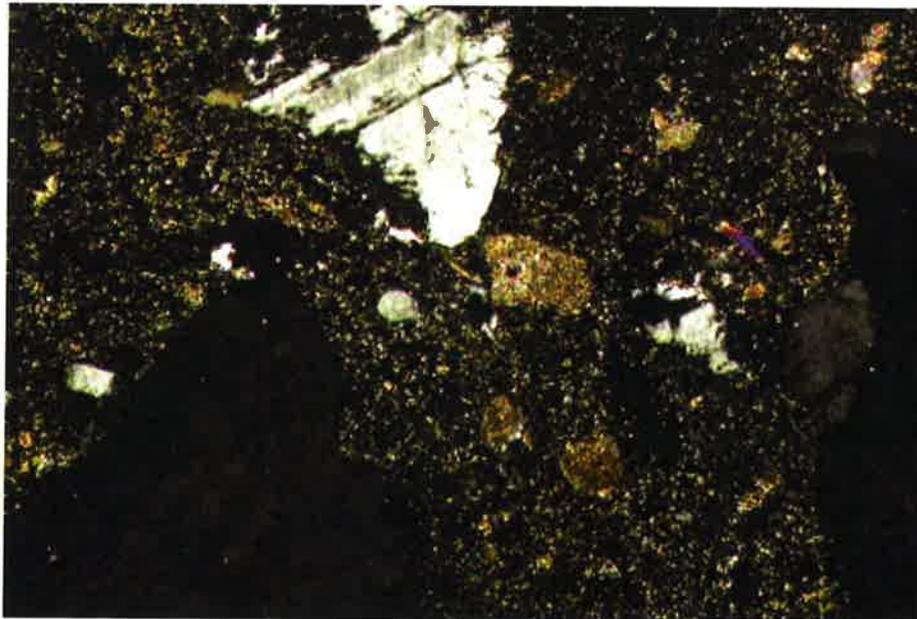
Photo C5-3 Thin section photomicrographs of Core C5, illustrating features in the paste. Both images show the same field of view but under different lighting. Length of field, left to right, is approximately 0.78 mm (0.03 in.).

C5-3a. Plane-polarized light. Blue arrows depict several residual/relic portland cement grains.

C5-3b. Cross polarized light.

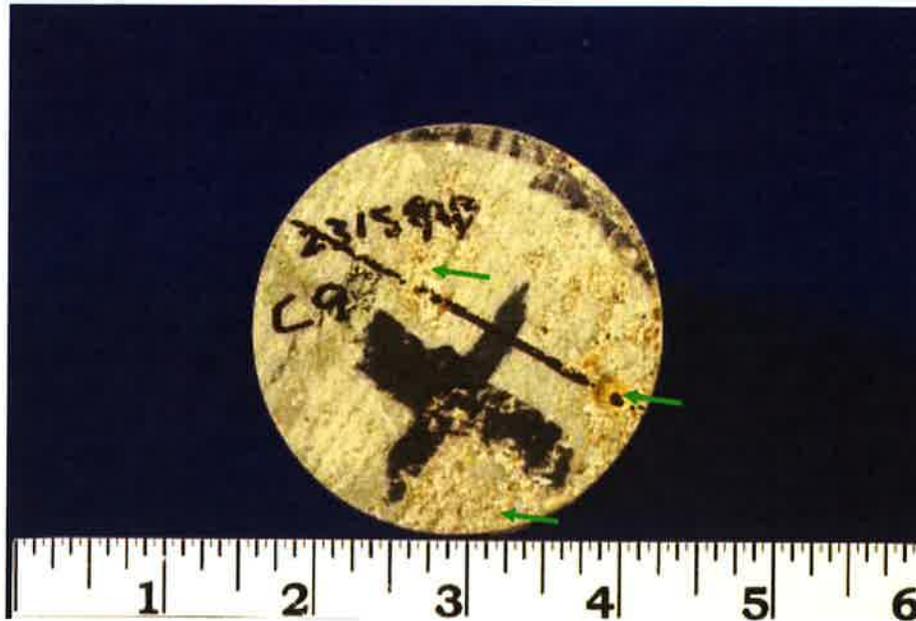
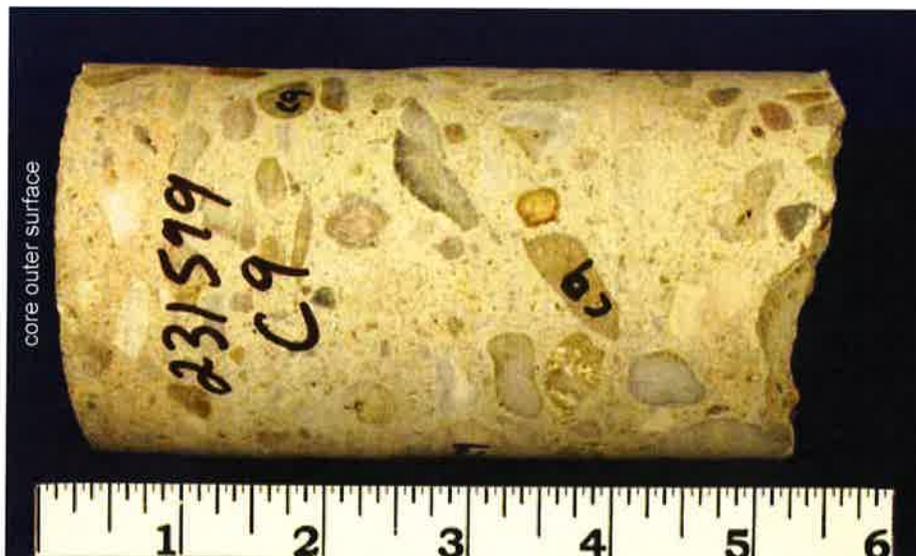
Photo C9-1 Core C9, as received for testing.

Outer Core Surface: Mostly flat, somewhat worn, striated, formed concrete surface, which exhibits a small amount of scaling or abrasion that exposes fine aggregate particles. Scaling or abrasion is to a depth of approximately 1 mm (0.04 in.).

C9-1a. Core (concrete) outer surface. The surface is a mostly flat, somewhat worn and striated, formed concrete surface, with shallow scaling or abrasion (green arrows) that exposes fine aggregate particles.

C9-1b. Side view of core.

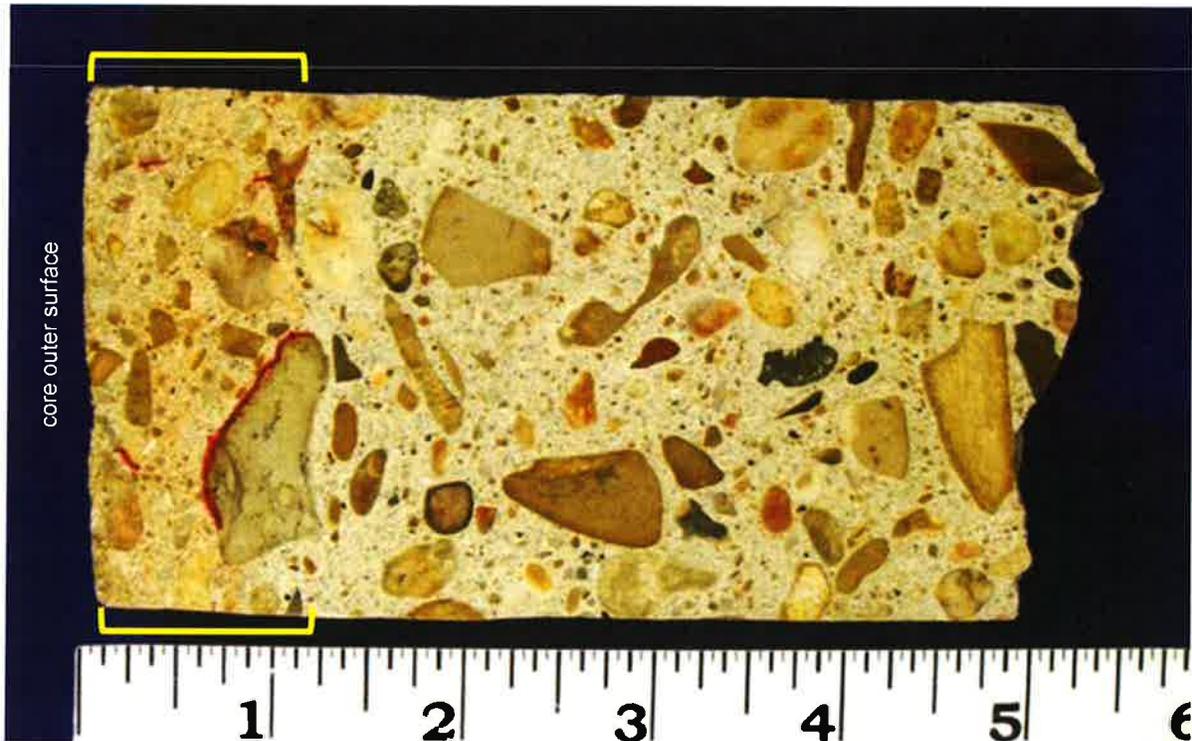
Photo C9-2 Lapped, cross-sectional (longitudinal) concrete surface of Core C9.

Paste carbonation is to a depth of 1.1 to 1.2 in. (yellow brackets) from the outer core surface.

The microcracks in the concrete are highlighted with red marker to depict their visibility in the image; the actual microcracks are much narrower. The concrete contains very few microcracks with no general orientation, within the outer 1.2 in. of the core. Microcracks extend around all aggregate particles.

The natural gravel coarse aggregate has an observed top size of 0.7 in., is rounded to subangular in shape, and uniformly distributed in the concrete.

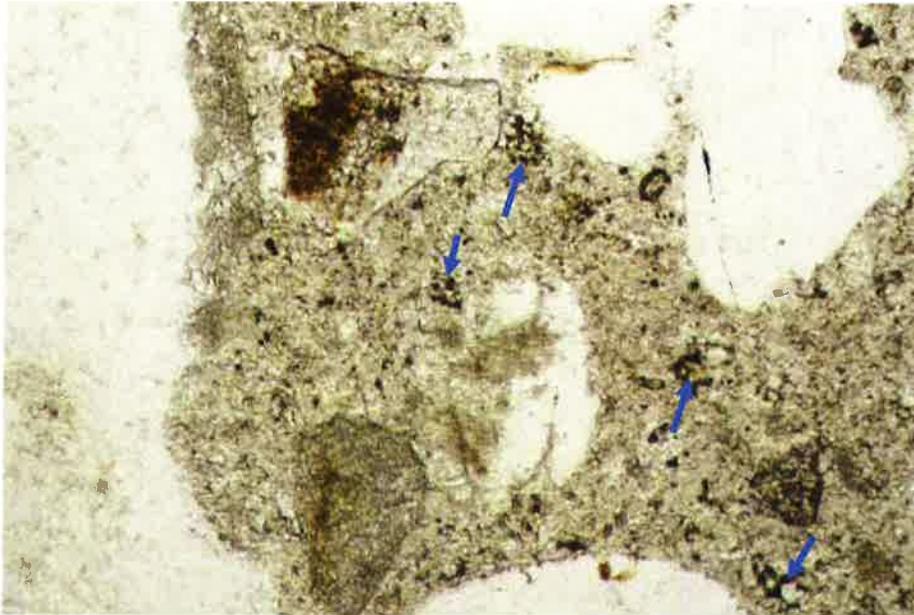
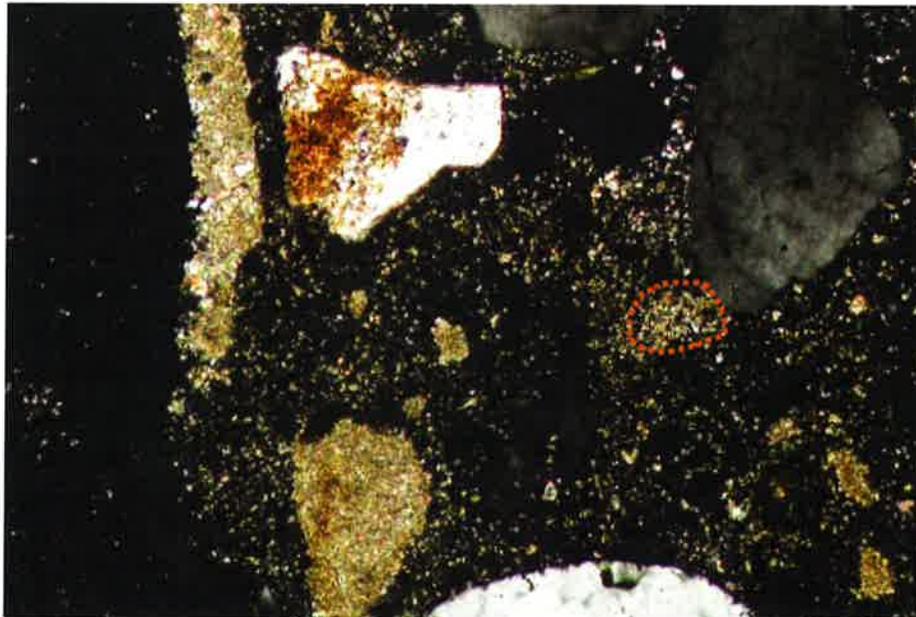
Photo C9-3 Thin section photomicrographs of Core C9, illustrating features in the paste. Both images show the same field of view but under different lighting. Length of field, left to right, is approximately 0.78 mm (0.03 in.).

C9-3a. Plane-polarized light. Blue arrows depict several coarsely ground residual/relic portland cement grains.

C9-3b. Cross polarized light. The paste is amorphous: calcium hydroxide particles have been leached out of the paste. Bright colored speckles are limestone dust and fines (orange encirclement).

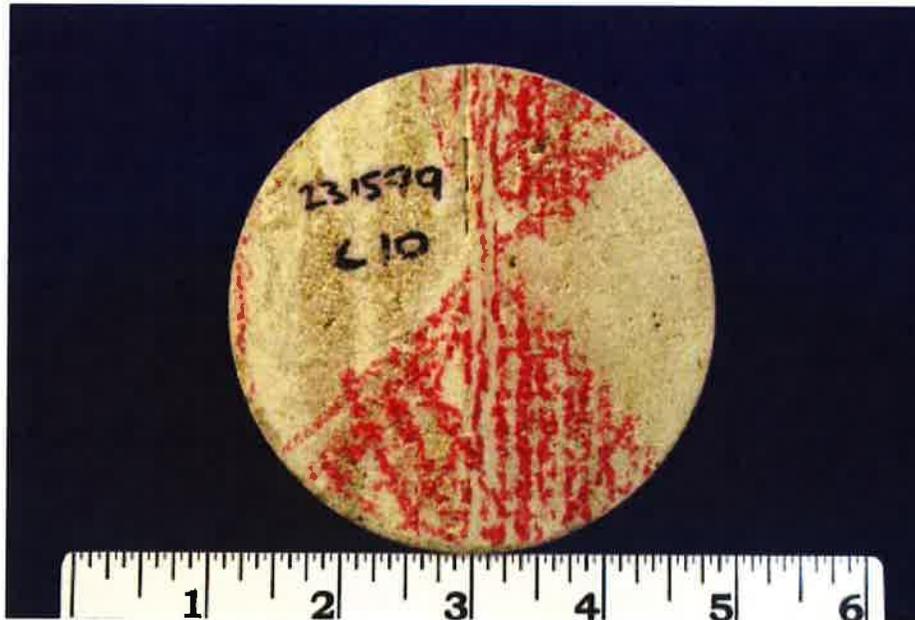
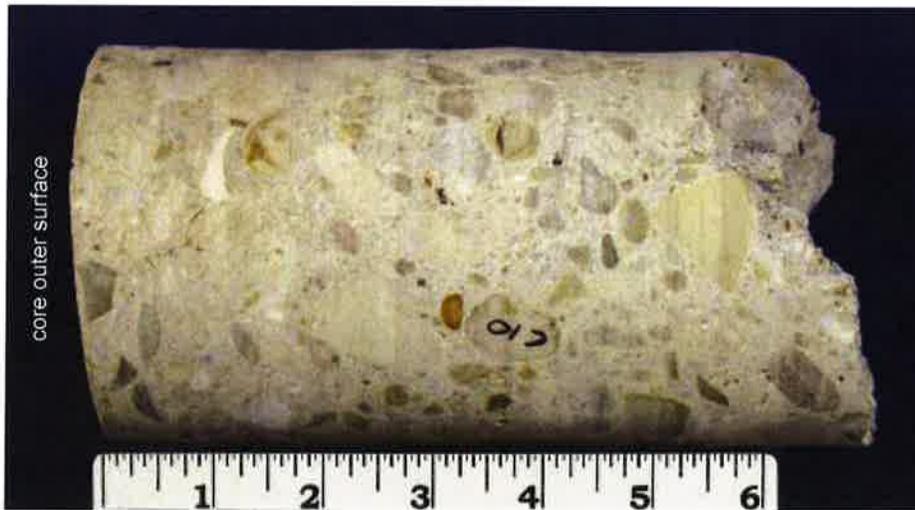
Photo C10-1 Core C10, as received for testing.

C10-1a. Core (concrete) outer surface. The surface is a mostly flat, somewhat worn, formed concrete surface, which exhibits some shallow abrasion that exposes exposed fine aggregate particles.

C10-1b. Side view of core.

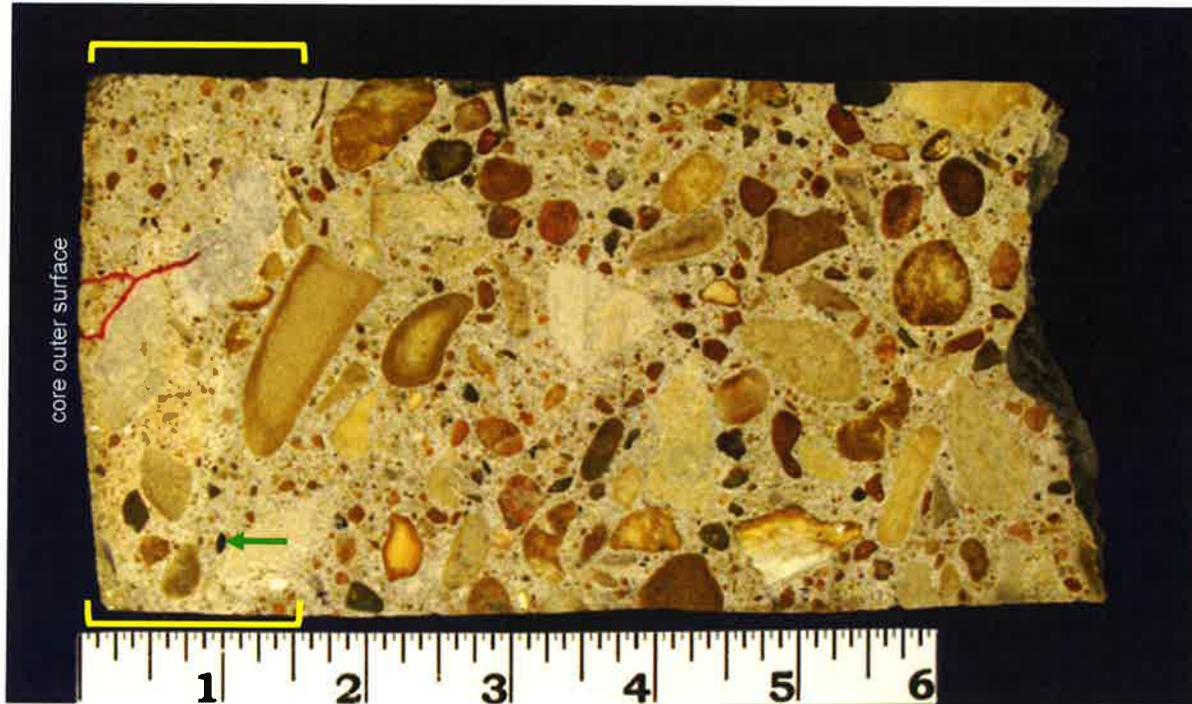
Photo C10-2 Lapped, cross-sectional (longitudinal) concrete surface of Core C10.

Paste carbonation is to a depth of 0.5 to 1.5 in. (yellow brackets) from the outer core surface.

The natural gravel coarse aggregate has an observed top size of 0.8 in., is rounded to subangular in shape, and uniformly distributed in the concrete.

Green arrow points to one small metal particle in the concrete. No associated corrosion product observed.

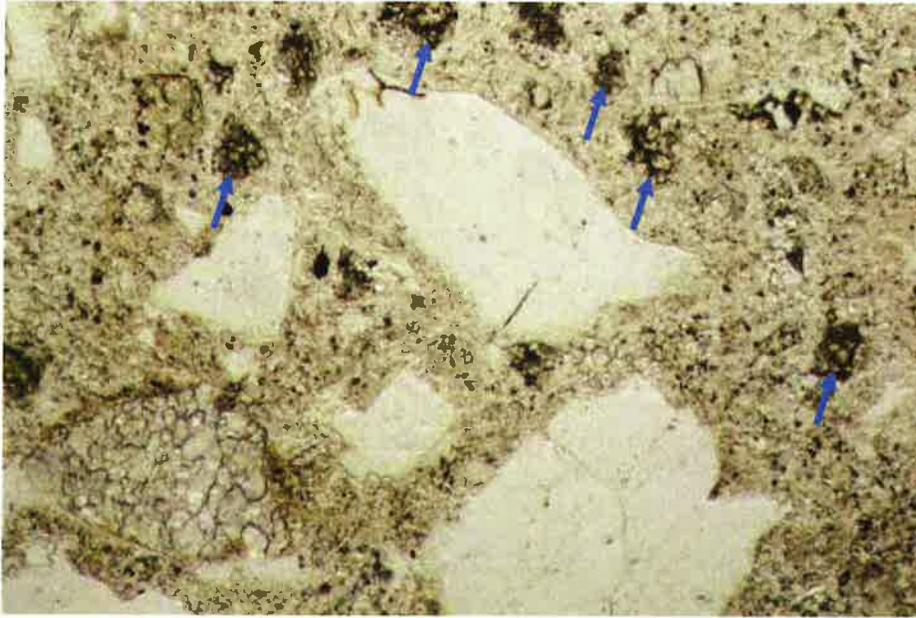
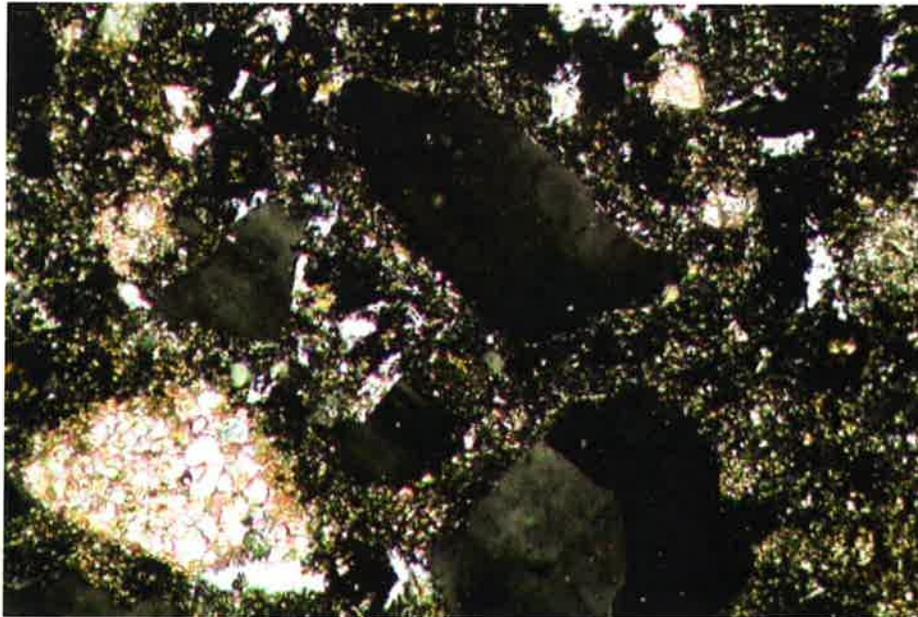
Photo C10-3 Thin section photomicrographs of Core C10, illustrating features in the paste. Both images show the same field of view but under different lighting. Length of field, left to right, is approximately 0.78 mm (0.03 in.).

C10-3a. Plane-polarized light. Blue arrows depict several coarsely ground residual/relic portland cement grains.

C10-3b. Cross polarized light.

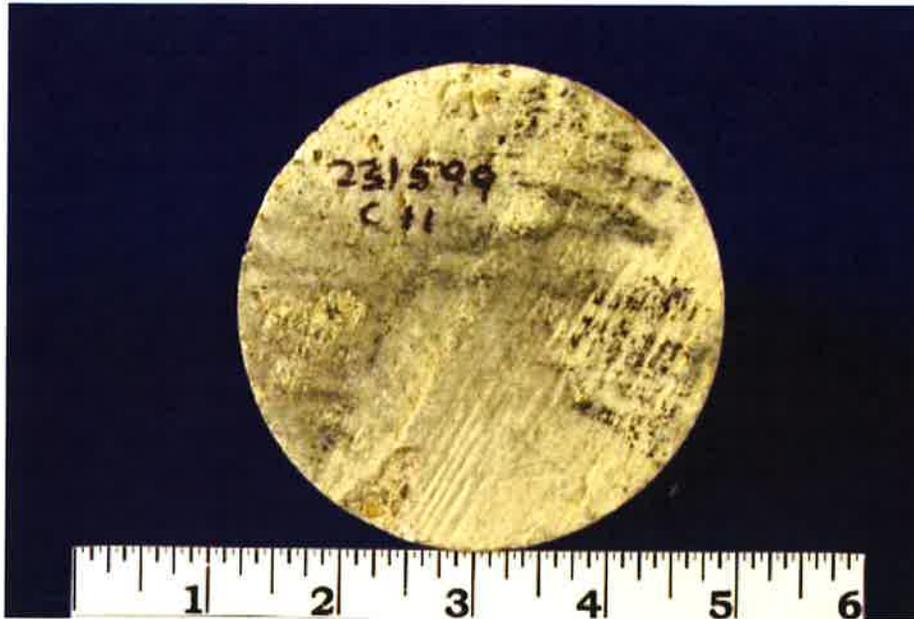
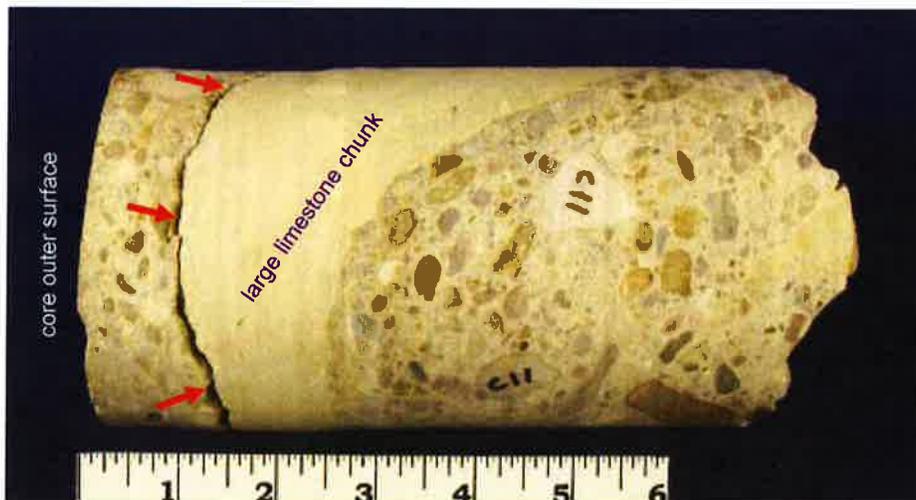
Photo C11-1 Core C11, as received for testing.

C11-1a. Core (concrete) outer surface. The surface is a mostly flat, slightly worn and striated, formed concrete surface, with some shallow abrasion present.

C11-1b. Side view of core. Core was received fractured (red arrows) partially around a large limestone aggregate chunk (large tan object in the center portion of the core); fractured is assessed to be due to the coring.

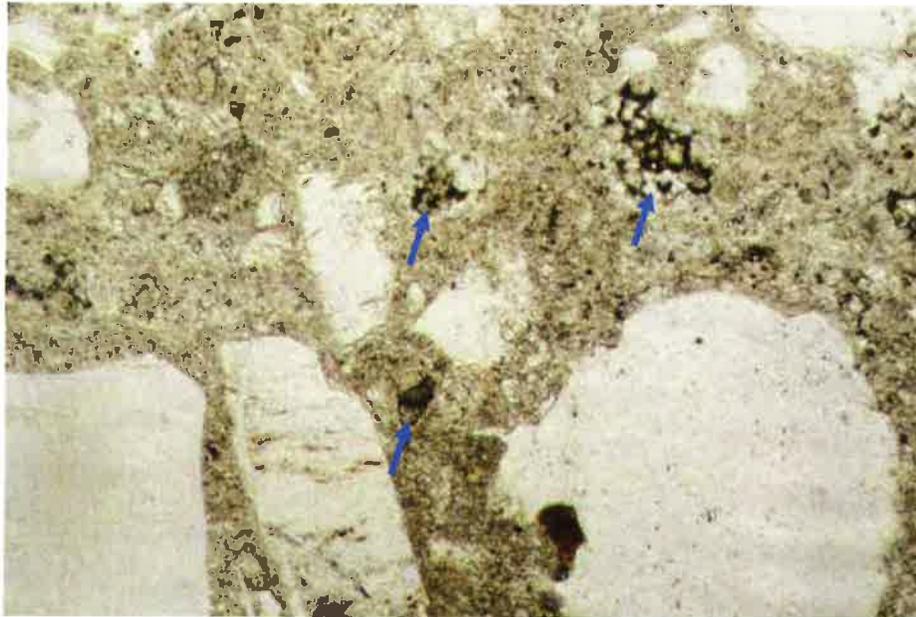
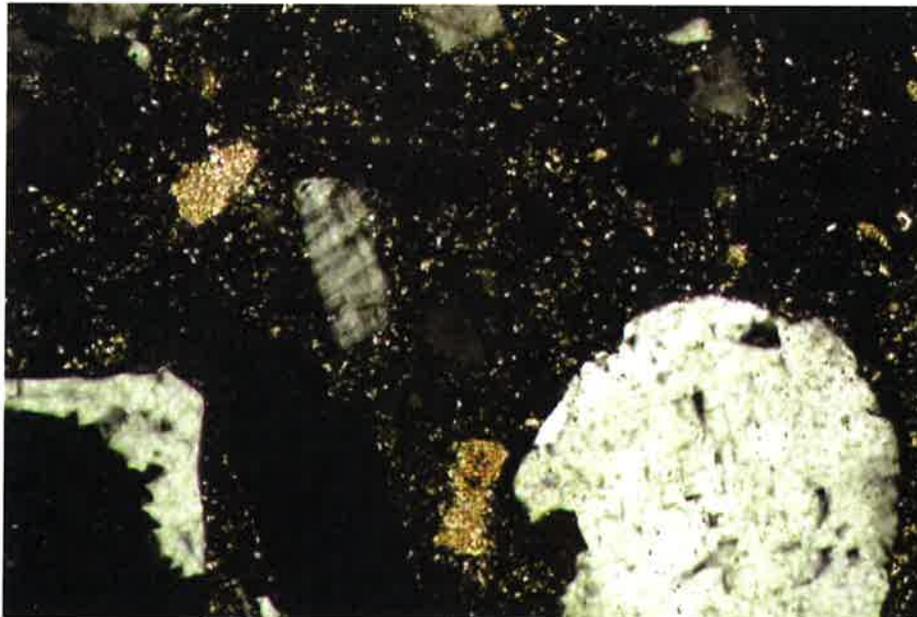
Photo C11-3 Thin section photomicrographs of Core C11, illustrating features in the paste. Both images show the same field of view but under different lighting. Length of field, left to right, is approximately 0.78 mm (0.03 in.).

C11-3a. Plane-polarized light. Blue arrows depict several coarsely ground residual/relic portland cement grains.

C11-3b. Cross polarized light.
