BARTON SPRINGS ROAD OVER BARTON CREEK

Bridge Inspection and Condition Assessment Report

Bridge 14-227-0-B002-26-001
Austin, Texas
January 2017

2016 Bridge Inspection Report
Barton Springs Road over Barton Creek
Bridge 14-227-0-B002-26-001

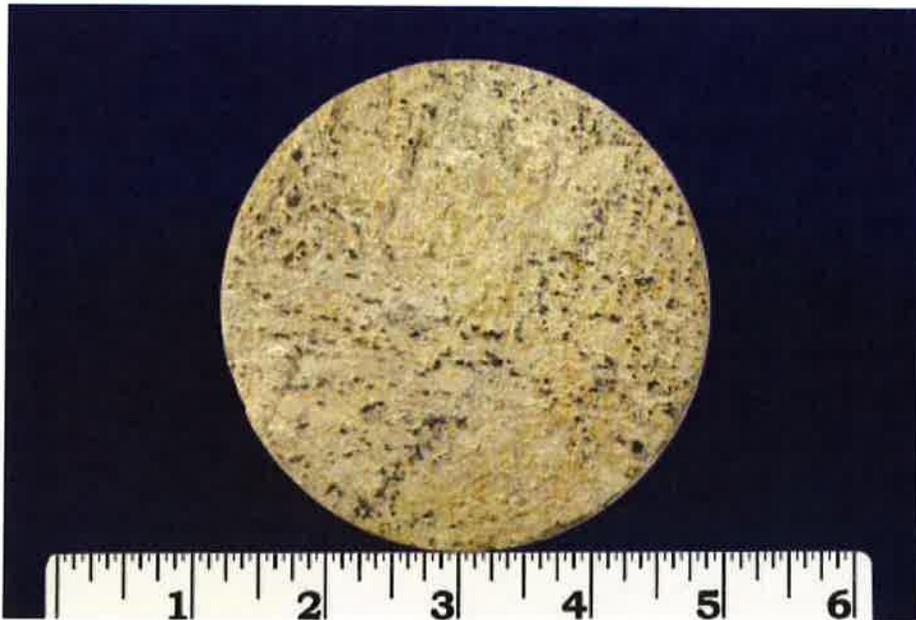
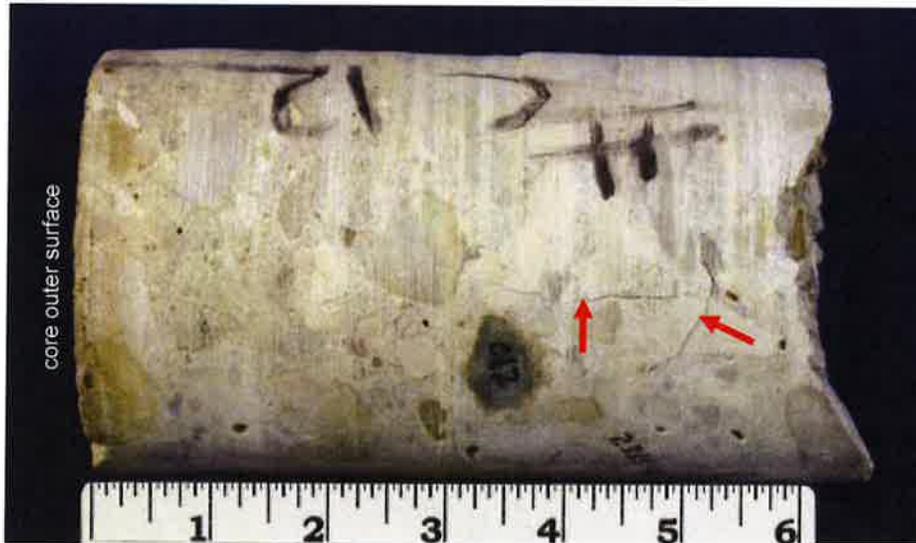
Photo C12-1 Core C12, as received for testing.

Of the 10 cores, only Cores C12 and C13 exhibit notable cracking. In Core C12 the cracking is attributed to alkali-silica reaction (ASR), which has occurred between a random particle of glass and the alkalis in the cement paste. Although the ASR appears localized to the one glass particle, a few glass particles are present in the core, suggesting the possibility for other localized areas of ASR in the surrounding concrete. In Core C13, 2 cracks are present, parallel to each other and approximately 3 inches apart. The cause for these cracks was not discerned petrographically.

C12-1a. Core (concrete) outer surface. The surface texture is a mortar-like coating over the underlying concrete.

C12-1b. Side view of core. Red arrows point to two random cracks.

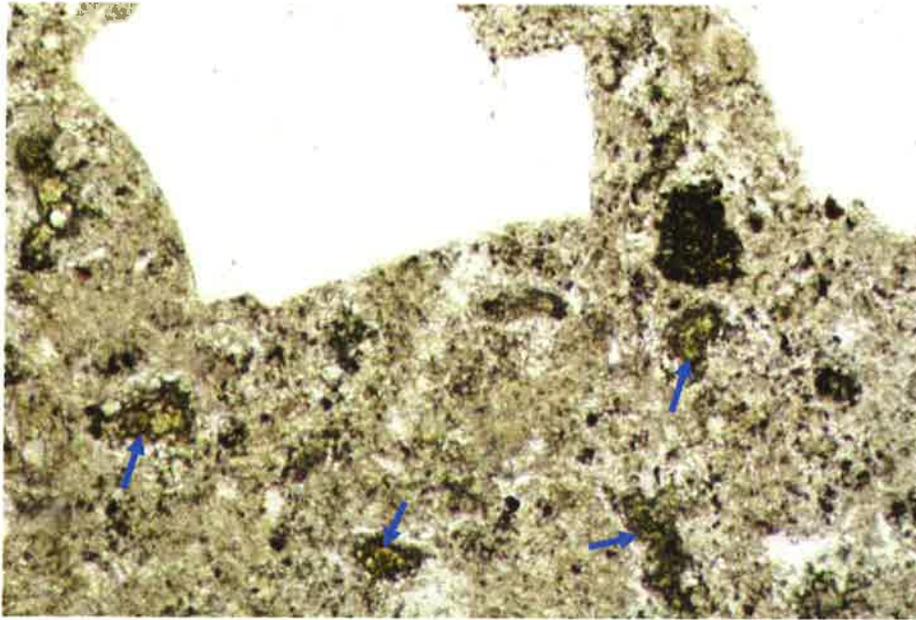
C12-3a. Plane-polarized light. Blue arrows depict several coarsely ground residual/relic portland cement grains.

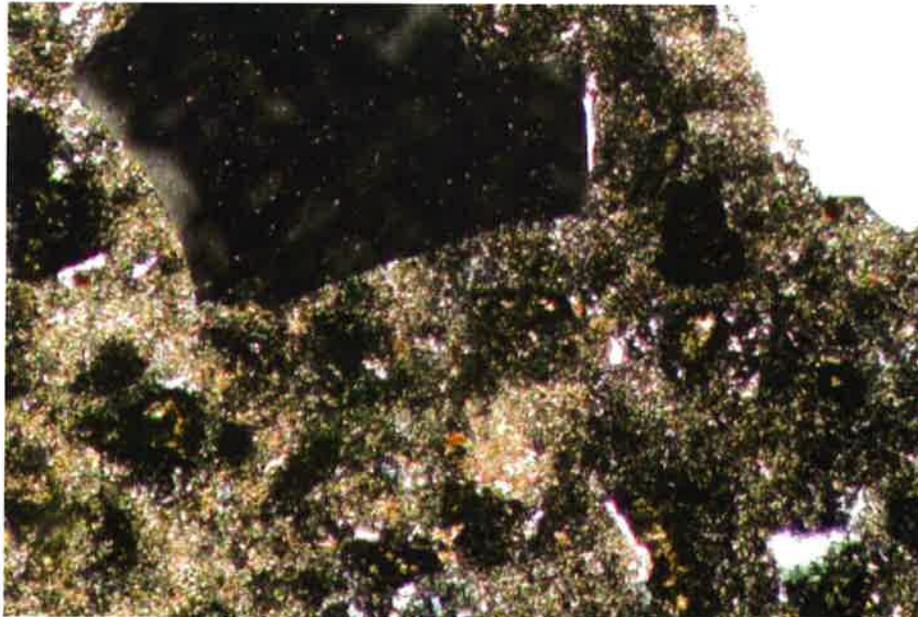
C12-3b. Cross polarized light. Paste is mostly carbonated, shown by its bright tan/brown color.

Photo C12-3 Thin section photomicrographs of Core C12, illustrating features in the paste. Both images show the same field of view but under different lighting. Length of field, left to right, is approximately 0.78 mm (0.03 in.).

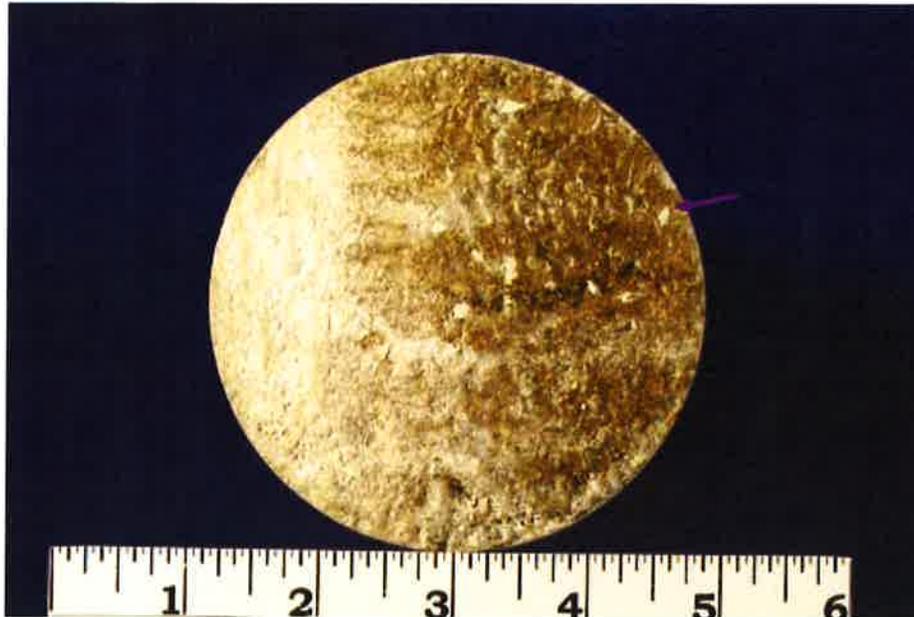
Outer Core Surface: Mostly flat, partially medium brown and partially medium beige, surface. Part of the surface is concrete and part is a thin mortar-like coating. A sealer is present on the part of the mortar-like surface that is medium brown, and worn off of the medium beige area. When water is applied to the area with the sealer, it beads up very readily and is not absorbed for an extended amount of time. When water is applied to the area without a sealer, water is readily absorbed.

C13-1a. Core (concrete) outer surface. The surface is a mostly flat, partially medium brown and partially medium beige, surface. A sealer is present on the part of the surface that is medium brown (purple arrow).

Photo C13-1 Core C13, as received for testing.

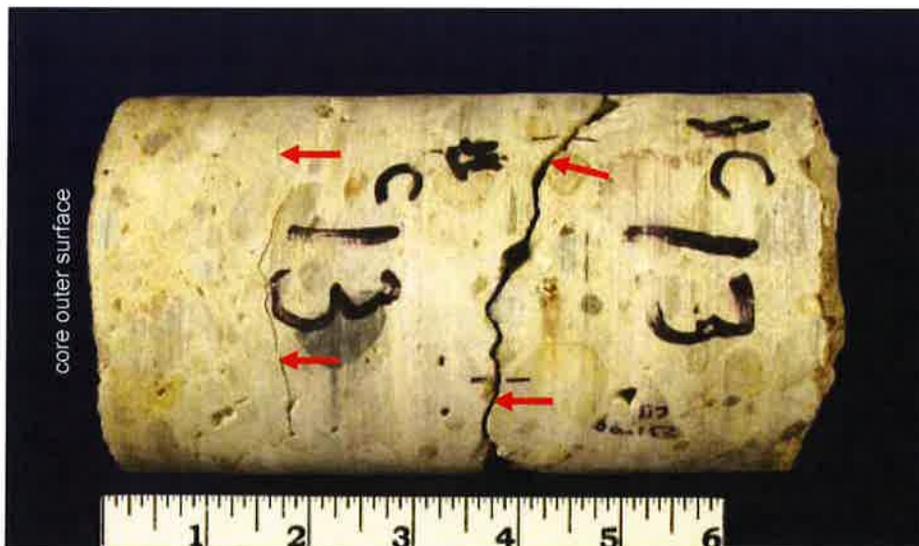
Cracks, Joints, Large Voids: One crack, 0.1 to 0.4 mm (0.004 to 0.2 in.) wide, parallel/slight angle to the core outer surface, occurs between depths of 21 to 48 mm (0.8 to 1.9 in.). One full fracture (crack separates the core in two segments, somewhat parallel to the overlying crack, between depths of 91 to 120 mm (3.6 to 4.7 in.). The cracks extend mostly around aggregate particles. No joints or large voids observed.

C13-1b. Side view of core.

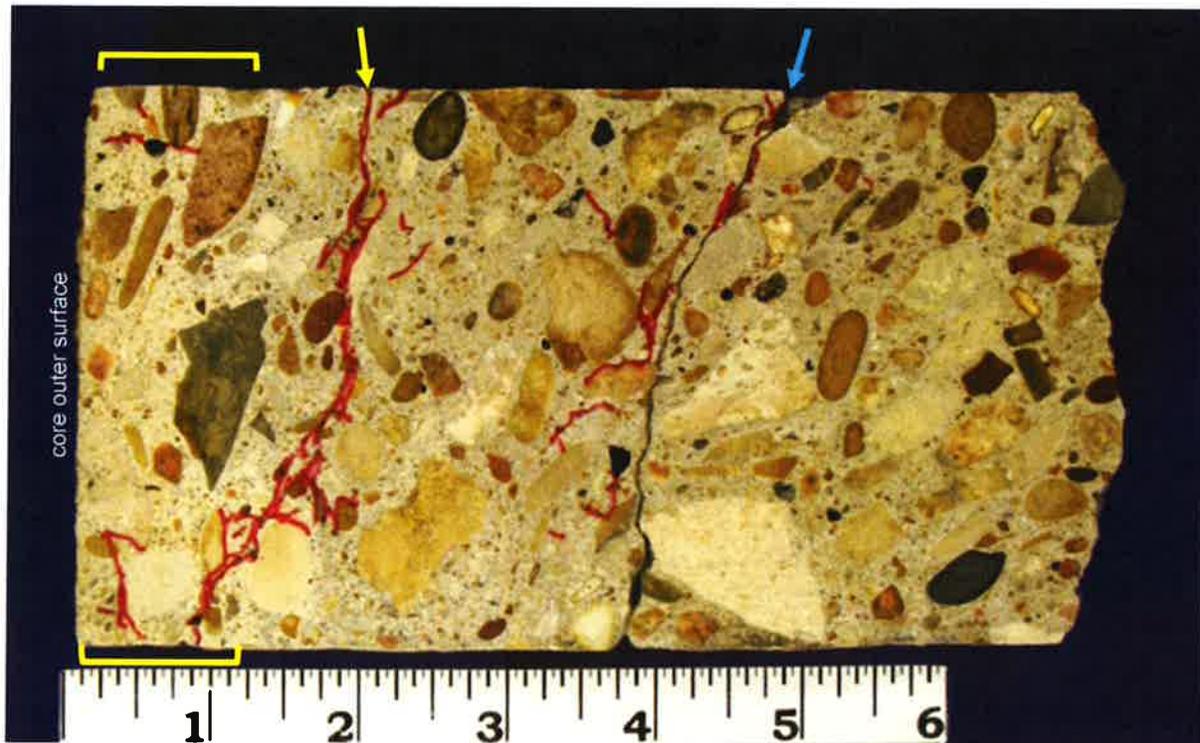
Photo C13-2 Lapped, cross-sectional (longitudinal) concrete surface of Core C13.

MICROCRACKING: Many microcracks occur splaying from the crack and from the full fracture/crack. Very few other microcracks are observed, with no general orientation, located within the outer 20 mm (0.8 in.) of the core. Microcracks extend around all aggregate particles.

Paste carbonation is to a depth of 0.6 to 1.1 in. (yellow brackets) from the outer core surface.

Cracks and microcracks in the concrete are highlighted with red marker to depict their visibility in the image; the actual microcracks are much narrower. The concrete contains many microcracks occur splaying from the crack (yellow arrow) and full fracture/crack (blue arrow). Very few other microcracks with no general orientation are present within the outer 0.8 in. of the core. Microcracks extend around all aggregate particles.

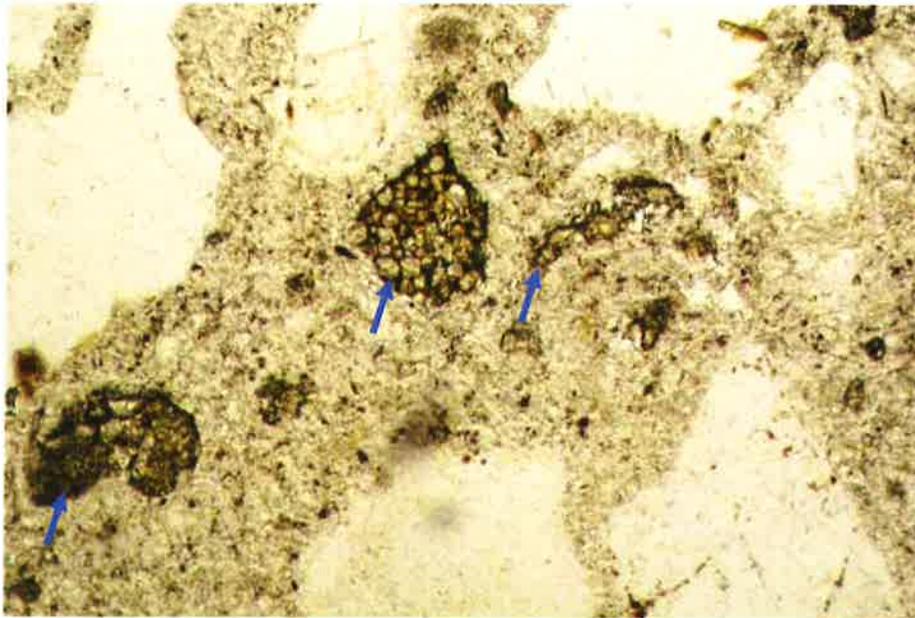
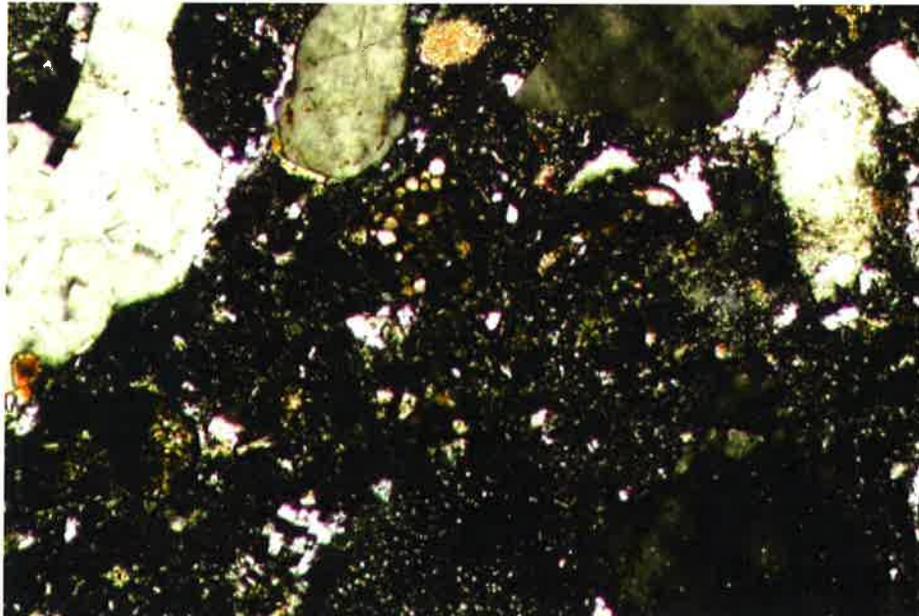
C13-3a. Plane-polarized light. Blue arrows depict several coarsely ground residual/relic portland cement grains.

C13-3b. Cross polarized light.

Photo C13-3 Thin section photomicrographs of Core C13, illustrating features in the paste. Both images show the same field of view but under different lighting. Length of field, left to right, is approximately 0.78 mm (0.03 in.).

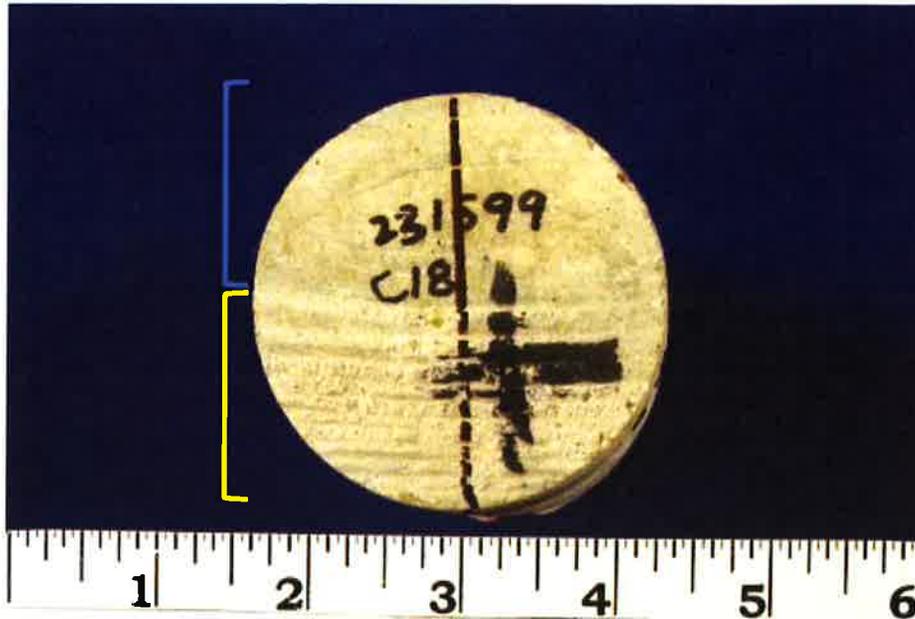
Outer Core Surface: Slightly worn, partially flat, and partially unevenly spaced striated, formed concrete surface.

C18-1a. Core (concrete) outer surface. The surface is a slightly worn, partially flat (blue bracket area), and partially unevenly spaced striated (yellow bracket area), formed concrete surface.

Photo C18-1 Core C18, as received for testing.

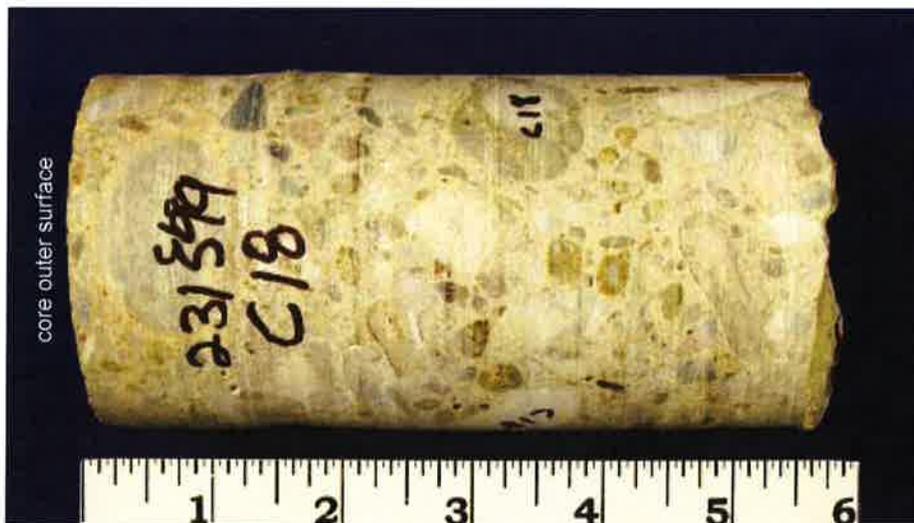
C18-1b. Side view of core.

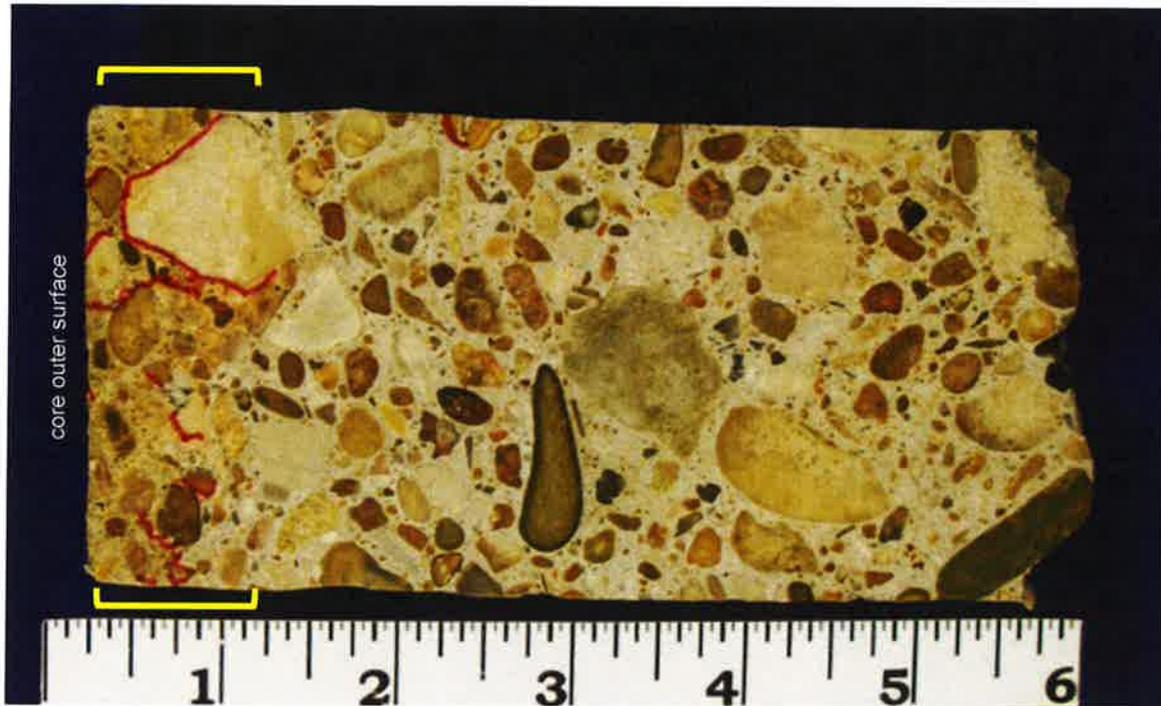
Photo C18-2 Lapped, cross-sectional concrete surface of Core C18.

Paste carbonation is to a depth of 0.6 to 1.1 in. (yellow brackets) from the outer core surface.

The microcracks in the concrete are highlighted with red marker to depict their visibility in the image; the actual microcracks are much narrower. The concrete contains a few microcracks with no general orientation, located within the outer 1.1 in. of the core. Microcracks extend around all aggregate particles.

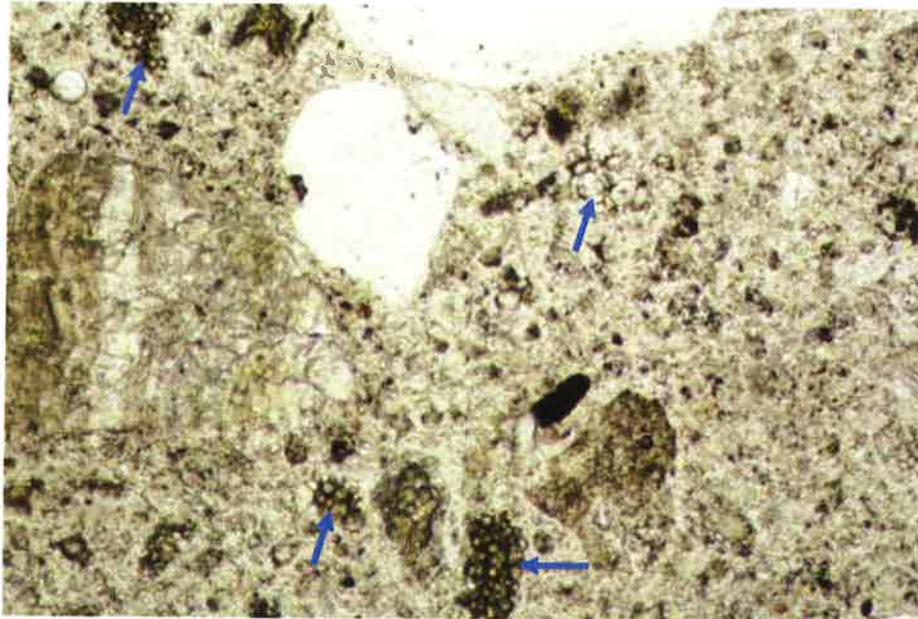
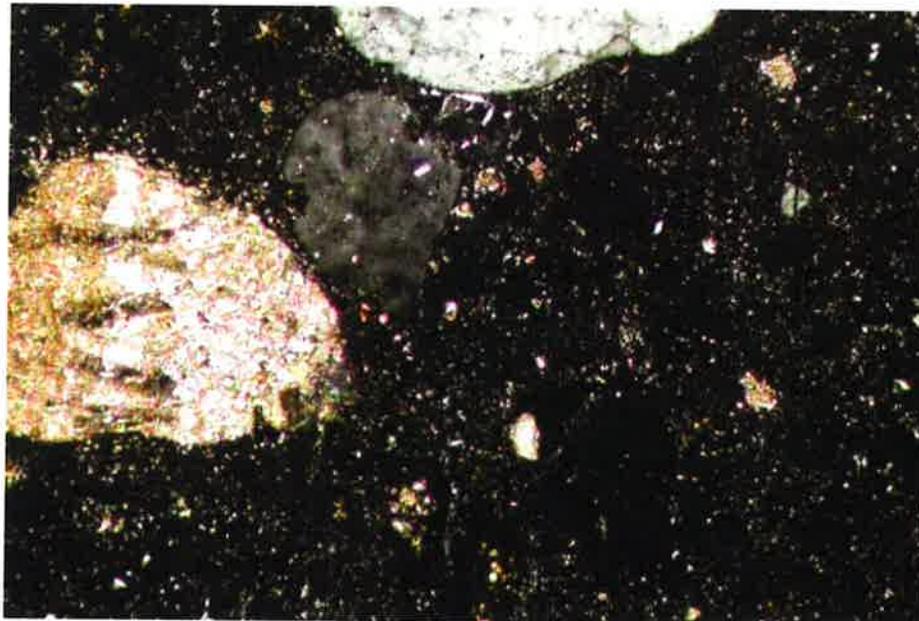
C18-3a. Plane-polarized light. Blue arrows depict several coarsely ground residual/relic portland cement grains.

C18-3b. Cross polarized light.

Photo C18-3 Thin section photomicrographs of Core C18, illustrating features in the paste. Both images show the same field of view but under different lighting. Length of field, left to right, is approximately 0.78 mm (0.03 in.).
